4 第6章（橋梁の基本設計）の関連資料

4.1 現況橋梁諸元

List record field survey and renovation policy decision(1)

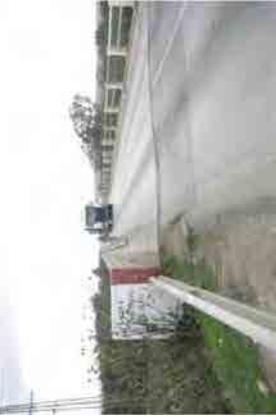
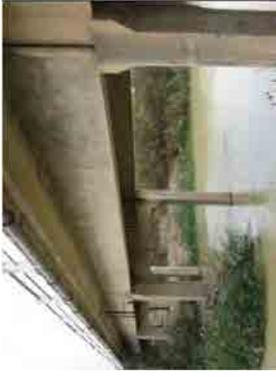
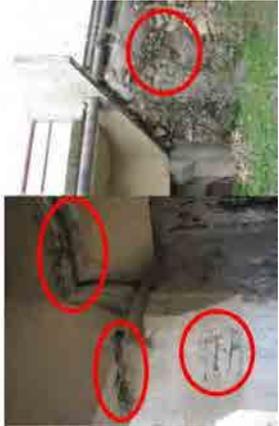
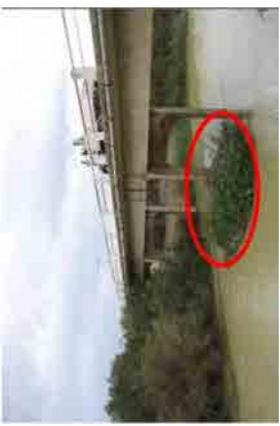
Width of Pillar (m)	0.60		
Height (m)	unknown		
Material	<input checked="" type="checkbox"/> RC <input type="checkbox"/> Stone <input type="checkbox"/> Other		
Form	<input type="checkbox"/> Inverted I type <input type="checkbox"/> Gravity type <input checked="" type="checkbox"/> Wall <input type="checkbox"/> unknown		
Height (m)	unknown		
Width of abutment (m)	8.20		
Location map			
Deterioration & damage		Condition	Not good
Main Deterioration		支間中央の曲げひびわれ、支点付近のせん断ひびわれ、コンクリート剥離、鉄筋露出、鋼材腐食	
Construction Overview

1. Excavation			
2. Reconstruction (1. のみでは困難の場合)			
Other important issues			
①劣化・損傷程度が大きい、			
②交通量が多く、架け替え時は仮橋が必要。			
Pictures of Site		Pictures of Site

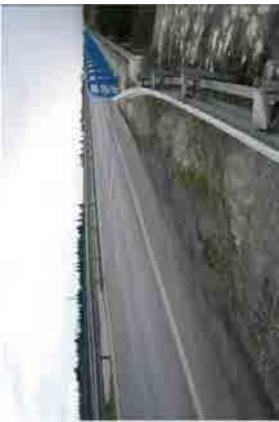
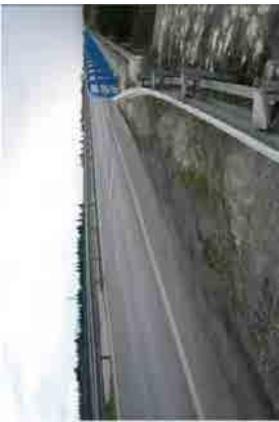
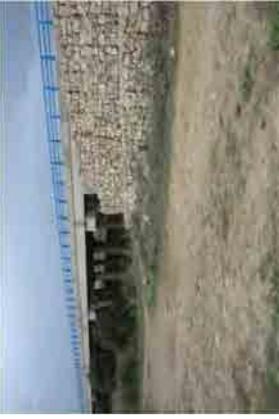
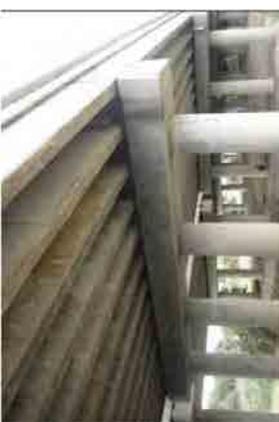
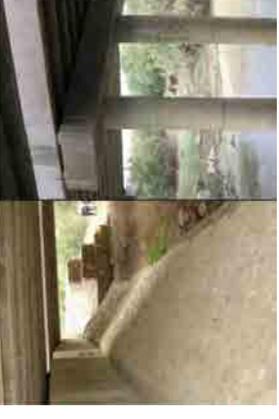
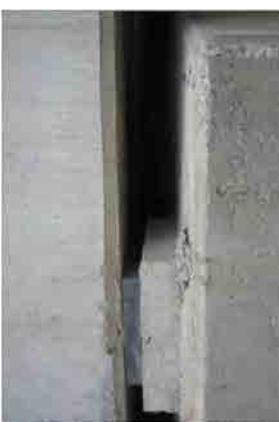
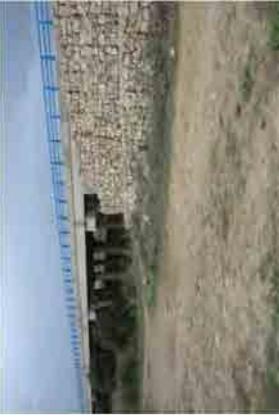
Height (m)	unknown	Pier	unknown	beam	unknown	
Material	<input checked="" type="checkbox"/> RC <input type="checkbox"/> Stone <input type="checkbox"/> Other	Form	<input checked="" type="checkbox"/> Inverted I type <input type="checkbox"/> Gravity type <input type="checkbox"/> Other	Width of abutment (m)	12.00	
Height (m)	2.10	Parapet	Wall	unknown		
Location map						
Deterioration & damage		Condition		Good		
1999-2002架設の新橋のため、損傷なし。						
Deterioration						
Main						
Construction Overview

1. Excavation						
Other important issues						
①1999-2002架設						
②上下線分離の橋梁である。						
Picture-1 Deck surface		Picture-2 Side		Picture-3 The underside of the beam

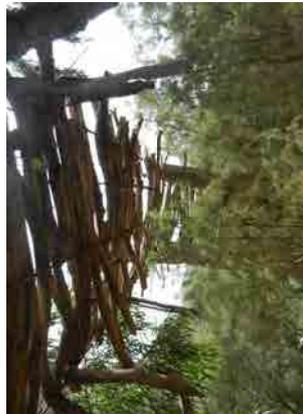
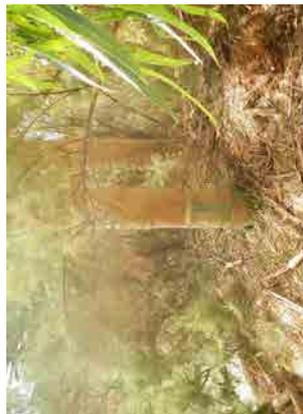
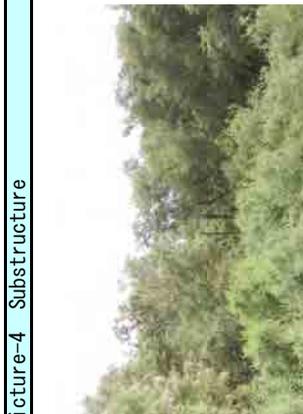
Deterioration	Condition	Good
		Main		
		Construction Overview		
		No measures		
		Other important issues		
		おそらく単脚桁で再利用不可のため、詳細調査は不要、橋長、幅員の計測のみ		
		Picture-1 Deck surface		Picture-2 Side

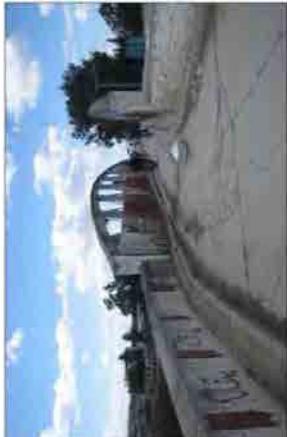
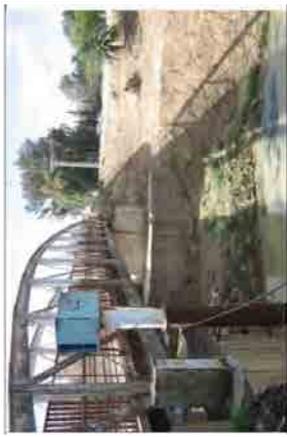
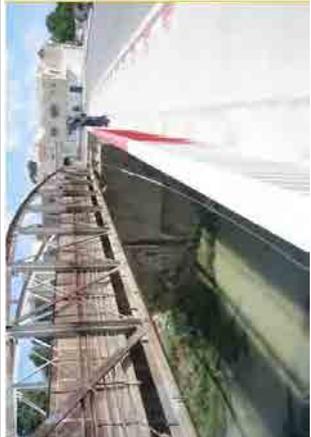
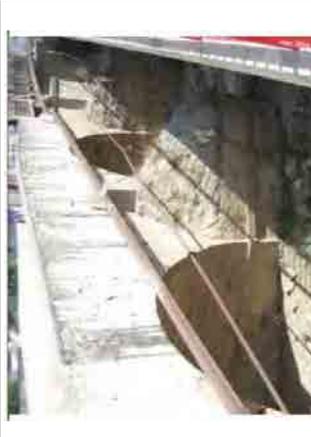
Condition	Not good	
		①欄柵のひび割れ、漏水 ②主径間の深刻な損傷 ③土砂堆積による部分的な河道閉塞		
		Construction Overview

1. removing of sediment. 2. constructing of by-pass		
		Other important issues		
		Because of historical bridge, removing bridge is difficult.		
		Picture-1 Deck surface

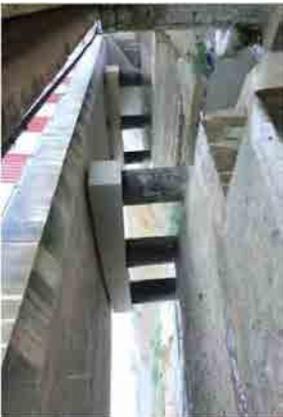
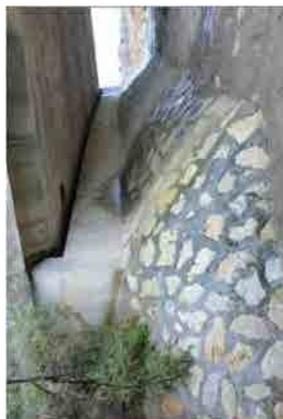
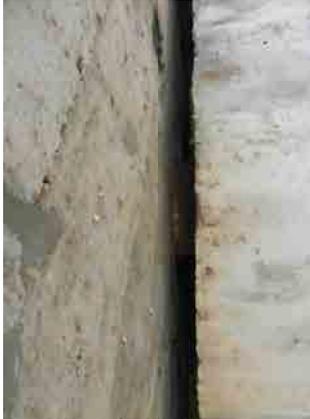
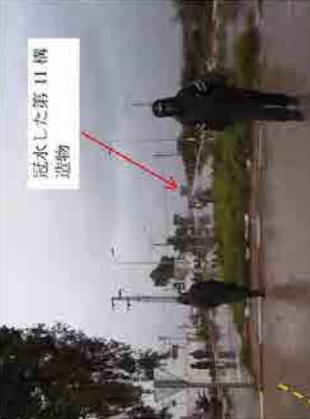
Form	<input type="checkbox"/> Single column <input type="checkbox"/> Bearing wall <input type="checkbox"/> Pile bent <input type="checkbox"/> Rahmen <input type="checkbox"/> Other			
Width of Pillar (m)	Longitudinal			
Height (m)	Pier			
Material	<input checked="" type="checkbox"/> RC <input type="checkbox"/> Stone <input type="checkbox"/> Other			
Form	<input checked="" type="checkbox"/> Inverted I type <input type="checkbox"/> Gravity type <input type="checkbox"/> Other			
Height (m)	Parapet			
Width of abutment (m)	Wall			
Location map				
Deterioration & damage		Condition		
①水漏れ		Not good		
Main		Deterioration		
Excavation		Construction Overview		
Other important issues		①水漏れ対策が必要。 ②左岸側は市街地、右岸側は農地 ③谷がやや深い

特になし。		Good	
<p>Construction Overview</p> <p>No measures</p>		<p>Other important issues</p> <p>①水理評価のため断面の把握(測量)が必要。 ②旧橋には添架管有り。 ③近接して水路橋がある。</p>

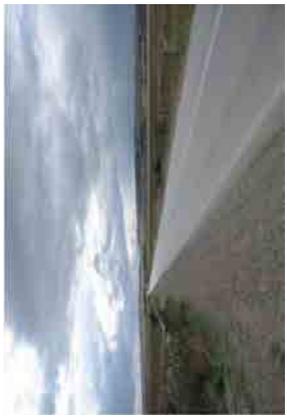
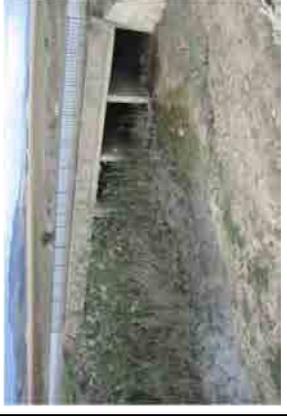
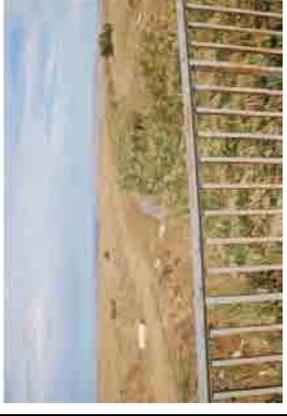
特になし	Good
		Deterioration	
		Construction Overview

1. Reconstruction (既存水路50m/sから200m/sへの改修のため、断面不足は明らか)	
		Other important issues	
		平面図と側面図・写真が不一致(平面図は単純の桁橋、写真は6径間のBoxCulvert)	
Pictures of Site		Picture-1 Deck surface	Picture-2 Side

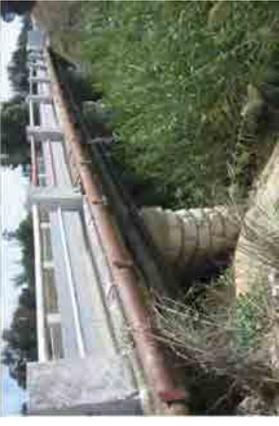
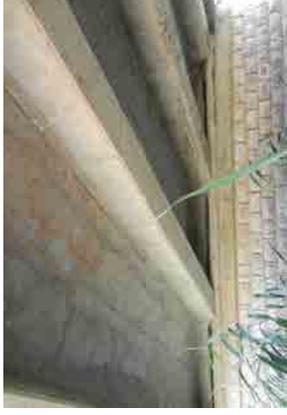
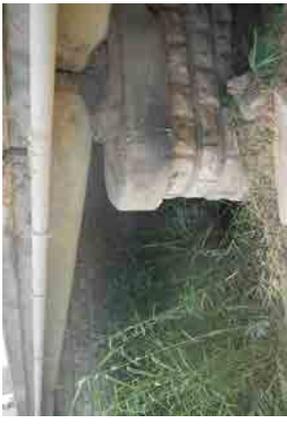
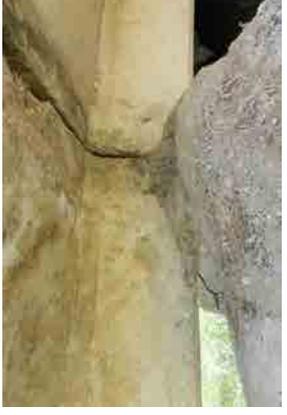
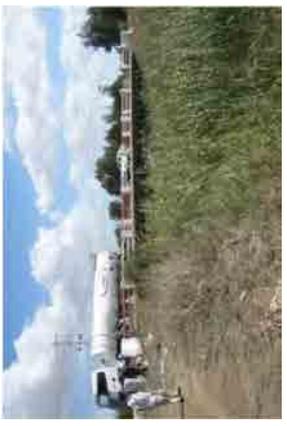
Mild damage		
		Deterioration		
		①伸縮装置の劣化		
		②排水装置の欠陥		
		No measures		
		Construction Overview		
		Other important issues		
		①河床を掘削する場合は掛け替えとなる。		
		②側面に添架管有り。
