**DATA COLLECTION SURVEY
FOR
RECONSTRUCTION OF TEOUMA BRIDGE
ON EFATE RING ROAD**

SURVEY REPORT

JANUARY 2017

CTI ENGINEERING INTERNATIONAL CO., LTD.

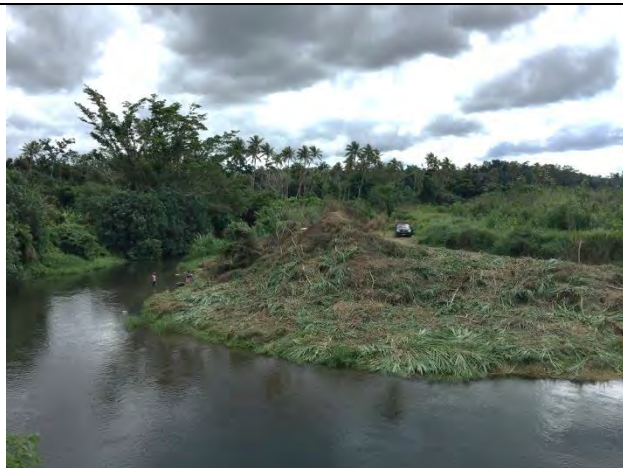
River Condition (Upstream of Teouma Bridge)

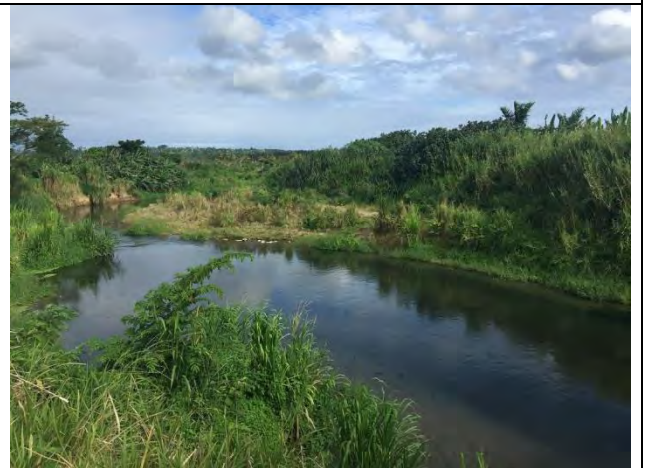
River Condition (Downstream of Teouma Bridge)

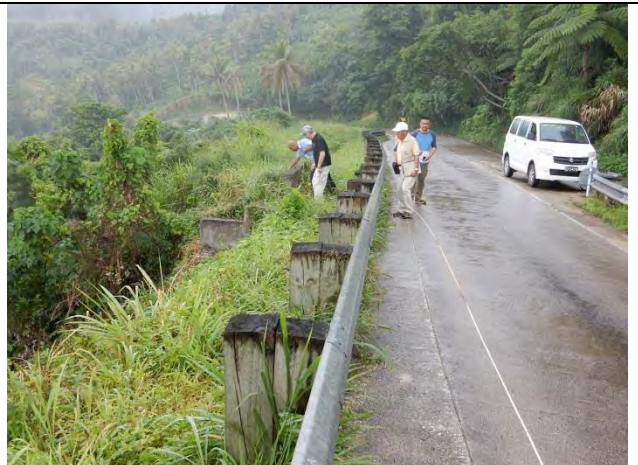
Klems Hill Slope Failure Area

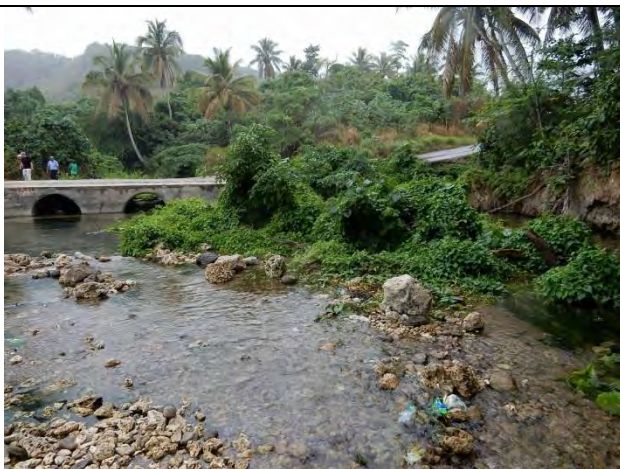
**Sedimentation and Trees Blocking Cross Section
Area in River (Creek Ai Culvert)**

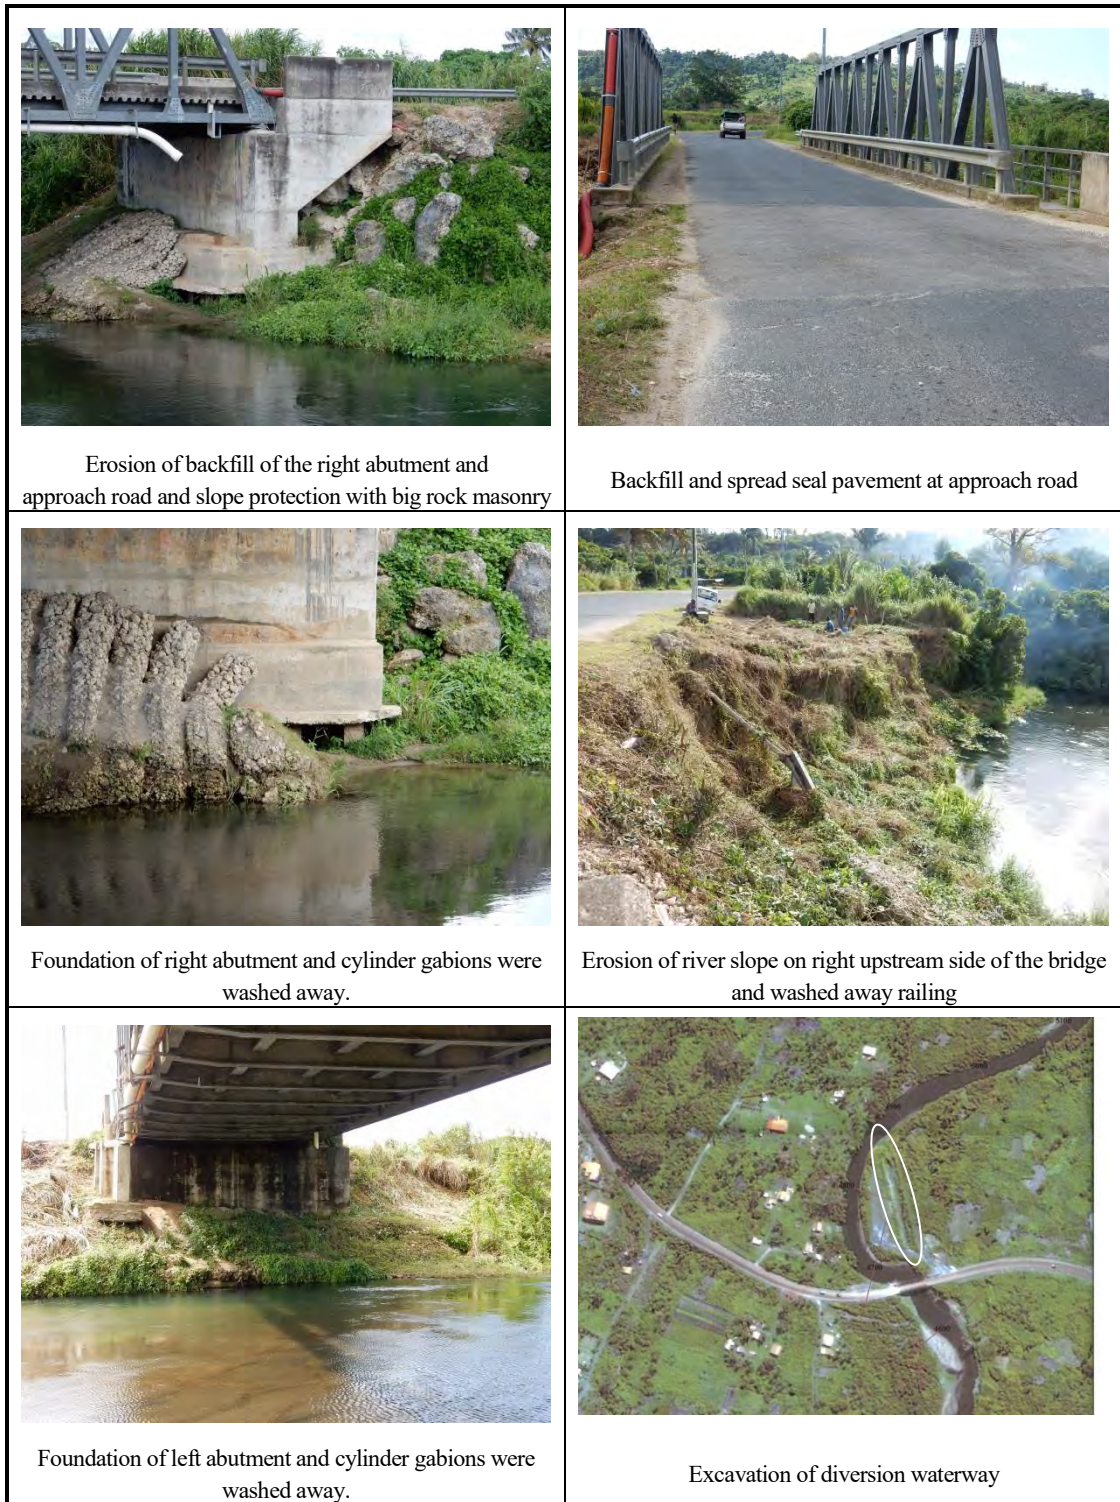
- Eroded portion of the backfill of the right abutment and the approach road was filled with soil. The approach road was coated with spread seal pavement and opened to traffic.
- Big rock masonry was applied for the slope protection of the approach road in the right upstream side of Teouma Bridge.
- The water pipe and cables are temporarily restored.
- Urgently, the diversion waterway with about 10 m in width was excavated toward Teouma Bridge at right angle.

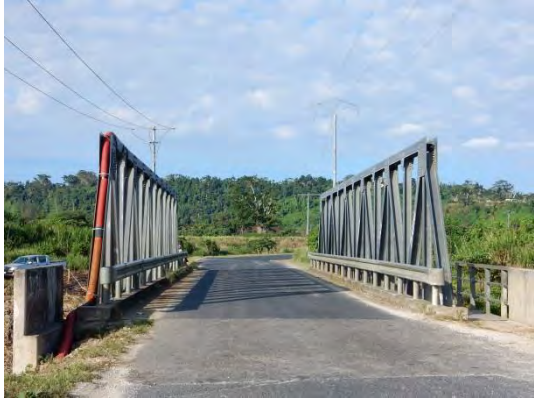
Superstructure (good condition)

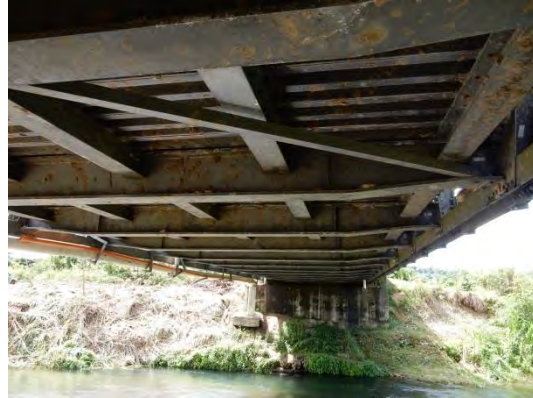
Superstructure (good condition)

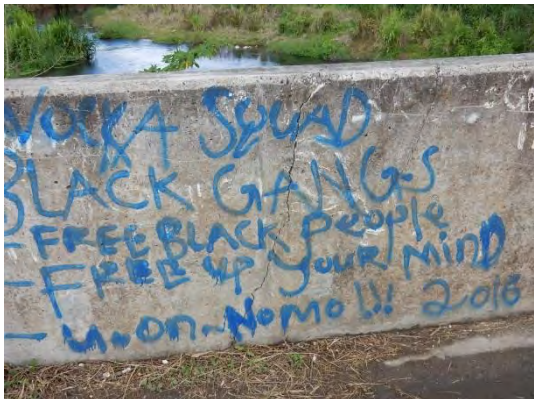
Side Wall on Right Abutment (Cracks)

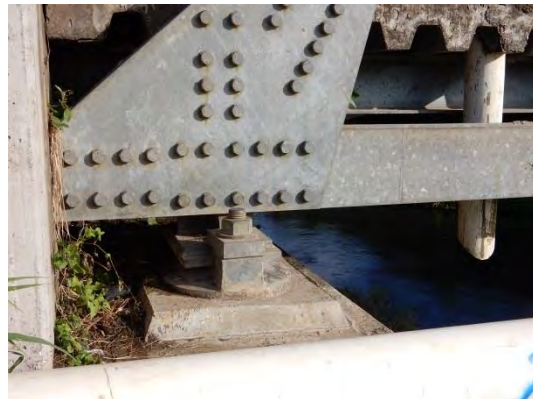
Hinged Bearing (good condition)

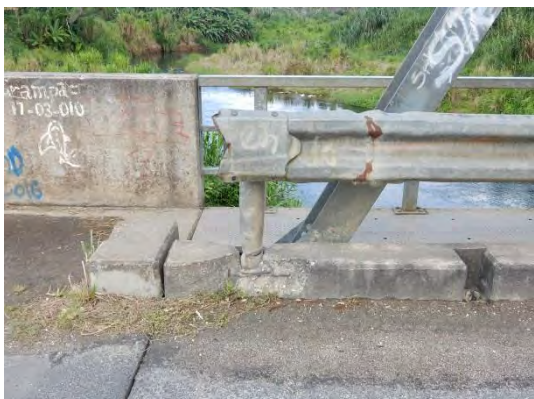
Damage on Railing and Curb

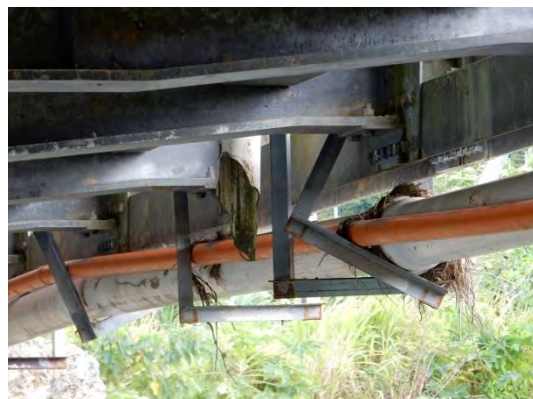
Damage on Drainage Pipe

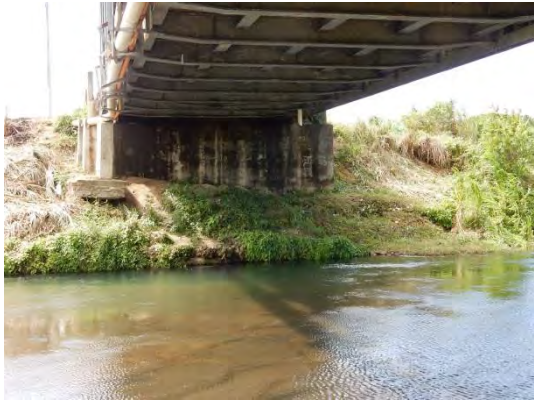
Damage on Gabion Protection (Left Bank)

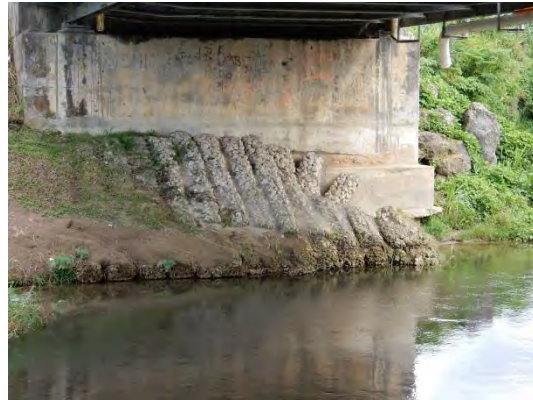
Damage on Gabion Protection (Right Bank)

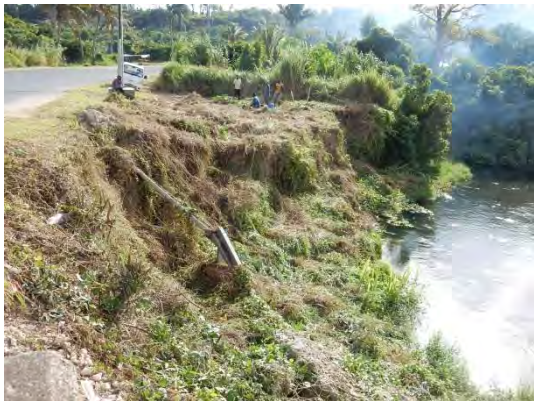
Damaged Railing
