FOLLOW-UP COOPERATION
ON
THE PROJECT FOR IMPROVEMENT
OF
INTERNATIONAL COOPERATION AND TRAINING CENTER
IN
LAO PEOPLE'S DEMOCRATIC REPUBLIC

Interim Report

August, 2015

Azusa Sekkei CO., LTD.

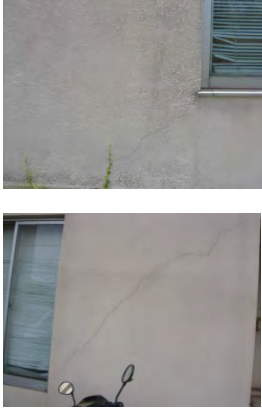
No.	Location	Condition		Cause	Countermeasure	Priority Rank
1-4	ADM

<p>0.1~0.3mm wide crack from the corner of window was observed.</p> <p>Leakage to the interior was not observed.</p>	<p>The mortar fill around the window frames were not enough. Also, the corner reinforcement for the window opening was not enough to prevent the cracks.</p>	<p>The delaminated mortar and other cracked area need to be removed. After the removal, the substrate needs to be repaired, and mortar resin spray finish needs to be applied.</p>	A
1-5

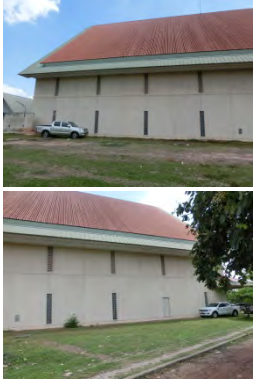
<p>Cracks due to the shrinkage and the movement of the different material underneath.</p>	<p>Shrinkage and dryouts are causing the cracks because there is no control joint between the different substrate underneath.</p>	<p>Remove the delaminated mortar and repair the substrate with mortar or mortar resin material. After the repair, mortar resin spray paint needs to be applied. For the control</p>	A

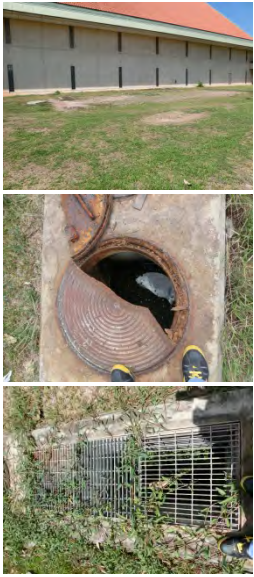
No.	Location	Condition		Cause	Countermeasure	Priority Rank
					area as is, interlocking pavement tiles are preferred.	
13	Sewerage Plant

A manhole cover is broken. Other covers are rusted and could not open.	Regular maintenance has not been conducted since the completion.	The septic tanks need to be cleaned, and broken parts need to be replaced. (No odor was observed. The demand for the treatment capacity seems low since the facility is used only during daytime. The capacity may have been meeting the demand so far with the acceleration of process due to the hot climate.)	A
14	Exterior Lighting

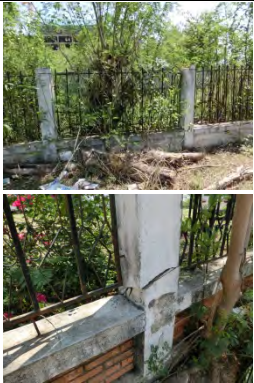
<p>Some of the exterior fences along the property are broken.</p>	<p>Aged deterioration and construction defects</p>	<p>Replace the defected part. There are no eminent danger nor security issues at this point.</p>	C

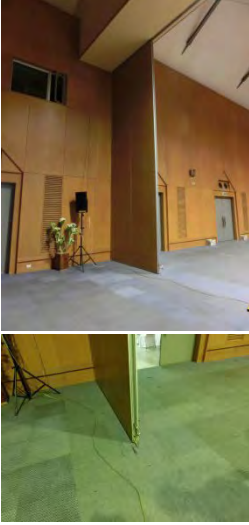
No.	Location	Condition	Cause	Countermeasure	Priority Rank
1F					
1	Multipurpose Room				
1-1	Room-A/B Sliding Wall

<p>The movable partition cannot be fully opened. (The movable base of the 22nd panel cannot be lifted due to the broken parts inside, hence the panel cannot be moved.) Also, the fourth panel is starting to have the same problem.</p>	Due to regular aged deterioration and misuse, the movable base parts are broken.	The panels are rarely opened. Hence only replacing the movable base mechanism of 4th and 22 nd panel suffices.	B
1-2	Room-B Screen

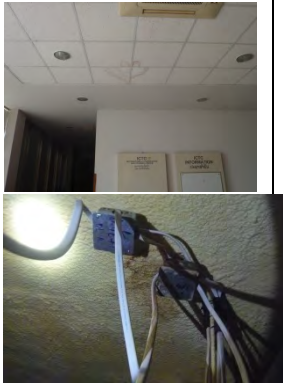
Water mark on the ceiling was observed.	After checking the ceiling space, traces of water leakage was observed under the roof slab. Defection of the water proofing	If the ceiling is a part of system ceiling, the stained panel can be simply replaced. If the stain is on the plaster board portion, enough area needs to be replaced with new plaster	A

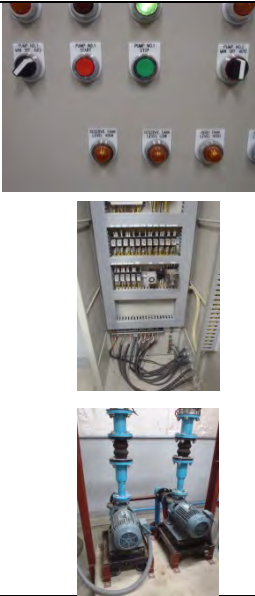
The water pumps cannot be operated alternatively.	One of the timers was broken and has been detached.	After replacing the timer, overall testing and inspection will be needed.	C
22	Electrical Room Grill

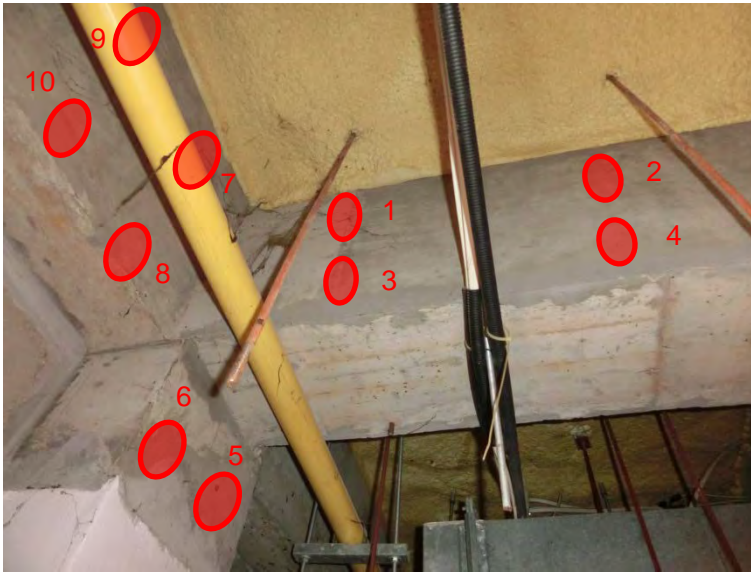
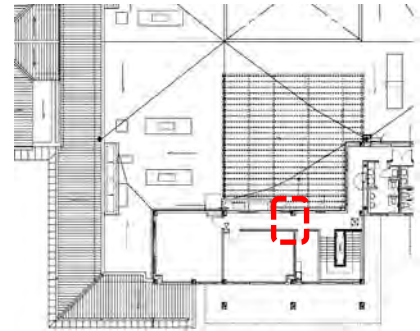
<Site 1:2nd Floor Corridor-1>

Location	Strength(N/mm ²)		INDEX		STA_A	STA_R	
1	40.1	◎	1.16	◎	0	0	◎
2	38.89	◎	1.13	◎	0	0	◎
3	43.47	◎	1.18	◎	0	0	◎
4	34.51	◎	1.13	◎	0	0	◎
5	32.43	◎	1.15	◎	0	0	◎
6	37.32	◎	1.21	◎	0	0	◎
7	50.79	◎	1.19	◎	0	0	◎
8	40.96	◎	1.14	◎	0	0	◎
9	50.02	◎	1.21	◎	0	0	◎
10	50.09	◎	1.46	○	0	0	◎

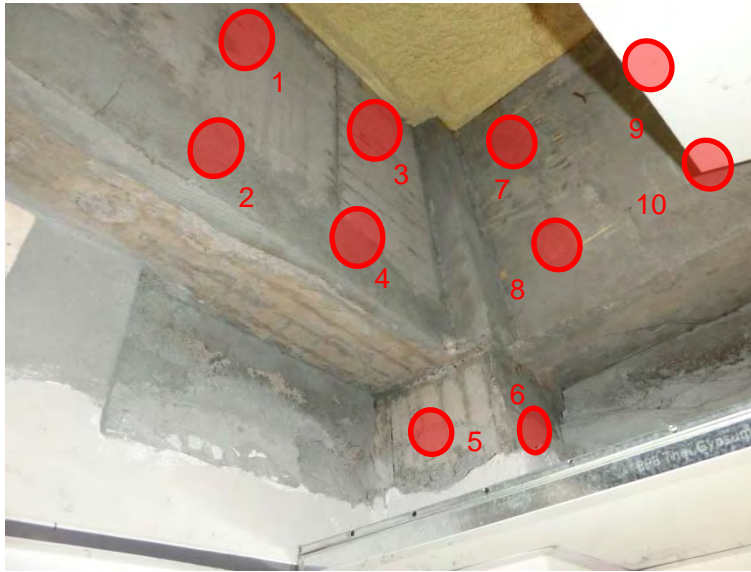
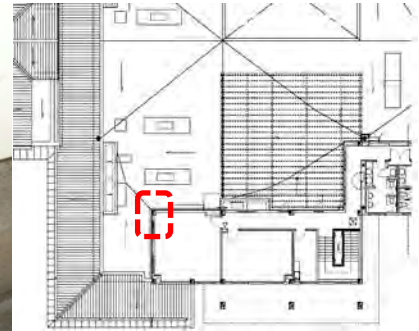
<Site 2: 2nd Floor Meeting Room>

Location	Strength(N/mm2)		INDEX		STA_A	STA_R	
1	31.73	◎	1.26	◎	0	0	◎
2	35.12	◎	1.15	◎	0	0	◎
3	56.95	◎	1.13	◎	0	0	◎
4	54.48	◎	1.14	◎	0	0	◎
5	36.65	◎	1.08	◎	0	0	◎
6	37.16	◎	1.13	◎	0	0	◎
7	55.54	◎	1.37	◎	0	0	◎
8	52.24	◎	1.21	◎	0	0	◎
9	34.96	◎	1.34	○	0	0	◎
10	43.04	◎	1.11	◎	0	0	◎

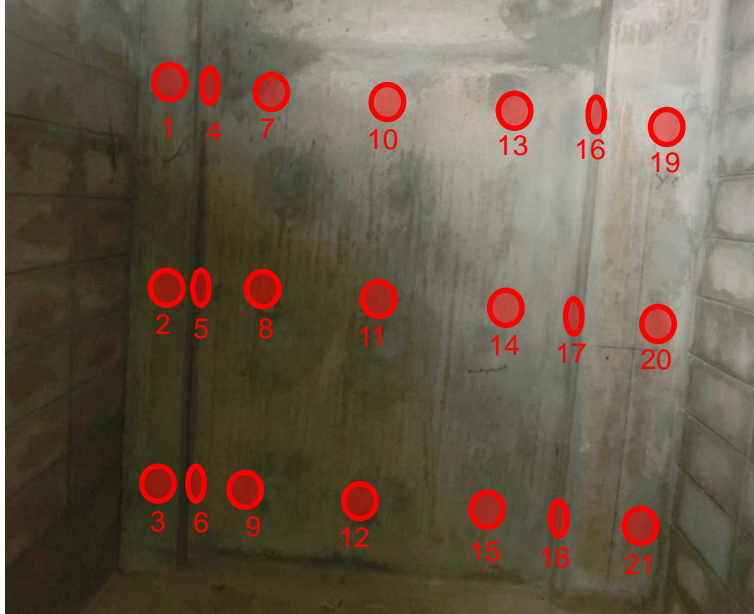
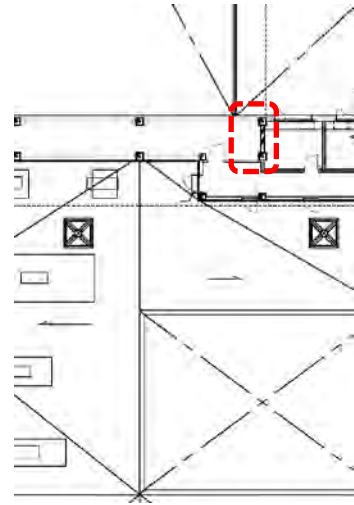
<Site 3: 2nd Floor Maintenance Corridor-4>

Location	Strength(N/mm2)		INDEX		STA_A	STA_R	
1	40.3	◎	1.18	◎	0	0	◎
2	38.48	◎	1.41	○	0	0	◎
3	42.99	◎	1.12	◎	0	0	◎
4	58.24	◎	1.17	◎	0	0	◎
5	42.05	◎	1.27	◎	0	0	◎
6	32.87	◎	1.09	◎	0	0	◎
7	39.94	◎	1.31	○	0	0	◎
8	41.34	◎	1.1	◎	0	0	◎
9	26.56	○	1.02	◎	0	0	◎
10	33.61	◎	1.25	◎	0	0	◎
11	28.72	○	1.2	◎	0	0	◎
12	41.39	◎	1.21	◎	0	0	◎
13	36.11	◎	1.1	◎	0	0	◎
14	44.65	◎	1.14	◎	0	0	◎
15	32.17	◎	1.25	◎	0	0	◎
16	36.86	◎	1.12	◎	0	0	◎
17	37.46	◎	1.09	◎	0	0	◎
18	35.73	◎	1.16	◎	0	0	◎
19	33.02	◎	1.1	◎	0	0	◎
20	44.24	◎	1.18	◎	0	0	◎
21	29.87	○	1.08	◎	0	0	◎

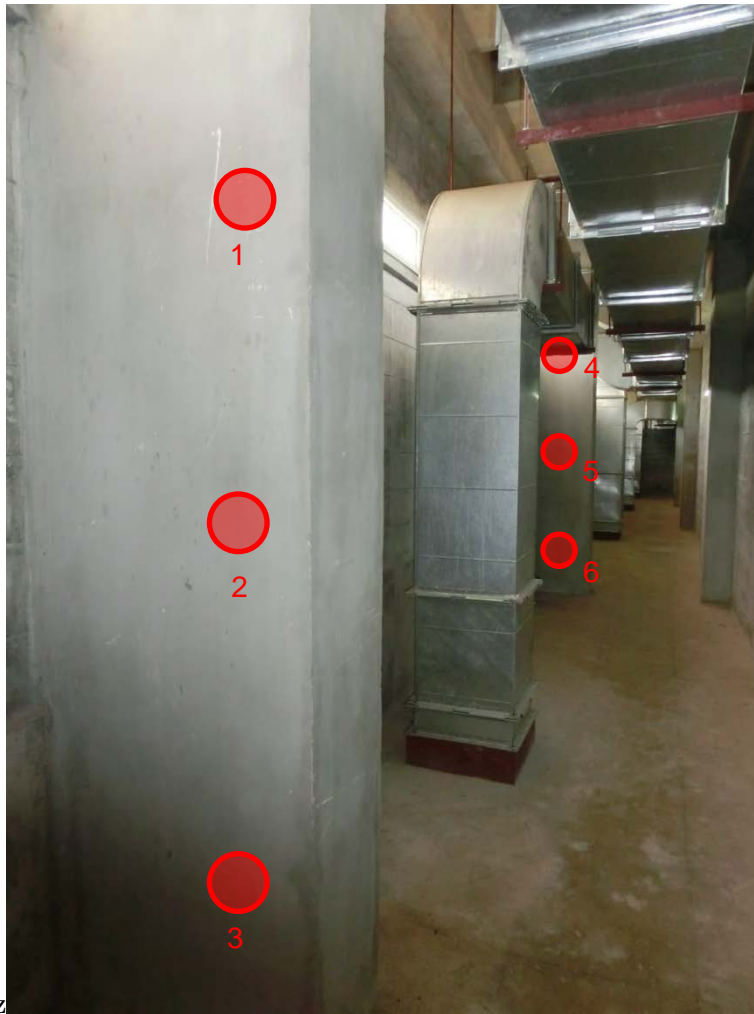
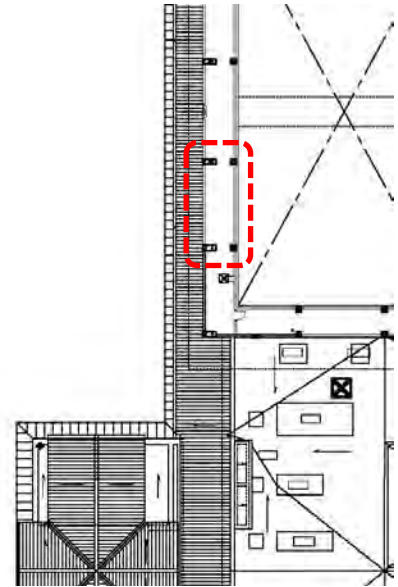
<Site 4: 2nd Floor Maintenance Corridor-3>

Location	Strength(N/mm2)		INDEX		STA_A	STA_R	
1	42.46	◎	1.26	◎	0	0	◎
2	38.93	◎	1.17	◎	0	0	◎
3	33.37	◎	1.15	◎	0	0	◎
4	34.01	◎	1.26	◎	0	0	◎
5	41.84	◎	1.14	◎	0	0	◎
6	27.97	○	1.36	○	0	0	◎

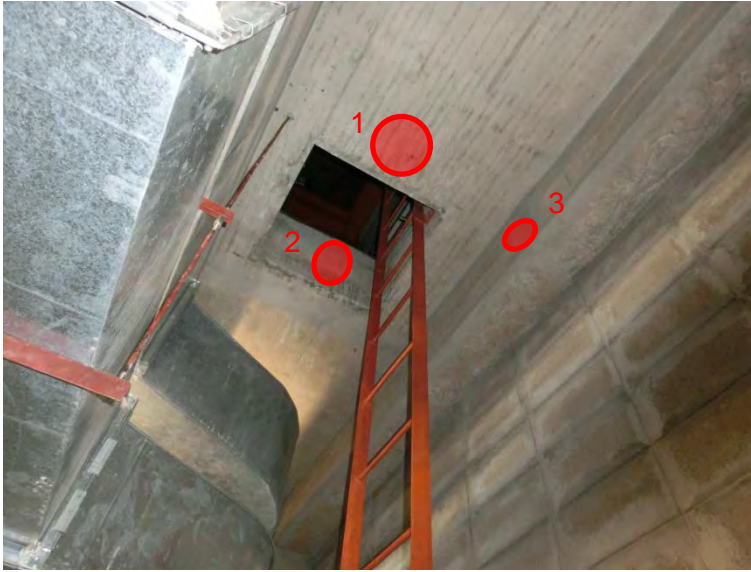
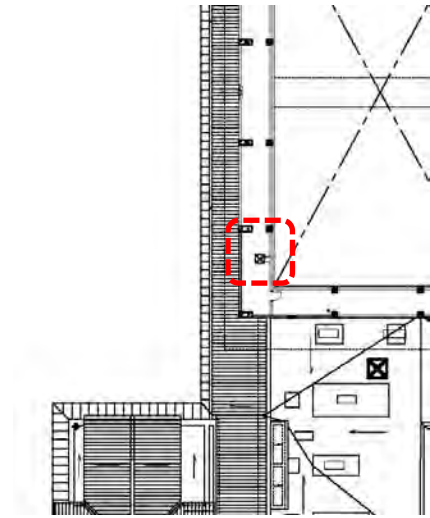
<Site 5: 3rd Floor Slab>

Location	Strength(N/mm2)		INDEX		STA_A	STA_R	
1	41.71	◎	1.15	◎	0	0	◎
2	41.54	◎	1.11	◎	0	0	◎
3	38.38	◎	1.3	◎	0	0	◎

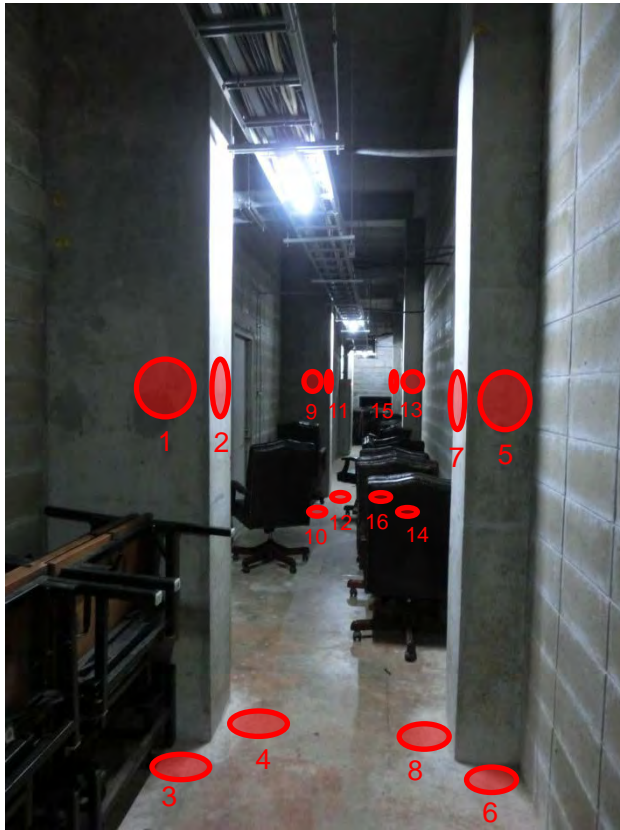
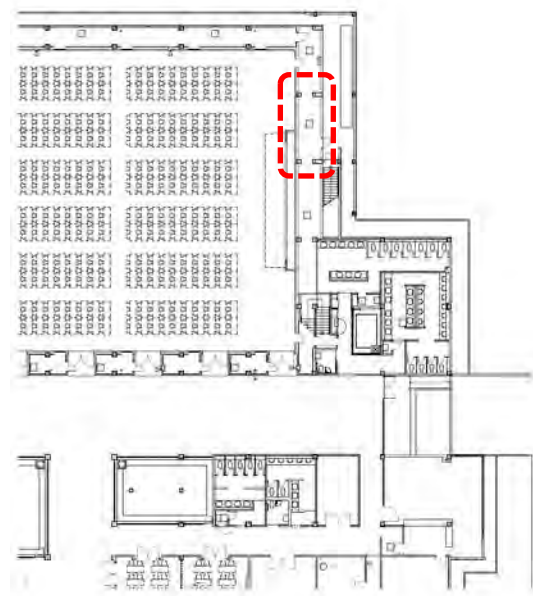
<Site 6: Maintenance Corridor-1>

Location	Strength(N/mm2)		INDEX		STA_A	STA_R	
1	38.83	◎	1.08	◎	0	0	◎
2	32.21	◎	1.22	◎	0	0	◎
3	24.25	○	1.05	◎	0	0	◎
4	32.46	◎	1.14	◎	0	0	◎
5	49.71	◎	1.08	◎	0	0	◎
6	43.18	◎	1.22	◎	0	0	◎
7	43.78	◎	1.33	○	0	0	◎
8	32.6	◎	1.22	◎	0	0	◎
9	24.06	○	1.56	○	0	0	◎
10	26.89	○	1.36	○	0	0	◎
11	36.12	◎	1.07	◎	0	0	◎
12	39.66	◎	1.12	◎	0	0	◎
13	27.1	○	1.18	◎	0	0	◎
14	23.87	○	1.3	◎	0	0	◎
15	33.89	◎	1.08	◎	0	0	◎
16	45.79	◎	1.17	◎	0	0	◎

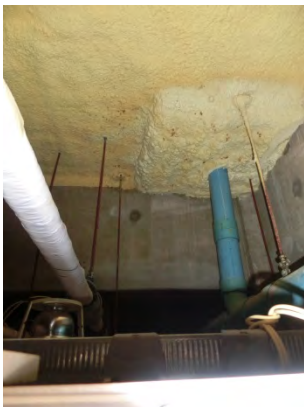
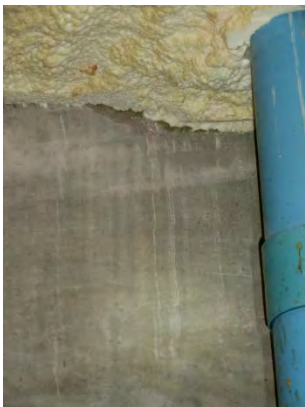
<Entrance Hall>

The water streak line on the wall was observed.

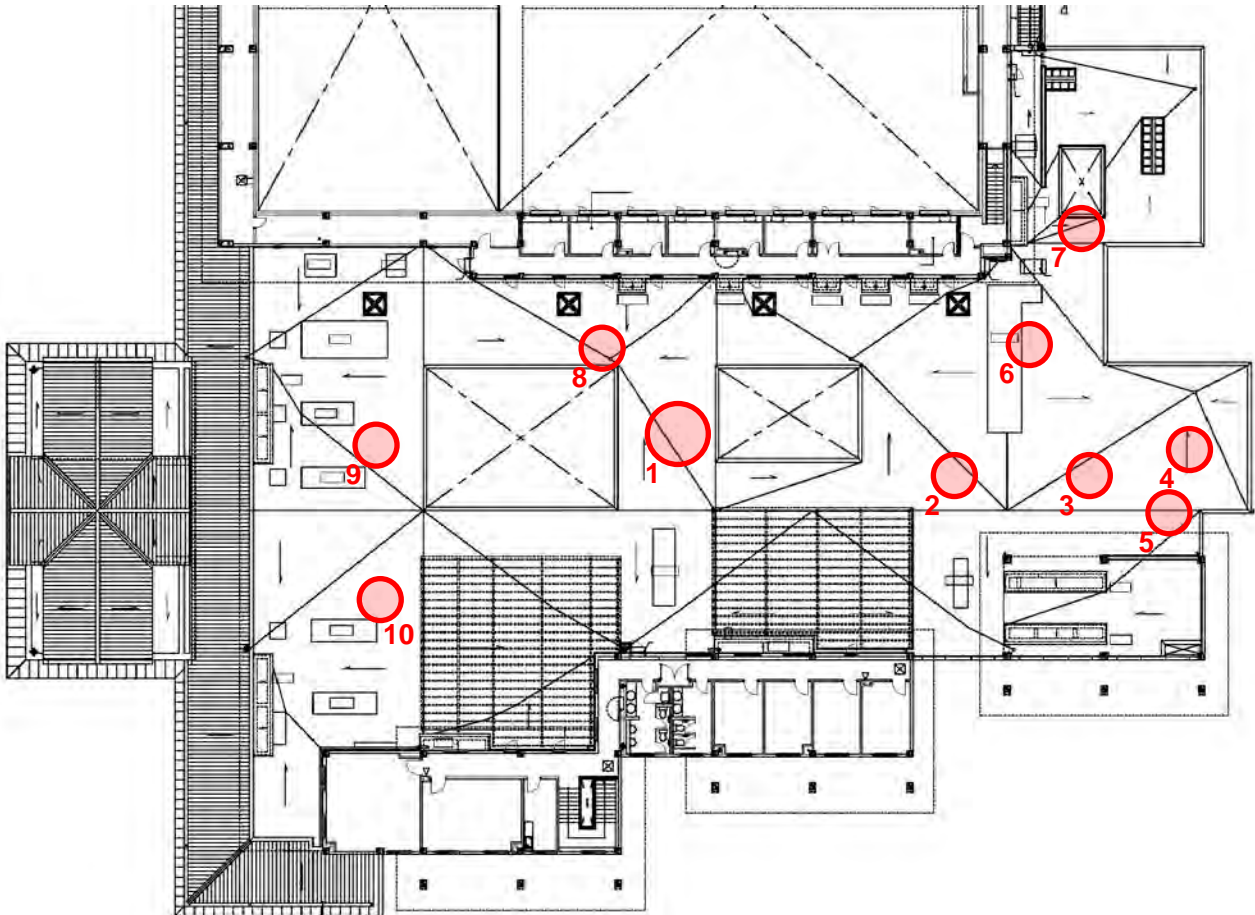
<Partial Roof Plan>

Due to the air trapped inside the waterproof membrane, the air pocket shows different temperature than the other properly adhered areas. These air pockets could be potential causes for retaining water between the waterproofing membrane and the concrete slab.

As it can be seen in the following roof plan, the air pockets were observed all over the flat roof.
