Inventory Sheet A

District	Nuwara Eliya	Management office	Nuwara Eliya	Road No	A-005	Road Name	Peradeniya - Badulla - Chenkaladi road						
Site No.	2		Disaster Type	Landslide	Location	Start	46/2	End	46/3	latitude	7°02'57.7"N	longitude	80°41'57.8"E
Main body	Both	Traffic control	Hourly	mm	Traffic volume	Week day	4442/12h	holiday		Bus route		Detour

Inventory Sheet B

Checked by	Yang Pucai
Organization	JICA Survey Team

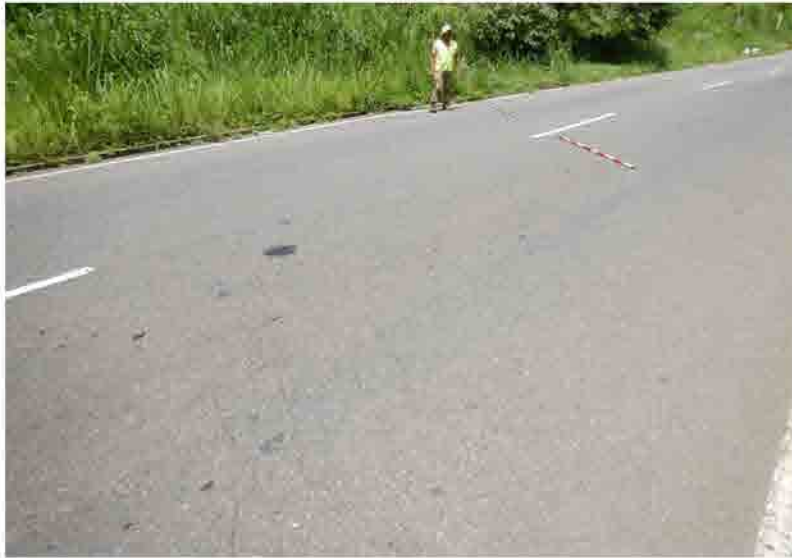
P1 Cracks across the road due presumably to landslide movement

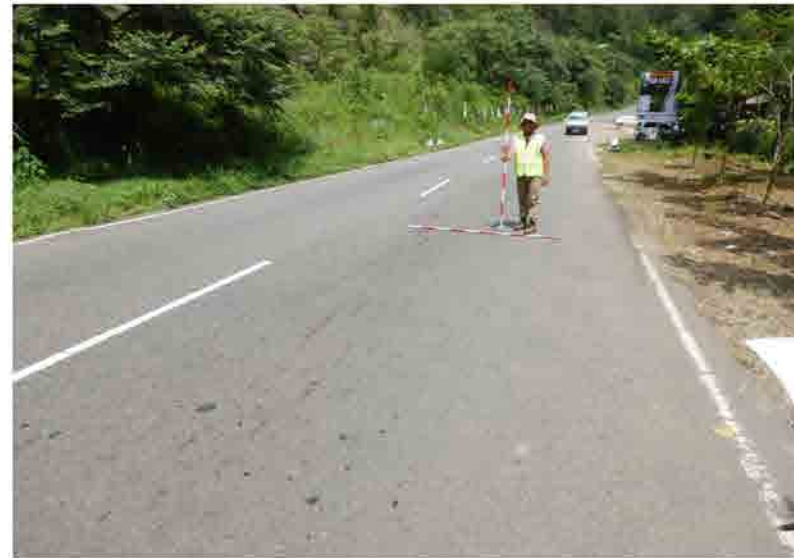
P2 Cracks across the road

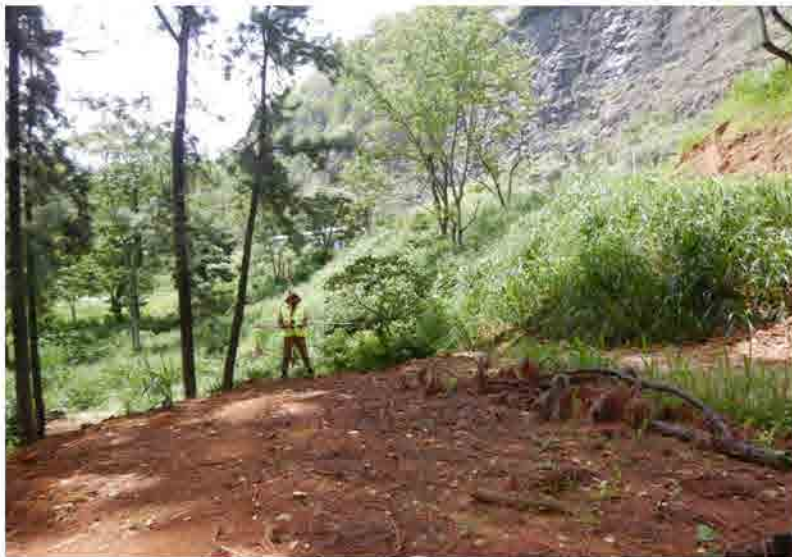
Steep slope consisting of relatively fresh rock are observed in section of 10 to 25 meters from the road. Talus deposits are distributed with thickness 3 to 15 meters between steep slope and the road. Debris likely moves toward the road in case of heavy rainfall.

P3 The lower slope the landslide below the road

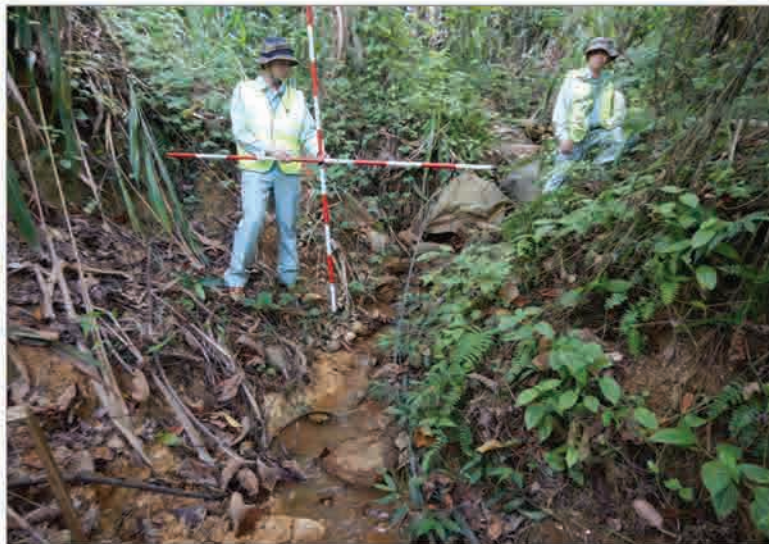
P3 The erosion condition of a mountain stream within the landslide

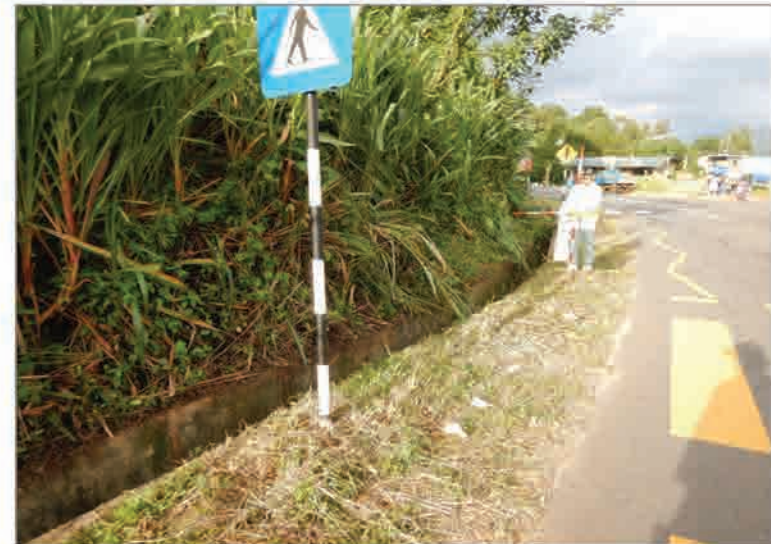
P4 The landslide toe along the road side ditch

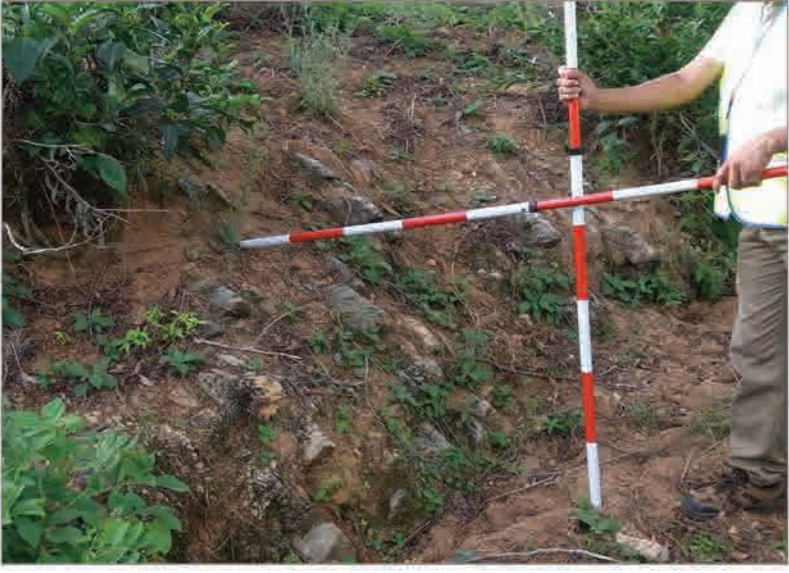
<p>P1 Landslide occurring along road cut slope, due presume to road excavation</p>			<p>P2 Same as that in P1</p>

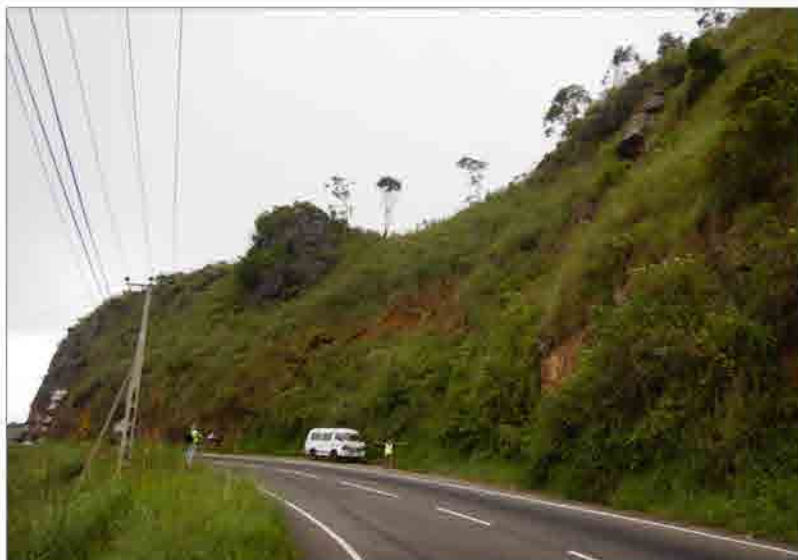
P1 Shallow failure on the cut slope above the road and some individual huge rock blocks on its upper natural slope

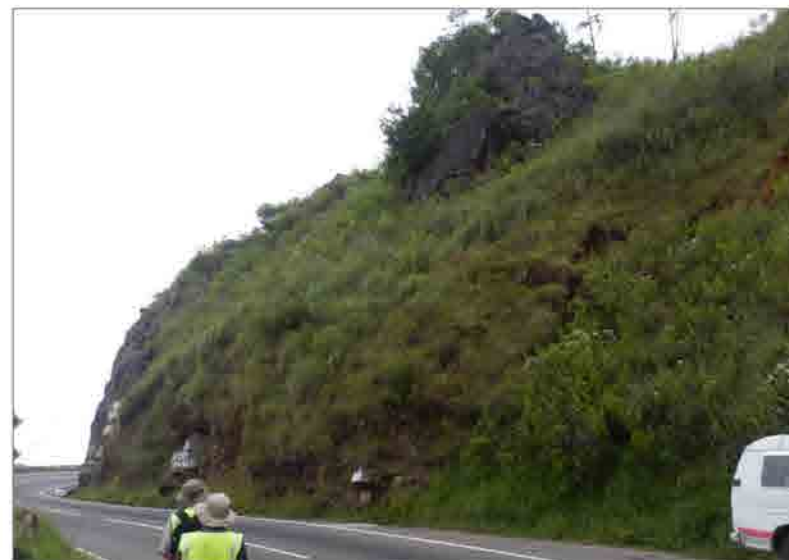
P2 Close view of P1, showing that shallow failure would contribute to potential for falling of huge rock block on its upper natural slope

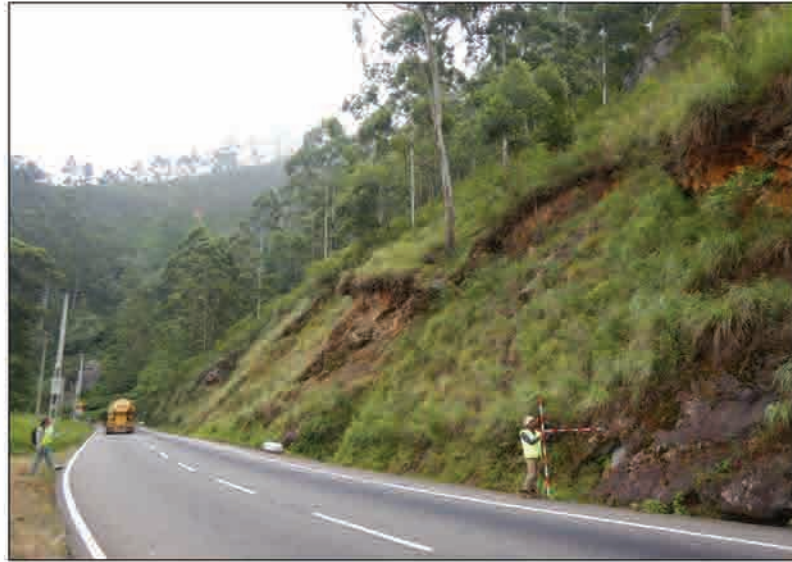
P5: The surface failure of cut slope

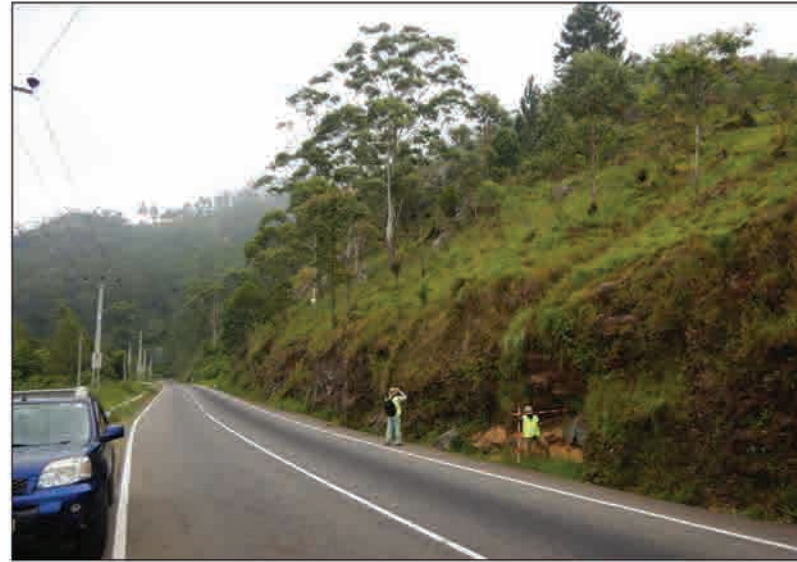
P7: Recognize unsteady stones in patches

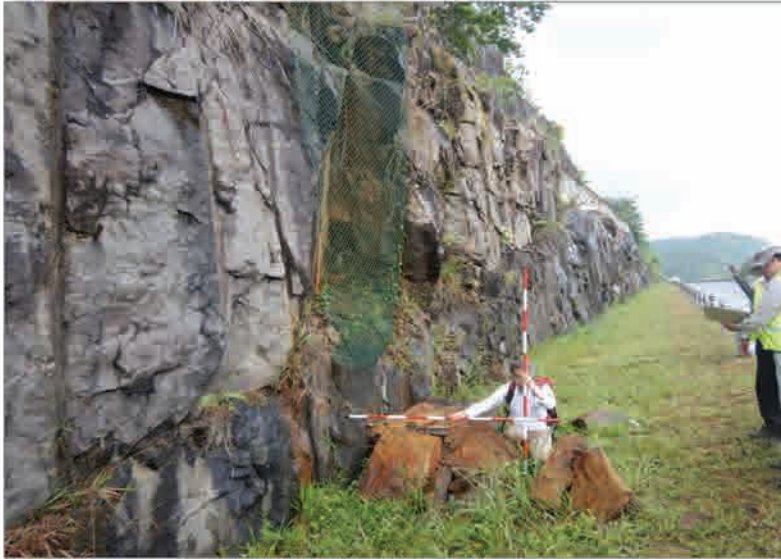
P1 Huge rock blocks falling due to wedge rock failure on the rock cut slope

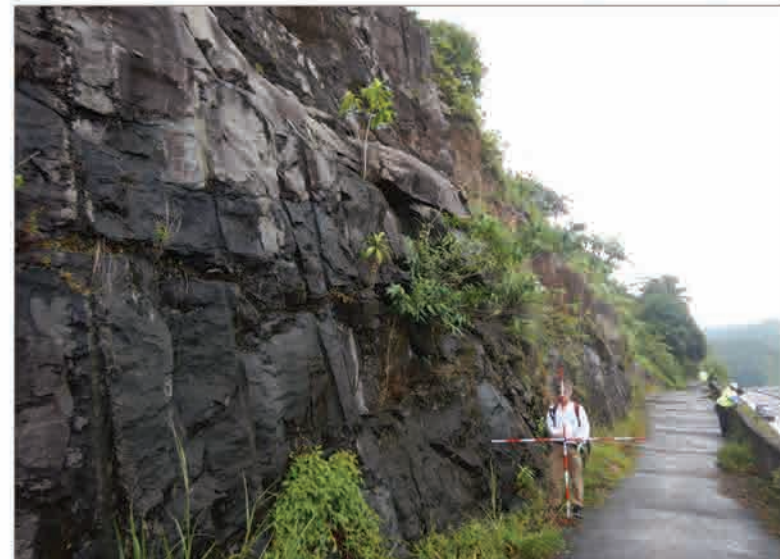
P3 A village road at the middle of rock cut slope, showing well-developed dip slope

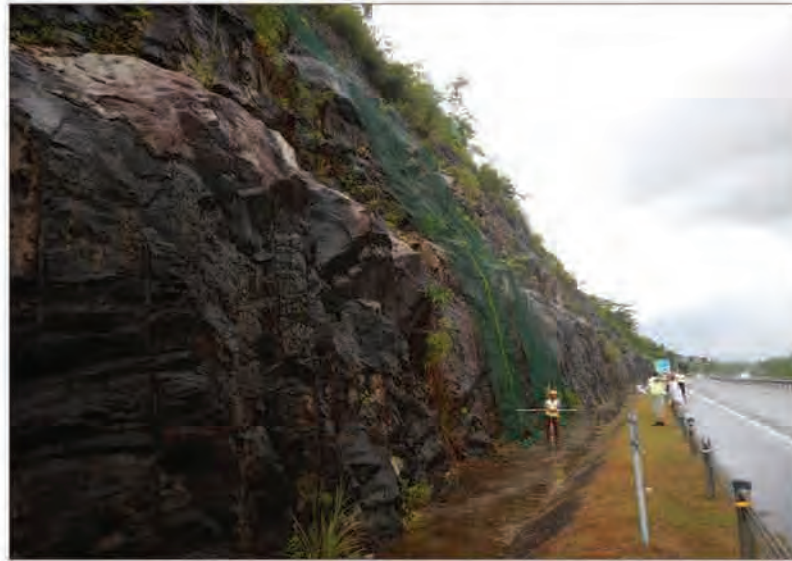
P5 Highly fractured rock mass and emergency nets installed by RAD

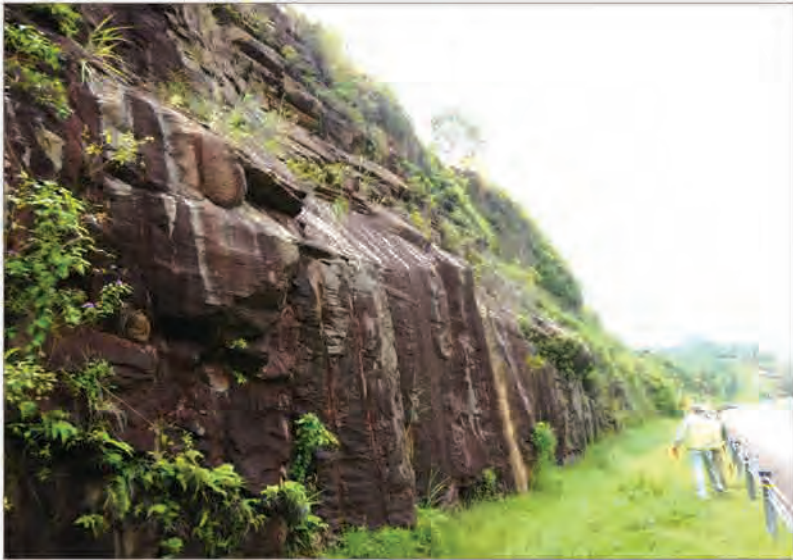
P5 Fractured rock slope, showing a dip slope - high potential for further rockfalls

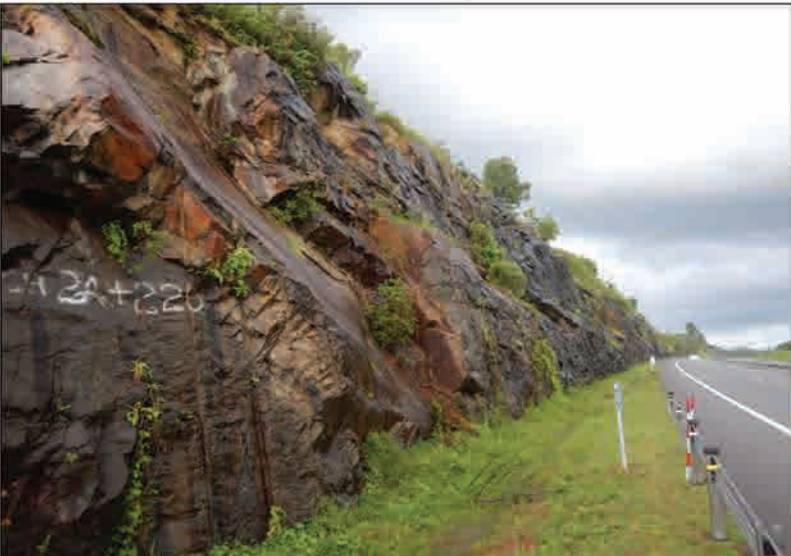
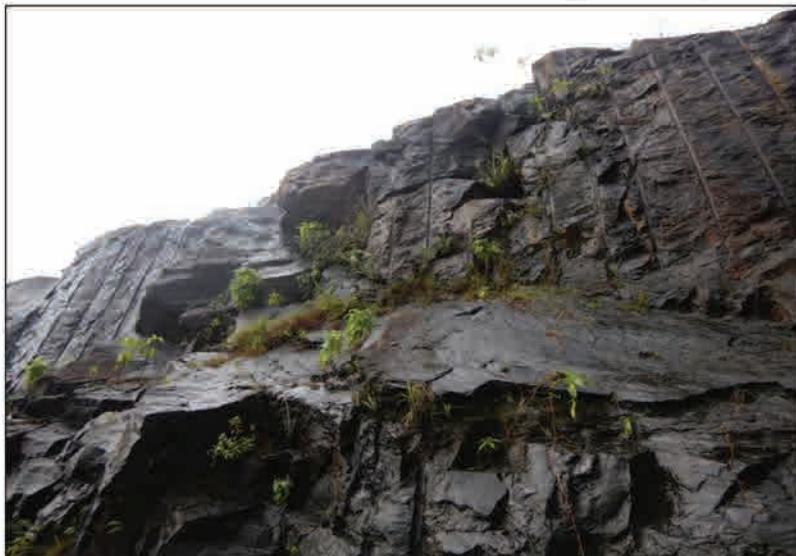
<p>P1 Rock slope failure or rockfall occurring along major joints, likewise, indicating further rockfalls along the joint surfaces</p>				<p>P3 High road cut slope of fresh rocks, showing potential wedge rock failure along two sets of joints</p>

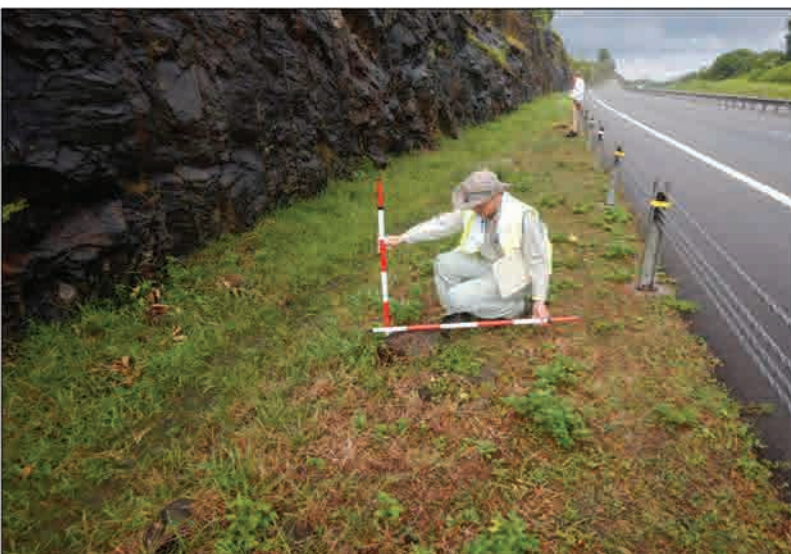
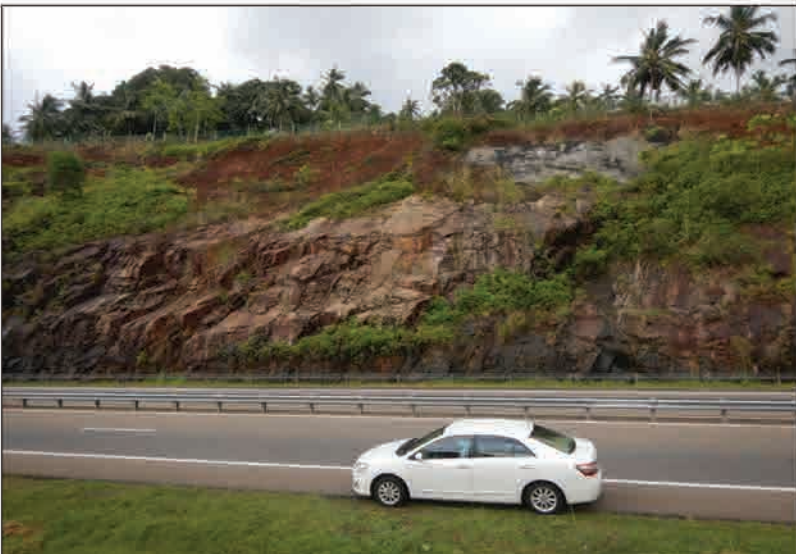
<p>P2 About 40cm of rock block falling down by rockfall</p>				<p>P4 Road cut slope of strongly and slightly weathered rocks, showing shallow slope failure on the strongly weathered rocks locally protected with mortar spraying method</p>

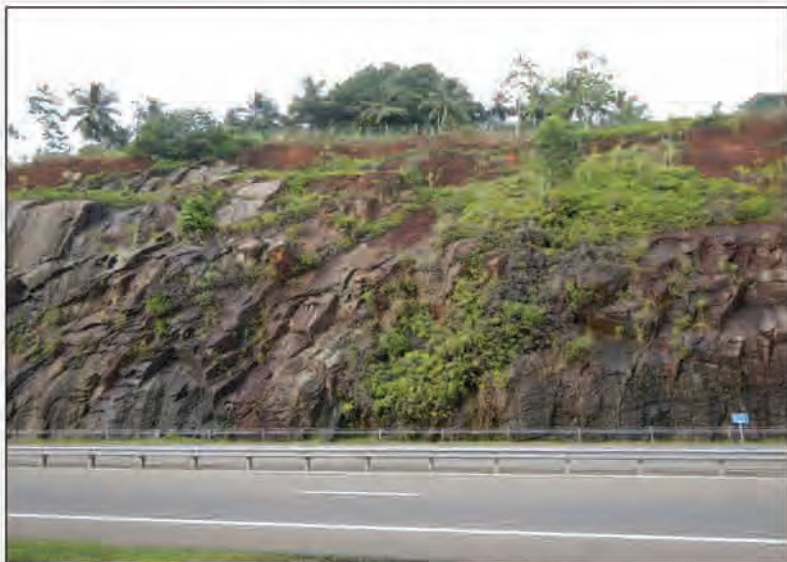
P5 Similar to that in P4, showing major joints dipping out of the cut slope in the slightly weathered rocks, further indicating a high potential for rockfalls

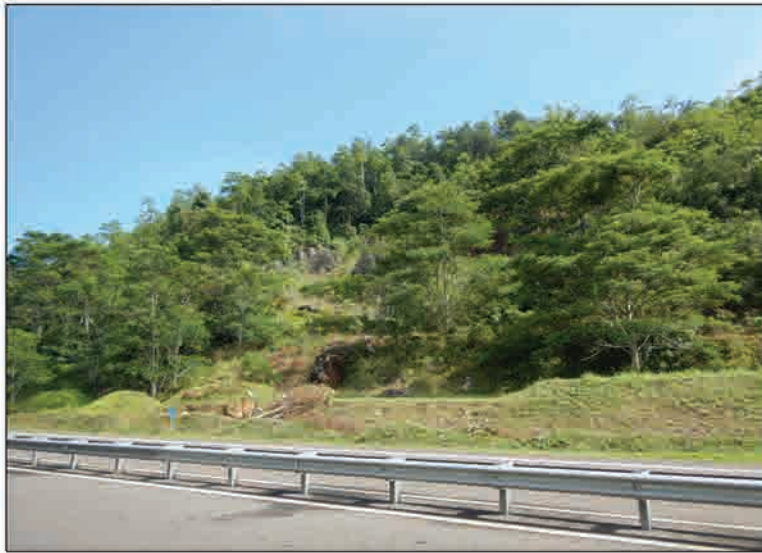
P1 Whole view of the slope failure, the collapsed materials were partially removed and partially flattened on the toe of cut slopes

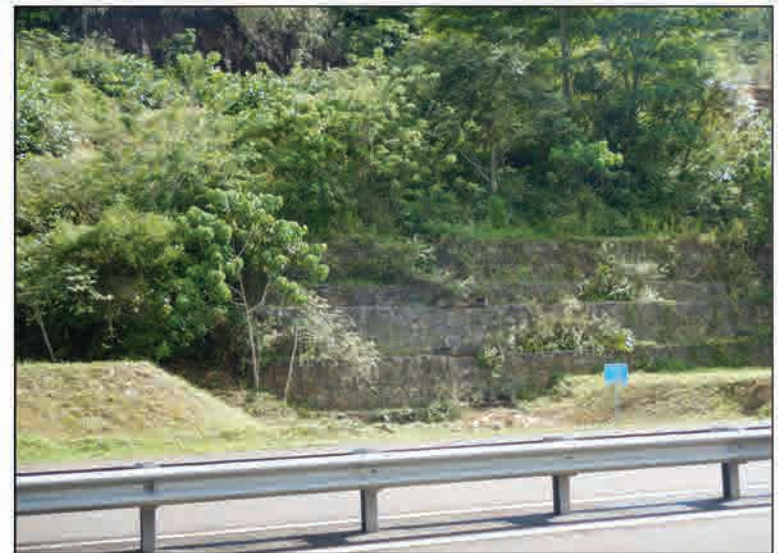
P3 The installed gabion retaining wall near the slope failure

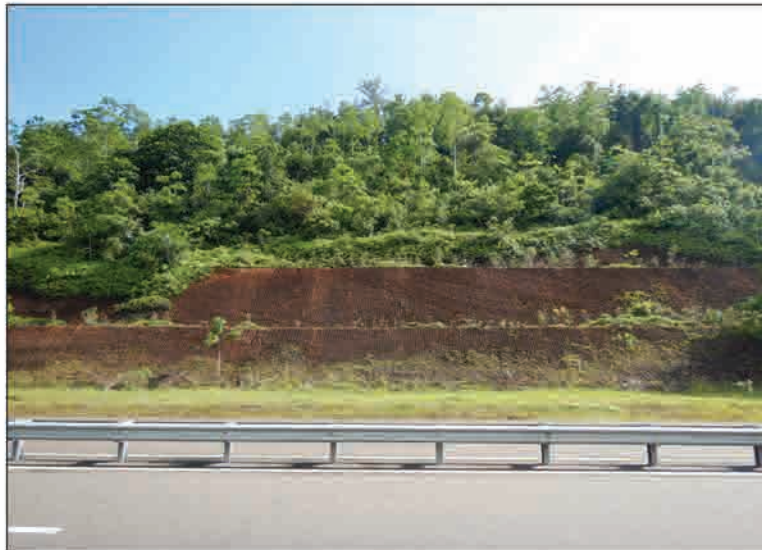
P2 Road cut slope of the strongly weathered rocks next to the slope failure

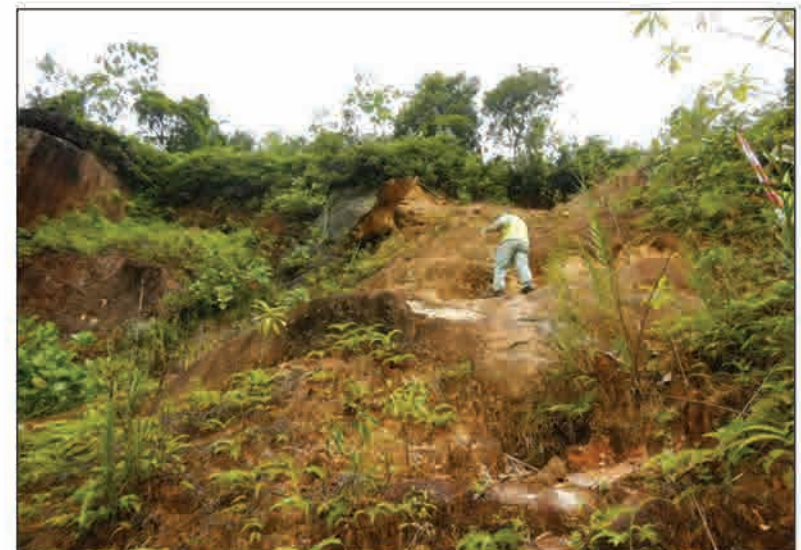
P4 Main scarp of the slope failure, showing the strongly weathered rocks

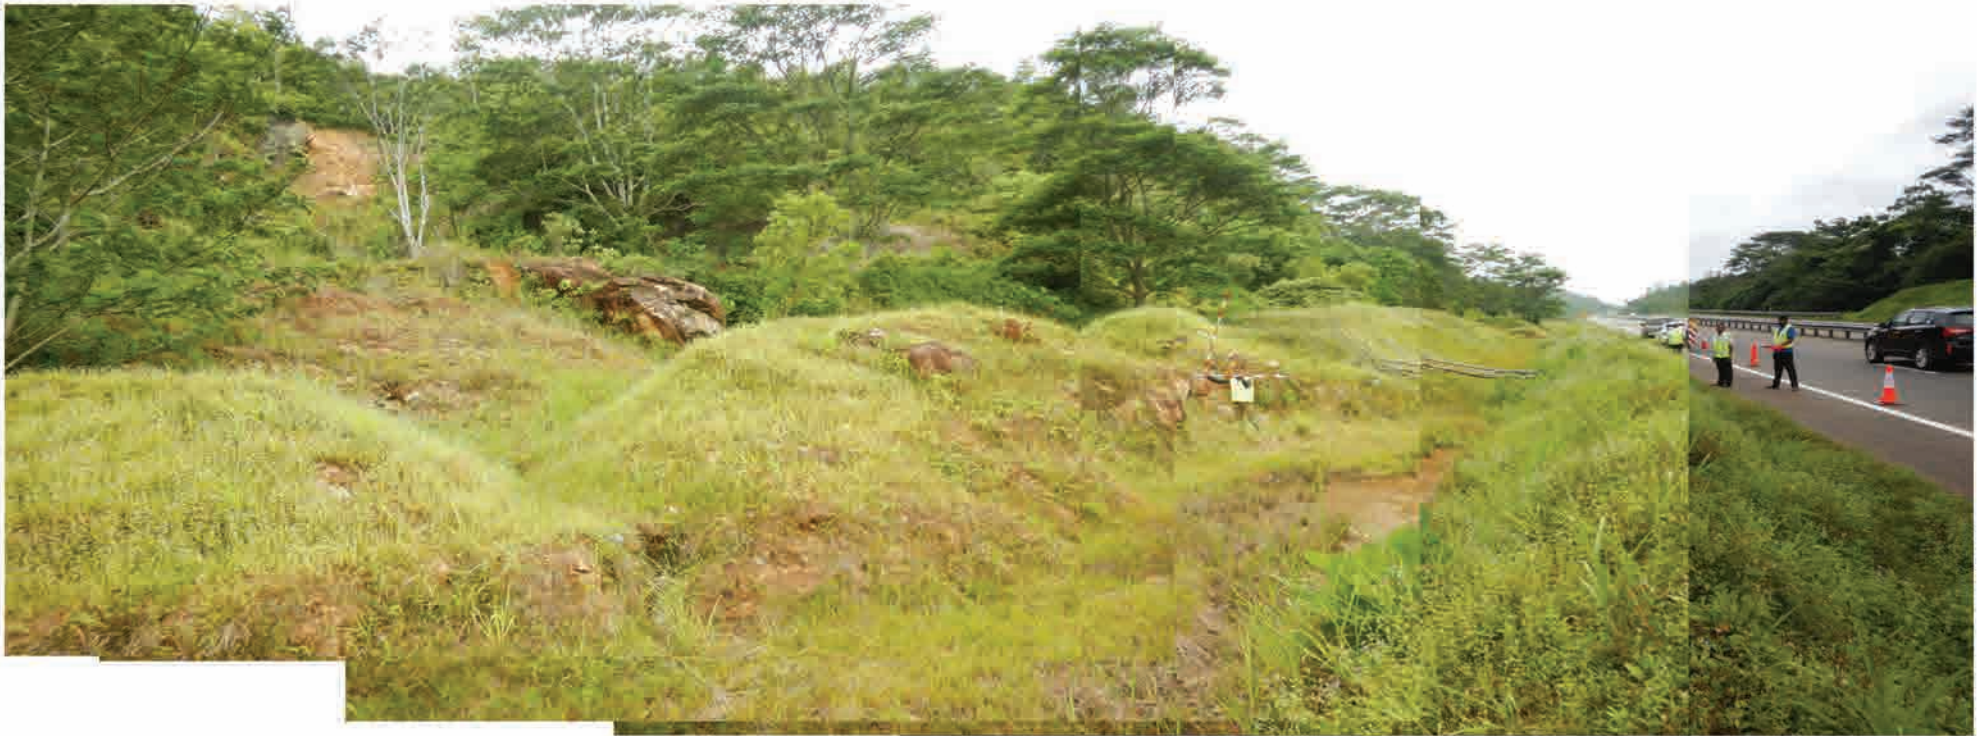
P5 Whole view of the slope failure looking upslope from the road

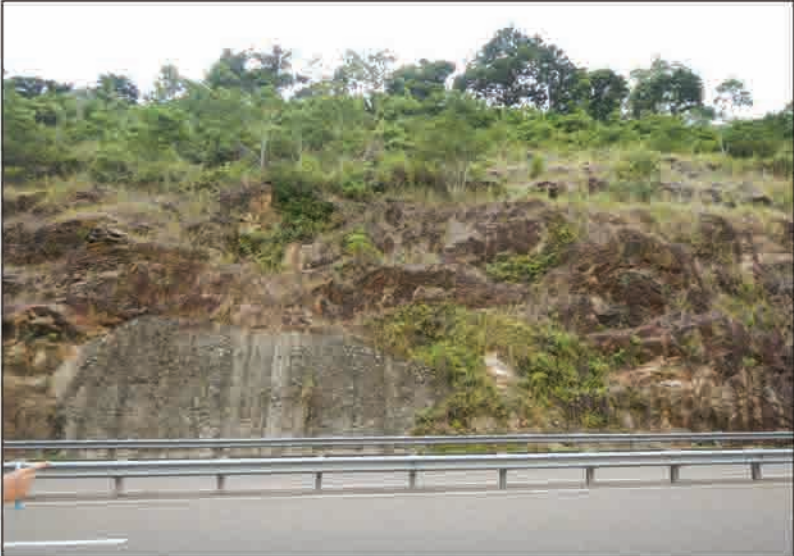
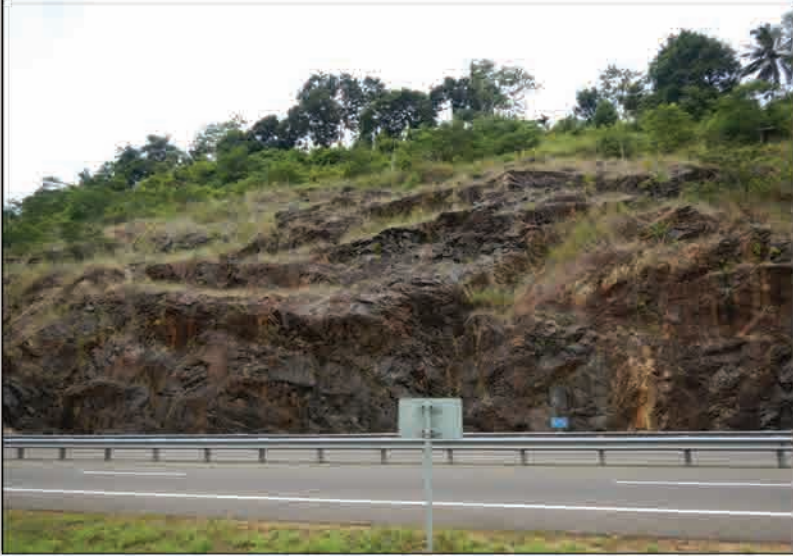
<p>P1 Road cut slope of the highly fractured rocks, showing major joints dipping into the cut slope. Stone pitching was installed to prevent rock slope failure in the fractured rocks</p>		<p>P3 Same as that in P2</p>

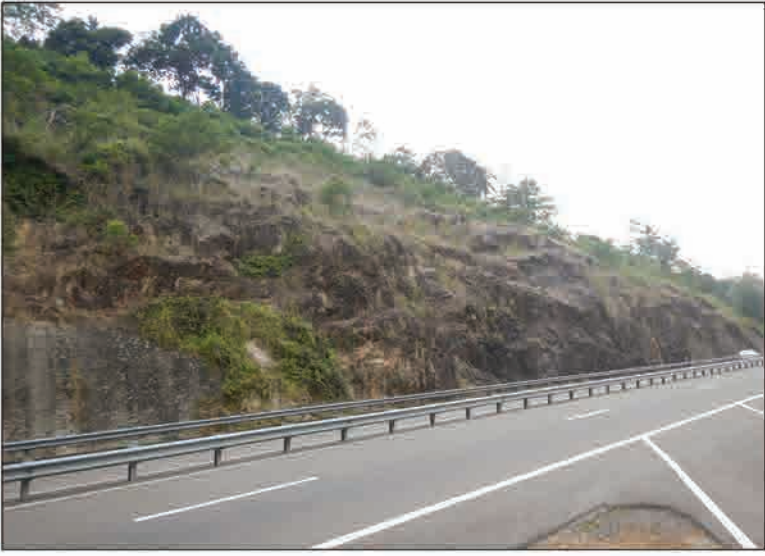
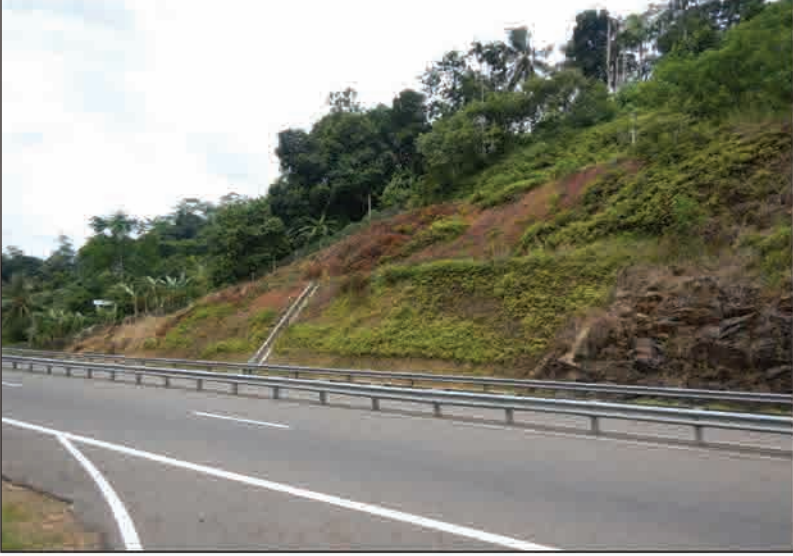
<p>P2 Unstable huge rock blocks and boulders predimante on the top surface of the rock slope</p>		<p>P4 Road cut slope of the strongly weathered rocks, surface drainage was installed on the cut slope</p>

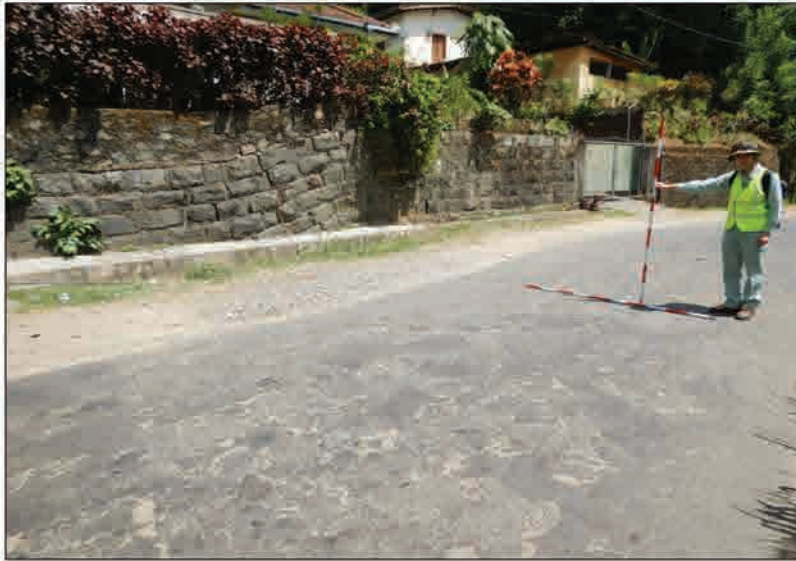
P1 The subsidence of the road surface and the deformation of masonry retaining wall within the landslide

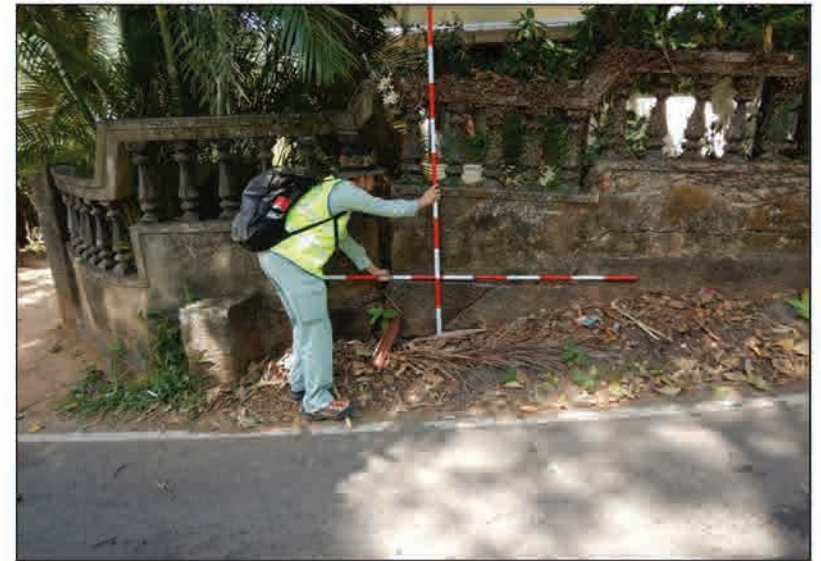
P3 Cracks occurring on the retaining wall within the landslide

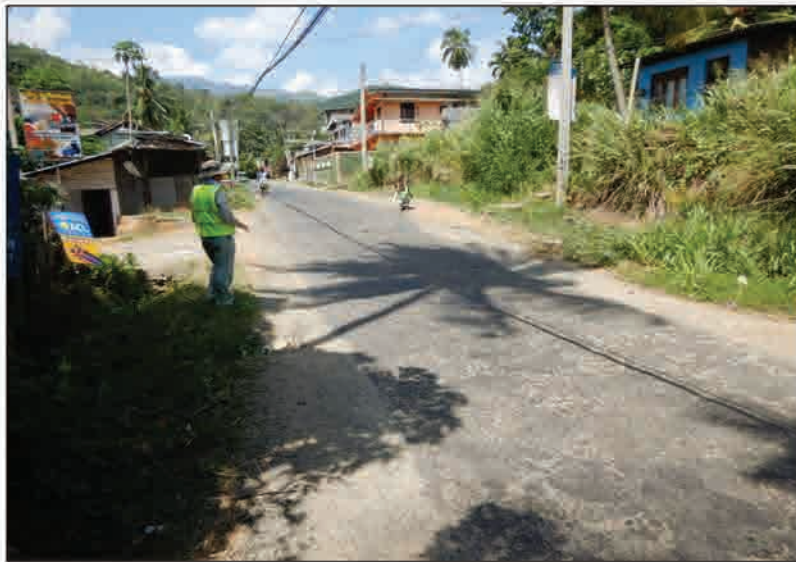
P2 The deformation situation of the road that pass along the middle part of landslide

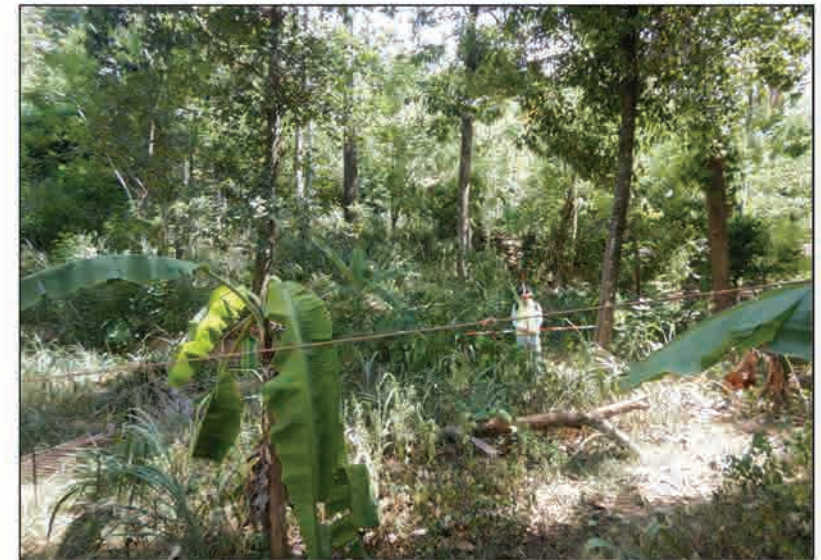
P4 The slope condition of the planned drainage well location

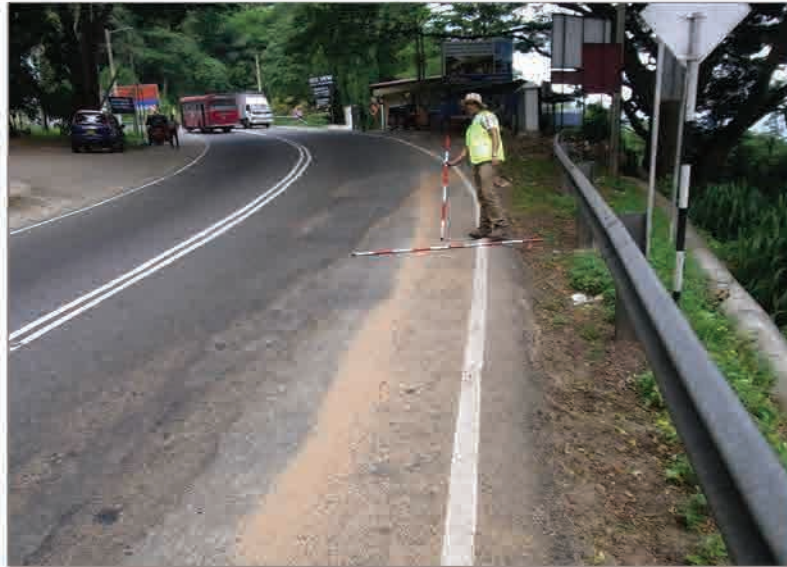
P1 Deformation situation of the road surface on the valley side of the road

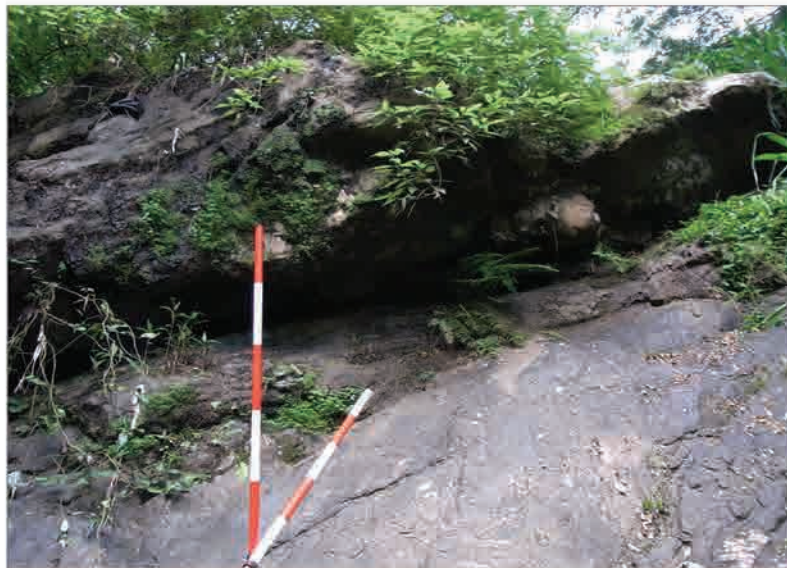
P3 Open cracks observed below the road

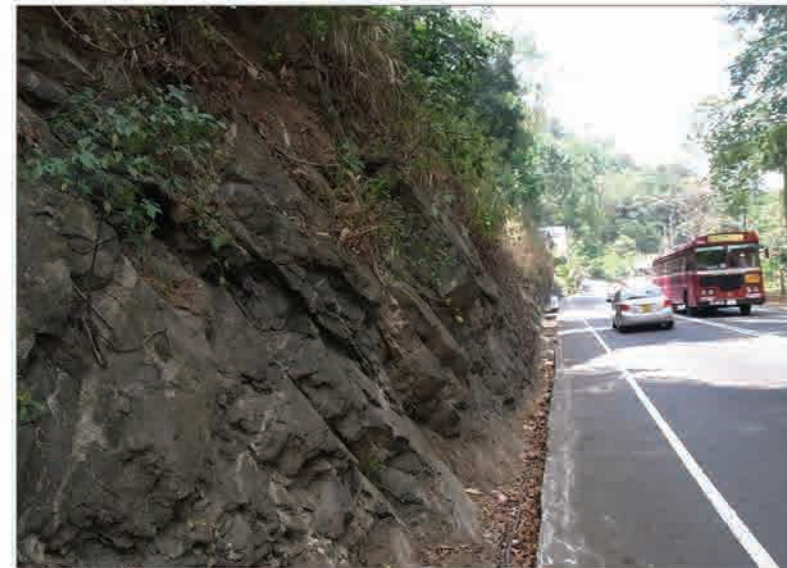
P4 Foliation joints dipping adversely out of the slope.

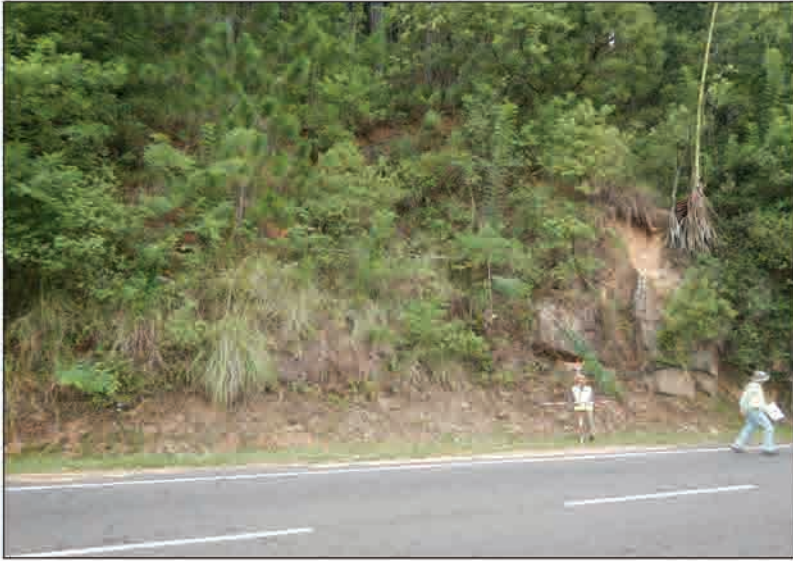
P1 The cut slope situation of the target section

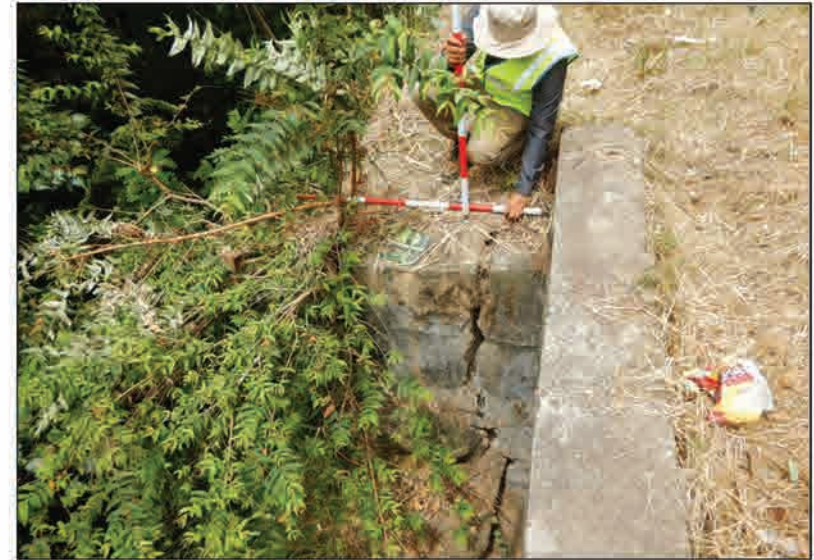
P3 Cracks occurring on the block wall on the valley side of the road

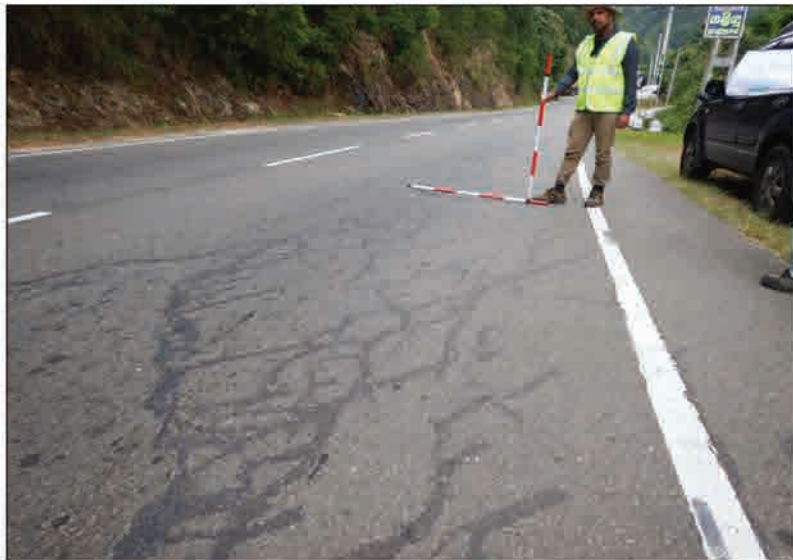
P2 Cracks and deformation situation of the road surface

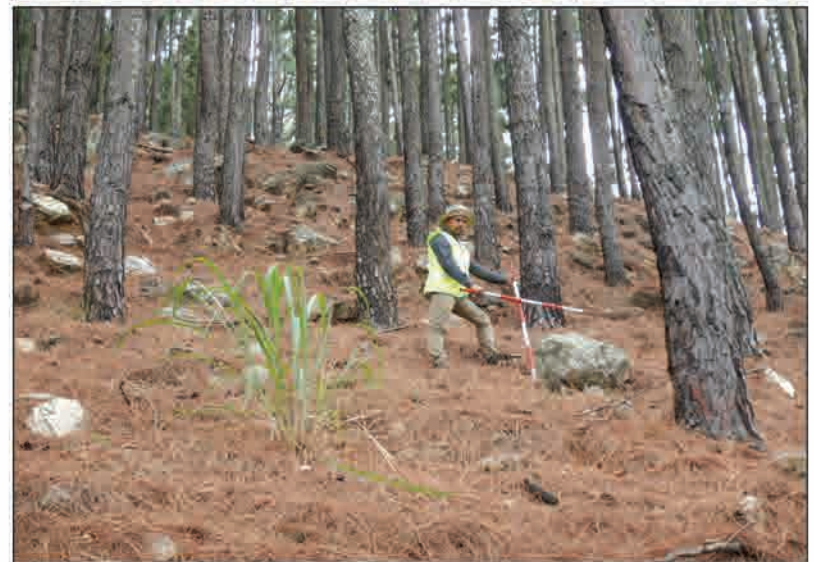
P4 Numerous boulders distributed on the upper slope of the road cut slope (diameter 60cm)
