**THE DETAILED DESIGN STUDY
FOR
THE PASIG-MARIKINA RIVER
CHANNEL
IMPROVEMENT PROJECT
(PHASE IV)**

**FINAL REPORT
(PRIOR RELEASE VERSION)**

**VOLUME-2
APPENDIX**

Table 6.2.1 The Result of Drainage Survey (RIGHT BANK) (1/30)

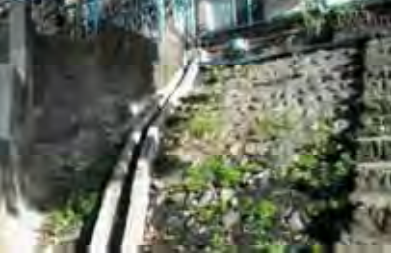
<p>Drainage Outlet No.= ML023 Northing= 1617345.336 Easting= 509839.770 Elevation= 19.934 Dimension= D120mm Type= PVC Date= 2019/6/13 Station no.= 11+996</p>	<p>Remarks: PVC is damaged.</p>

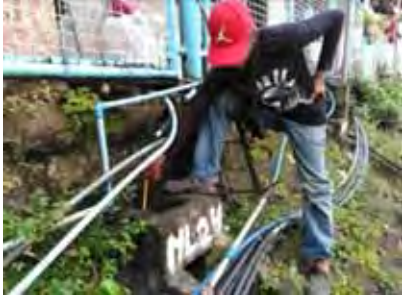
<p>Drainage Outlet No.= ML024 Northing= 1617345.336 Easting= 509829.385 Elevation= 19.979 Dimension= D120mm Type= PVC Date= 2019/6/13 Station no.= 11+990</p>	<p>Remarks: PVC is damaged.</p>
<p>Photo (distant view)</p>

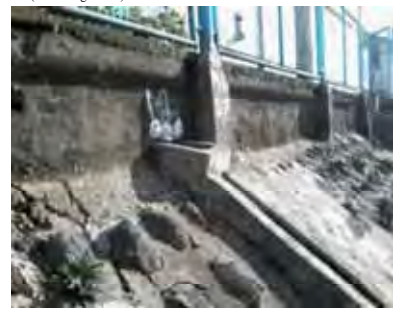
<p>Drainage Outlet No.= ML027 Northing= 1617345.359 Easting= 509809.984 Elevation= 19.754 Dimension= D180mm Type= PVC Date= 2019/10/9 Station no.= 11+974</p>	<p>Remarks: PVC is damaged.</p>

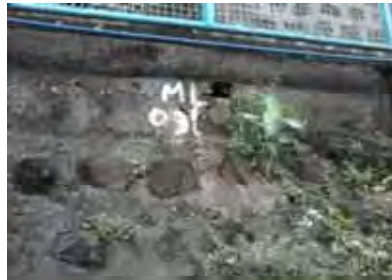
<p>Drainage Outlet No.= ML031 Northing= 1617344.936 Easting= 509771.587 Elevation= 20.092 Dimension= D100mm Type= PVC Date= 2019/6/13 Station no.= 11+945</p>	<p>Remarks: PVC is damaged.</p>
<p>Photo (distant view)</p>

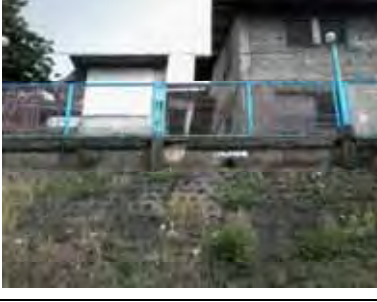
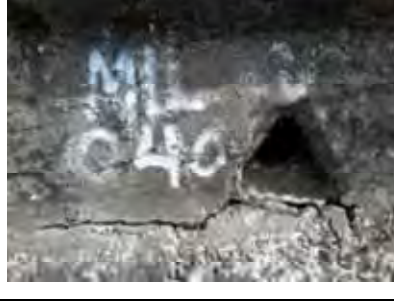
<p>Drainage Outlet No.= Northing= Easting= Elevation= Dimension= Type= Date= Station no.=</p>	<p>ML040 1617343.115 509682.555 19.894 D200mm PVC 2019/10/10 11+867</p> <p>Remarks: PVC is damaged.</p>
<p>Photo (distant view)</p>

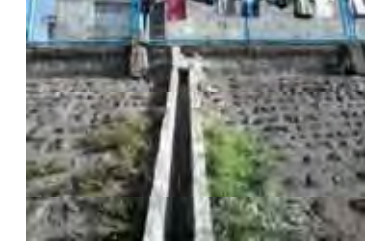
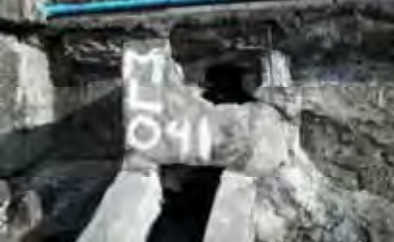
<p>Drainage Outlet No.= Northing= Easting= Elevation= Dimension= Type= Date= Station no.=</p>	<p>ML041 1617343.212 509679.002 20.399 D160mm PVC 2019/10/15 11+864</p> <p>Remarks: PVC is damaged.</p>

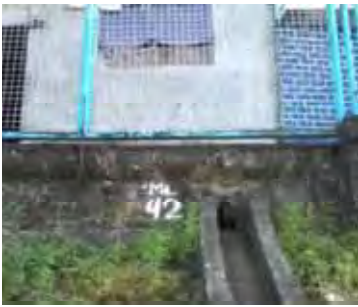
Drainage Outlet No.= Northing= Easting= Elevation= Dimension= Type= Date= Station no.= Remarks:	ML042 1617343.410 509668.165 19.825 D100mm PVC 2019/6/13 11+856 PVC is damaged.
Photo (distant view)

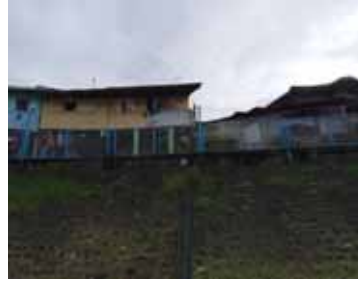
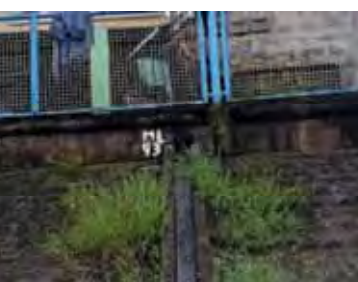
Drainage Outlet No.= Northing= Easting= Elevation= Dimension= Type= Date= Station no.= Remarks:	ML043 1617345.389 509654.465 20.142 D130mm PVC 2019/10/15 11+843 PVC is damaged.
Photo (distant view)

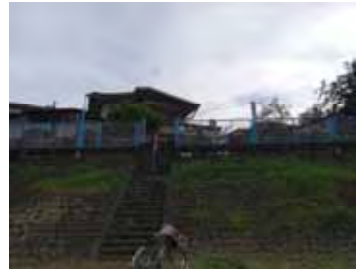
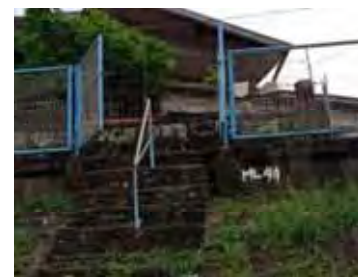
Drainage Outlet No.= Northing= Easting= Elevation= Dimension= Type= Date= Station no.= Remarks:	ML044 1617349.516 509640.776 19.649 D130mm PVC 2019/6/13 11+832 PVC is damaged.
Photo (distant view)

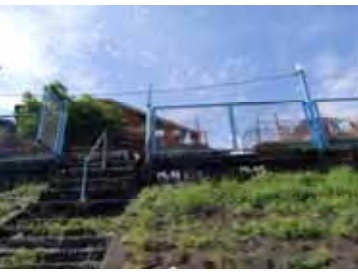
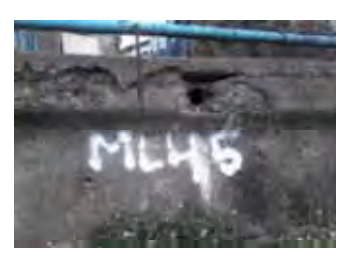
Drainage Outlet No.= Northing= Easting= Elevation= Dimension= Type= Date= Station no.= Remarks:	ML045 1617350.029 509638.466 20.344 D80mm PVC 2019/10/10 11+829 PVC is damaged.
