**The Democratic Republic of Timor-Leste
Ministry of Public Works
Directorate of Roads, Bridges and Flood Control**

**Timor-Leste
The Post-Disaster Survey for
New Comoro Upriver Bridge
Construction Plan
Post-Disaster Survey Report (Summary)**

December 2021

**INGÉROSEC CORPORATION
IDEA CONSULTANTS, INC**

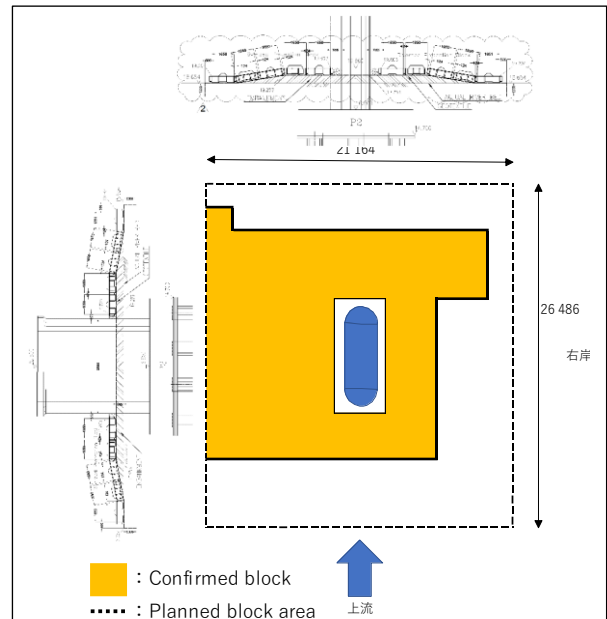
Figure 4 Protection blocks of Pier P2

Many protection blocks could be visually checked in the riverbed on the side facing pier P3, and the current extent of the protection blocks was determined by measuring the site. Most of the other blocks that could not be confirmed are located in the peripheral area, which is lower in elevation than the others by design, and it is assumed that they are buried in place under sediment deposits.

- (b) The following measures are proposed for the protection blocks around the piers of the Hinode Bridge.
 - Although the existing 3tf blocks are stable against the flow according to calculations, it is recommended that the weight of the additional blocks should be 3tf or more to prevent another disaster;

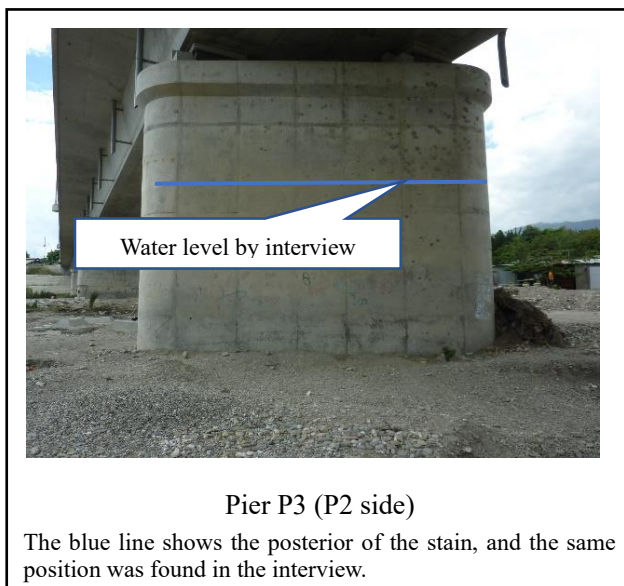
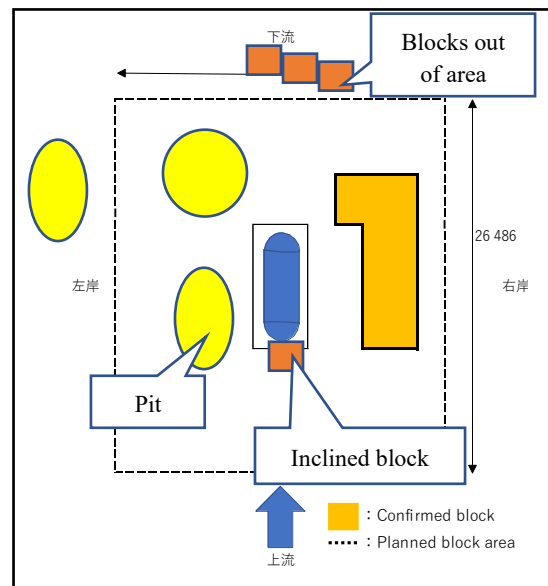
Figure 5 Pier P3 (left) & Protection blocks of Pier P3 (right)

Traces of the flood water level were seen on the pier column. No noticeable damage was found on the pier.

The protection blocks could be confirmed in parts of the planned area for block installation. Of the five piers, there were particularly many gravel pits near this pier. The size of the holes reaches several meters and the depths are over 1 m.

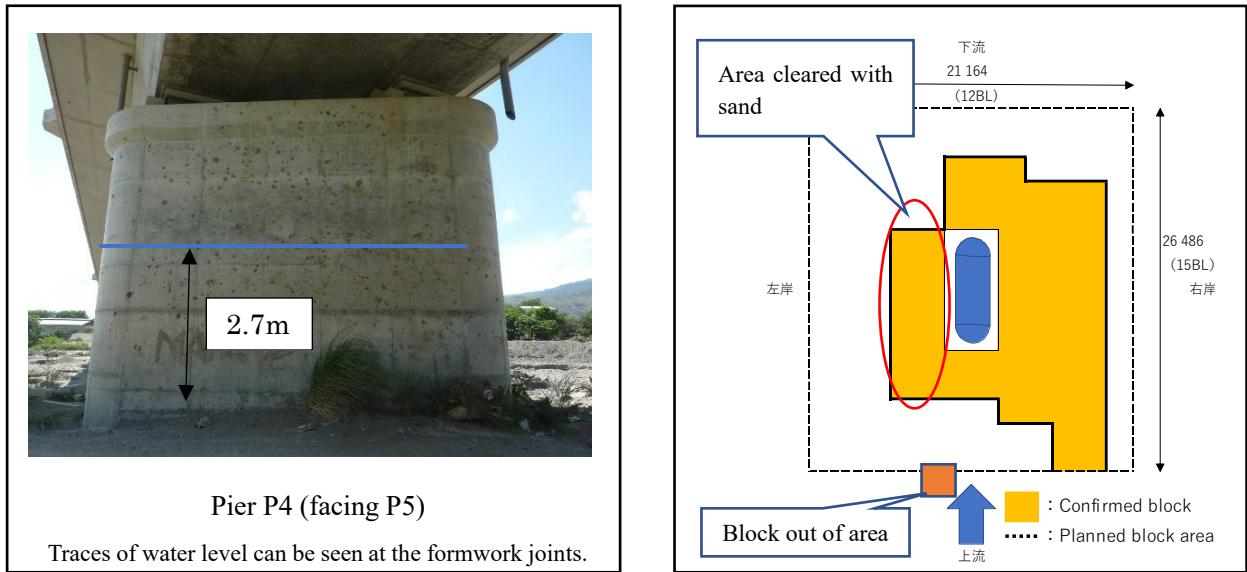
Figure 6 Pier P4 (left) & Protection block of Pier P4 (right)

Faint traces of a water level were seen at a height of 2.7 m from the current riverbed height. The riverbed is leveled with sand to facilitate driving on the protective blocks of this pier in the areas that are frequent used by residents and mining companies. Some metal fittings connecting the blocks were missing in places.

This section will assess the possibility that the protection blocks were washed away by the flood flow. As described in "1.7.1(d)", the trace water level during the current flood was found to be 2.7 m above the riverbed at pier P4. The flow rate of the trace water level at the bridge site was approximately 650-750 m³/s and the velocity was 3-4 m/s according to a back-calculation of the flow rate using a non-uniform flow calculation and a river channel cross section created from AW3D data. The evaluation including the flow rate of this year's flood will be discussed based on the latest survey results from the Post Situation Data Collection Survey for the Flood Countermeasures in Dili (hereafter the "Collection Survey in Dili") which is being conducted separately.

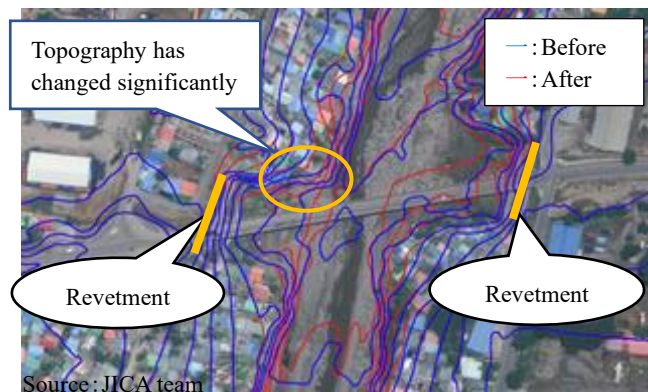
Figure 7 Contour lines before and after the flood near Hinode Bridge

The Figure 7 shows the contour lines created from satellite elevation data before and after the flood this year superimposed on a satellite image. The field survey confirmed that the embankment gradient became shallower after the flood in the circled location and that the embankment has collapsed due to erosion, despite not being on a curved section or part that would be impacted by the flow.

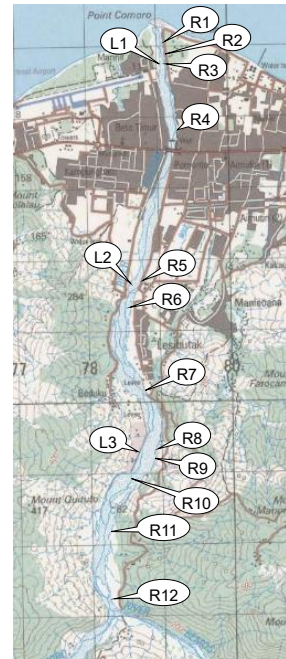
Figure 8 Locations of damaged river walls

The location of the damaged sections of the river wall are about 9 km from the mouth of the Comoro River (upstream of the confluence with the Bemós River) as shown in Figure 8. The damaged sections are mainly on the right bank. Especially sections R7 to R12 on the right bank, which are 5.5 km upstream of the river mouth and which were constructed after 2013, have been continuously damaged. The left bank of the same section has not been developed and no revetments have been constructed because the road along that riverbank has been cut off.

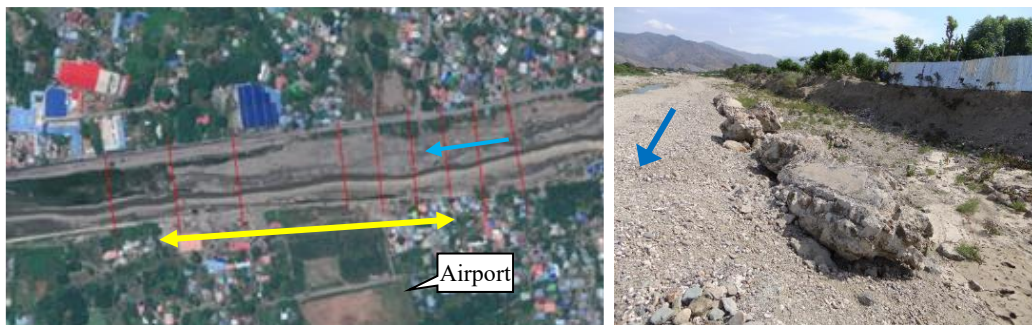
Figure 9 Damage to river wall (L1)

(a)L1 (Approximately 0.7 km from the mouth of the river, 460 m in length)

It is thought that the 3.5-to-4-m-high stone revetment collapsed due to scouring caused by the current flood and due to a reduced the embedment depth of the revetment caused by the level of the riverbed becoming lower over time. Since the revetment does not contain any lateral strips, the collapse at one point is thought to have adversely affected the adjacent revetments. The riverbank is close to the airport runway, so the restoration of this section is a high priority.

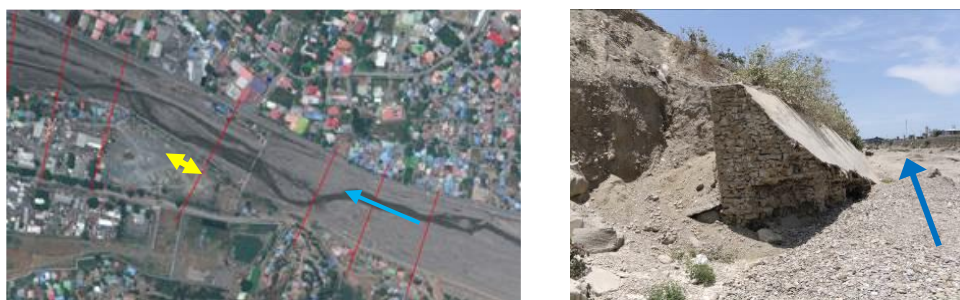
Figure 10 Damage to river wall (L2)

(b)L2 (Approximately 3.8 km from the mouth of the river, 23 m long)

A low-water revetment (about 2m high) on the left bank 100 m downstream of the check dam has been washed away. The structure is made of masonry and the surface is finished with mortar. With the construction of the check dam 100m upstream in 2019, it is feared that sediment transport from upstream during floods will be inhibited and the level of the riverbed will become lower. The check dam was constructed in 2017 to prevent riverbed degradation due to the erosion of gravel.

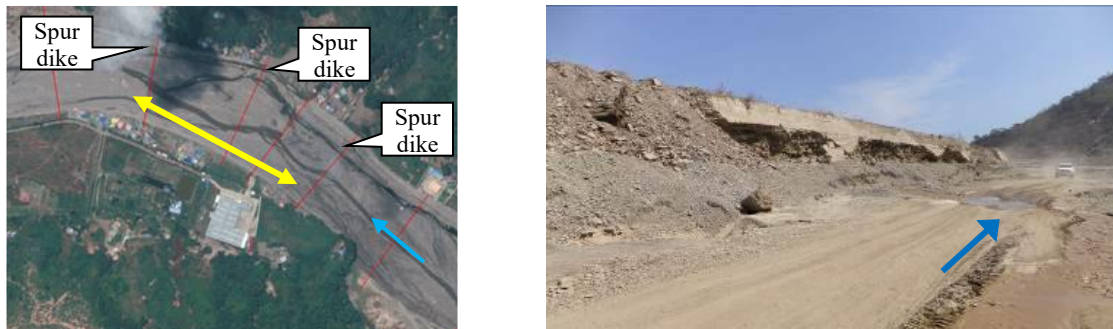
There is a mixture of sections where the entire revetment has been washed away and sections where only the upper part of the revetment has been left and the lower part has been washed away. The structure is a masonry retaining wall. There are spur dikes on the right bank on the outside of the bend in the river. The spur dikes may have caused the mainstream floodwaters to hit the left bank and scour the edge of the river wall, leading to the collapse of the river wall.

These three spur dikes were constructed around 2013. Their purpose is to protect the riverbank by directing the flow during floods toward the center of the river channel.

Source: (Left) Compiled by the research team from NTT DATA satellite images, (Right) Taken by the research team
Figure 11 Damage to river wall (L3)

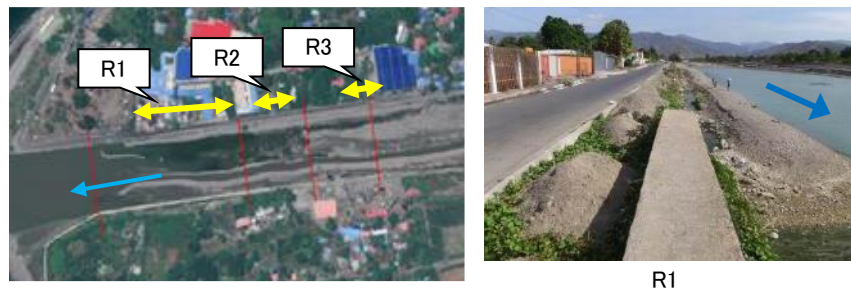
(d)R1 (0.3 km from the mouth of the river, 168 m long), R2 (0.5 km from the mouth of the river, 39 m long) and R3 (0.6 km from the mouth of the river, 38 m long)

The satellite image of before the flood shows that there are water routes near the riverbank, which suggests that the foundation of the riverbank was washed away during the flood and collapsed. After the flood, a small embankment with a width of 5 to 10 meters has been constructed at the edge of the riverbank.

Source: (Left) Compiled by the research team from NTT DATA satellite images, (Right) Taken by the research team
Figure 12 Damage to river wall (R1, R2, R3)

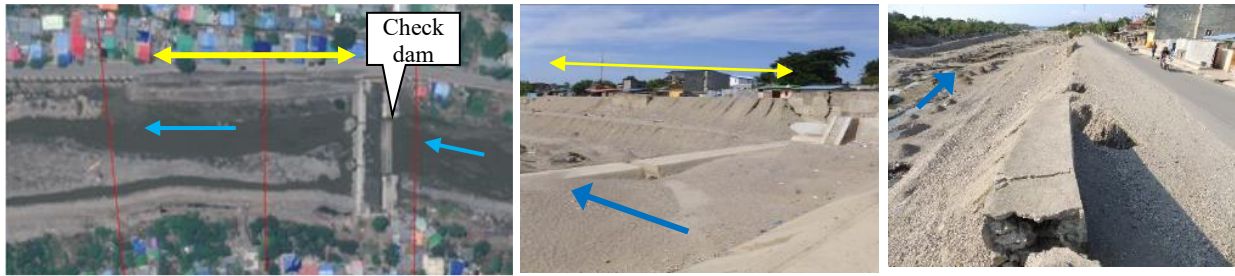
Figure 13 Damage to river wall (R4)

(e)R4 (about 1.6 km from the mouth of the river, 141 m long)

The alignment of the river channel changes direction to the left near the check dam, and the affected section is located on the outer bank of the bend. Although a 4-to-5-m-wide embankment has been placed at the edge of the riverbank to stabilize the slope, which is currently covered with earth, it is desirable to restore the embankment as soon as possible or to place protection blocks on the embankment.

The check dam had been severely damaged since around 2017 and it was repaired in 2019 because the missing section was causing sediment to be washed away on the upstream side and there was a risk that the riverbed scour could extend to the Comoro Bridge.

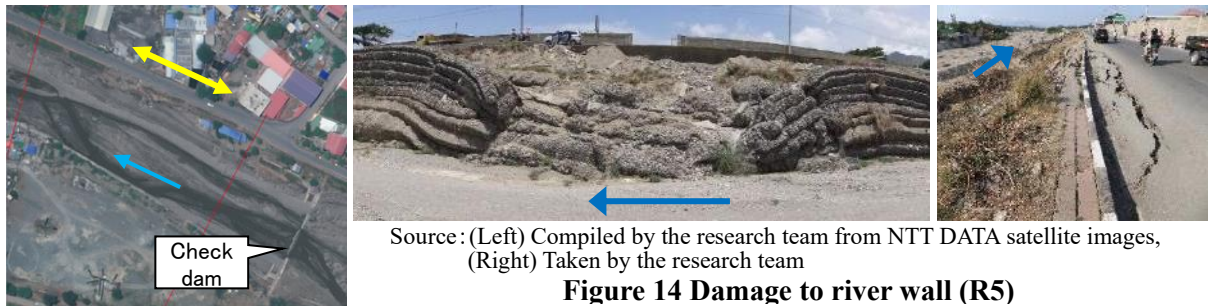
Figure 14 Damage to river wall (R5)

(f)R5 (3.8 km from the river mouth, 100 m long)

The gabions have collapsed near the middle of the 570-m-long gabion revetment section. Ten tiers of gabions were piled up on the riverbank to a height of about 10 meters. In the remaining section, the shape of the bottom gabions are deformed. The slope up to the road on the riverbank has collapsed and the road is currently one-sided, so restoration is urgently needed.

The restoration of 110 m and 120 m of revetments (R5 and R6 as discussed in 1.7.2(1)) upstream and downstream of the upstream check dam are necessary. Furthermore, the associated road rehabilitation works will necessitate the removal of the damaged parts of the concrete revetments, gabions, pavement, subbase and embankment, and then the restoration of the lower subbase, upper subbase and pavement. In addition, ancillary facilities such as guardrails, curbs and road marking should be installed where necessary. The Figure 25 shows the proposed restoration structure for the river wall and road, and the restoration quantities for R5 and R6 were calculated based on this idea.

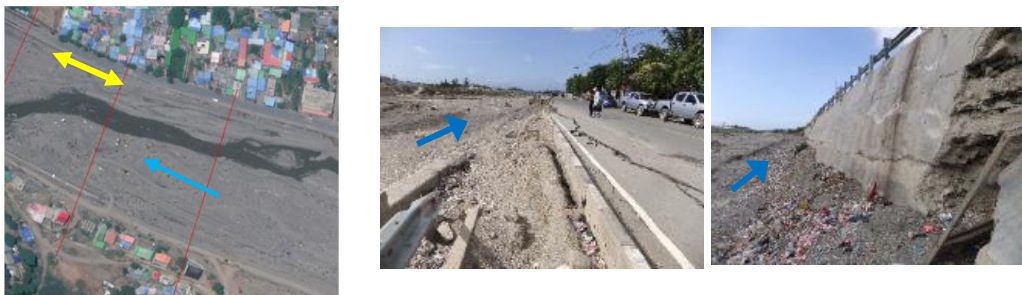
Figure 15 Damage to river wall (R6)

(g)R6 (4.1 km from the mouth of the river, 110 m long)

A retaining wall about 7 m high collapsed, and gravel was piled up in front of the riverbank to protect the slope as an emergency measure. The width of the river narrowed from 140 m to 115 m at a point 230 m upstream of this section, which may have led to the collapse of the riverbank due to a higher flow velocity of the river. The road on the riverbank is cracked and caved in, which has restricted traffic to one side of the road, so the restoration of this section is highly urgent.

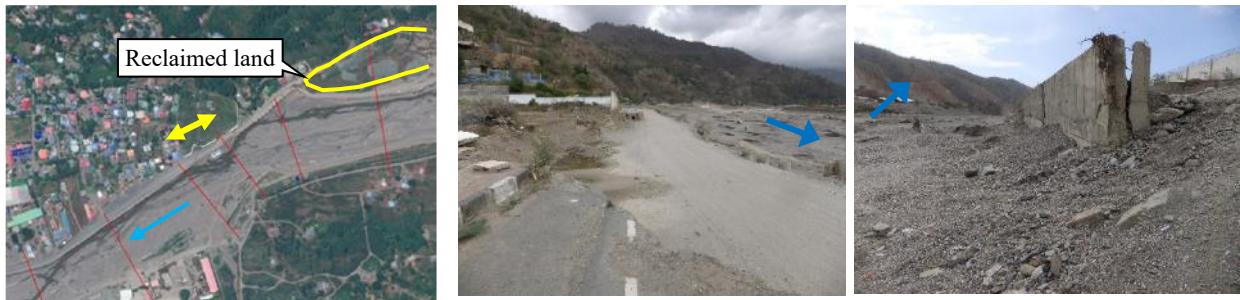
Figure 16 Damage to river wall (R7)

The floodwaters directly hit the section because of the land reclamation in the river by a gravel mining company on the right bank upstream of this section. The collapse of the revetment is thought to have been caused the scouring of the revetment foundation and the removal of sediment from the behind the revetment. The road surface of both lanes of the riverside road have been washed out, and vehicles are driving on the

road surface about 2 meters lower than the original surface. Although the urgency of reconstruction is high, countermeasures need to be considered in conjunction with measures to deal with the land reclamation activities upstream.

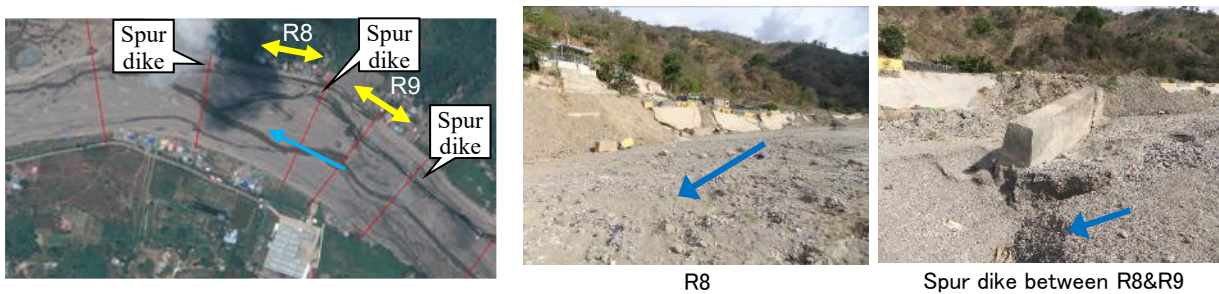
Figure 17 Damage to river wall (R8, R9)

(i) R8 (approx. 6.3 km from the mouth of the river, 100 m long) and R9 (approx. 6.5 km from the mouth of the river, 121 m long)

There are three spur dikes on the outer bank of the bend. The angle of the spur dikes is downstream (i.e., not at a right angle to the revetment), so it is possible that the flow over the spur dikes directly hit the revetment during the flood and scoured the revetment foundation. Two of the three spur dikes on the downstream side were severely damaged, so repairs to the spur dikes when restoring the revetments are recommended.

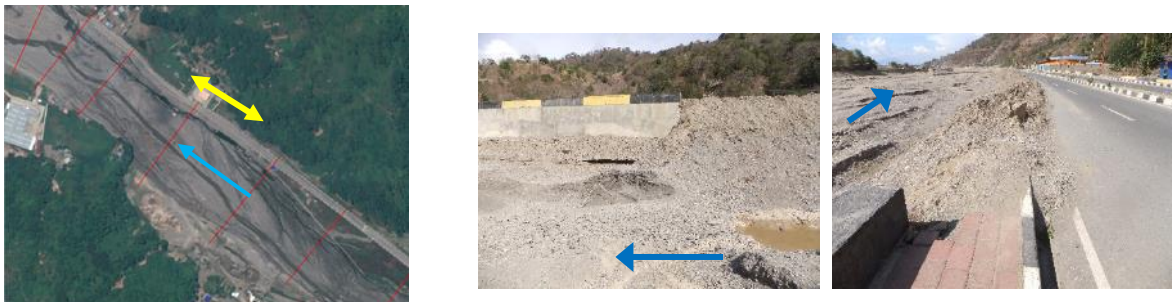
Figure 18 Damage to river wall (R10)

(j) R10 (6.8 km from the river mouth, 223 m long)

The bedding area (about 1.5 m) of the remaining river wall in this vicinity was exposed and floating. In this section, sediment was deposited in front of the riverbank before the flood, but it was eroded during the flood and the flow reached the river wall, lifted the foundation and caused the wall collapse.

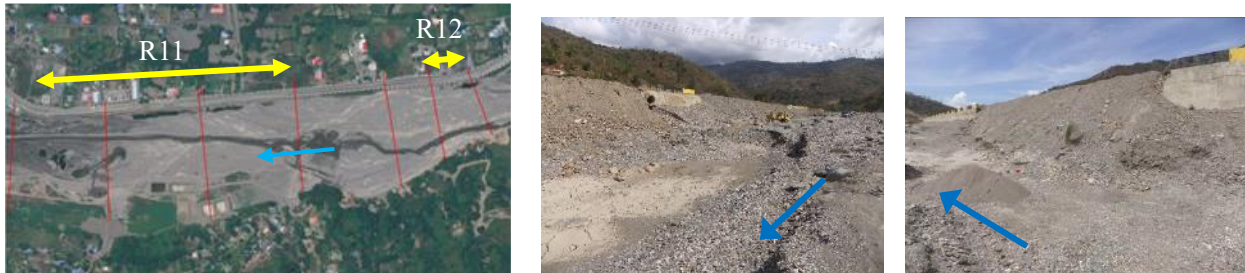
Figure 19 Damage to river wall (R11, R12)

(k)R11 (7.8 km from the mouth of the river, 560 m long) and R12 (8.6 km from the mouth of the river, 53 m long)

Gravel was piled up on the riverbank as a first measure, but the gravel was collected from the riverbed near the damaged area that resulted in the formation of a channel near the riverbank. The length of the damaged section on R11, 560 m, is the largest among the surveyed sections in this study. For the restoration, it is recommended that the revetment be reinforced with lateral strips at regular intervals to prevent displacement and damage from spreading to other areas, and that protection blocks be laid in front of the revetment.

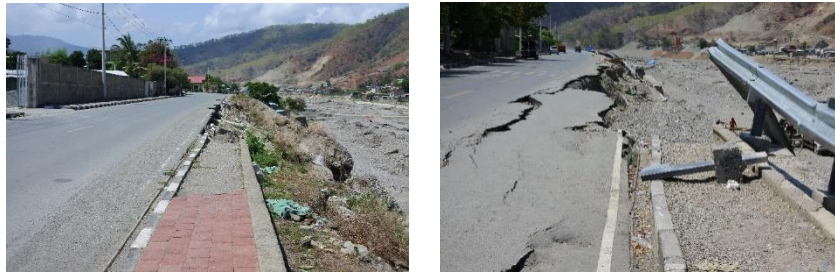
Figure 20 Road damage at 3.8 km (left, R5) & at 4.1 km (right, R6)

(b)Road damage at 3.8 km (R5) and 4.1 km (R6) from the river mouth

As mentioned above, no road damage was observed in the Hinode Bridge area, but the foundation of a masonry retaining wall upstream of the Hinode Bridge was washed away causing the retaining wall to collapse and the sidewalk and pavement of the road on the embankment collapsed along with it. The damaged retaining wall was upstream and downstream of the check dam that is located 3.9 km from the mouth of the river and it was constructed to a height of 7-10 m from the riverbed. As a result, the road has been reduced to a single lane, which is not only a hindrance to vehicular traffic, but also affects the houses that are in the vicinity. If left unattended, the damage to the road will continue to interfere with traffic and may also increase the risk of flooding for nearby residents.

The restoration structure of this river wall will be described later.

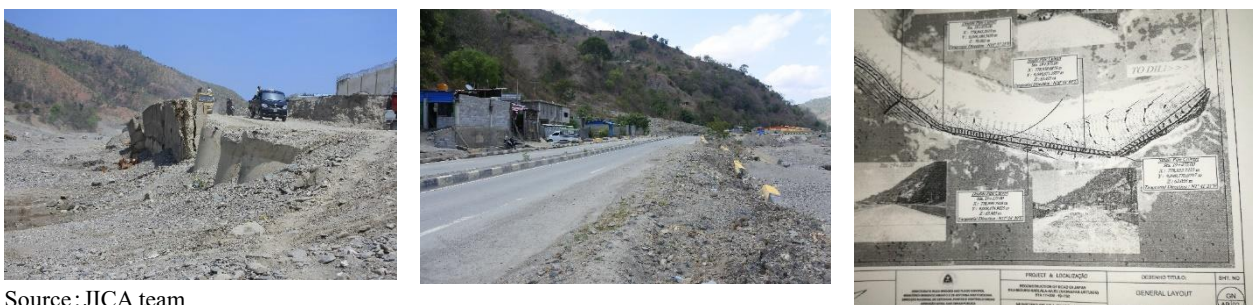
Figure 21 Road damage at 5.5 km (left, R7), Mudslide at 6.3 km (center, R8) & Road plan for 5.5-6.3 km (right)

(c) Road damage at the point 5.5 km (R7) to 6.3 km (R8) from the mouth of the river

There is road damage near the Bemós Water Treatment Plant at the point where the alluvial fan of the Comoro River begins at 5.5 km from the mouth of the river. In this location, the revetment had been damaged in the past, causing overflow and flooding of the city downstream. Therefore, the current ground near the embankment had been raised in the past to prevent the overflow from occurring, but the reinforced concrete revetment collapsed because the foundation was washed away and the road collapsed along with the embankment.

This section of the road was blocked by a private stone quarrying factory and the road overhang was damaged by the muddy water caused by heavy rain. In addition, there are many bare areas in this section because the hills are close together and the vegetation in the valleys has been stripped by the crushed stones. As a result, counterpart organizations have been removing mud and stones from the roads immediately after the disaster to allow the passage of traffic.

However, the intrusion into the river area and damage to the revetment caused by the blockage of road facilities by the private sector is a problem that should be addressed by the maintenance of revetments and roads in the original river area. As for Japan's measures to deal with the current damage, since this is a domestic issue, it is recommended that the local government improve the location of the river and the structure of the riverbank, and restore the existing riverbank road or the original road position.

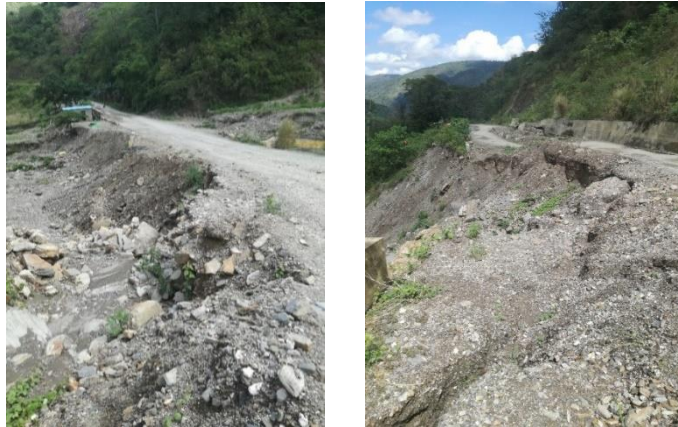
Figure 22 Cross culvert and road damage at 12.2 km (left) & Road damage at 15.4 km (right)

At the crossing box culvert 12.2 km from the mouth of the river after the junction, heavy rains from the mountains have washed away the road and river side retaining walls, resulting in the road being reduced to a single lane and the unpaved lower subbase is severely scoured. The section upstream of this point is under construction up to the lower subbase, but since two lanes of traffic are maintained in the section before and after this point, it is recommended that restoration work be carried out as soon as possible.

At the 14.6 km and 15.4 km points from the mouth of the river as well as at the 12.2 km point, heavy rains from the mountain side have washed away the road and retaining wall, reducing the road to a single lane, so it is recommended that restoration work be carried out as soon as possible.

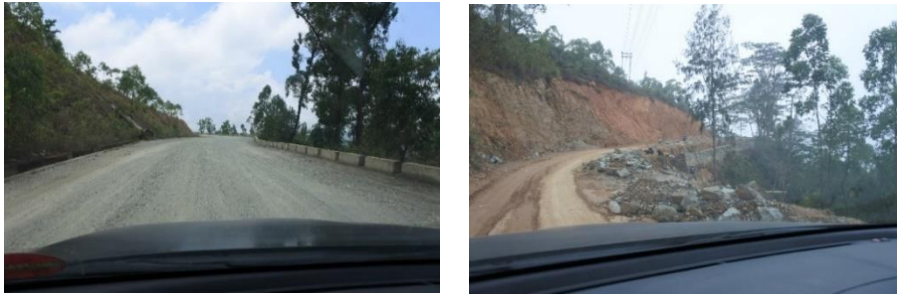
**Figure 23 Construction of subbase on Ex-Japan Road (left)
& Cross culvert / retaining wall on NH2 (right)**

(g) After the above-mentioned sections, there is little damage to the road and only erosion of the lower subbase by rainwater. The construction of the lower subbase under construction should proceed. The upper subbase of the section connecting to National Highway No.2 from further upstream has been completed, and a wide two-lane road has been completed.

NH2, which connects the southern part of the country, is undergoing a complete renovation of the existing drainage facilities and embankment retaining walls along almost the entire route. In addition, the road is muddy because it is only one lane and is made of earth road, which significantly hinders the safe passage of vehicles and motorcycles, resulting in low traffic volume. The Ex-Japan Road along the Comoro River is used as a bypass for NH2.

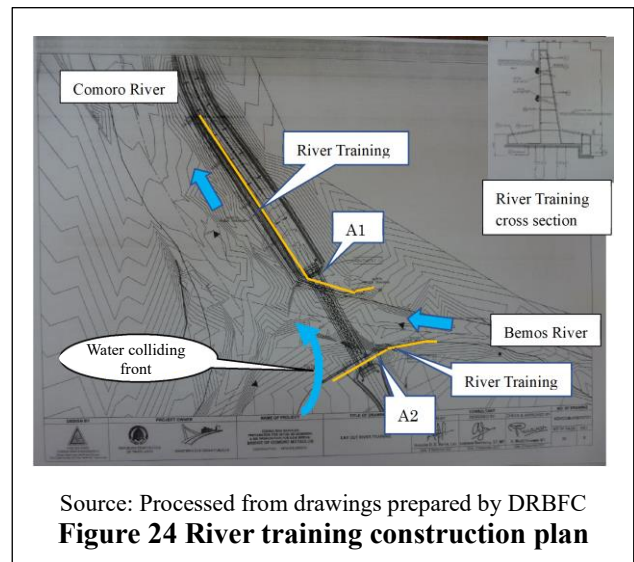
- There is an indication of the 50-year and 100-year probable flood levels. Obviously, these levels are low and do not seem to take into account the volume of water in the Comoro River, which joins the Bemos River. It is necessary to review the river plan in the future based on the results of the recommendations made in the information gathering survey.

- The back of the abutment may be eroded because the southern abutment (A2 abutment) is at the water colliding front on the outside of the bend of the Comoro River. However, since river training is not sufficiently planned for the flow and water level of the Comoro River, it is important to review the location of the revetment to protect the back of the abutment from erosion, taking into account the above water level and the flow speed of the river. It is also necessary to take measures against erosion of the approach road embankment slopes.
