ジンバブエ共和国
土地・農業・水産・水・地方再定住省
灌漑局

灌漑開発および流域農業開発に向けた 情報収集・確認調査

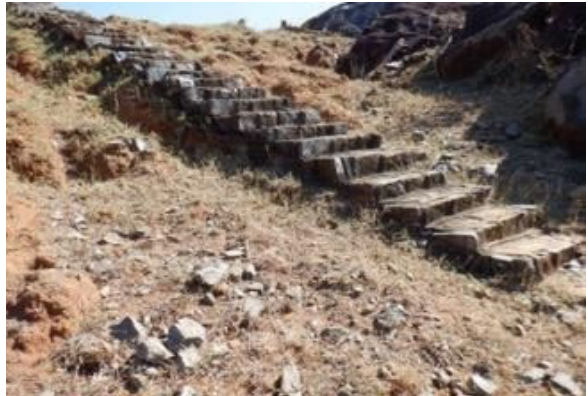
D(4) Embankment Downstream: Erosion is also observed on both sides of the stairway on the left bank.

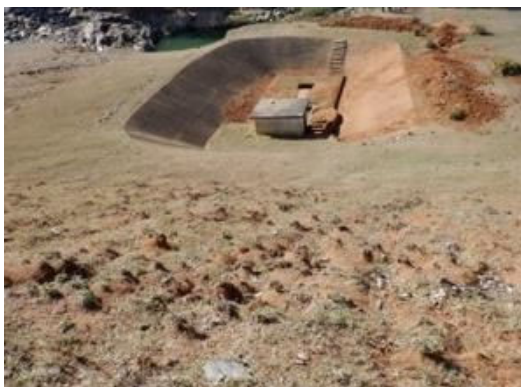
D(5) Embankment Downstream: Eroded soil and sand are flowing to the valve house slope. (Excavating around the valve house.)

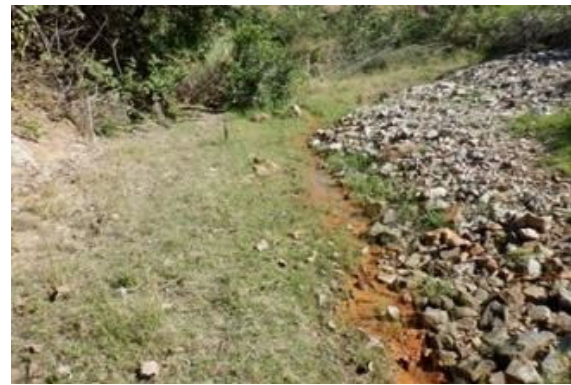
D(10) Foot of slope: In the downstream, a small stream is observed and connects to the connecting canal (on the flowbed, reddish brown and a film is also observed).

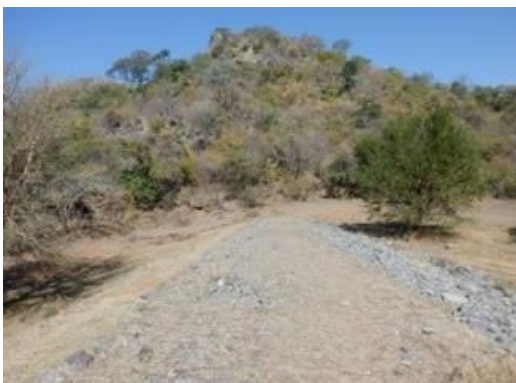
D(11) Right side abutment: There is no disturbance in the abutment. The land is high mountain. There is farmland on the downstream side.

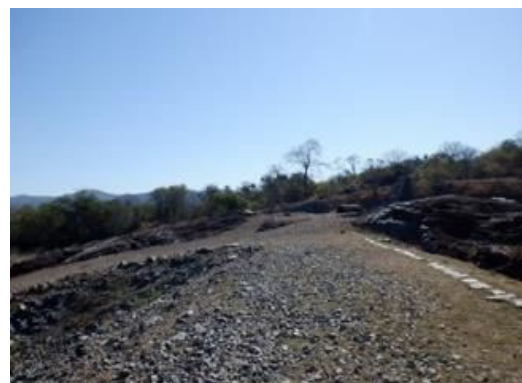
D(12) Right side abutment: At the boundary of the spillway, no disturbance is observed.

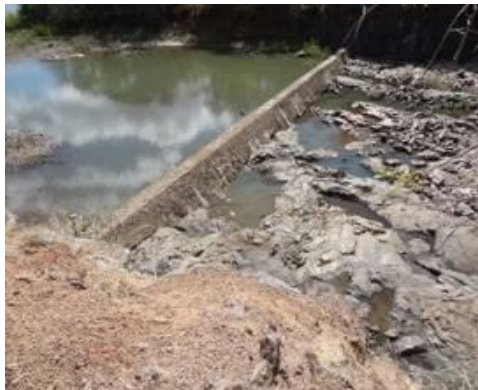
S(1) Spillway entire: No significant damage is observed.

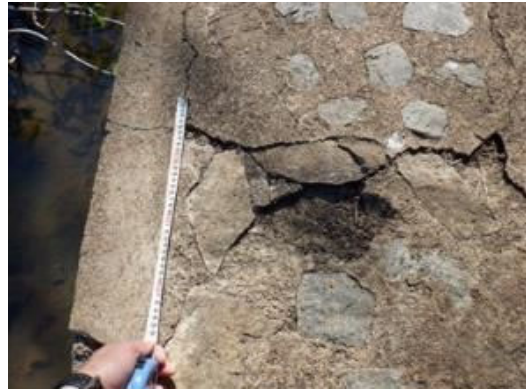
S(2) Spillway Weir: Surface concrete peeling at the top of the weir.(L7.5m/t5cm)

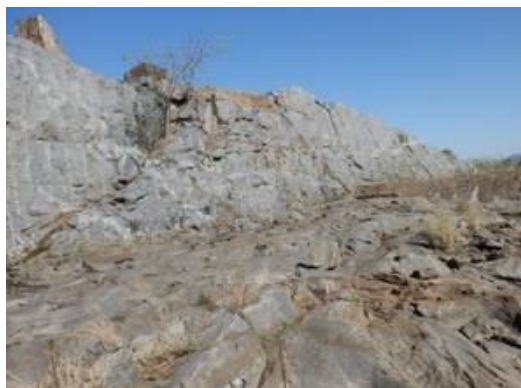
S(5) Spillway Retaining wall(Right side): No significant damage is observed.

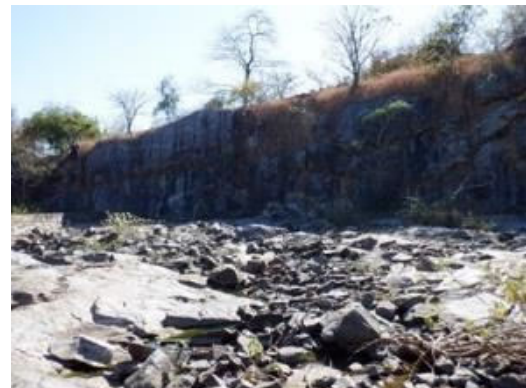
S(6) Spillway Retaining wall(Left side): No significant damage is observed.

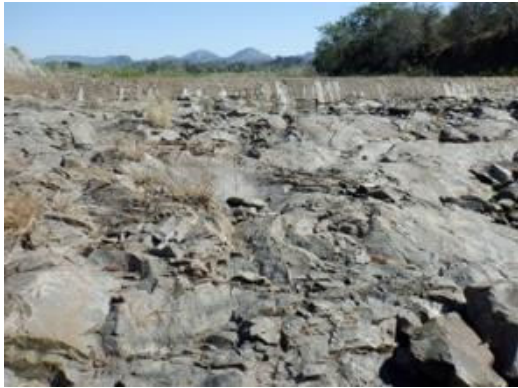
S(7) Spillway Apron: No significant damage is observed.

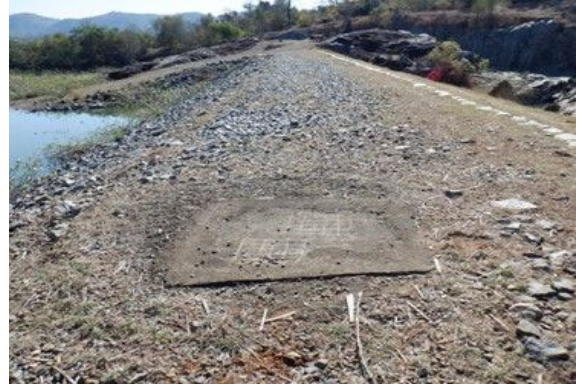
I(1) Intake Inlet: There are no water intake facilities left.

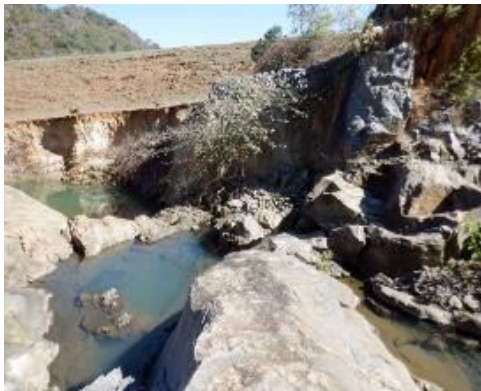
C(1) Connecting Canal: The large erosion is observed on the right bank side (embankment side).
According to the existing photo data, the bank is eroded by about 70cm every year.

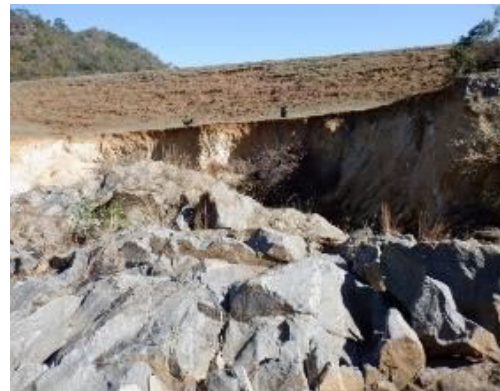
C(2) Connecting Canal: The large erosion is observed on the right bank side (embankment side).
According to the existing photo data, the bank is eroded by about 70cm every year.

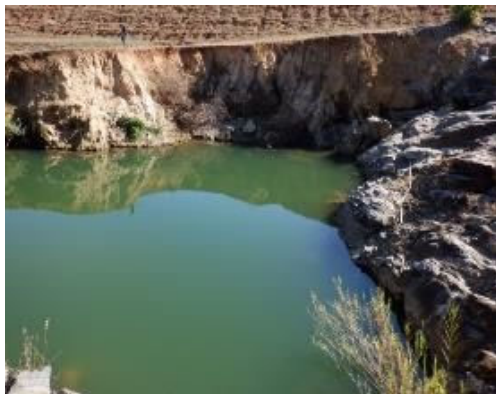
C(3) Connecting Canal: The large erosion is observed on the right bank side (embankment side).

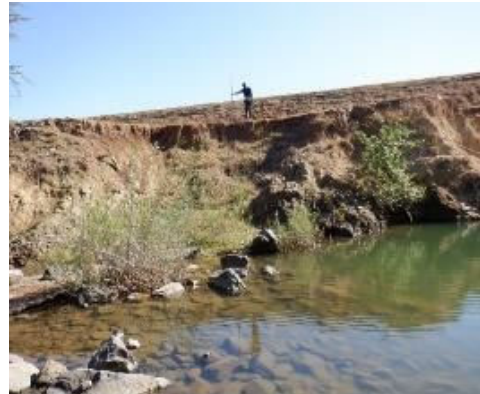
C(4) Connecting Canal: The large erosion on the right bank side (embankment side) extends beside of the valve house.

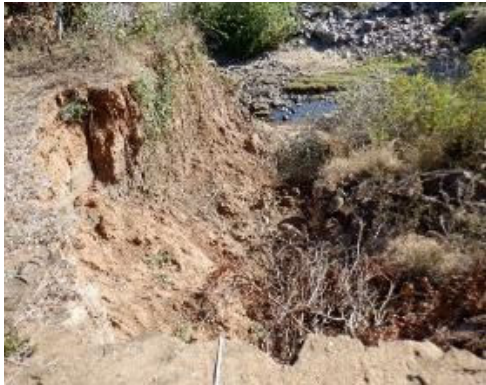
C(5) Connecting Canal: Erosion is also observed on the left bank side (downstream). The bridge has been washed away.

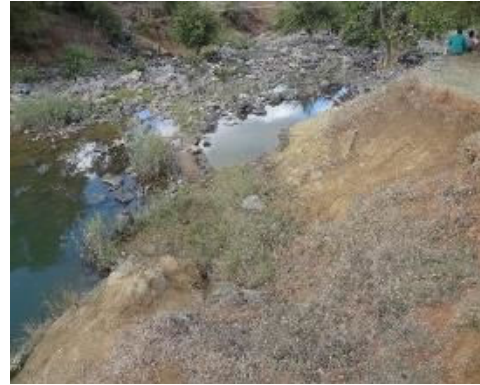
C(6) Connecting Canal: The canal bed has been eroded and the concrete siphon protection are exposed.

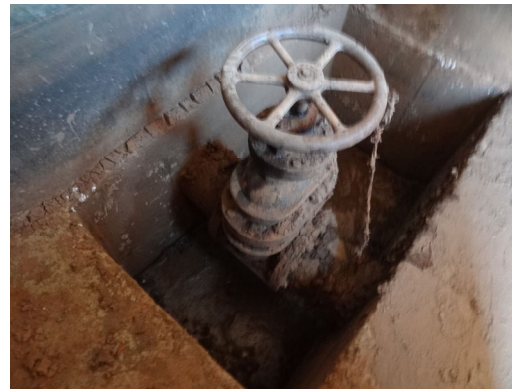
I(2):Outlet (Valve):Good condition.

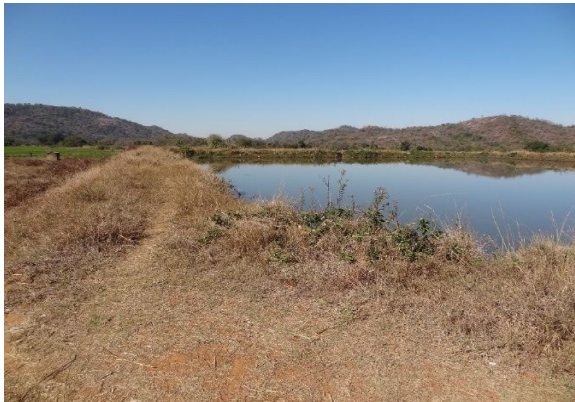
Night strage body is good condition, but it has a little sedimentation.

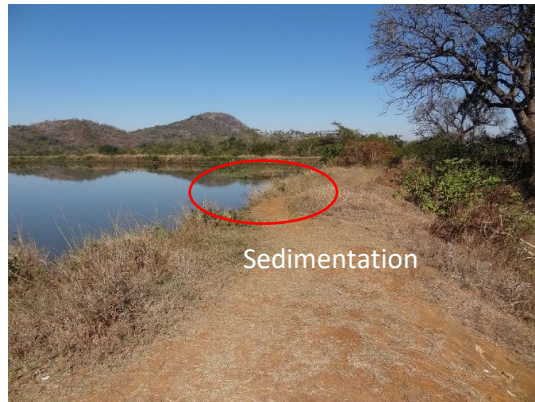
Night strage body is good condition, but it has a little sedimentation at inlet.

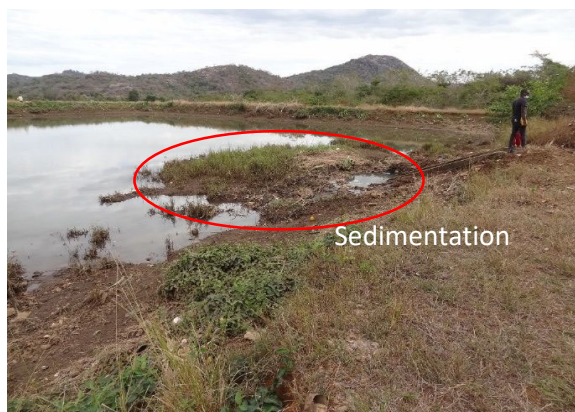
Situation of sedimentation at inlet.

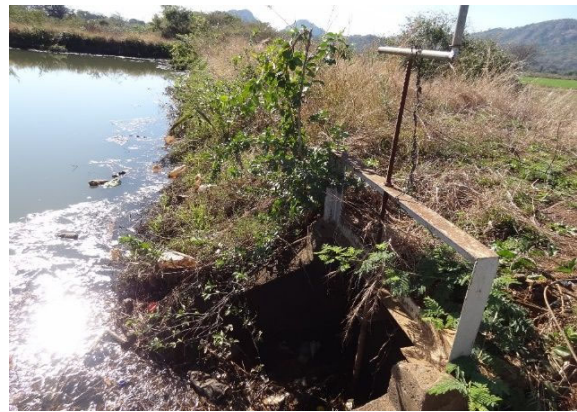
The upstream gate has broken.

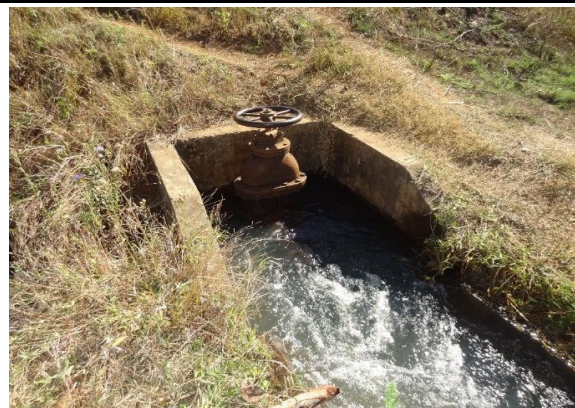
The downstream valve is movable and in good condition.

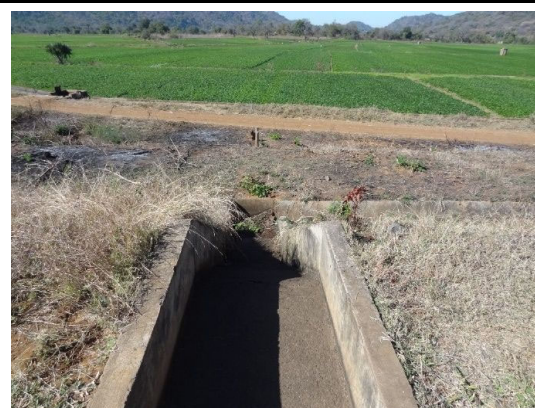
OF(5):Night strage(Outlet valve)

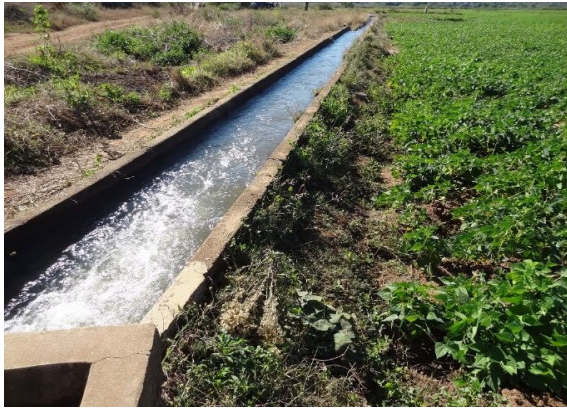
The Canal is in good condition. But there is no embankment on the field side in the entire deliver canal.

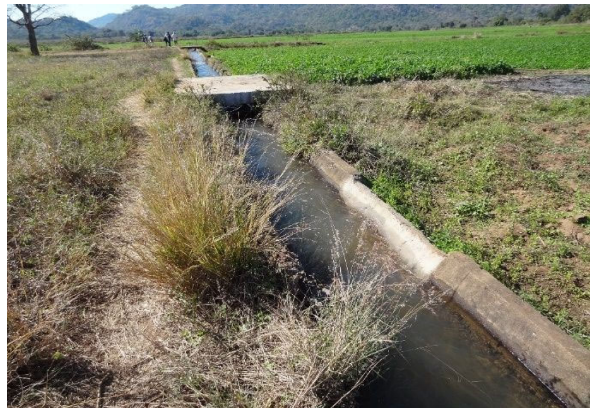
There are repaired On farm canal by FAO in 2018.

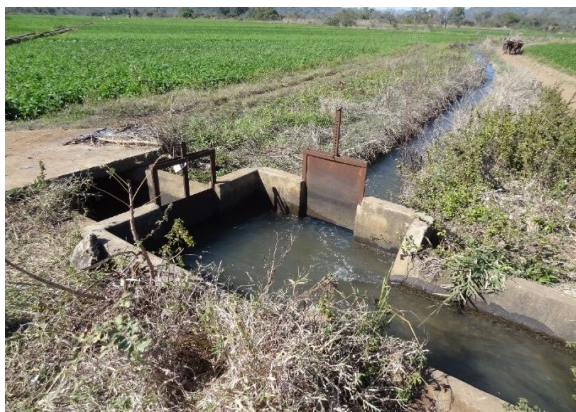
OF(8):On farm canal(2)

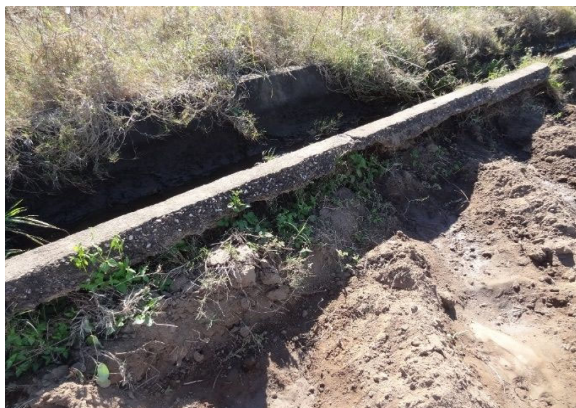
The back soil is flowing out.

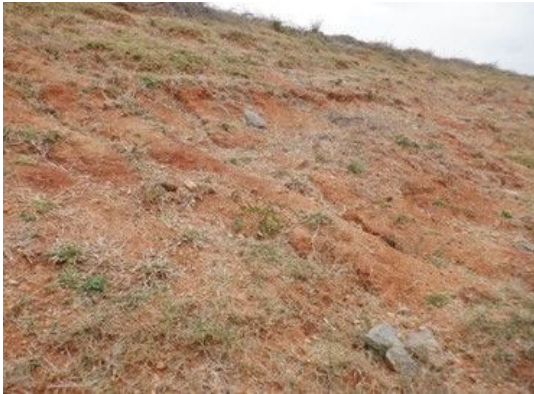
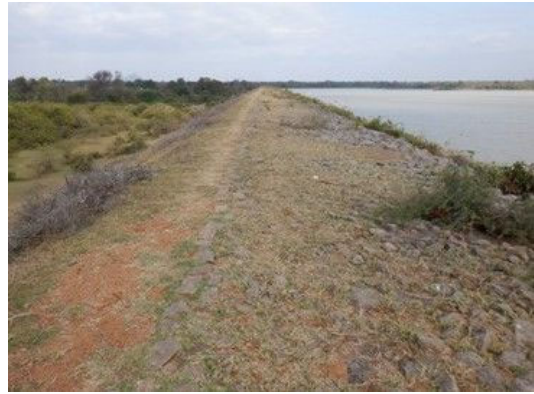
D(3) Embankment Downstream: Gully erosion on the downstream surface.
Downstream flow (ditch) formed by surface runoff is also observed.(h20cm)

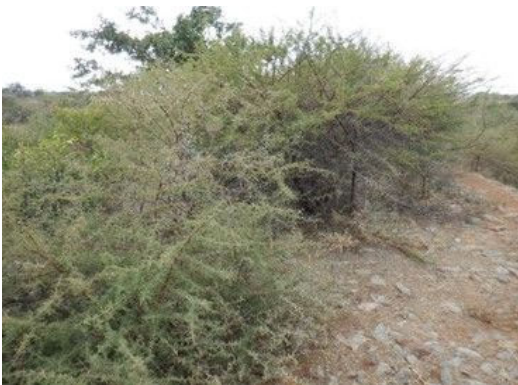
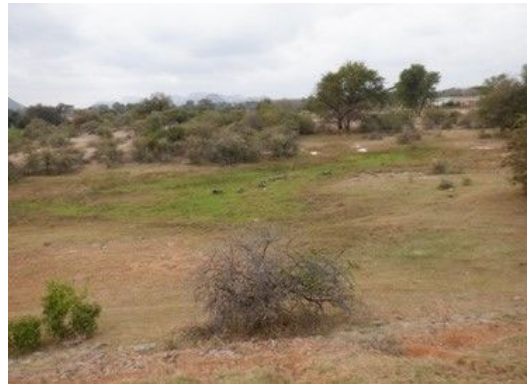
D(5) Crest of Embankment: Many trees on the both edges. (This makes it impossible to see and pass through, especially on the left side.)

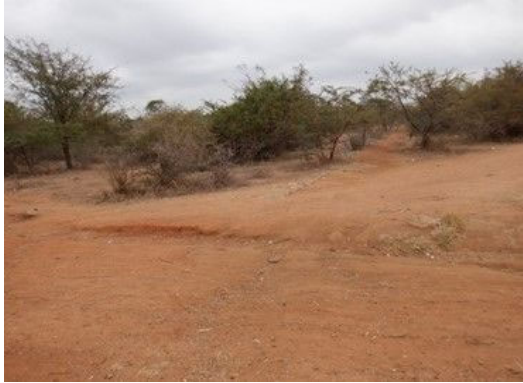
D(7) Right side abutment: No significant damage. Abutment area around edge of crest is flat.

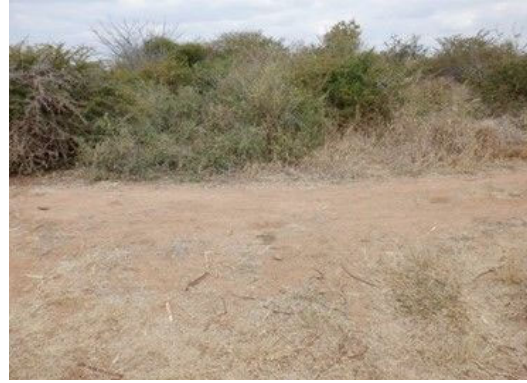
D(8) Left side abutment: Many trees on and around embankment surface (higher than FWL) making it impossible to look out over and pass through. Out side of edge is flat.

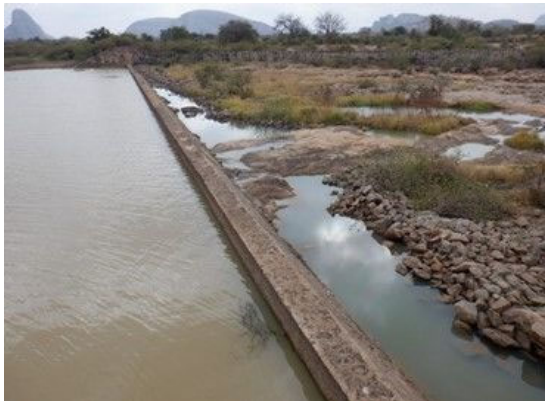
S(1) Spillway Entire: No significant damage.

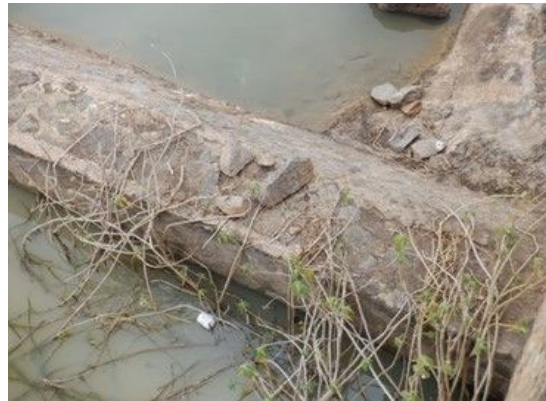
S(2) Spillway weir: Surface peeling and lack of stones on the top

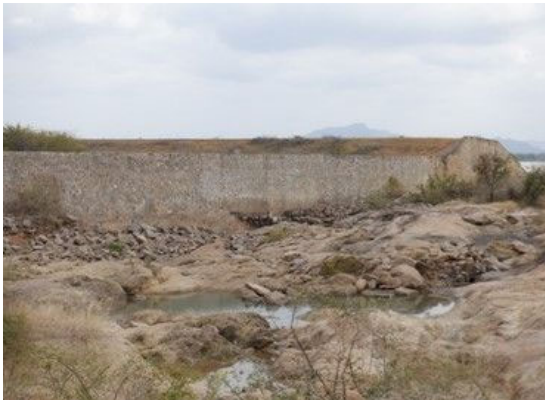
S(5) Spillway retaining wal (right)!: No significant damage.

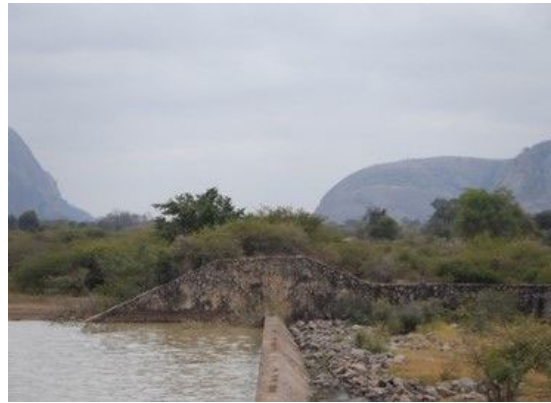
S(6) Spillway retaining wall (left): No significant damage.

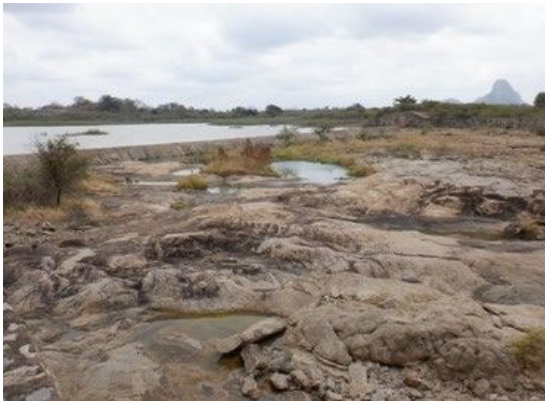
S(7) Spillway apron: The bed is digged rock. No significant damage.

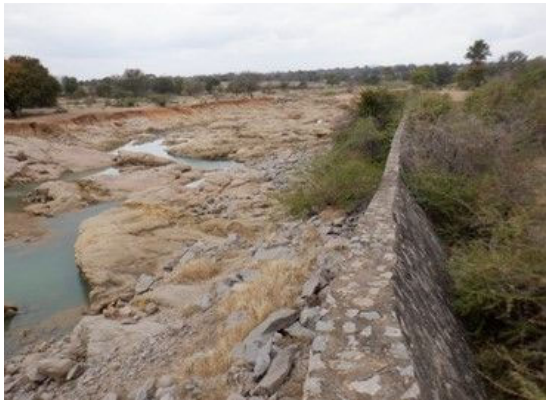
S(8) Spillway apron: The bed is digged rock. No significant damage.

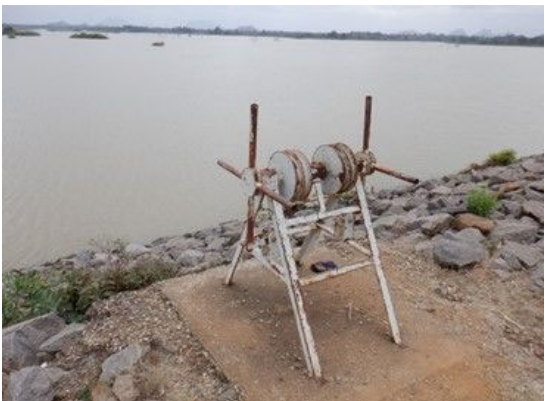
I(1) Intake Inlet:The winch is still in place, but the wires are disappeared. There is rusting all over. The handle on the right bank side is movable.

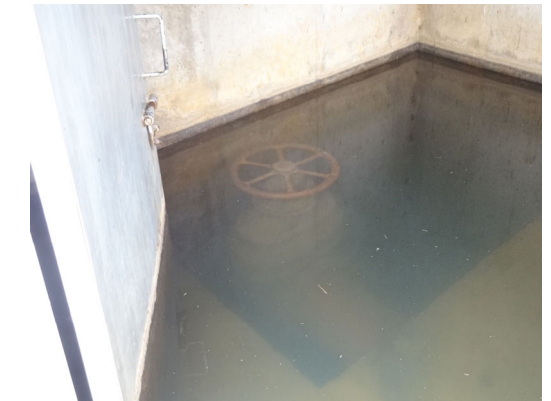
I(2) Intake Outlet:The valve has movable and submerged.

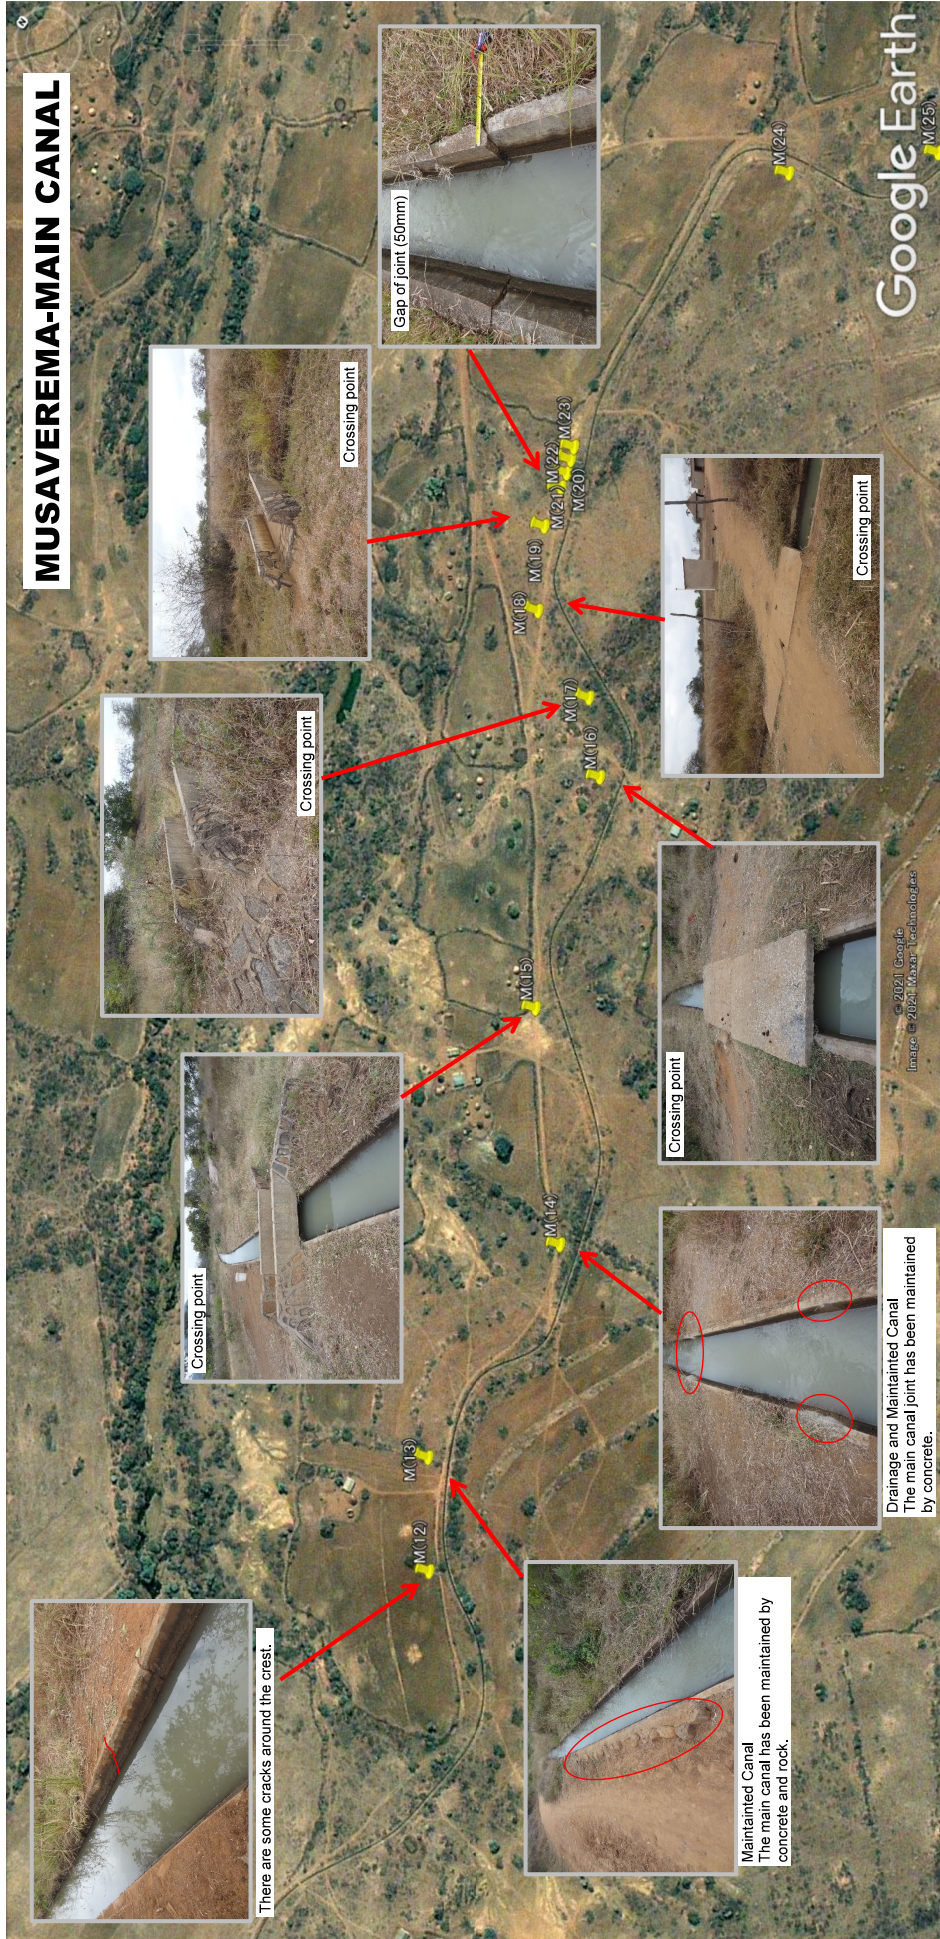
There are some cracks around the crest.

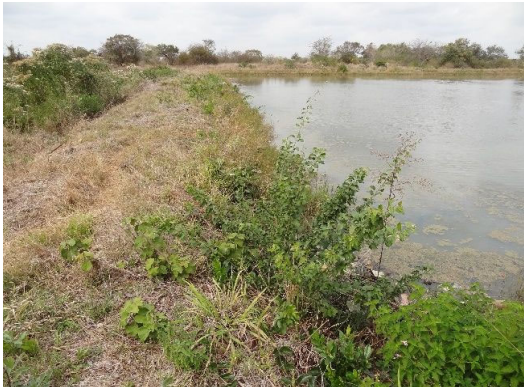
No sedimentation and good condition.
OF(1):Night storage(1)

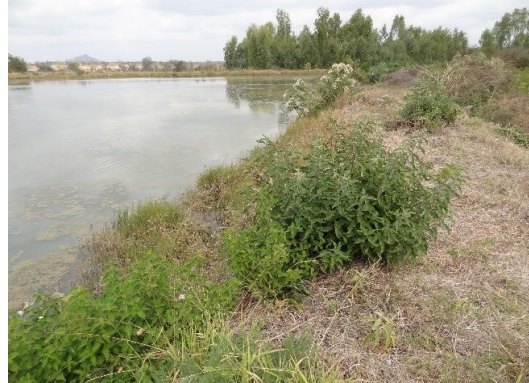
No sedimentation and good condition.
OF(2):Night storage(2)

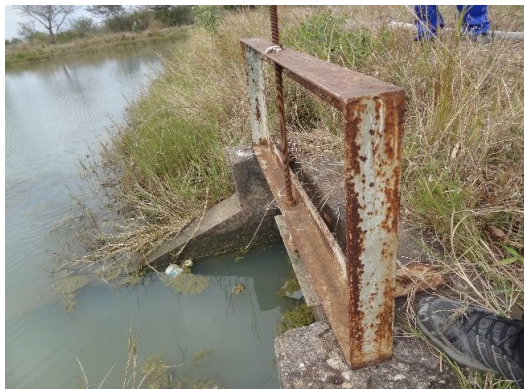
The gate has been broken. (B700xH400)
OF(3):Night storage(Inlet gate)

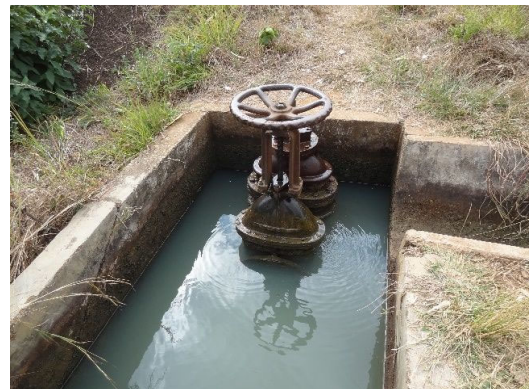
The valve have a deficit.
OF(4):Night storage(Outlet valve)

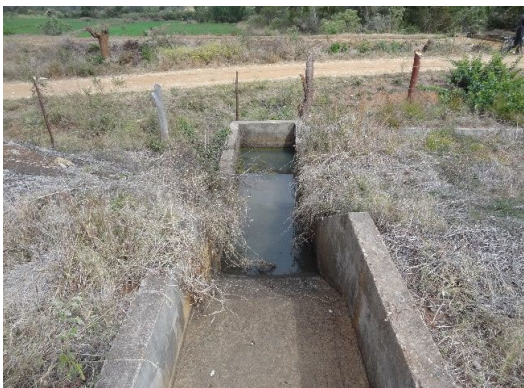
Good condition.
OF(5):Night strage(Spillway)

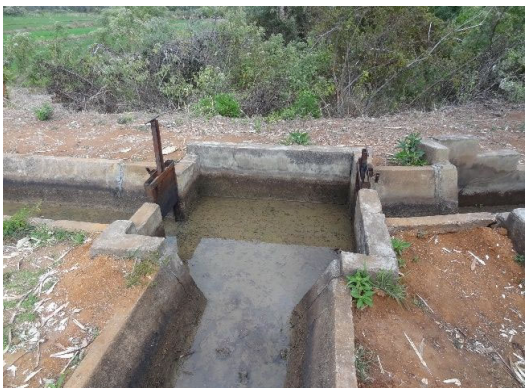
Good condition.
OF(6):Diversion(1)

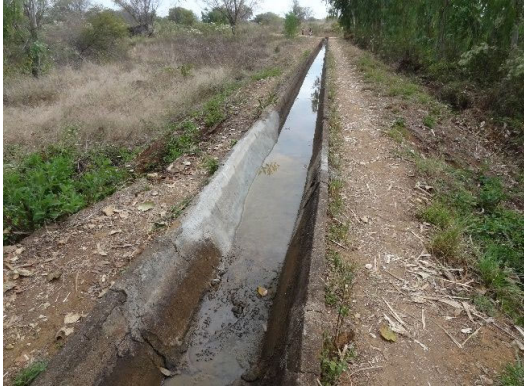
The on farm canal has been maintained by farmers committee.

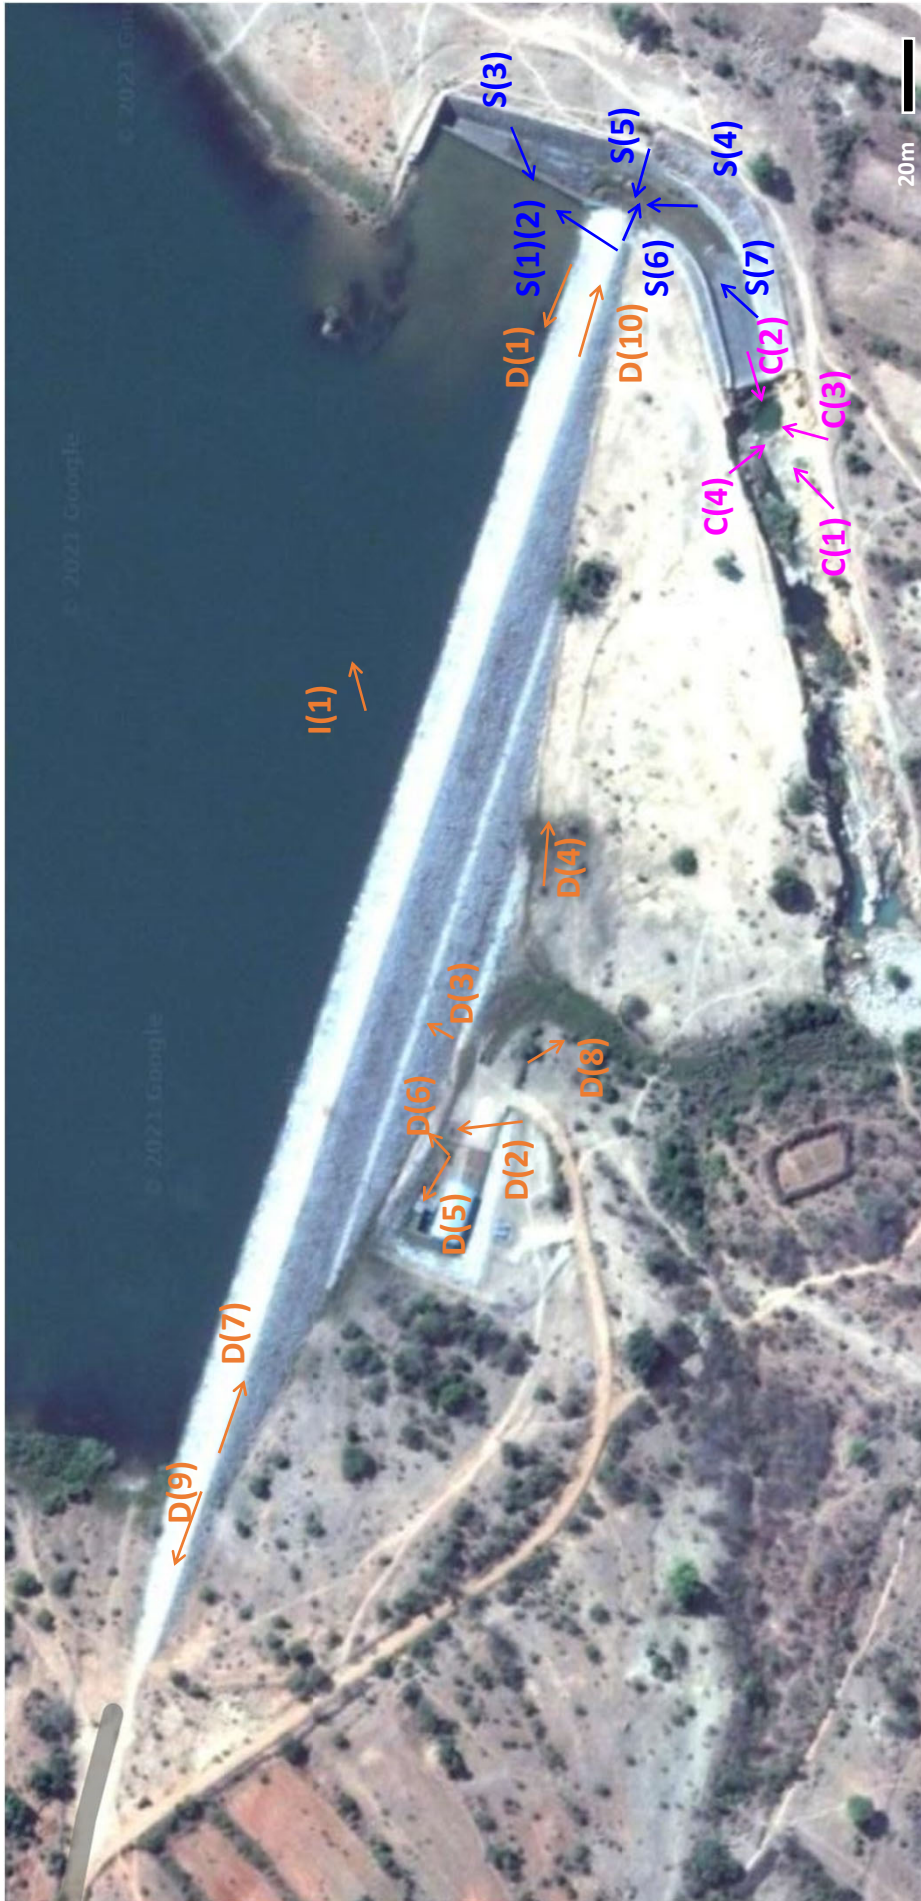
CHINYAMATUMWA DAM (1)

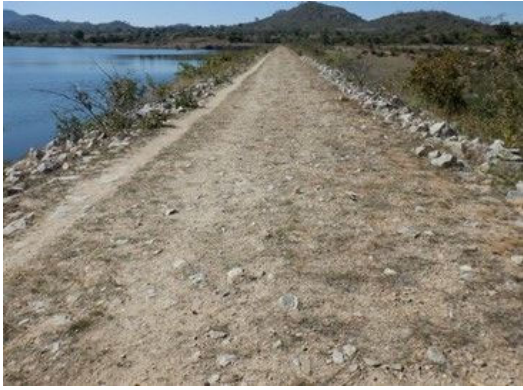
D(7) Crest of Embankment: Since no significant damage is observed.

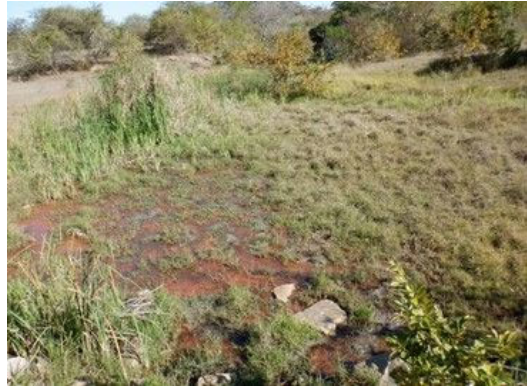
D(8) Foot of slope: It is a wetland. The bed is turned reddish brown and a film of iron bacteria can be seen. The flow is slight.

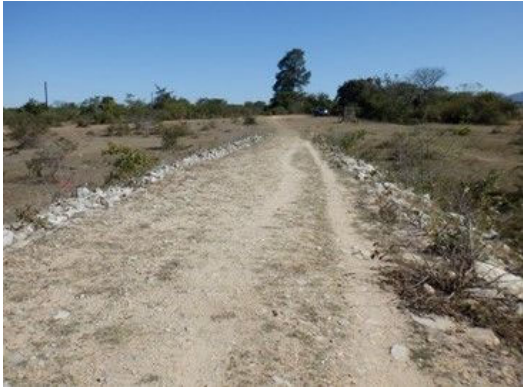
D(9) Right side abutment: No significant damages are observed. Elevation difference is small (hill-like terrain) .

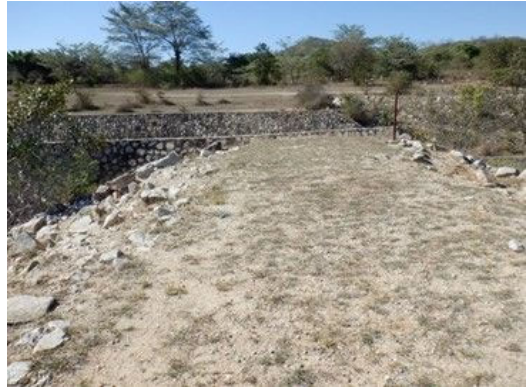
D(10) Left side abutment: No significant damages are observed at the boundary with the spillway. Elevation difference is small (hill-like terrain) .
There is farmland in the upstream side.

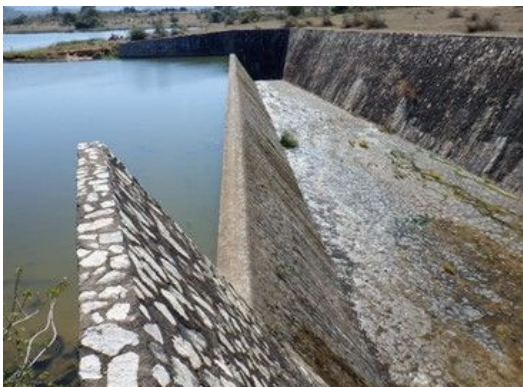
S(1) Spillway entire: No significant damages are observed.

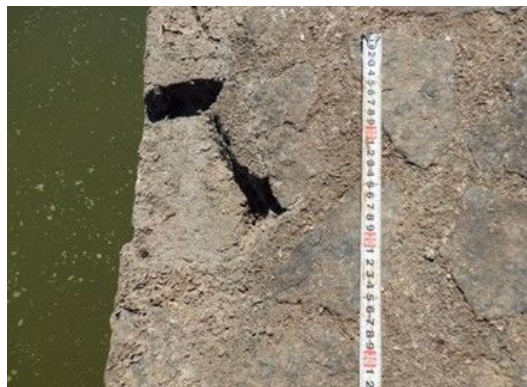
S(2) Spillway weir: Slight damage on the crest.

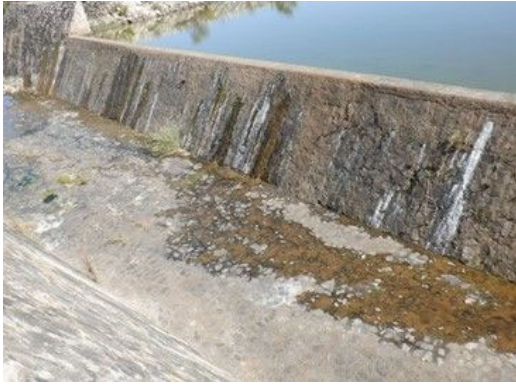
S(3) Spillway weir: Leakage on the downstream side

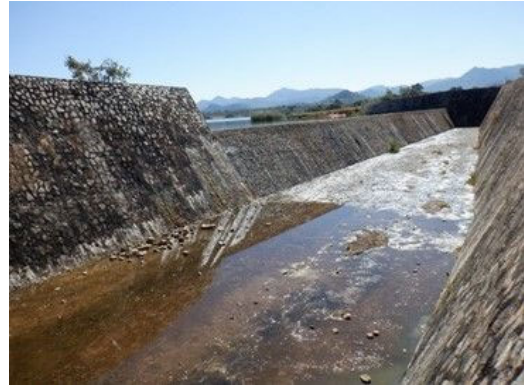
S(4) Spillway apron: Small rocks, a slight plants, and some water are observed.

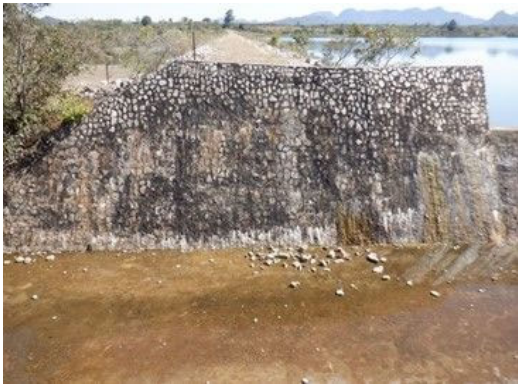
S(5) Spillway Retaining walls(right): No significant damages are observed.

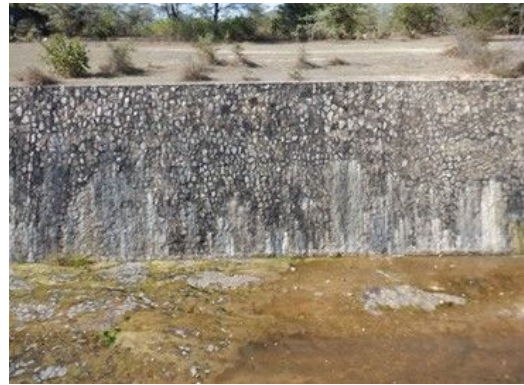
S(6) Spillway Retaining walls(left): No significant damages are observed.

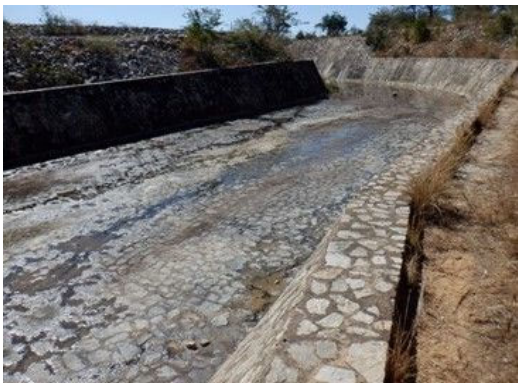
S(7) Spillway canal: Small rocks, a slight plants, and some water are observed.

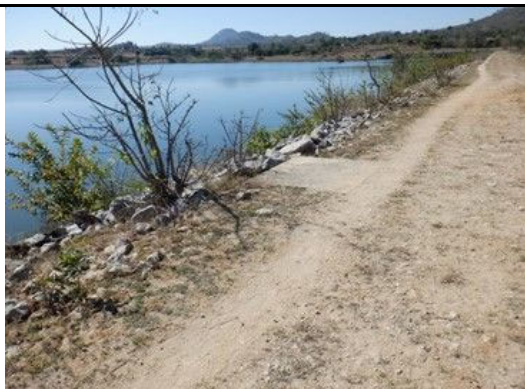
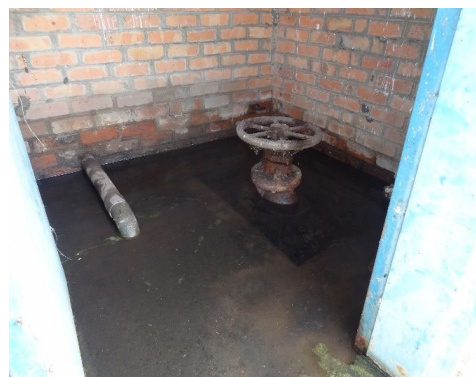
I(1) Intake Inlet: The flap valve at the inflow port stays open all the time, It has been stolen.

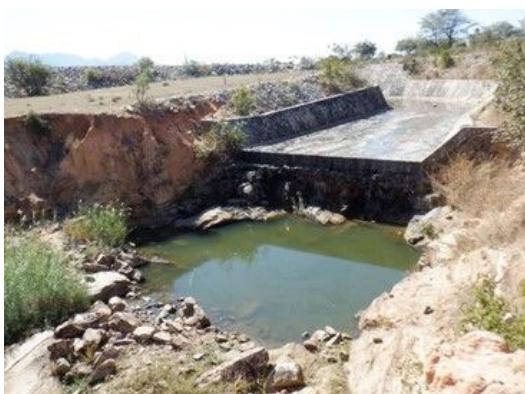
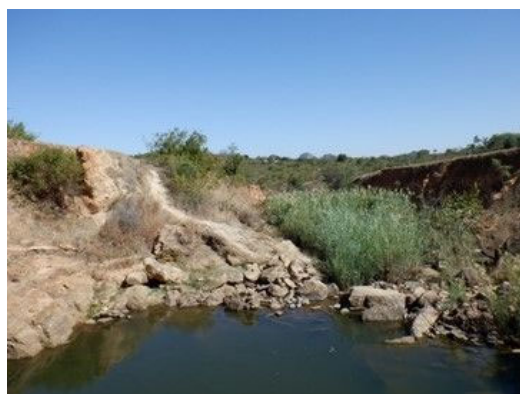
C(1) Connecting Canal: No significant damages are observed. A slight leak can be seen, which seems to have flowed down the back of the canal.

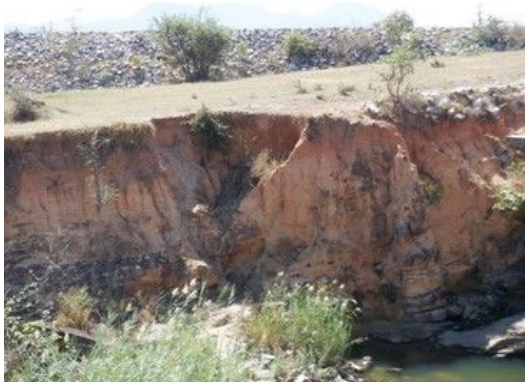
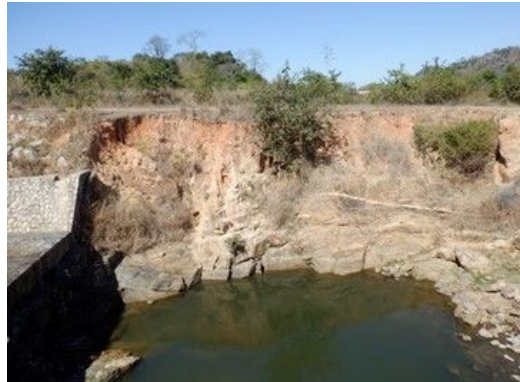
C(3) Connecting Canal: Collapse of both banks at the end of the spillway canal (right: L5m, B1.5m, H6m).

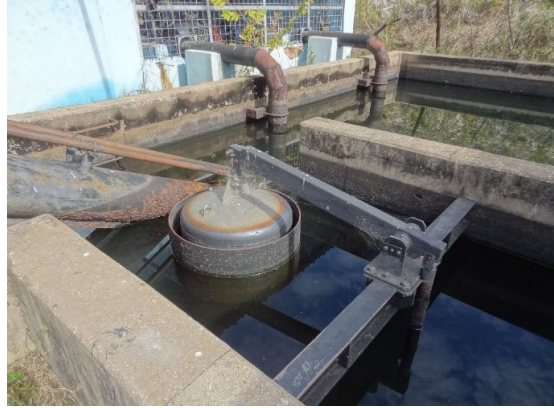
PS(1): Full view of pump station

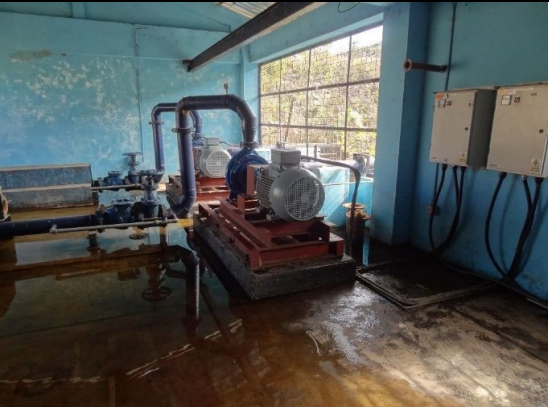
Electric pump equipment has been installed by FAO in 2016.

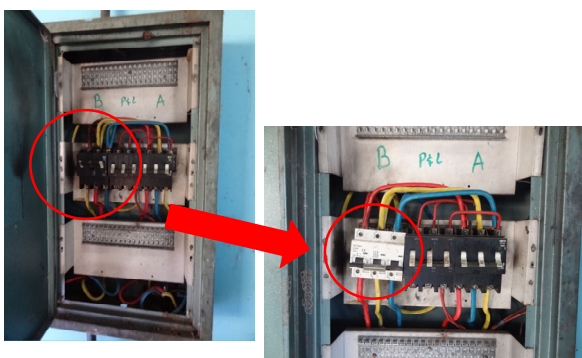
Circuit breaker has been replaced by DOL on 7th July, 2021.

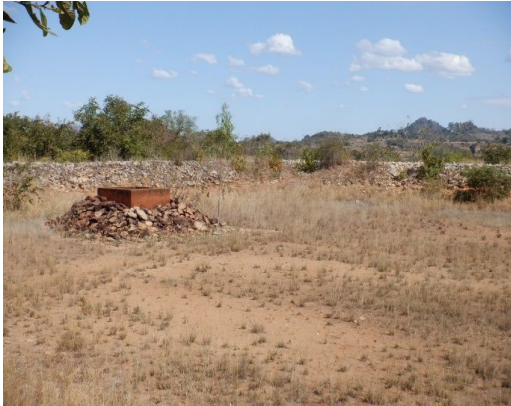
No sedimentation and good condition.
OF(1):Night storage (1)

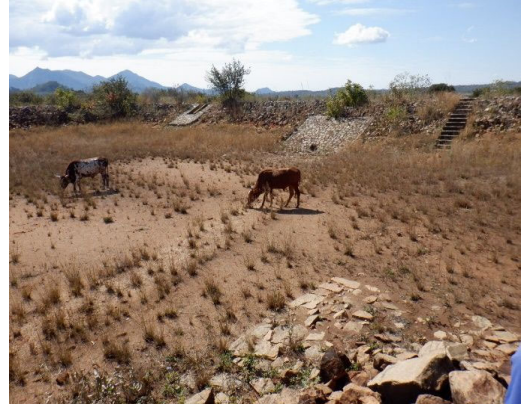
No sedimentation and good condition.
OF(2):Night storage(2)

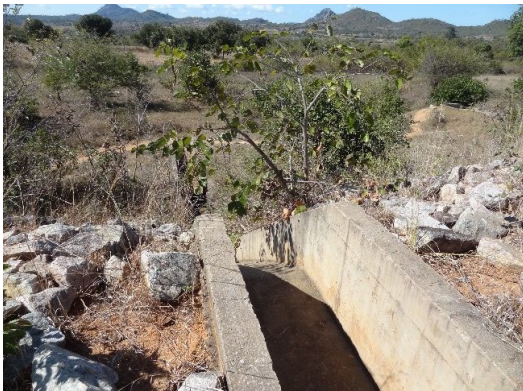
Good condition.
OF(3):Night storage (Spillway)

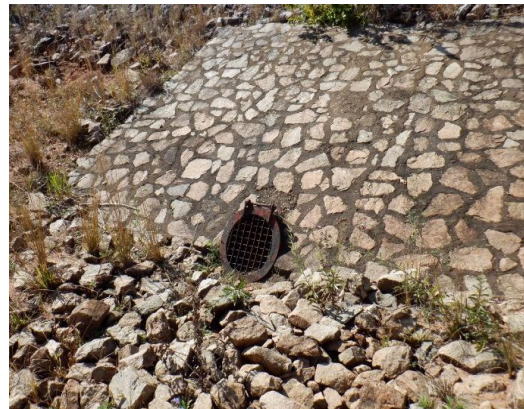
Good condition.
OF(4):Night storage(Distribution hole)

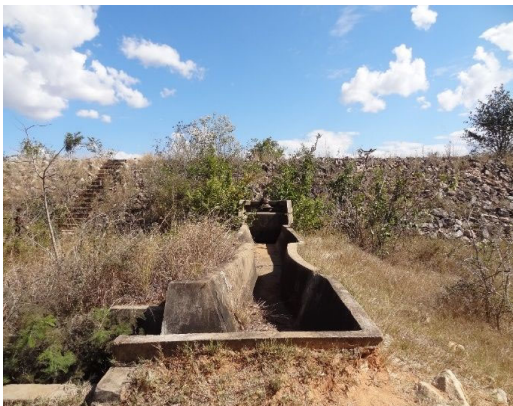
Good condition.
OF(5):Night strage (Distribution facility)

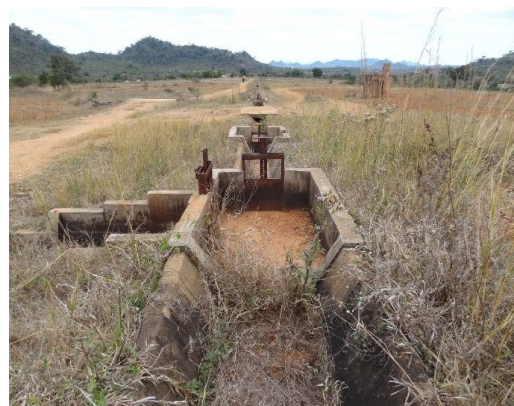
Good condition of movable gate and divirsion.
OF(6):Diversion

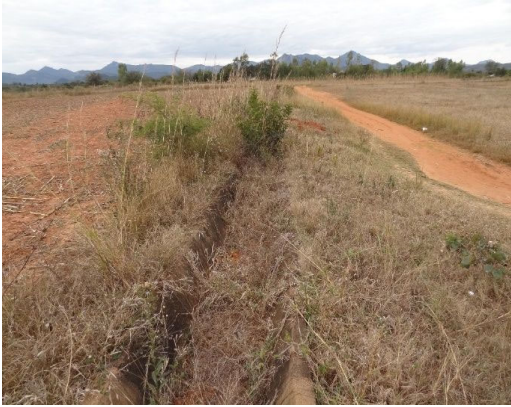
This on farm canal has not been distributed for more than 5 years and is not maintained.

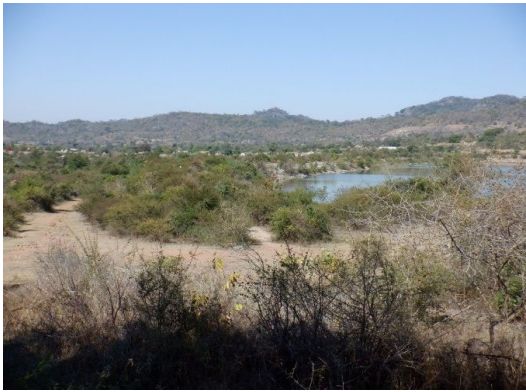
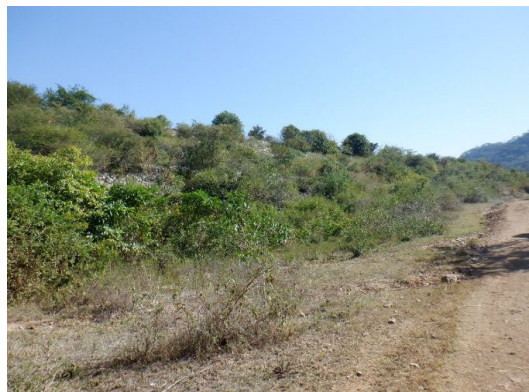
D(1) Embankment Upstream: Many trees (making it impossible to see the condition of the surface) . Partially disturbed riprap and exposure of dam body.

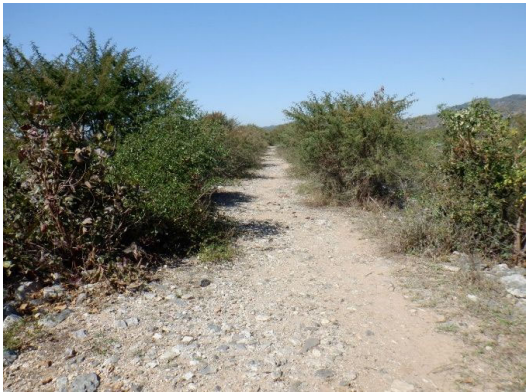
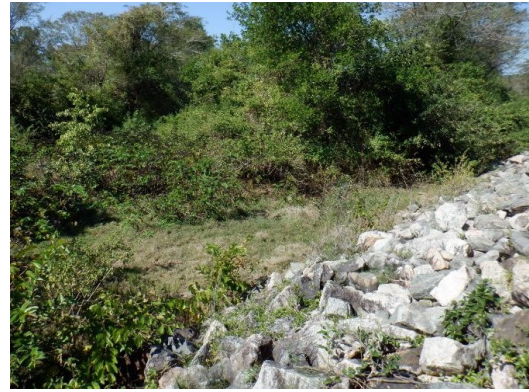
D(3) Crest of Embankment : ditto

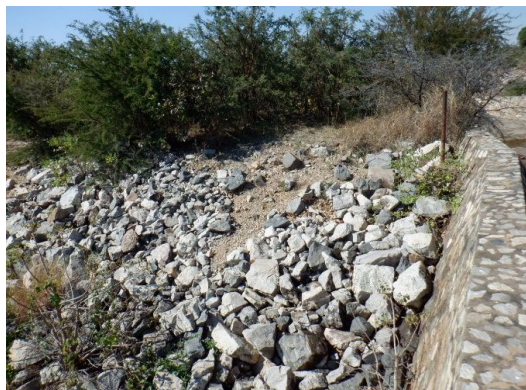
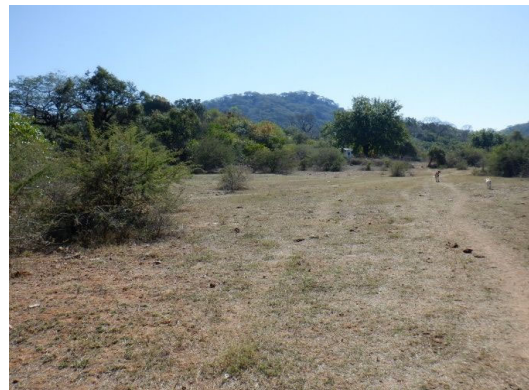
D(5) Right side abutment: Many trees (making it impossible to see the condition of the surface) . No damage is observed at the boundary between the embankment and the spillway.

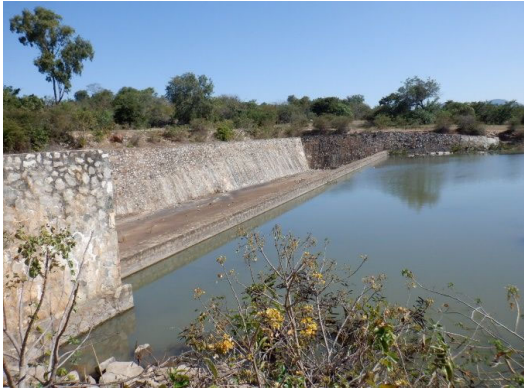
S(1) Spillway over view: No significant damage.

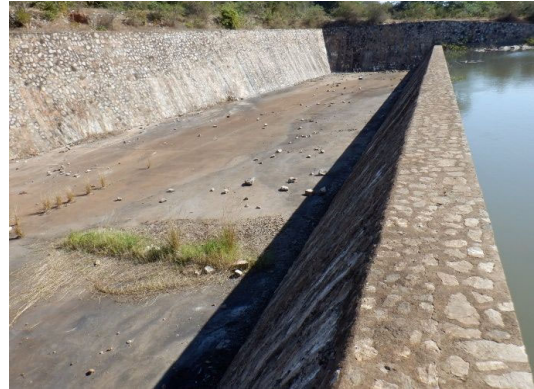
S(2) Spillway crest: No significant damage.

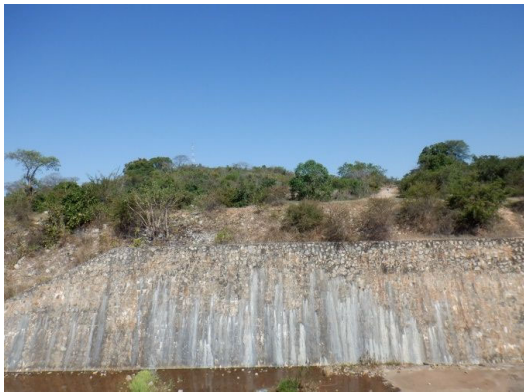
S(3) Spillway Retaining wall (right):
Efflorescence from cracks (not draining from drainage holes).
