ジンバブエ共和国
土地・農業・水産・水・地方再定住省
灌漑局

灌漑開発および流域農業開発に向けた 情報収集・確認調査

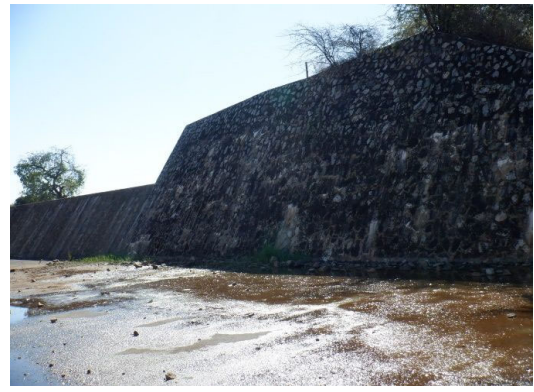
S(4) Spillway Retaining wall (left):
Efflorescence from cracks (not draining from drainage holes).

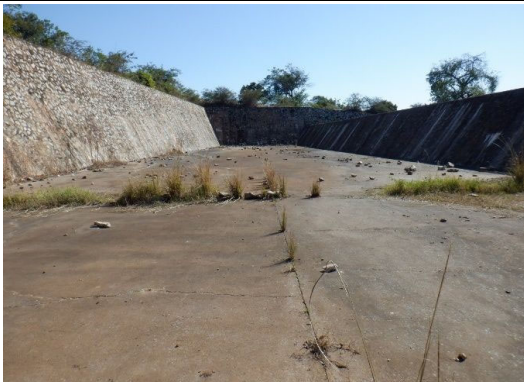
S(5) Spillway Apron: A few rocks and cracks are observed on the bottom.
There is no scouring at the bed.
Low plants in joints.

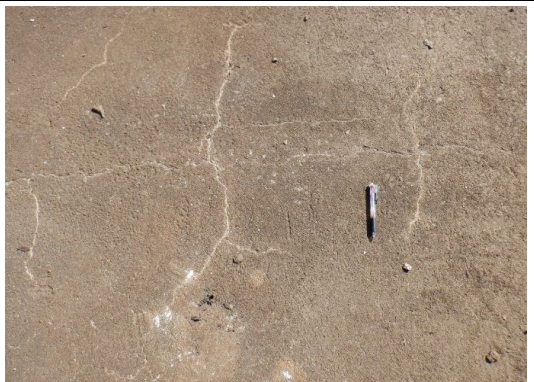
S(6) Spillway Apron: A few rocks and cracks are observed on the bottom.
There is no scouring at the bed.
Low plants in joints.

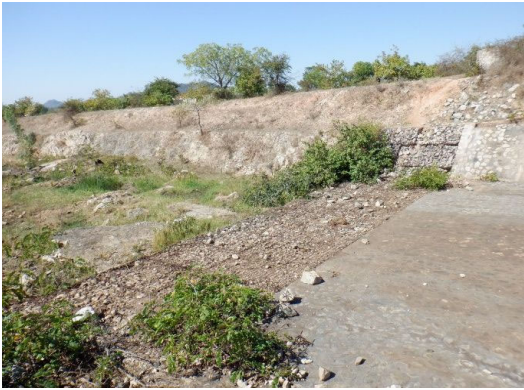
S(7) Spillway canal: The end of the spillway canal is a gabion works of L4.5m (t50cm). There is no erosion. Crossing road across canal.

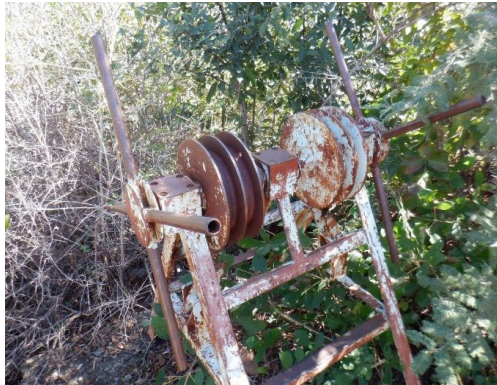
I(1) Intake Inlet: Wire is missing and equipment is dysfunctional. Rust over all. The left side lever is not functional.

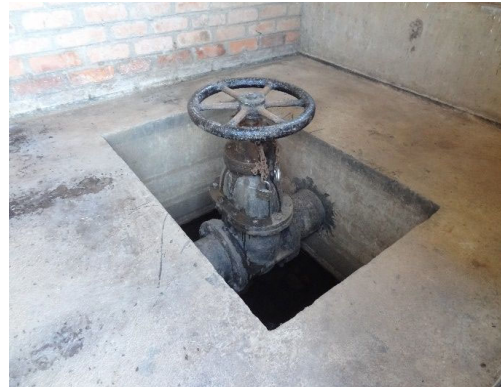
I(2) Intake Outlet: The valve is movable and there is no problem so far.

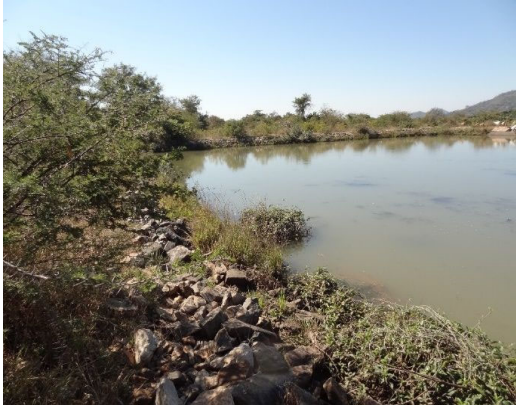
No sedimentation and good condition.
OF(1):Night storage(1)

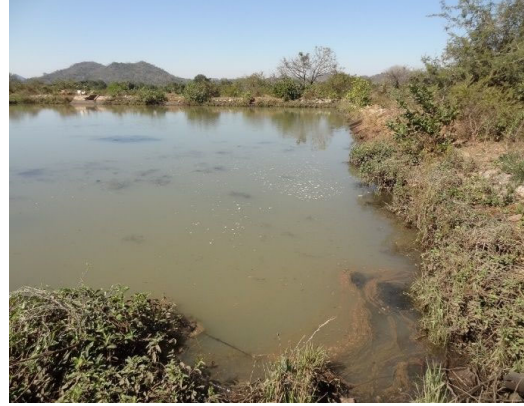
No sedimentation and good condition.
OF(2):Night storage(2)

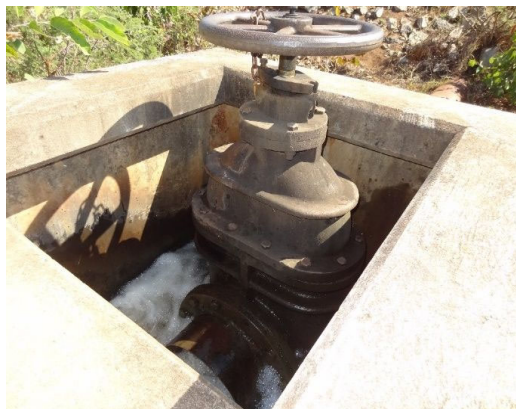
The valve is movable and in good condition.
OF(3):Night storage(Outlet valve)

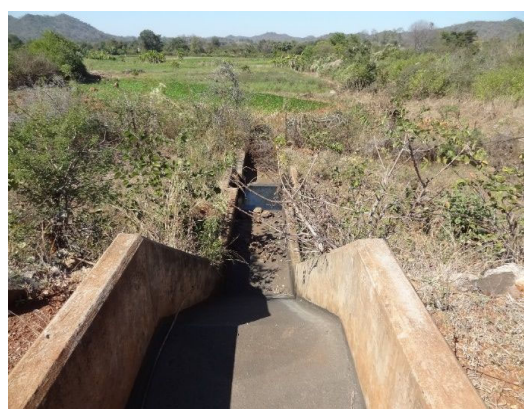
Good condition.
OF(4):Night storage(Spillway)

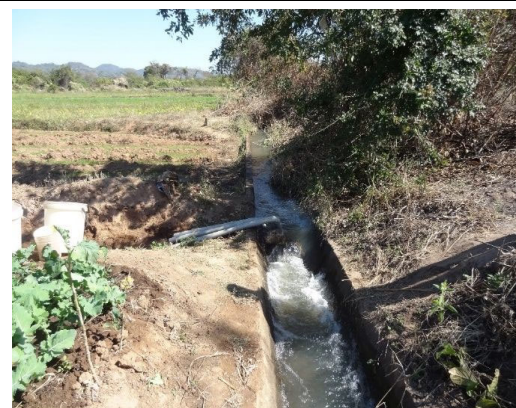
Good condition.
OF(5):On farm canal(1)

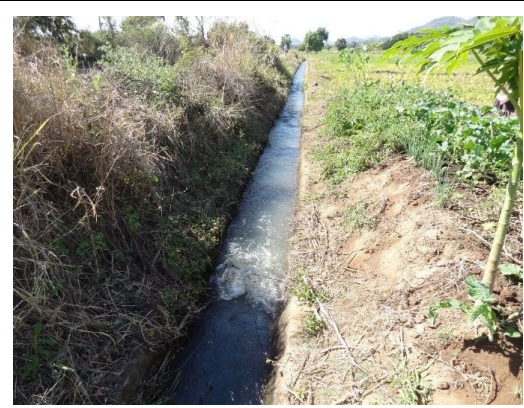
Good condition.
OF(6):On farm canal(2)

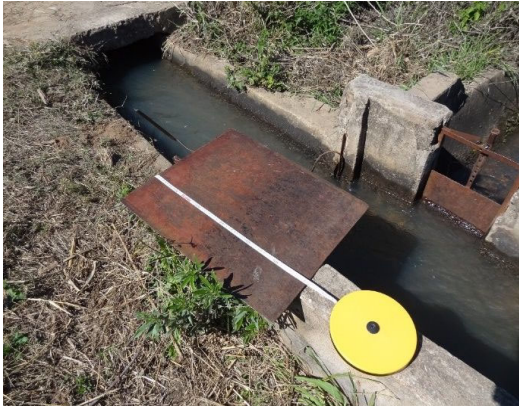
Gate has been broken. (H600xW520)
OF(7):Diversion(1)

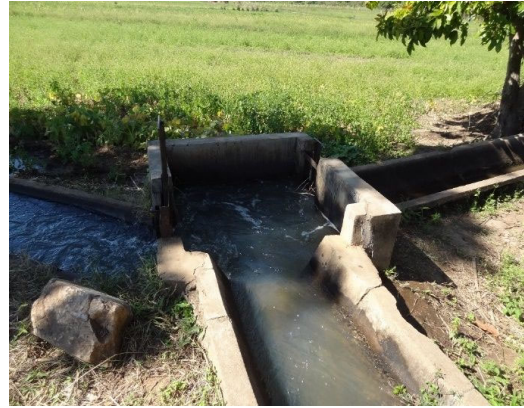
A small amount of water leaks, but there is no problem.
OF(8)Diversion(2)

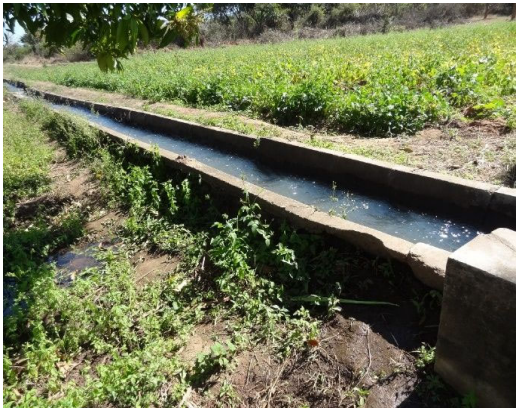
The back soil is flowing out.
OF(9):On farm canal(3)

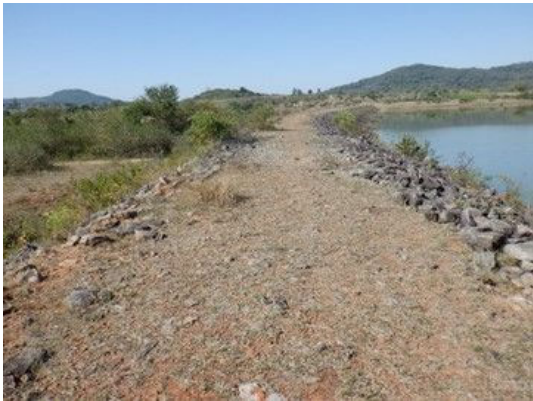
D(9) Crest of Embankment: No significant damage is observed.

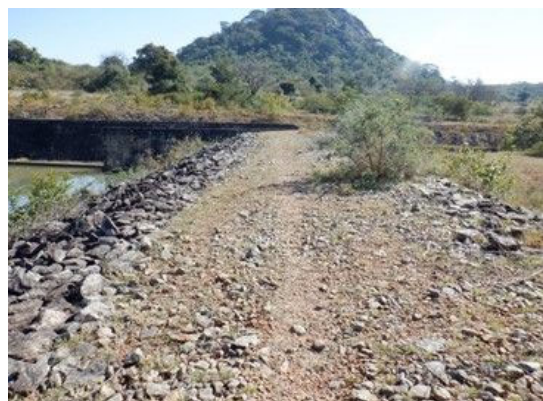
D(10) Crest of Embankment: Tree in the left side.

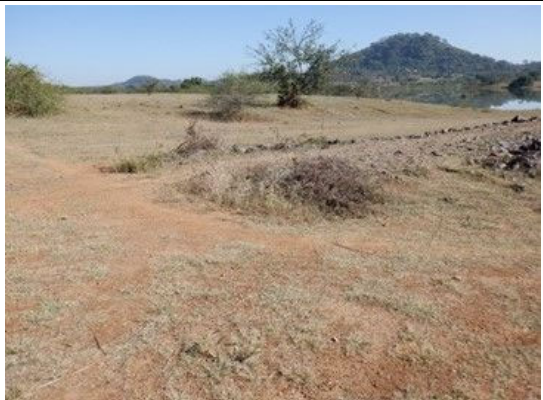
D(11) Right side abutment: No significant damage is observed. The abutment around the edge of the crest is flat.

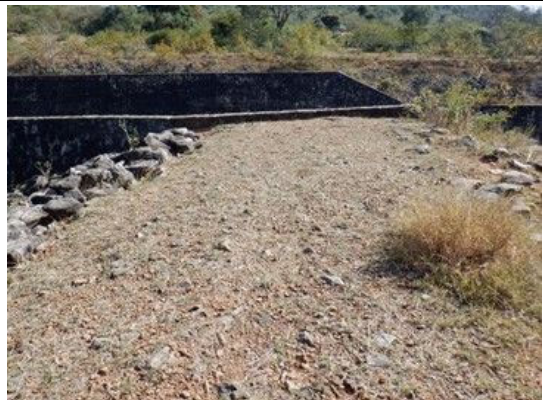
D(12) Left side abutment: No significant damage is observed between embankment and spillway. The abutment is about 1m higher than the crest, and around there is flat.

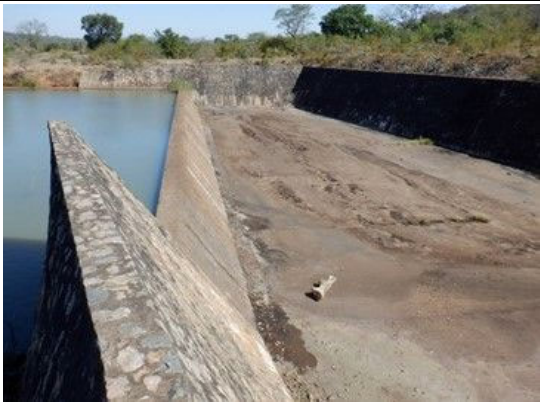
S(1) Spillway entire: No significant damage is observed.

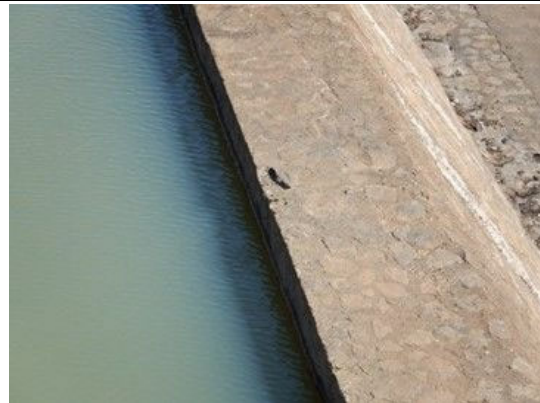
S(2) Spillway weir: Only slight damage (lack of stone) is observed on the top of weir.

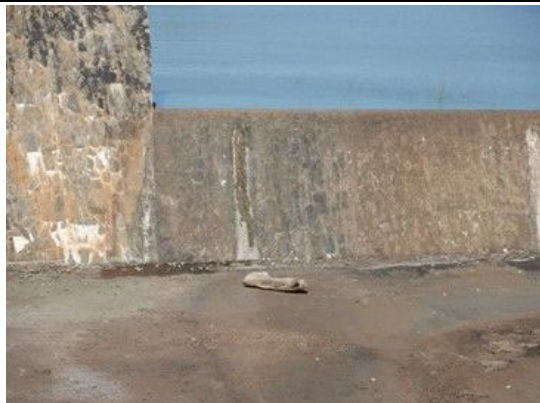
S(3) Spillway weir: There is small leakage from crack on the downstream, no flow can be seen.

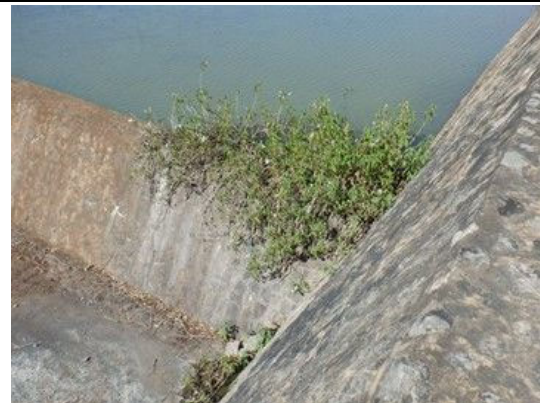
S(4) Spillway weir: Slight plants on the left side of weir.

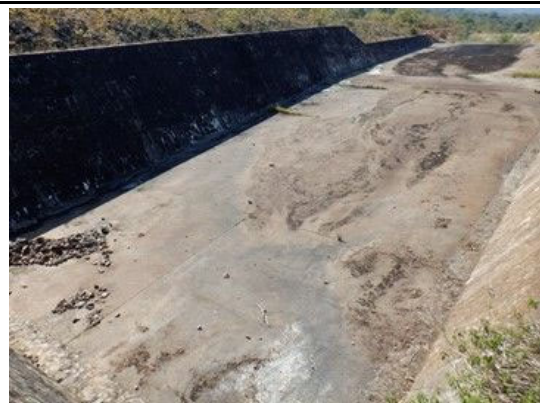
S(5) Spillway Apron: No scour is observed, and small rocks, plants, and open joints can be observed.

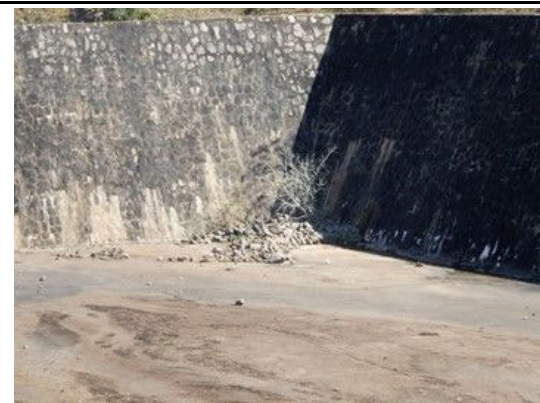
S(6) Spillway Apron: Stones are deposited at the upstream end.

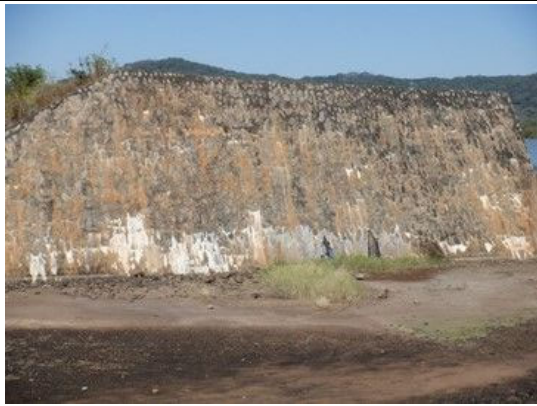
S(7) Spillway Retaining wal(right): Efflorescence is observed.

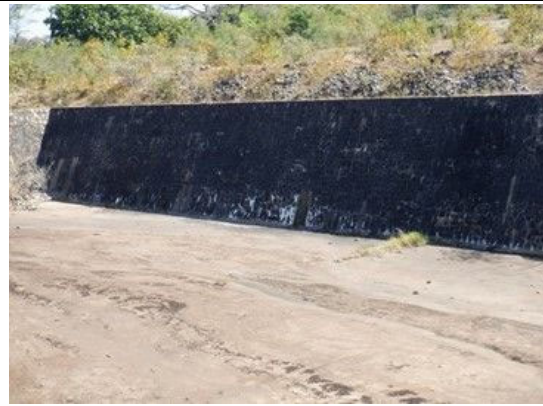
S(8) Spillway Retaining wall(left): Efflorescence is observed. On the left bank side, leakage of seepage water from the ground (water can be seen, but there is no flow).

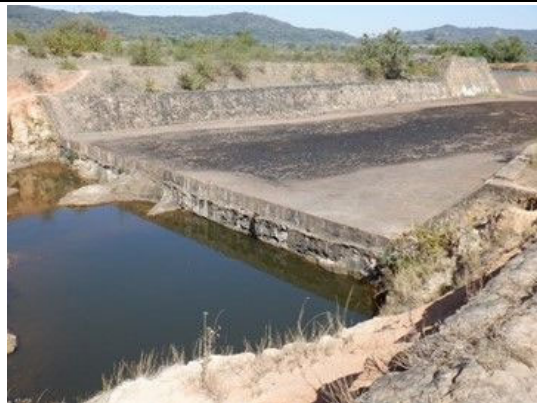
S(9) Spillway canal: There is a slight leak from the back of the canal.

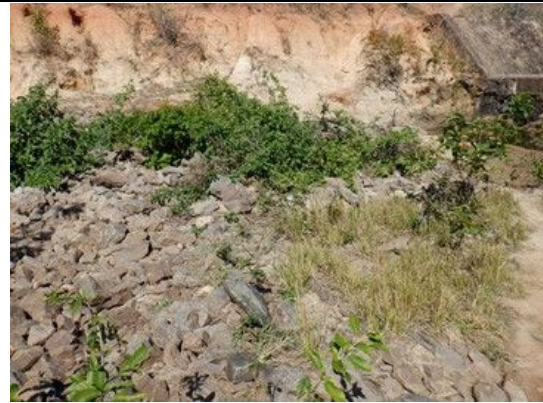
S(10) Spillway canal: Although there is no gabion, it may be the result of previous gabions that were washed away because of the rock material scattered around there.

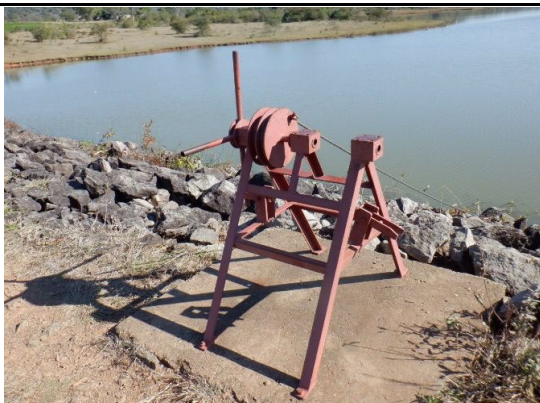
I(1) Intake Inlet: No significant damage is observed.

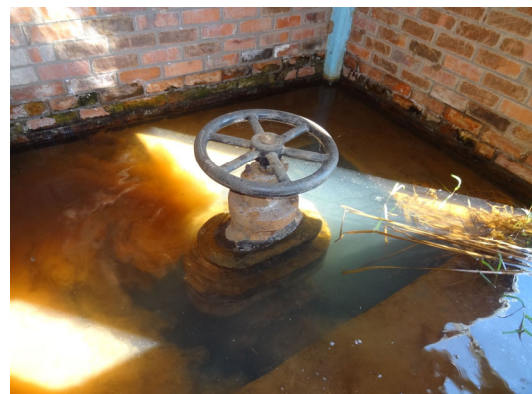
I(2) Intake Outlet: The valve has movable and submerged.

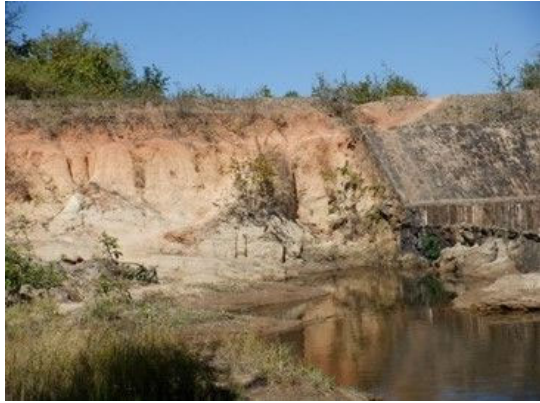
C(1) Connecting Cana(right): No significant damage is observed.

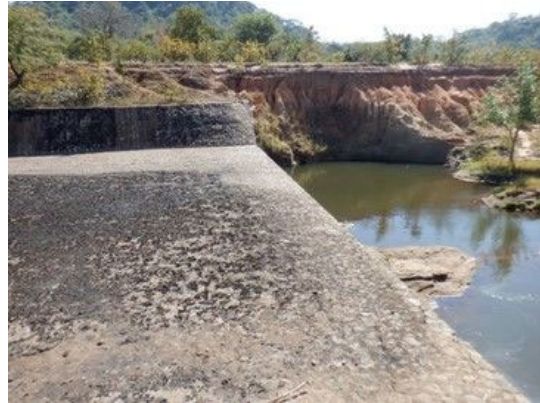
C(2) Connecting Canal(left): Collapses next to the spillway canal, but those does not seem to be in progress(L10.0m,B3.0m,H7.0m).

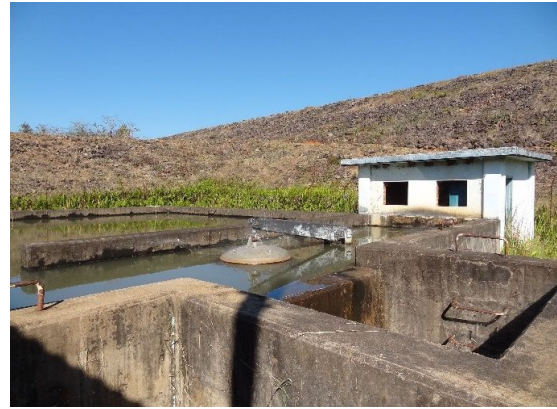
PS(1): Full view of pump station

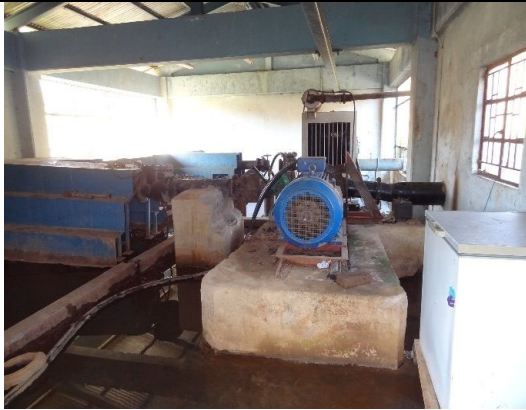
One electric pump equipment has been installed by FAO in 2017.

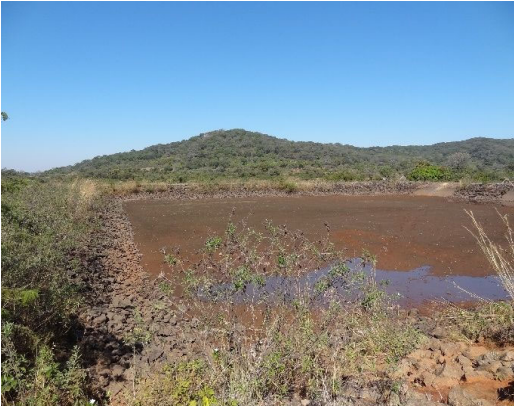
No sedimentation and good condition.
OF(1):Night strage (1)

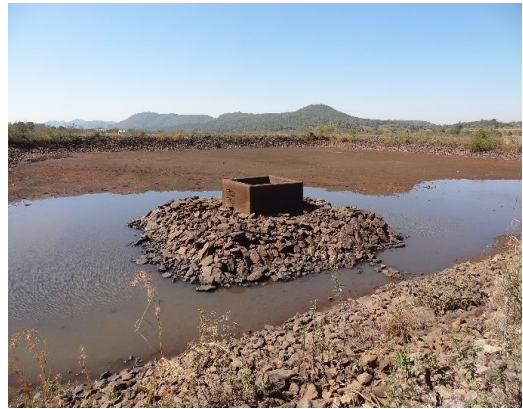
No sedimentation and good condition.
OF(2):Night storage(2)

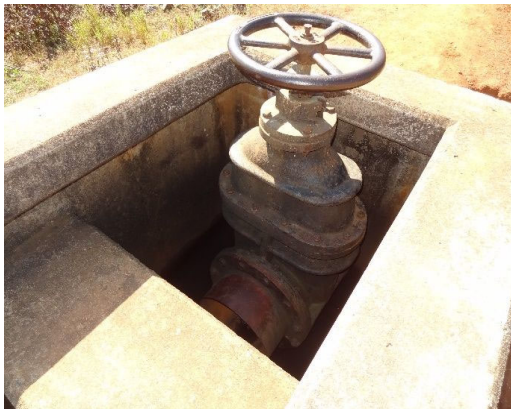
Good condition.
OF(3):Night storage(Outlet valve)

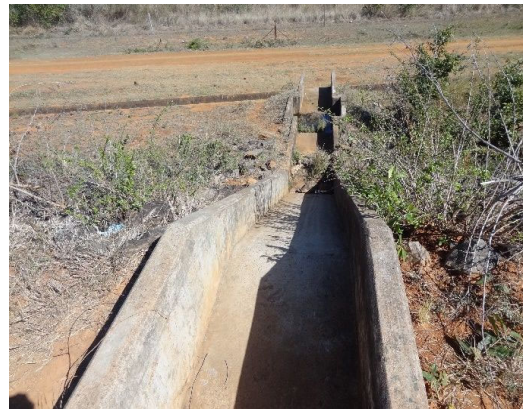
Good condition.
OF(4):Night storage(Spillway)

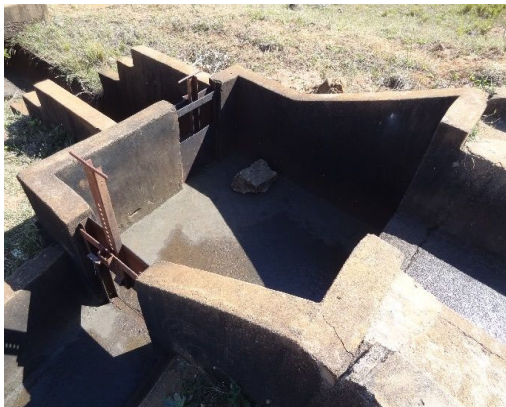
Good condition.
OF(5):Night storage (Distribution facility)

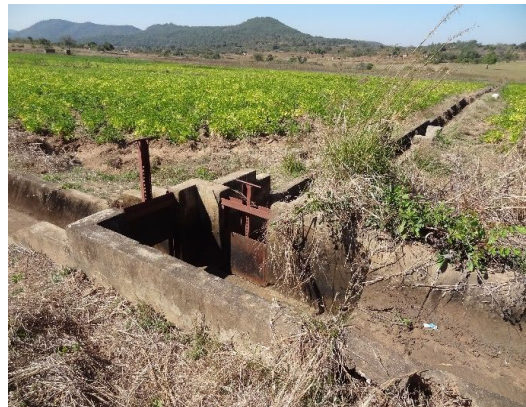
Good condition of movable gate and divirsion.
OF(6):Diversion

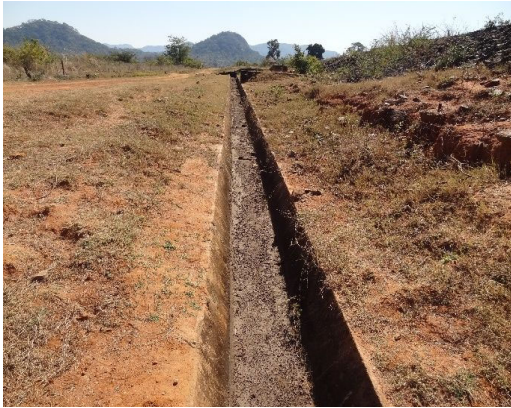
MABVTE DAM - ON FARM(2)

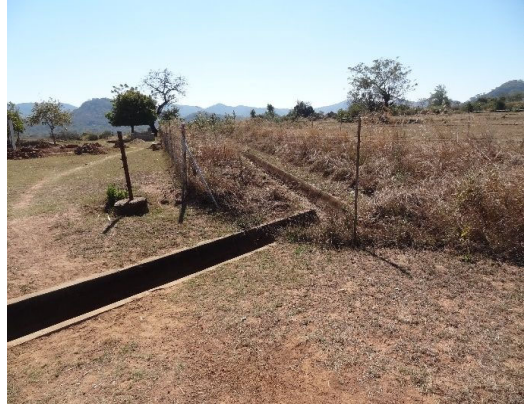
OF(7):On farm canal(1)

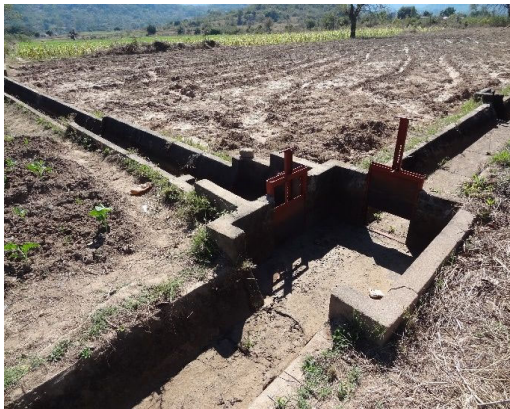
Diversion is properly maintained.

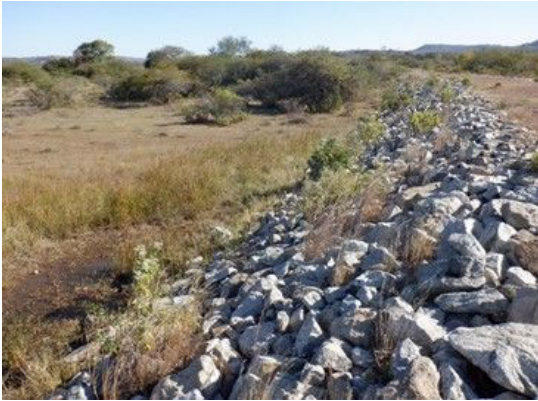
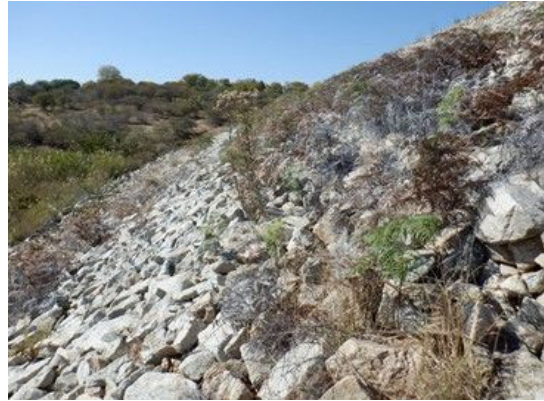
D(1) Embankment Upstream: Overall, there is limited plant growth, but relatively thick trees are found only near the edge of the left bank (elevation above FWL at the abutment). There is almost no collapse of riprap or exposure of embankment materials.

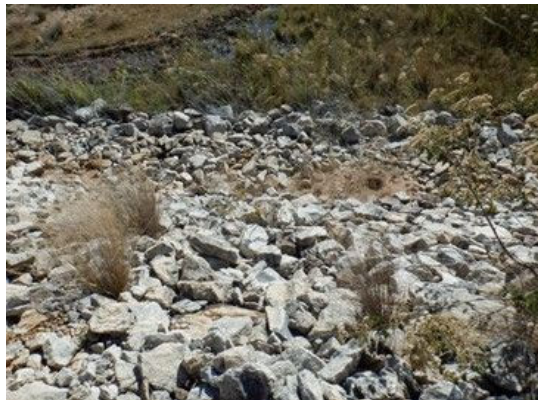
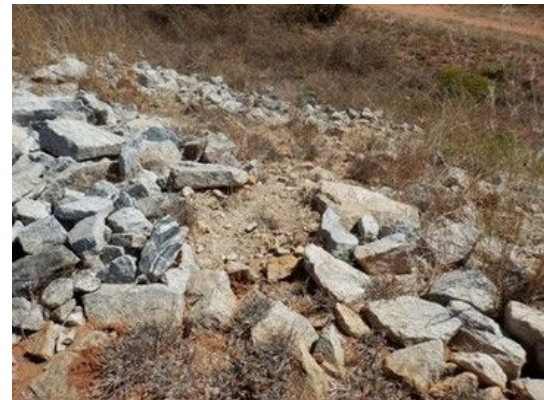
D(3) Embankment Downstream: Erosion under riprap makes downstream ditches (filled with rocks). In the lower part of those area, fine particles of embankment material are deposited (there is no seepage).

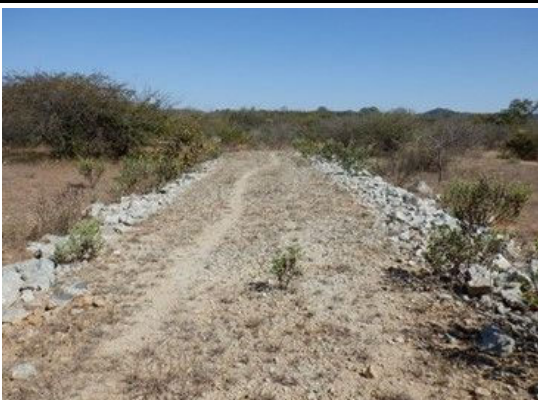
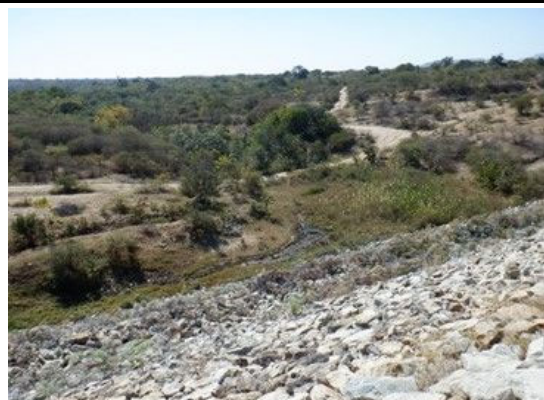
D(5) Crest of Embankment : Overall, there is limited plant growth, but relatively thick trees are found only near the edge of the left bank (elevation above FWL at the abutment).

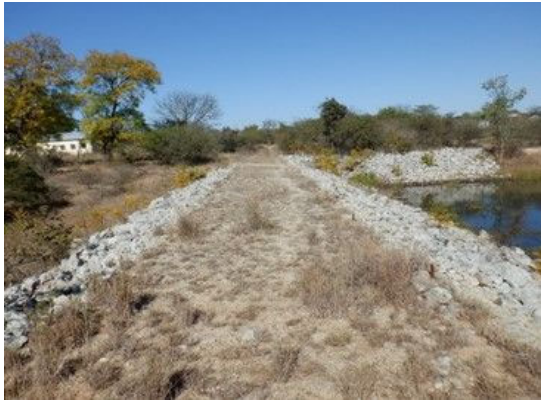
D(7) Right side abutment : No significant damage is observed. The abutment is flat.

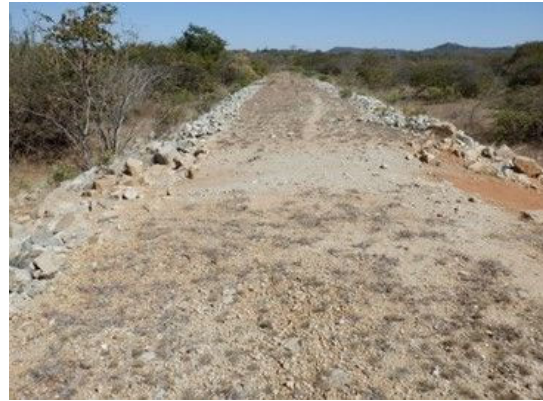
D(8) Left side abutment : No significant damage is observed. The abutment is flat.

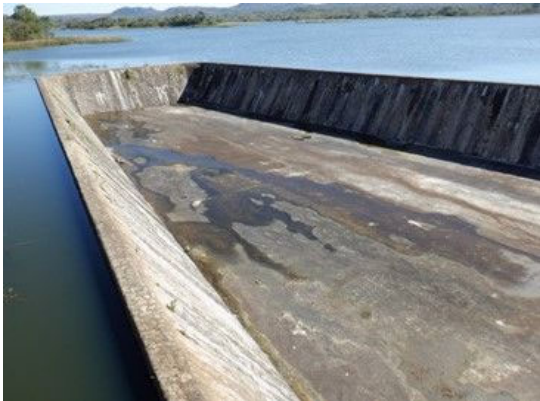
S(1) Spillway entire: No significant damage is observed. The abutment is flat.

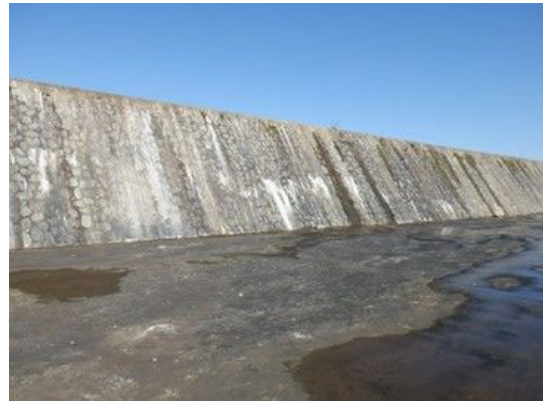
S(2) Spillway 越流堰: There are slight leakages and flows from cracks on the downstream.

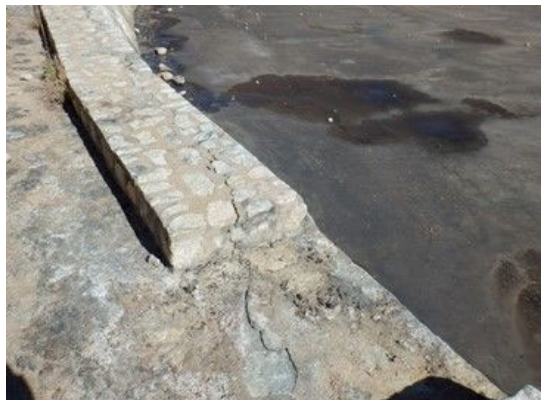
S(3) Spillway retaining wall (right): There is a crack less than 1cm width on the top of the retaining wall. (L12m).

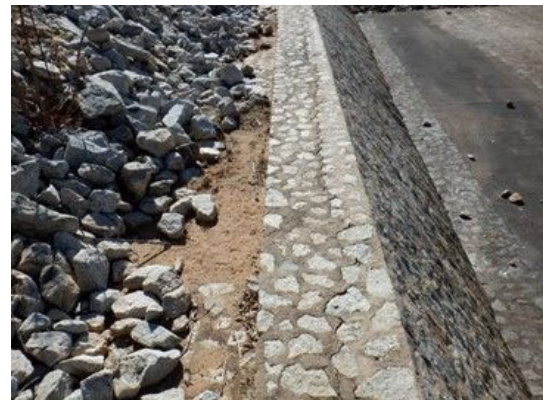
S(4) Spillway retaining wall (left): There is a crack less than 1cm width on the top of the retaining wall. (L10m).

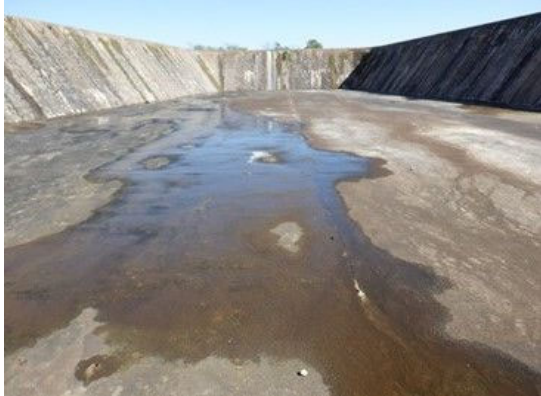
S(5) Spillway apron : No cracks, plants, or washes are observed.

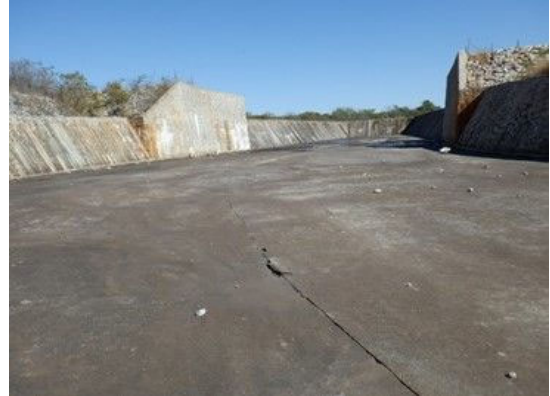
S(6) Spillway apron : Opening of joints (up to 3cm, detached joint material), damage to joints (60cm, 40cm), and small stoners are observed.

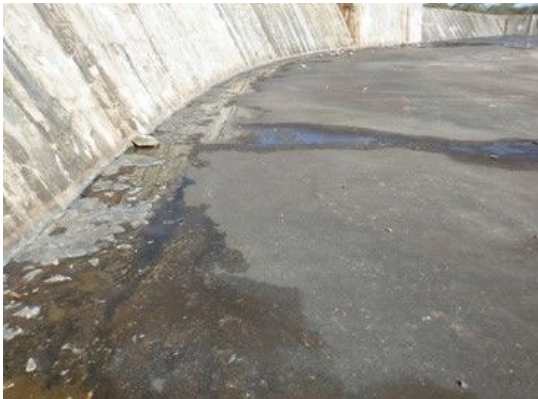
S(7) Spillway canal: There is seepage at joints and the boundary of the retaining wall (no flow is observed).

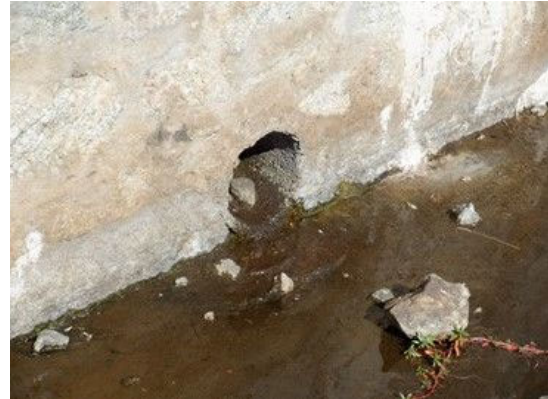
S(8) Spillway canal: The bottom of the drainage hole at the bottom of the retaining wall is wet.

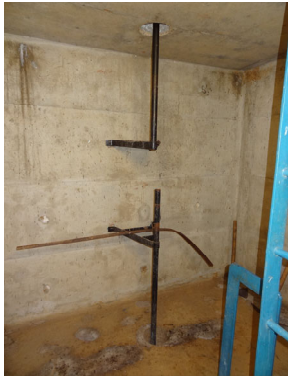
I(3) Intake Outlet: The middle of spindle had been broken.

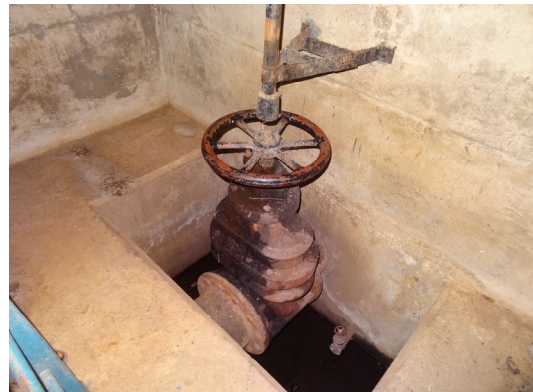
I(4) Intake Outlet: The valve has been controlled in good condition.

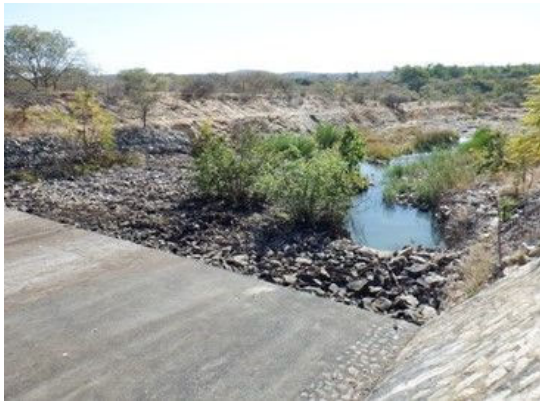
C(1) Connecting Canal: The right side of the gabions (t50cm) has been washed away.

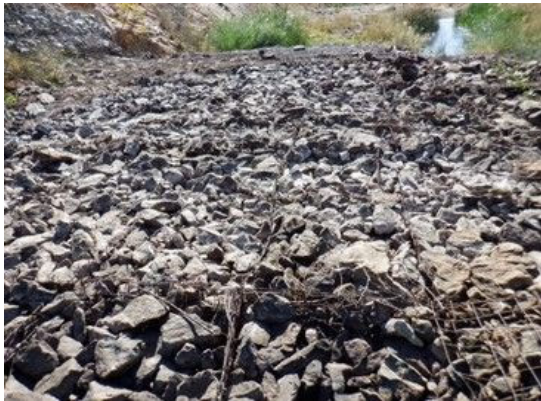
C(3) Connecting Canal: The cages are damaged. It is used as a walkway for crossing.

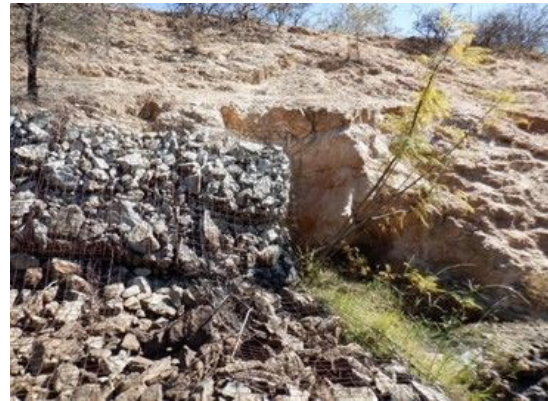
C(4) Connecting Canal: Downstream of the gabions, there is a collapse on the left side (L1.8m, B1.2m, H3.0m).

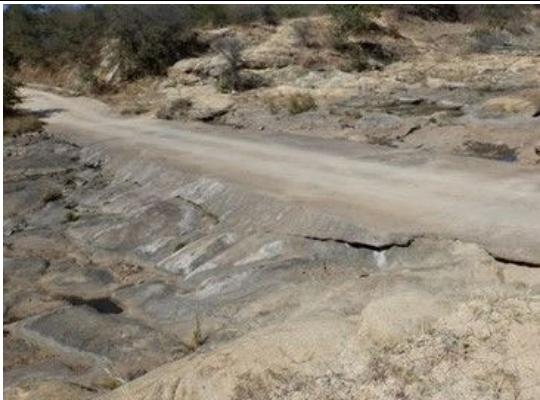
O(1) Others: No damage is observed at the entry road downstream of the river.

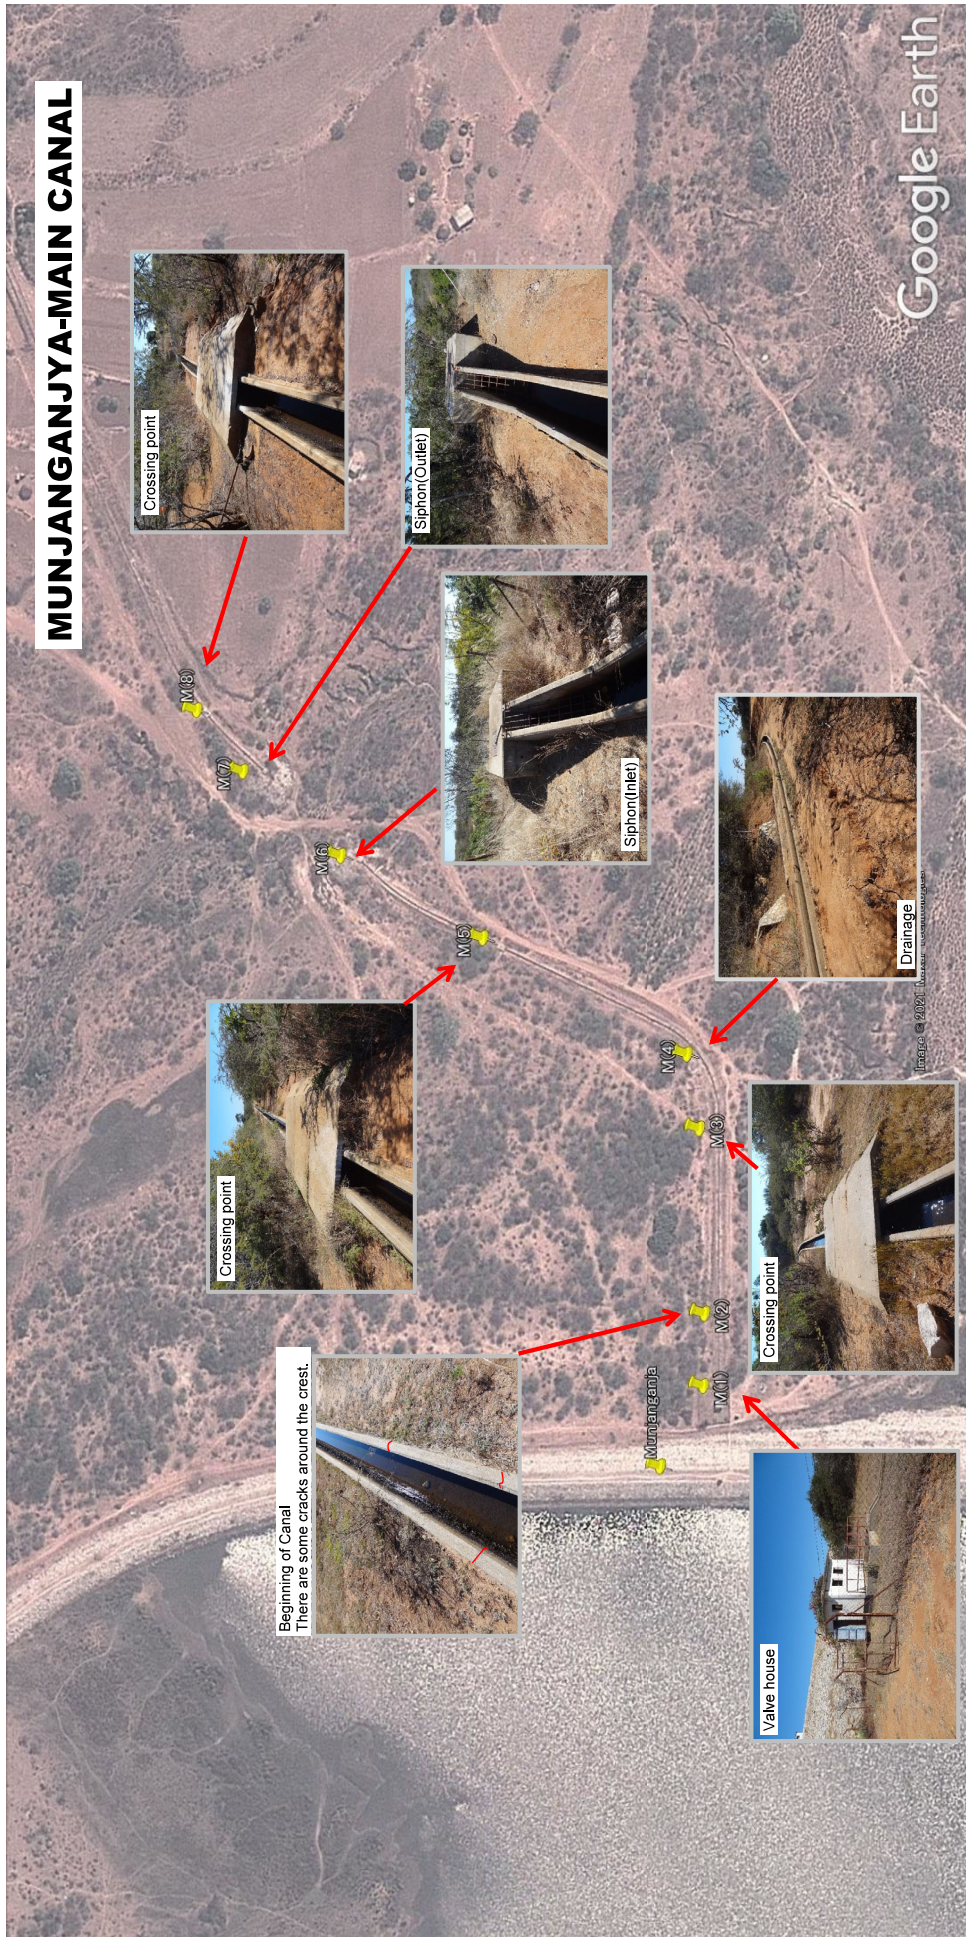
MUNJANGANJYA-MAIN CANAL

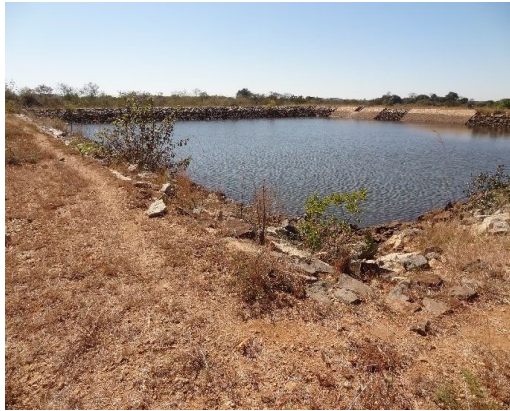
No sedimentation and good condition.
OF(1):Night storage (1)

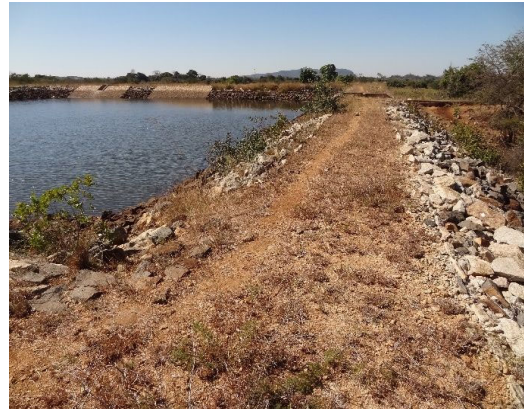
No sedimentation and good condition.
OF(2):Night storage(2)

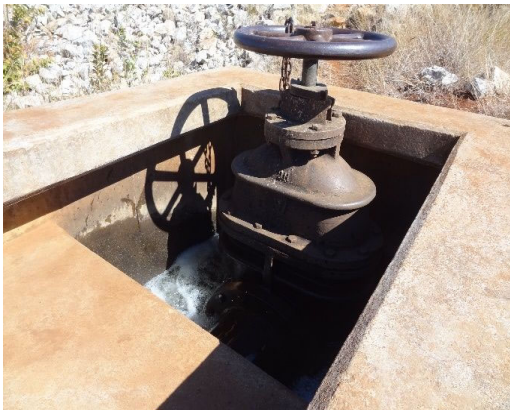
The valve is movable and in good condition.
OF(3):Night storage(Outlet valve)

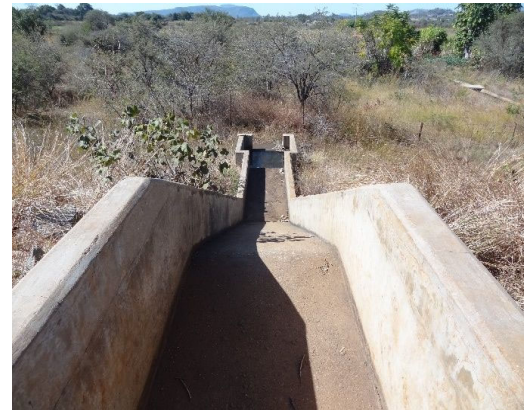
Good condition.
OF(4):Night storage(Spillway)

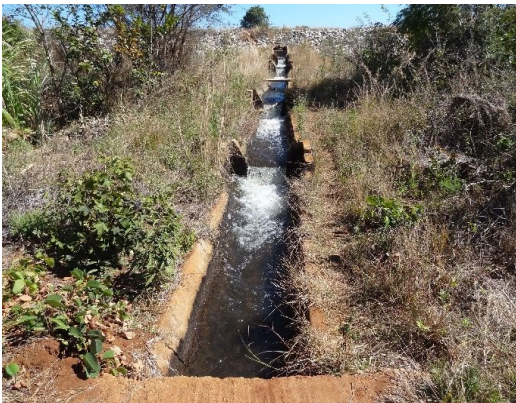
Good condition.
OF(5):On farm canal(1)

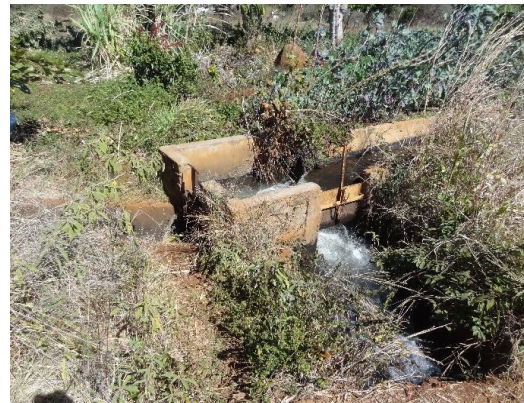
Good condition.
OF(6):Diversion(1)

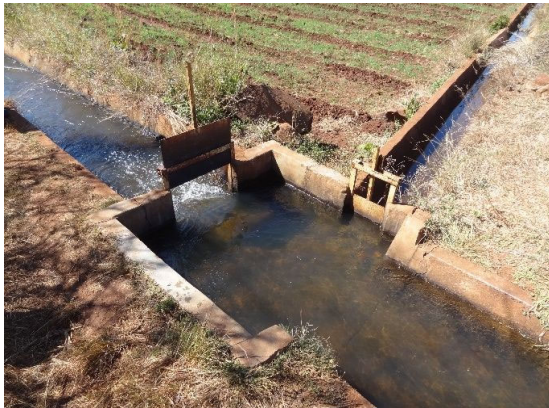
The diversion has been rehabilitated by FAO in 2019.

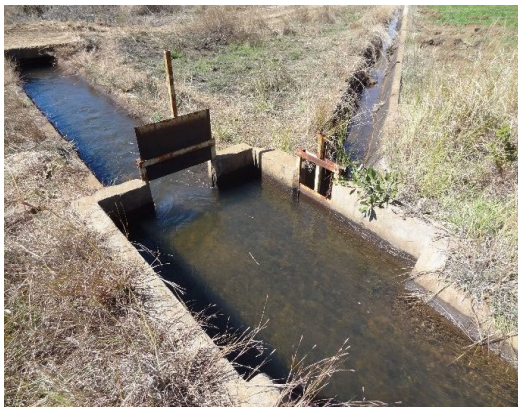
The diversion has been rehabilitated by FAO in 2019.
