**Ex-Post Project Evaluation 2020:
Package III-2 (Rwanda, Uganda, Tanzania)**

FY2020 Simplified Ex-Post Evaluation Report of Japanese Grant Aid Project

Country Name	The Project for Rural Water Supply (Phase III)
Republic of Rwanda

Country name	Project for improvement of Queensway substation
Republic of Uganda

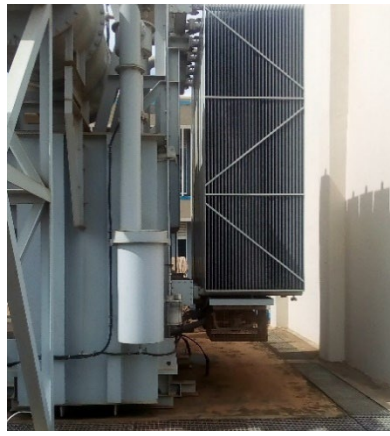
After routine maintenance in March 2019, unknown person entered the Queensway substation and vandalized the substation grounding copper wire. The transformers were left disconnected to the grounding system and this subsequently led to failure of Transformer No.3 (TX 3) when it was exposed to fault. According to the post-incident investigation by the manufacturer conducted in February 2020, the other two transformers (Transformer No.1 (TX 1) and 2 (TX 2)) had sustained mild damage during the incident; and were still in operation at the time of ex-post evaluation. UETCL believes that in addition to non-earthed substation operating condition due to theft of earthing conductor, the reason why the transformers got damaged is the weak design of the tertiary winding of the transformers. The damaged TX 3 is currently in the process of being repaired and UETCL has scheduled to embark on reinforcement for the tertiary winding of TX 1 and 2 as recommended by the manufacturer, upon completion of repairs of the already damaged TX 3. The reason for the time taken to repair TX 3 after the discovery of the malfunction is as follows. After the malfunction was confirmed, the transformer could not be opened on site, and it took time to assess the degree of damage. It also took time to locate a contractor who could handle the problem, as malfunctions of this sort do not occur frequently. Since the parts needed for the repair were not available in Uganda, UETCL contacted the manufacturer in Japan, estimated the cost of the repair, and applied for a budget. However, after approval was granted, it was found that the spare materials were taxable, yet the tax was not included in the budget estimates; and consequently, UETCL needed to reapply for the budget. In addition, after the procurement funds were secured, the manufacturer was unable to send engineers to repair the transformer because of the travel ban imposed owing to the COVID-19 pandemic. For this reason, UETCL is currently importing the parts and the transformer repairs are scheduled to commence by the Japanese supplier in January 2022 at a company that specializes in repairing substation equipment. It should be additionally noted that on 2nd November 2021, while awaiting reinforcement of its tertiary winding, TX 1 malfunctioned and is currently pending repair. The repairs for TX

Grounding part of transformer

UETCL has strengthened security at the substation and is checking the operation of the substation more regularly. In the near future, permanent staff members are to be appointed at the substation office. UETCL also stated that preventive measures would be taken to prevent theft and destruction, such as using copper clad steel instead of pure copper. As the process of applying for and securing funds for the repairs would take some time, UETCL said it was also considering credit agreements with providers of replacement parts.

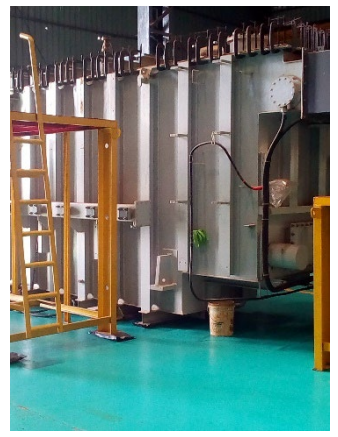
As described above, at the time of the ex-post evaluation, it was found that one of the transformers developed under the project had a problem and was out of service. The necessary parts have been arranged and repairs are scheduled to be completed at the end of FY2021. Since preventive measures are being taken, it is judged that there is no serious concern about the status of operation and maintenance. The operational status of other facilities and equipment is good, daily inspections and regular preventive maintenance are conducted, and spare parts are systematically procured. Therefore, it is considered that there are no problems with the current status of the operation and maintenance system.

Transformer under repair

One transformer developed under the project has been out of service since March 2019 and is currently under repair. In addition to external factors such as the COVID-19 pandemic, the reasons it has taken time to repair the transformer are the procurement of parts that are unavailable in Uganda repair measures, and the complexity of the procurement process. When reinforcing substation facilities in the future, as well as the prompt repair of transformers, it is desirable to confirm that the parts are available in Uganda and to check thoroughly that there are no mistakes in the procurement procedures if the parts are difficult to obtain and must be procured from overseas.
