**INFORMATION COLLECTION AND  
PRELIMINARY SURVEY  
FOR THE FORMATION OF  
DISASTER RECOVERY PROJECTS  
AGAINST VOLCANIC ERUPTIONS AND  
TSUNAMI DAMAGE  
IN KINGDOM OF TONGA**

**FINAL REPORT**

**OCTOBER 2023**

**JAPAN INTERNATIONAL COOPERATION AGENCY (JICA)**

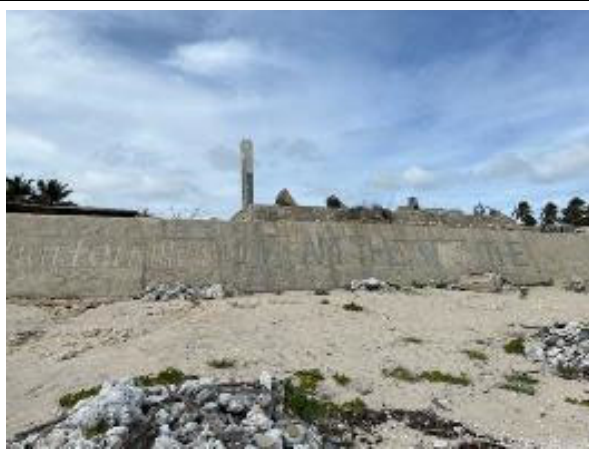
**Photo 2.7.3 Foundation that Remained after a Tsunami**

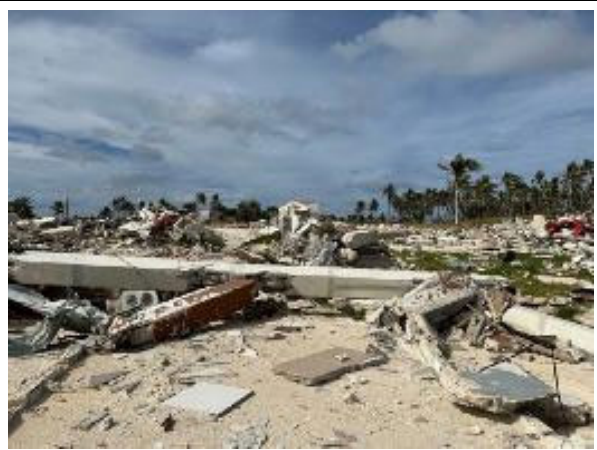
**Photo 2.7.4 Completely Destroyed Resort Hotel**

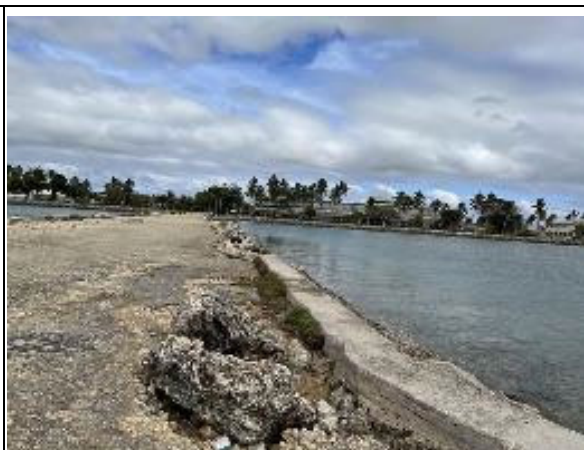
**Photo 2.7.8 Damage on the West Side of the Jetty**

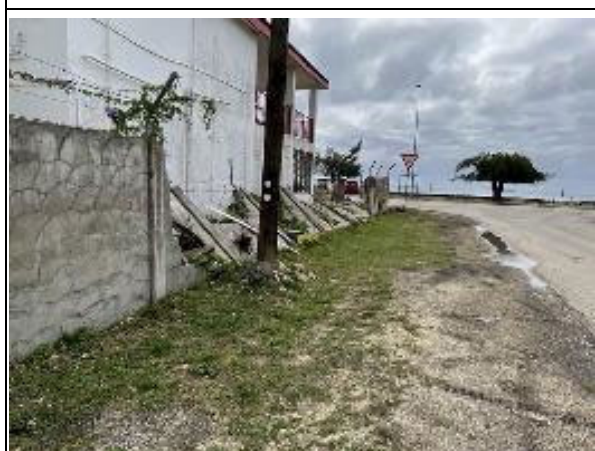
**Photo 2.7.9 Block Wall Destroyed by Tsunami**

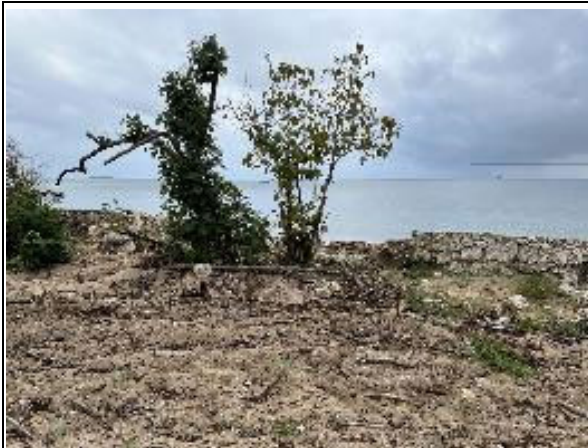
Different seawalls were constructed in the northeastern part of Tongatapu Island, including those funded by ADB and constructed by residents. A reef is in front of the seawalls. Although the force of the tsunami weakened, most masonry seawalls and structures along the coast were damaged. In particular, areas maintained by residents where water flowed out from the base of the seawall were destroyed.

**Photo 2.7.11 Condition of Masonry Seawall after the Tsunami**

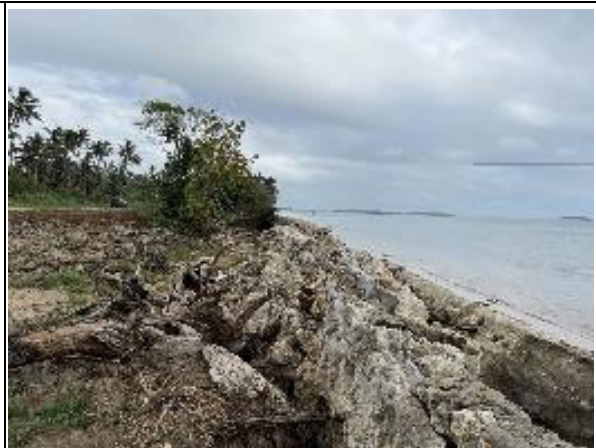
**Photo 2.7.12 Destroyed Masonry Seawall**

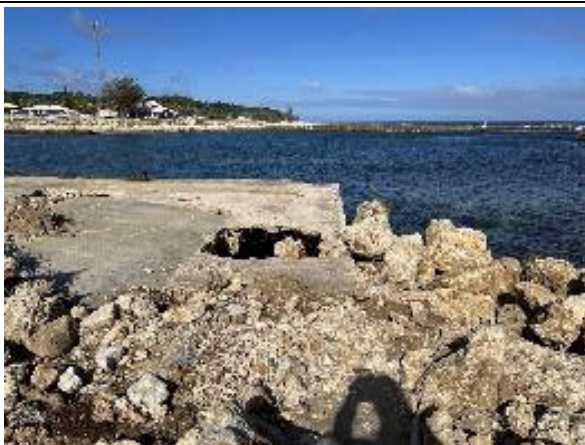
**Photo 2.7.19 Damage to New Port Apron**

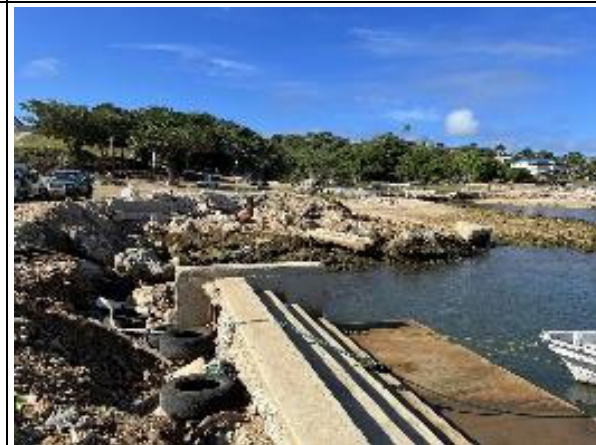
**Photo 2.7.20 Damage to Small Vessel Wharf**

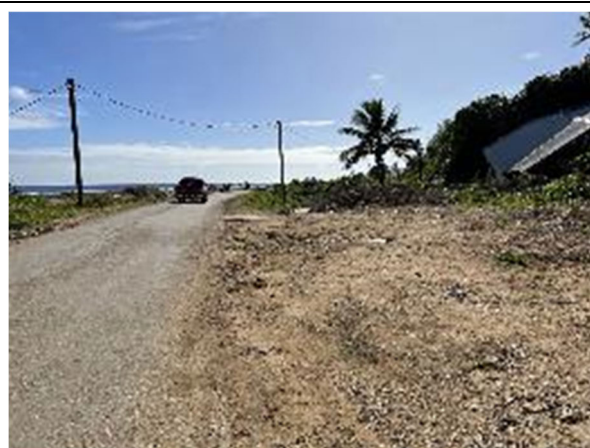
**Photo 2.7.21** Tsunami Went up High on the House at the Right

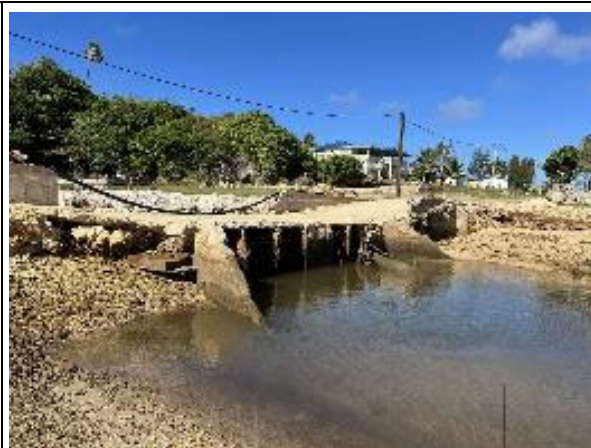
**Photo 2.7.22** Damaged Bridge (Culvert)

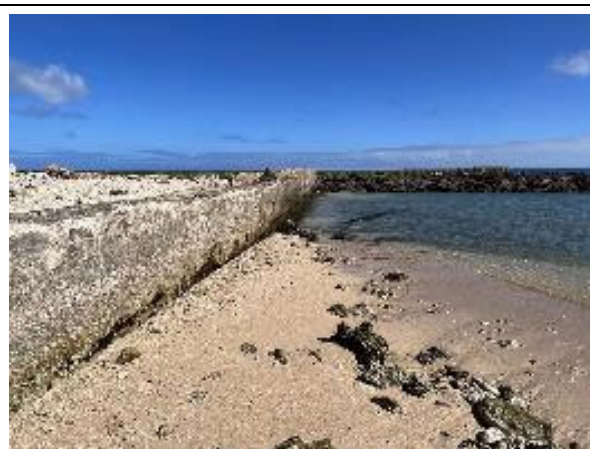
**Photo 2.7.23** Concrete Block Quay of Old Port

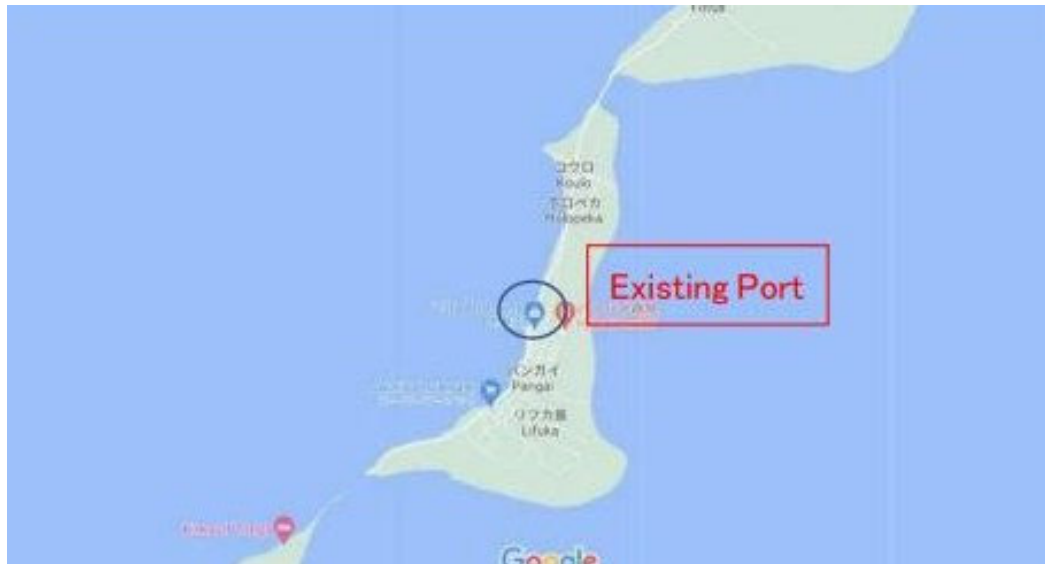
The structure of the breakwater consists of a masonry seawall and a sheet pile quay with the tip tilted into the bay. But a large part of the masonry has disappeared, and it is unknown how far it was originally extended. When restoring this port, the design plan of the breakwater is most important such as the location and structural design.

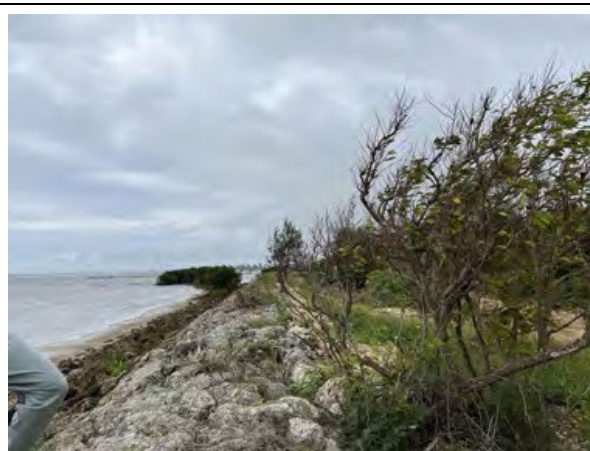
Photo 4.1.2 Damaged masonry seawall by tsunami

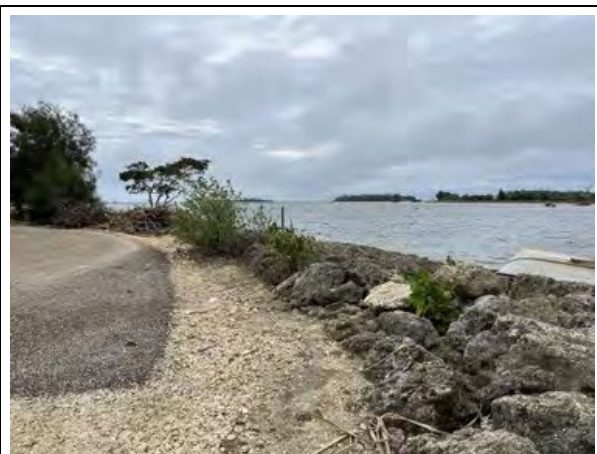
Photo 4.1.10 This area has almost no damage by tsunami.
