FEASIBILITY STUDY REPORT
ON
THE REHABILITATION OF
NITROGENOUS FERTILIZER PLANT
THE REPUBLIC OF ZAMBIA

MARCH, 1982

JAPAN INTERNATIONAL COOPERATION AGENCY

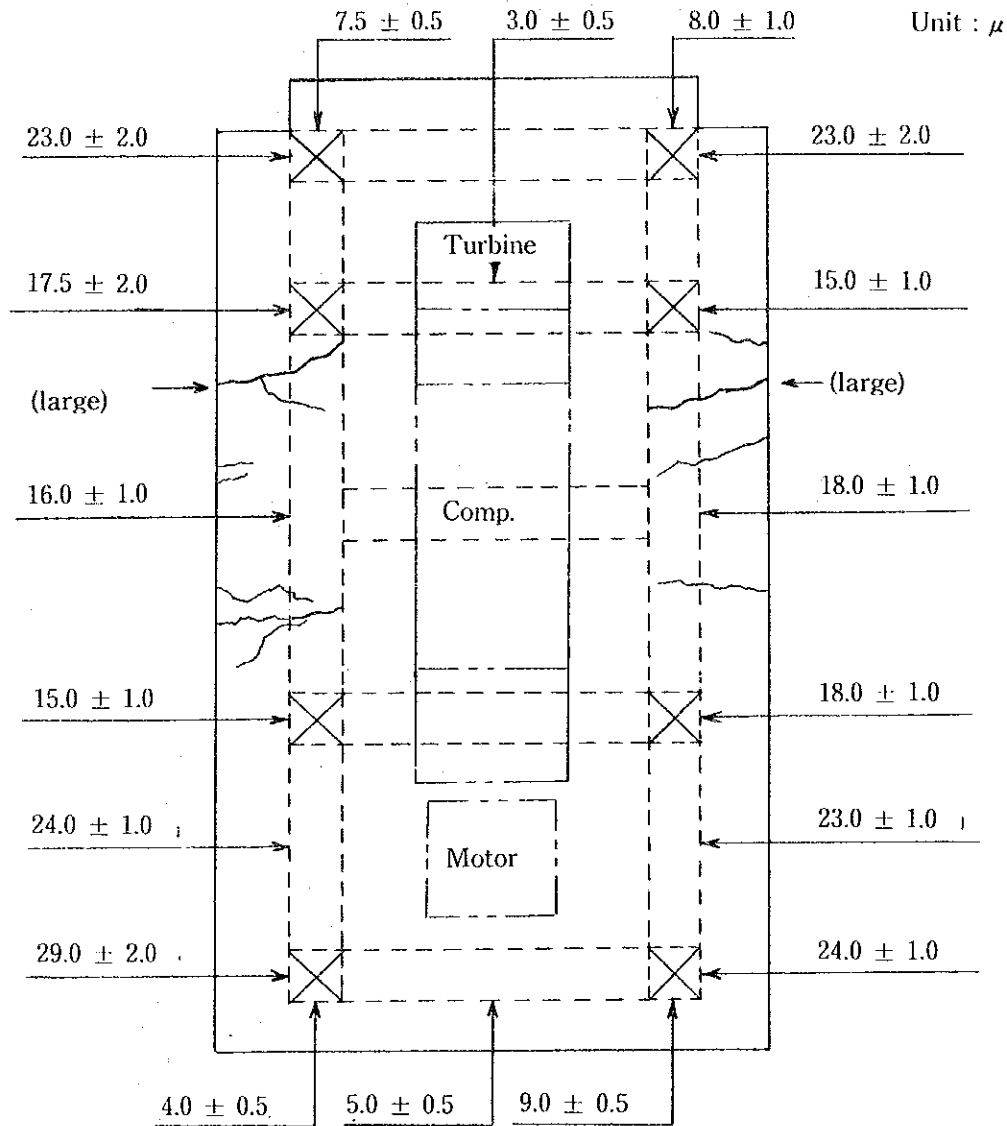
(5) Foundation of K01 Air Compressor

The following is the condition of vibrations and the occurrence of cracks detected in the concrete foundation by the first field survey.

As shown above, vibrations were large, registering 29μ at the maximum (the usual allowable value is around 10μ), and as a number of cracks were seen in the part where the compressor is installed, reinforcement of the foundation will be required.
