## 2-3 Survey of Leakage

### 2-3-1 City-Owned Systems

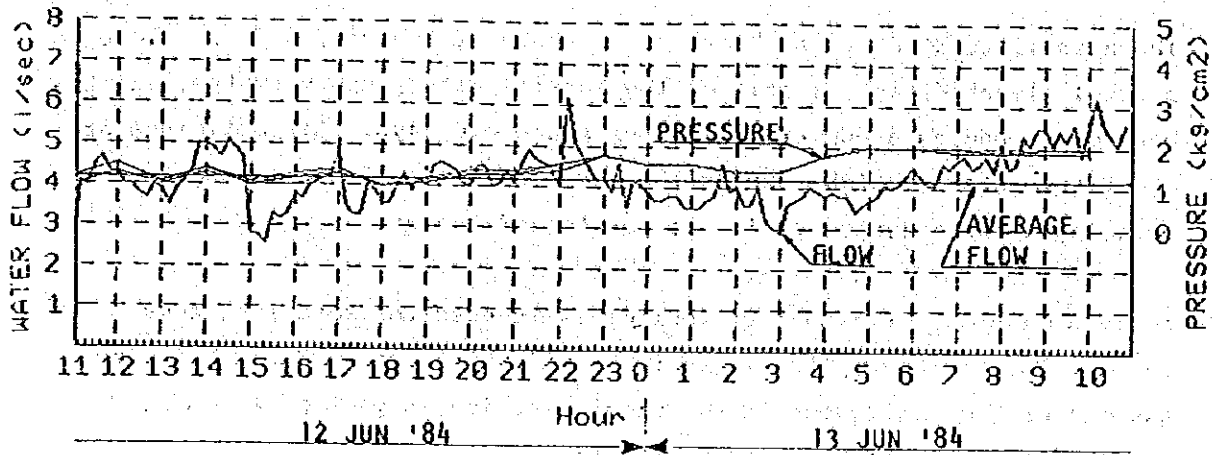
Fig-8 WATER FLOW AND PRESSURE

Fig-8 shows the result of 24 hours' flow measurement, the flow including the above mentioned leakage. Contrary to the anticipation, the supply pressure increases together with the flow rate for some part of the day and the possible reasons was that the number of pumps in operation was increased to catch up the demand and this area, located close to the pumping station, was affected by its directly.

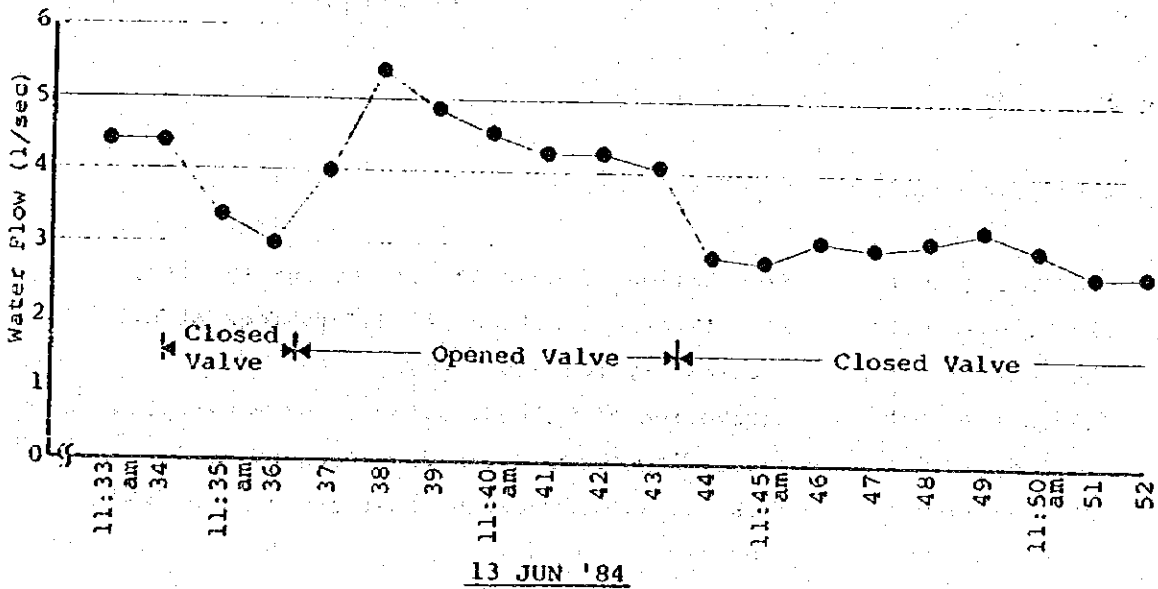
Fig-9 WATER FLOW UNDER CLOSED TAPS

Fig-9 shows the response of the flow rate on open and closing of the valve upstreams of the leakage point. The leakage, caused by a broken valve installed downstreams of a water meter, amounted to about 2.0 liters/sec. as calculated from it.

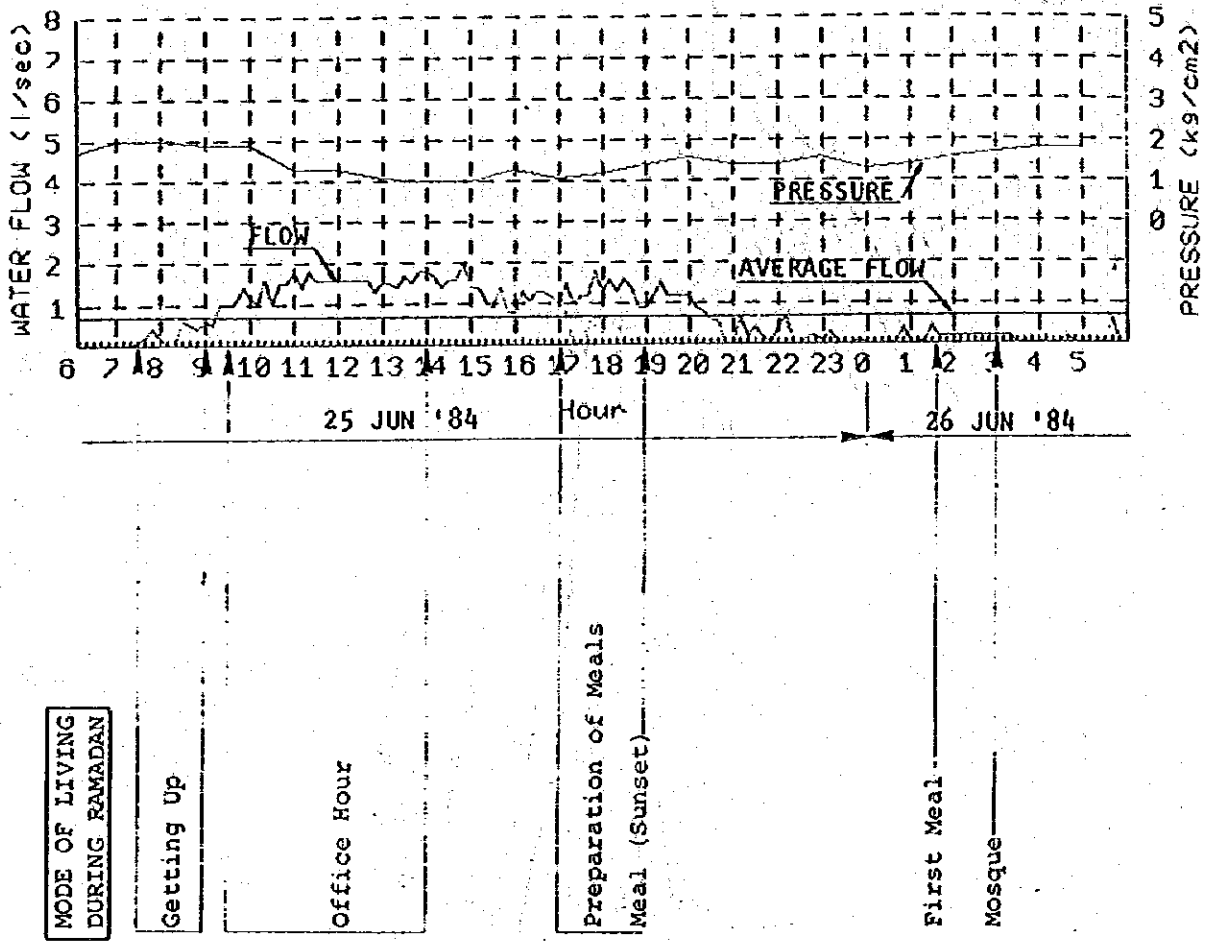
Fig-12 WATER FLOW AND PRESSURE

The observed minimum flow was below the sensitivity of the meter, as shown in Fig-12, consequently. And it verifies that leakage in the area is almost non-existent.

The Ramadan (Islamic fast season) was from 1 to 29 June this year. The observed pattern of water consumption, Fig-12, can be considered as showing domestic usage during the Ramadan period. A slight rise of the flow at very early morning will mean possibly the consumption for the first meal and washing prior to praying at mosques.

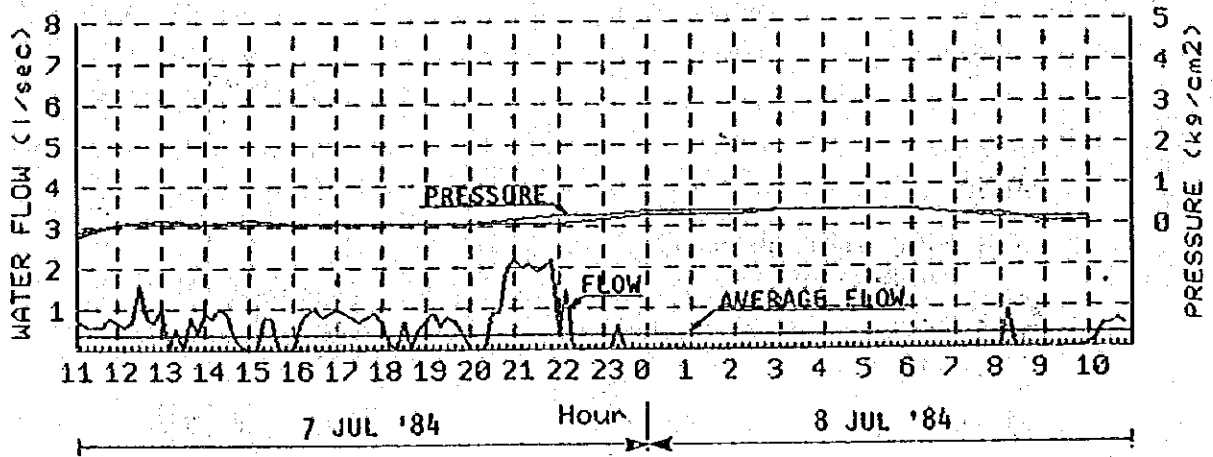
Fig-15 WATER FLOW AND PRESSURE

During the flow observation, the pressure was measured at two taps hourly. The taps location is shown in Fig-14 and the survey results are in Fig-15. At the end of the 24 hours flow observation, all taps closed condition was brought on for 1 hour from 11 a.m. on a July As it was anticipated, the flow rate fell down to nearly zero.

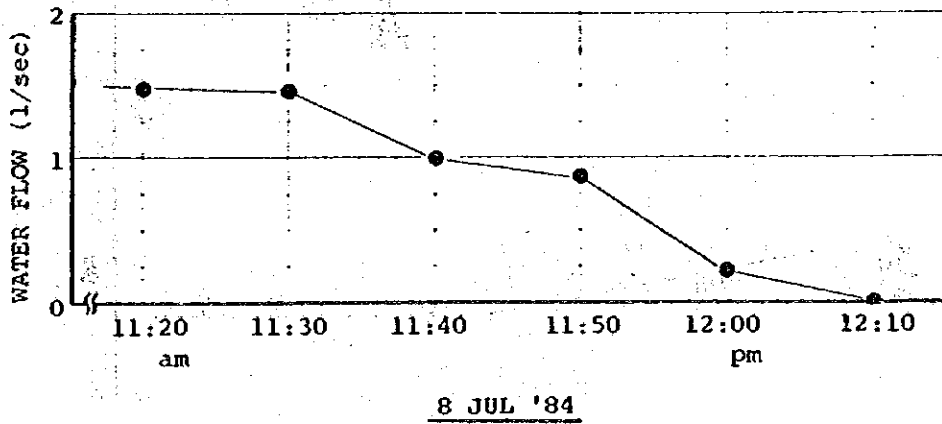
Fig-16 WATER FLOW UNDER CLOSED TAPS

Measurement of the flow was carried out under such a condition and the result, as shown in Figs. 14 - 16, indicates that no leakage was existent in the pipelines and service pipes. As the figure shows also, the nearly zero flow continued even after the closed valves had been responded by the

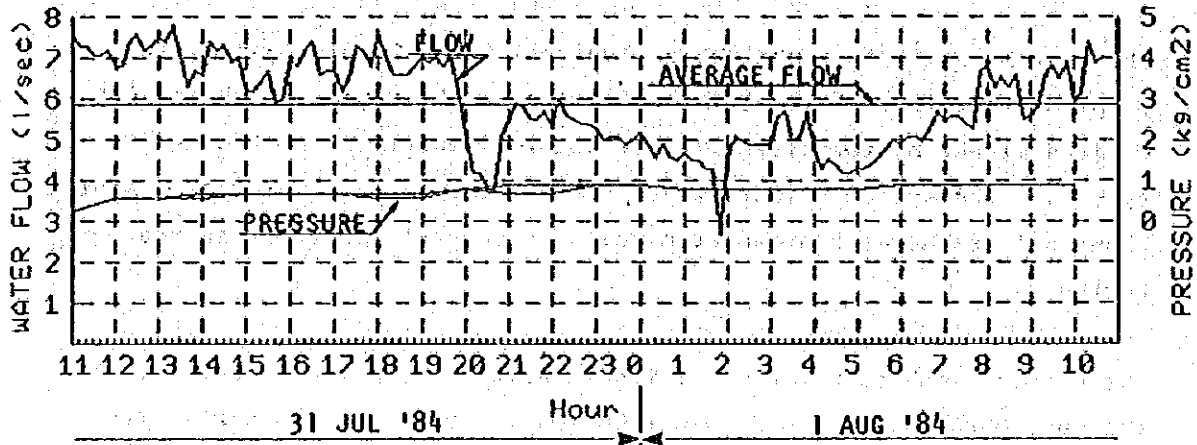
Fig-18 WATER FLOW AND PRESSURE

The observed flow diagram is shown in Fig-18 with a pressure curve. In the figure the flow suddenly dropped to 2.8 liters.sec at 1:50 a.m., and rose twice between 3 a.m. and 4 a.m.

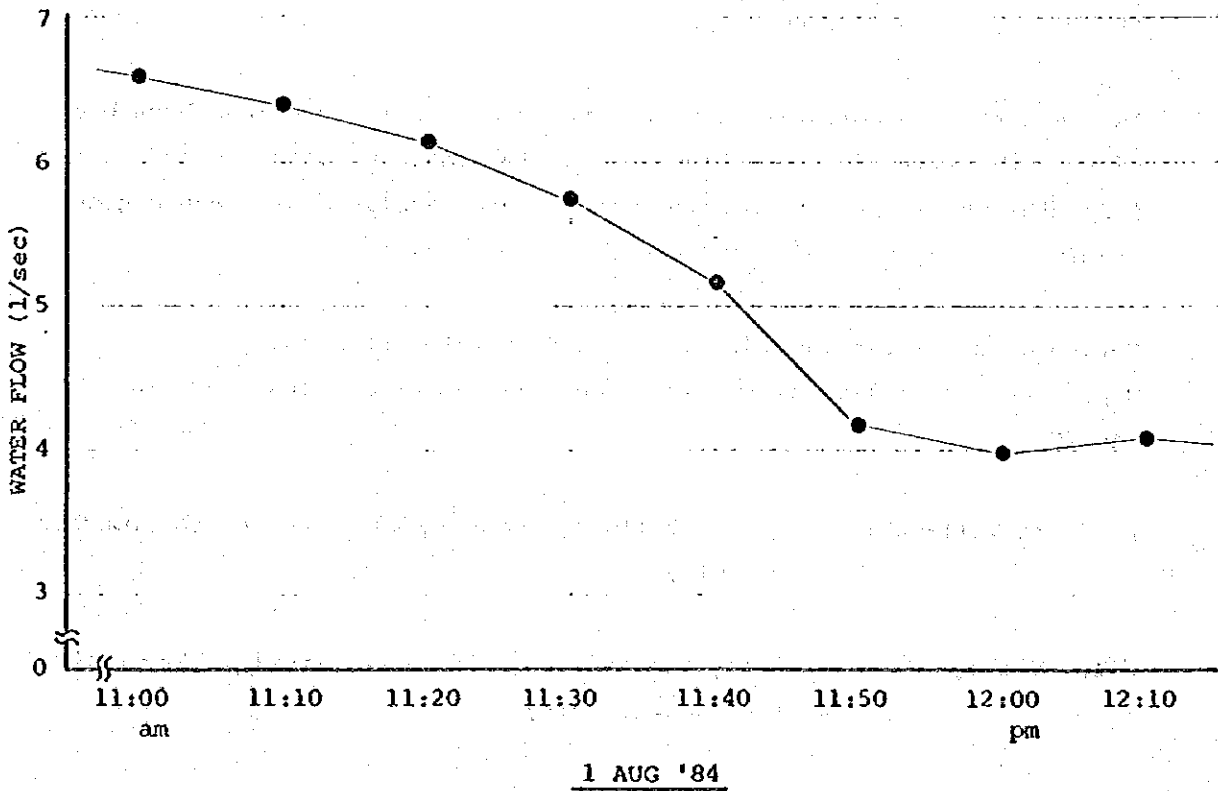
Fig-19 WATER FLOW UNDER CLOSED TAPS

After the 24 hour flow observation, the flow under the closed taps was observed from 11 a.m. of 1st August for a half hour successively. The result is as Fig-19. The minimum flow was 3.8 liters/sec.

Out of three observed leakings, one was from a Valve and other two from joints as stated above. By means of a reconnaissance adjacent to the leaking sound it was found that the remaining of three was from a pipe located in the premises of the dairy factory, by which pipe the water was supplied to several local offices through the premises. The leaking spot became like a paddy field due to the leakage and water-weed was growing thickly. From the condition it was assumed the leakage was left for a considerable while.

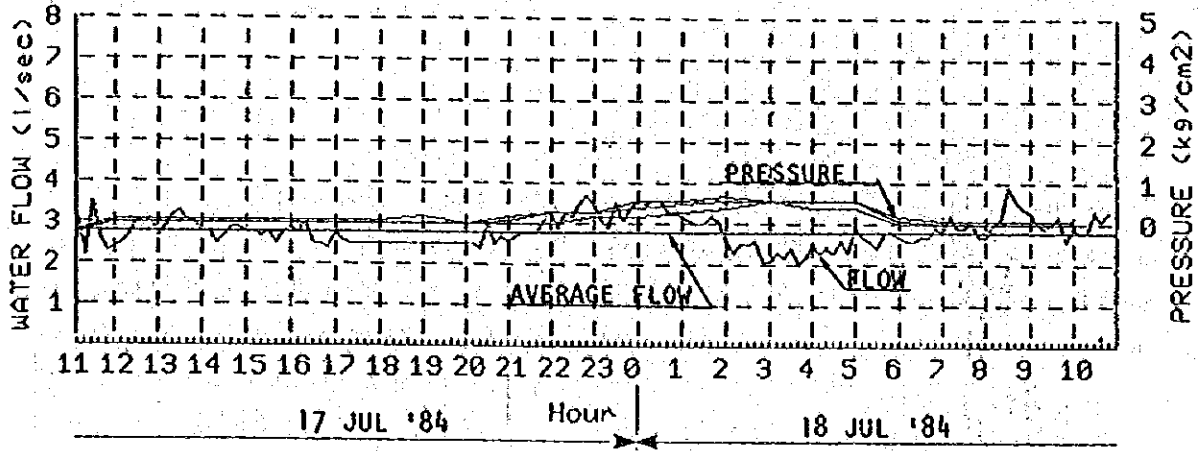
Fig-22 WATER FLOW AND PRESSURE

As shown in Fig-22, therefore, the width of fluctuation of the measured flow is narrower than in the results of other surveys, standing between 2 and 4 liters/sec. Considering such a suppressed condition, this minimum flow, registered at 2 liters/sec at midnight, should not be interpreted as leakage and/or wastage.

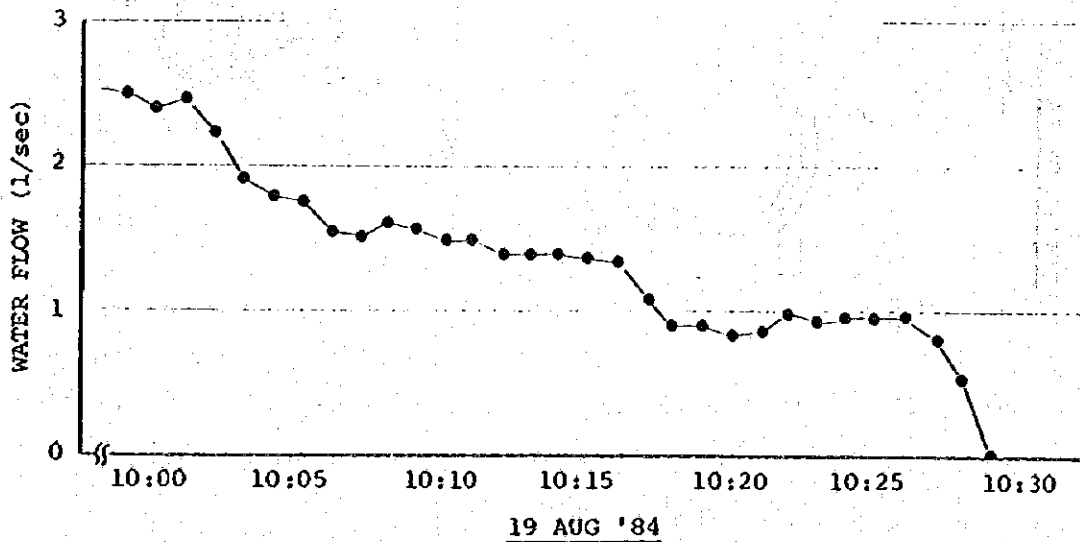
Fig-24 WATER FLOW UNDER CLOSED TAPS

After the 24 hours observation, the water flow measurement under all taps closed condition was conducted, starting at 11 a.m. on 18 July. Every means of instructing the people was employed, but it was not effective as the result, shown in Fig-23, tells. The observed minimum flow was about 1.4 liters/sec. When all valves/cocks of the service pipes and public branches were closed by technicians and workers from 10 a.m. on the next day, 19 July, the water flow fell as low as below the sensitivity of the flow meter. (Fig-24)

From the result, leakage from the pipelines and service connections is scarce obviously, however, considerable amount of water discharged from the free taps of mosques, schools and such like is used very ineffectively. Remarkable is the fact that most these taps are faulty and leaking.

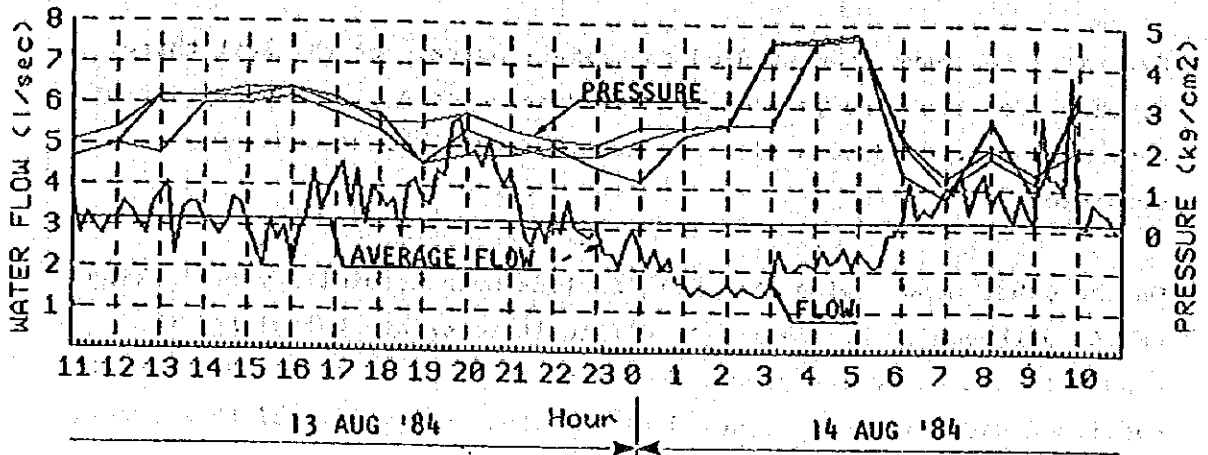
Fig-30 WATER FLOW AND PRESSURE

The observed maximum flow 5.7 liters/sec occurred at around 8 a.m. when villagers would come back from their field and be released from their daily jobs, and minimum flow 1.5 liters/sec arose between 1 to 3 a.m. as expected from their living mode. The detailed survey result is as in Fig-30.

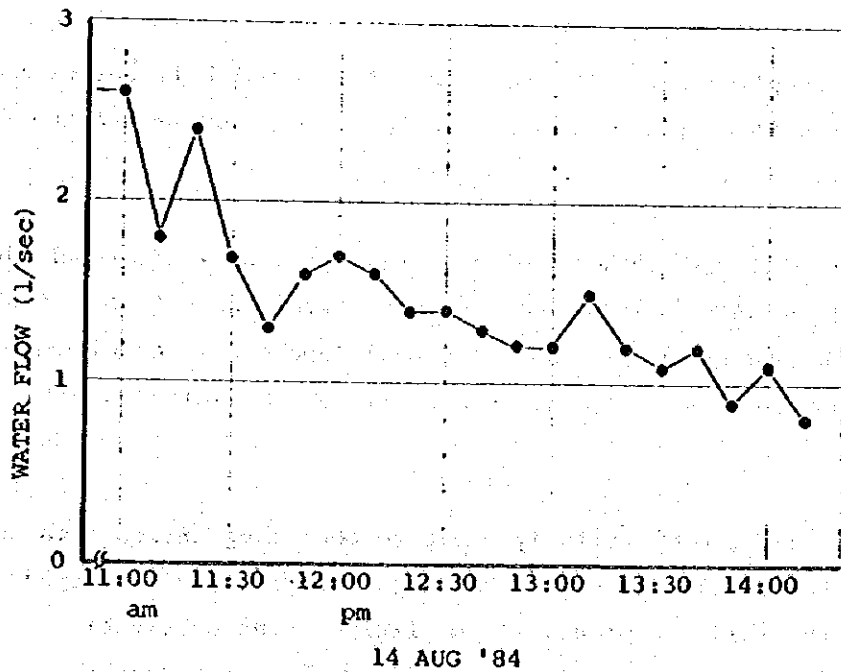
Fig-31 WATER FLOW UNDER CLOSED TAPS

Succeedingly the water flow measurement under all taps closed condition was conducted from 11 a.m. on 14 August. The closed condition was made by closing stop cocks which were set between saddle and meter of every house connection.

Essentially stop cocks are set for replacement of meters and they have never been operated after their installation. At this time the stop cocks were turned to create the closed condition. As the result deteriorated packings of the cocks were damaged and water dripped out from about two thirds of the cocks despite keeping them watertight. The survey result under taps closed condition is shown in Fig-31.

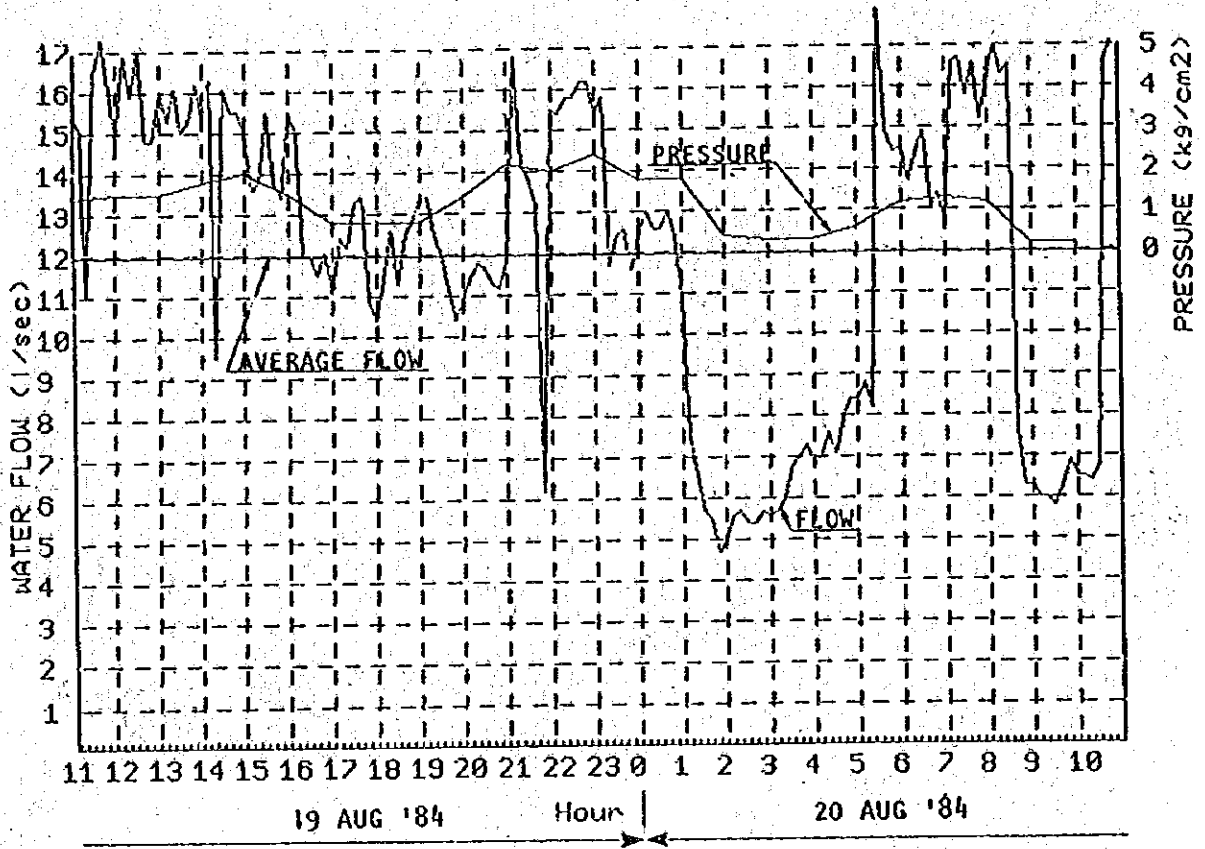
Fig-33 WATER FLOW AND PRESSURE

The water flow and supply pressure were observed for two days of 19 and 20 August as scheduled. The obtained result is shown in Fig-33.

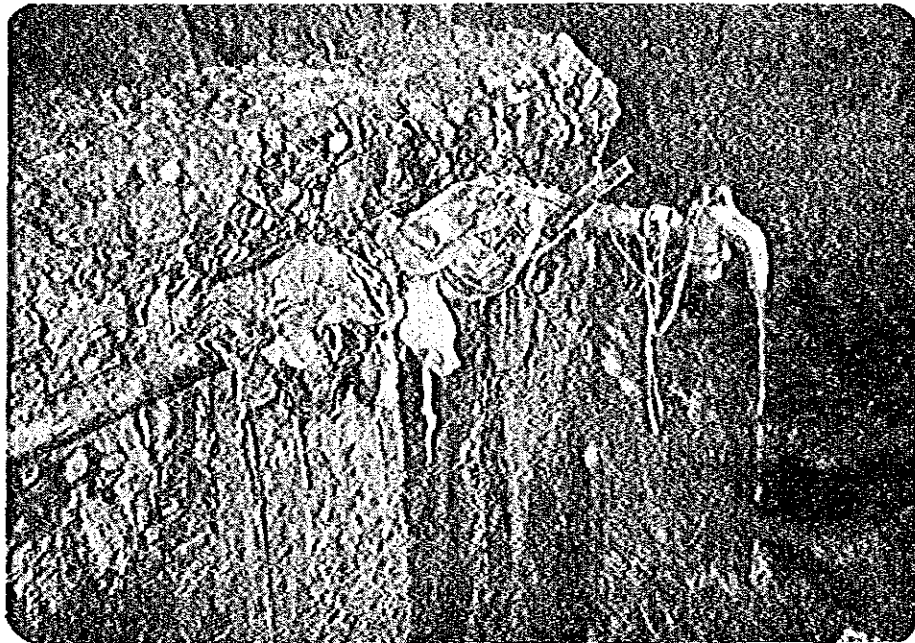
All standpipes in use are faulty, leaking even when closed. When they are opened for use, they tend to be opened fully and usage cannot be distinguished from wastage. Economizing water shall rely on the users' manner and consciousness. The discharge of a standpipe, both when in and out of use, was measured as shown below:

Leakage from closed standpipe : about 30 liters/hour

Dripping tap and damaged tap covered with rags of  
a standpipe
