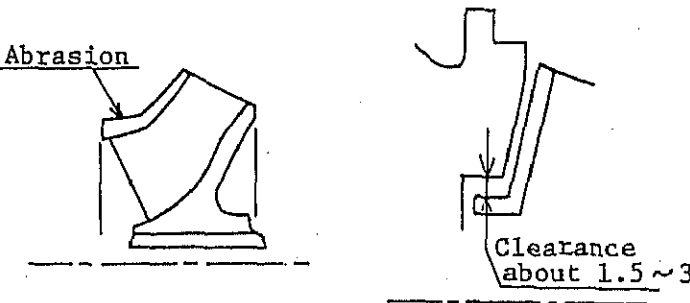
<p>Abrasion</p> <p>Clearance about 1.5 ~ 3</p>
Intermediate Bowl	15

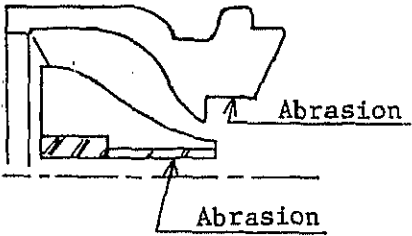
<p>Abrasion</p> <p>Abrasion</p>
Pump Shaft	1

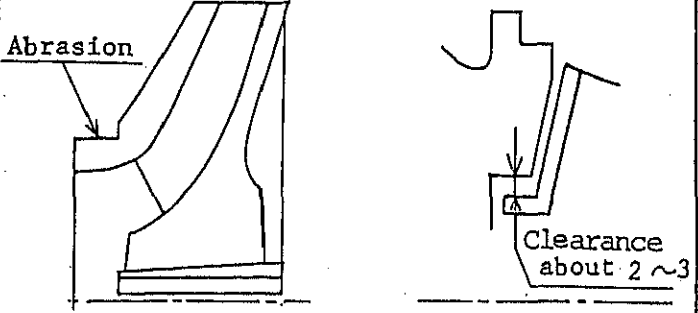
<p>Abrasion</p> <p>Clearance about 2 ~ 3</p>
Intermediate Bowl	2

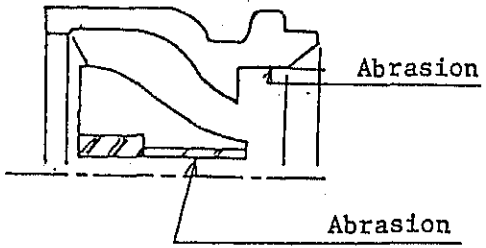
<p>Abrasion</p> <p>Abrasion</p>
Pump Shaft	1

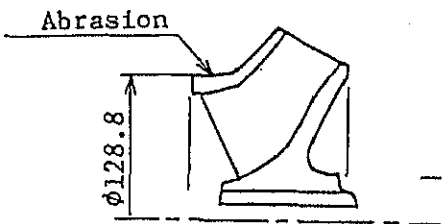
<p>Impeller has corrosion .</p>
Intermediate Bowl	22

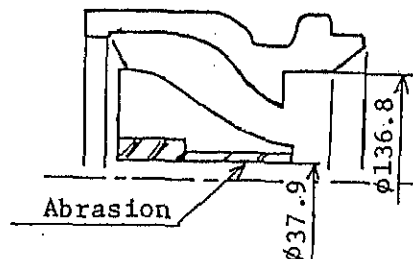
<p>Abrasion</p>
Pump Shaft	1

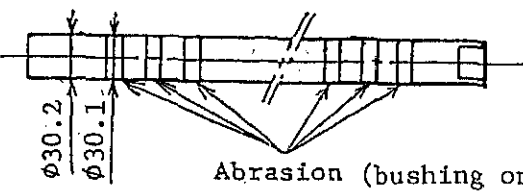
<p>Abrasion (bushing only)</p>
Comment

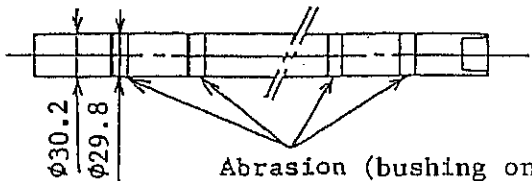
<p>Abrasion (bushing only)</p>
Comment		End play 19 mm

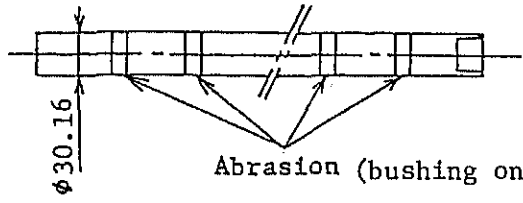
<p>Abrasion (bushing only)</p>
Comment		<p>Discharge case and top intermediate bowl have the most scale.</p>

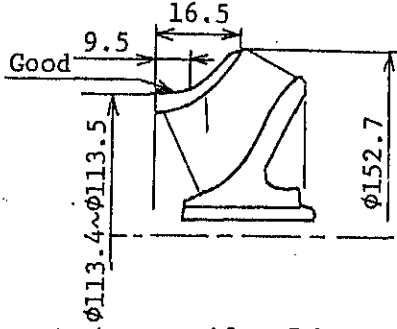
<p>Discharge side of bane is damaged</p>
Intermediate Bowl	12

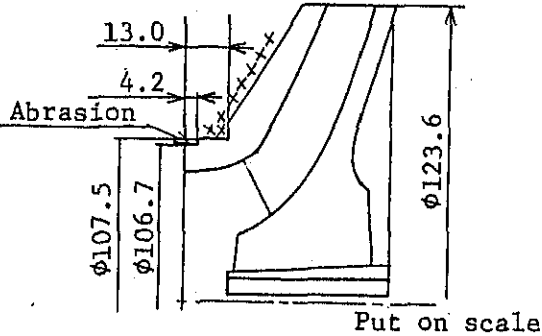
<p>Put on scale</p>
Intermediate Bowl	15

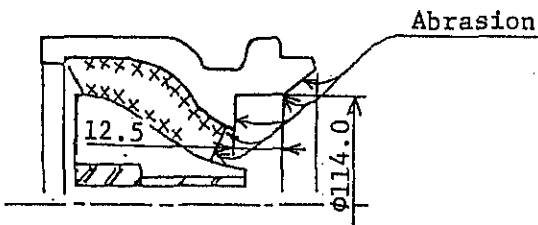
<p>x Put on scale</p>
Pump Shaft	1
