REPORT ON DAMAGE TO PORT FACILITIES  
IN THE PORT OF VALPARAISO  
BY THE EARTHQUAKE ON MARCH, 3 1985

APRIL 2, 1985

JAPANESE EXPERT MISSION

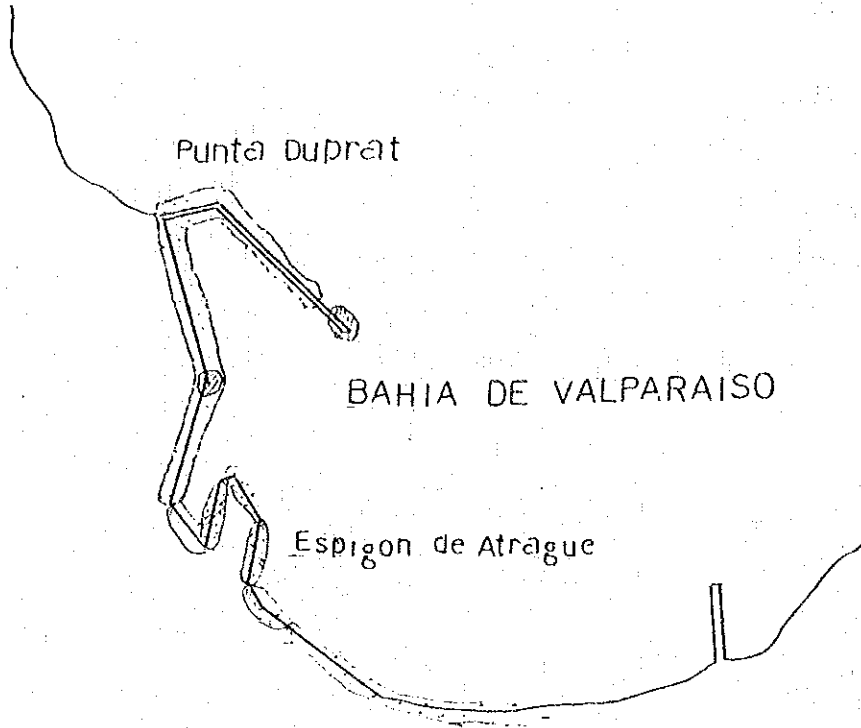
Fig 4-2

All these damage appeared exclusively in the filled area as shown in Fig. 4-2.

Distribution of damage

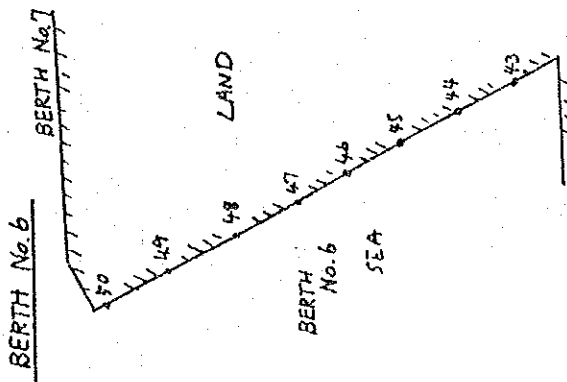
Fig. 4-4-d

INVESTIGATION POINT	H	H'	B	S1	S2	D	NOTE
50	13.45m	2.90m	3.0m	70cm	20cm	9.1m	
49	13.40m	3.20m	5.0m	"	35cm	9.1m	
47	12.70m	3.20m	over 5.0m	"	25cm	9.1m	
45	13.40m	3.30m	over 5.0m	"	28cm	9.1m	
43	6.95m	3.50m	over 5.0m	"	50cm	3.9m

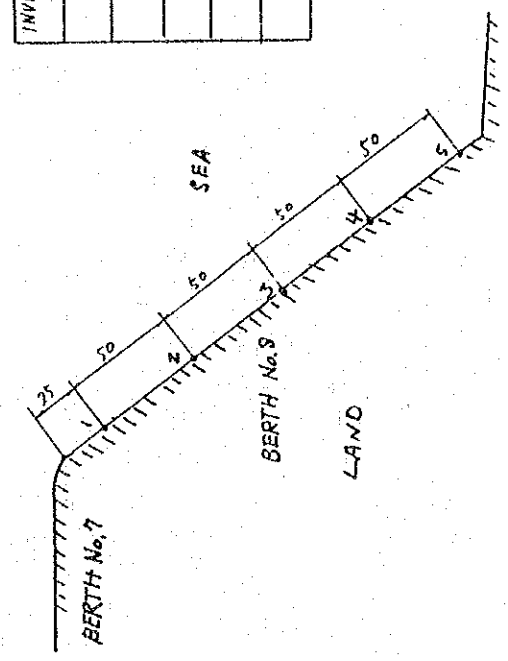
Fig. 4-4-e

INVESTIGATION POINT	H	H'	G	S1	S2	D
1	13.5m	3.0m	—	50cm	30cm	9.8m
2	13.05m	3.2m	2.0m	"	40cm	9.8m
3	12.5cm	3.5m	2.0m	"	35cm	9.8m
4	12.7m	3.5m	5.0m	"	45cm	9.1m
5	12.5m	3.8m	5.0m	"	15cm	9.1m
