CHAPTER - 6

EXISTING CONDITION
OF
THE PROJECT ROAD

6-1 General

The Project Road is part of the national road, stretching over a distance of about 500 km from Bogota, the capital of Colombia, to the Port of Buenaventura, and which crosses the Cordillera, mountain range for a distance of about 310 km. It is this 310 km portion which is the object of this study.

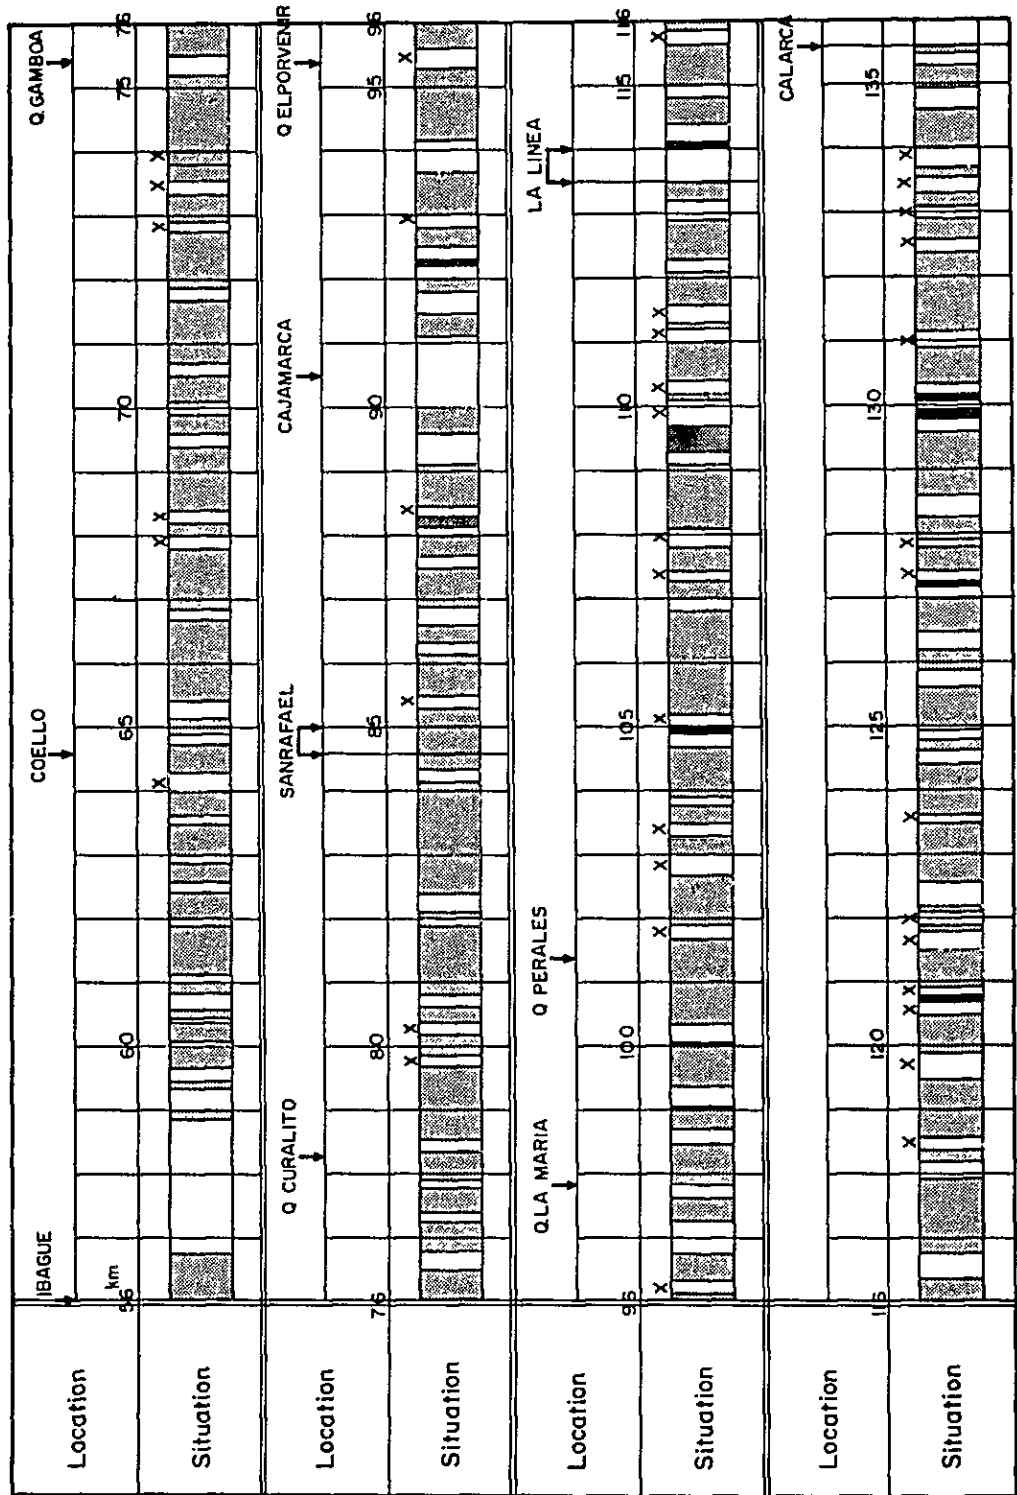
Fig. 6-3 Survey Result of Passing Sight Distance

- 4) Soil piled up on edge of road acting as guard fence and over grown trees cause a serious obstruction to view and it is not possible to get the 150 m passing sight distance required for a design speed of 30 km/h. (See Fig. 6-3)

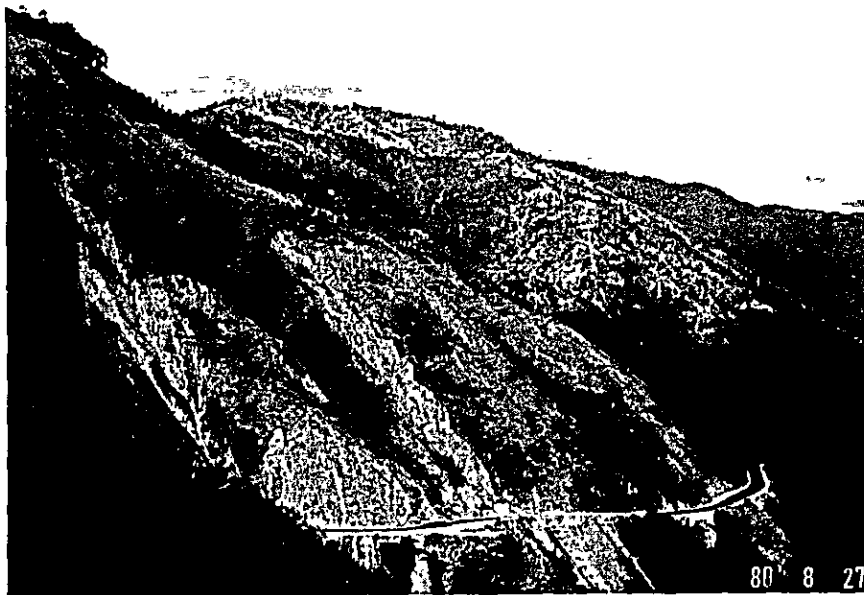
Photo 6-2 The Site in Danger of Landslide

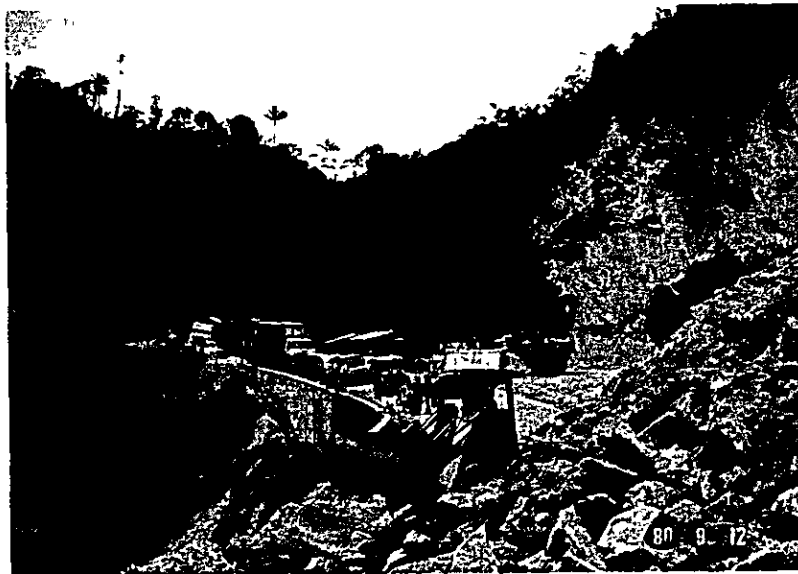
Photo 6-4 The Site of Landslide which needed one day
before Road Reopening.
