**SURVEY REPORT  
FOR  
REHABILITATION  
OF  
THERMAL POWER PLANTS  
IN METRO MANILA  
IN THE REPUBLIC OF THE PHILIPPINES**

**VOLUME I**

**(MAIN REPORT)**

**JAPAN INTERNATIONAL COOPERATION AGENCY**

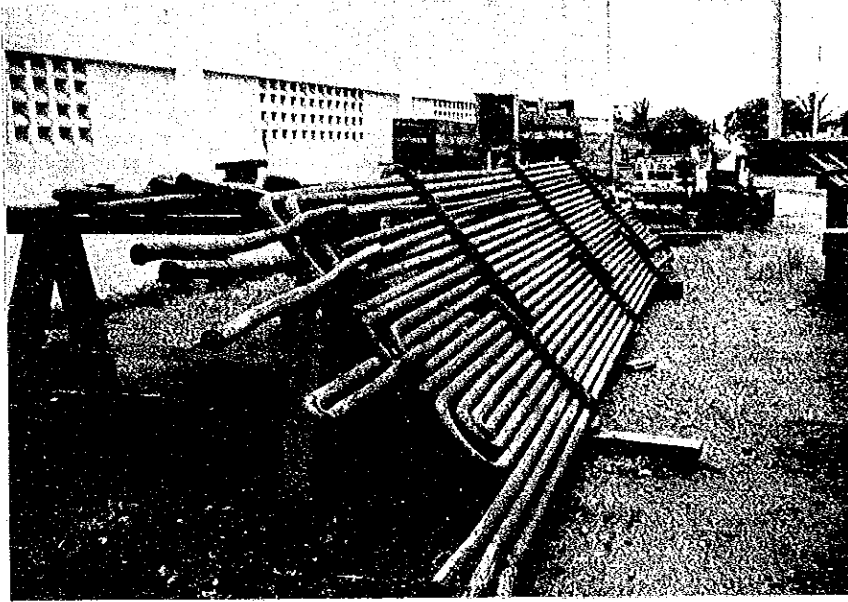
G-2 SECONDARY SUPERHEATER TUBES  
REMOVED DURING RECENT OVERHAULING

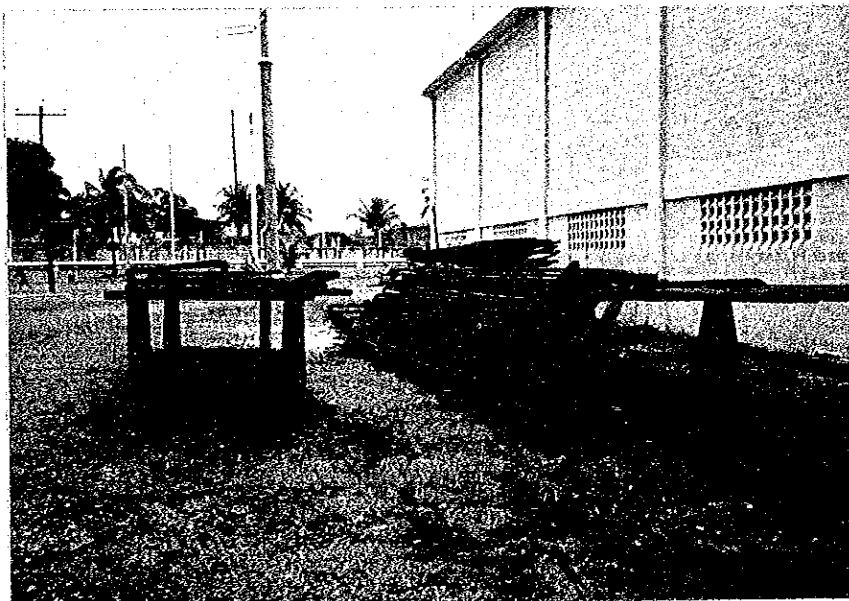
G-2 REMOVED SECONDARY SUPERHEATER TUBE

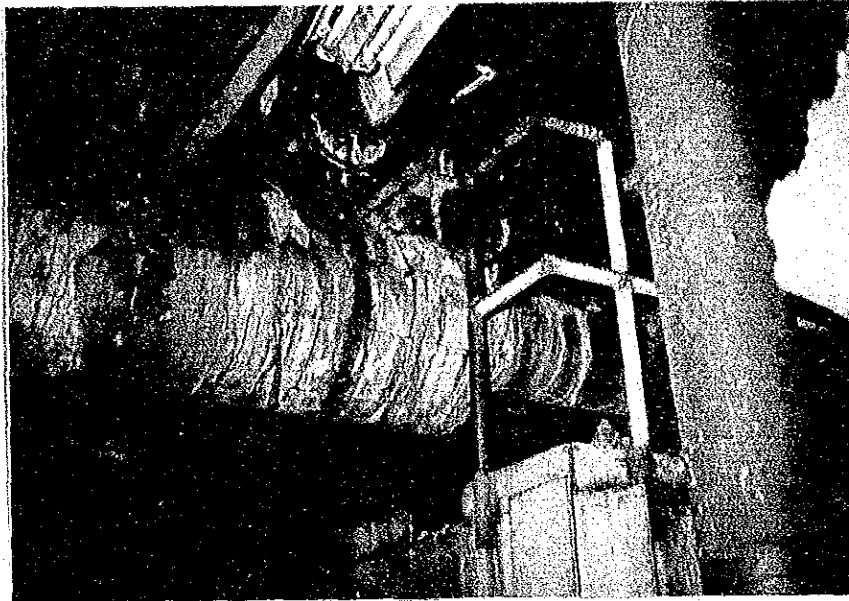
SITUATION OF PIPING  
INSULATION (note  
safety valve already  
at bent position)

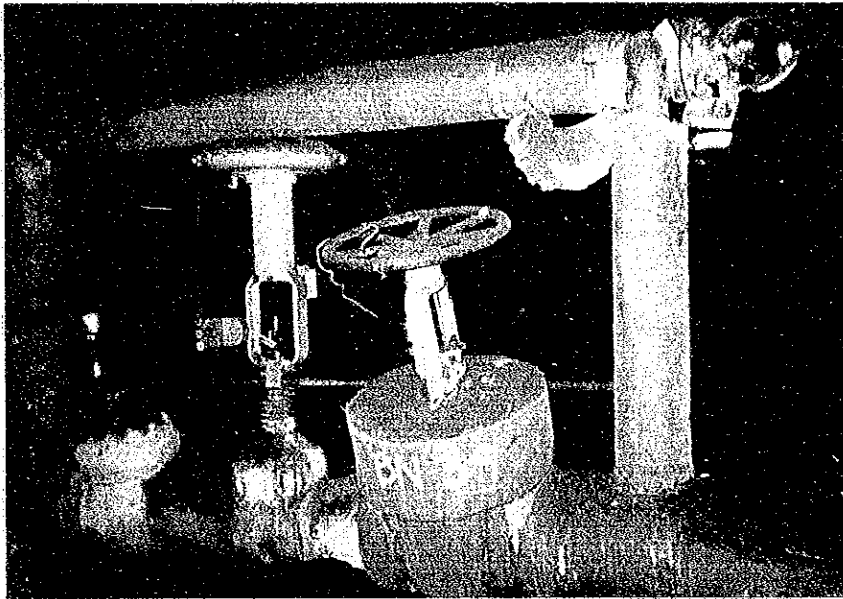
NON-OPERATIONAL AUXILIARY STEAM CONTROL VALVE

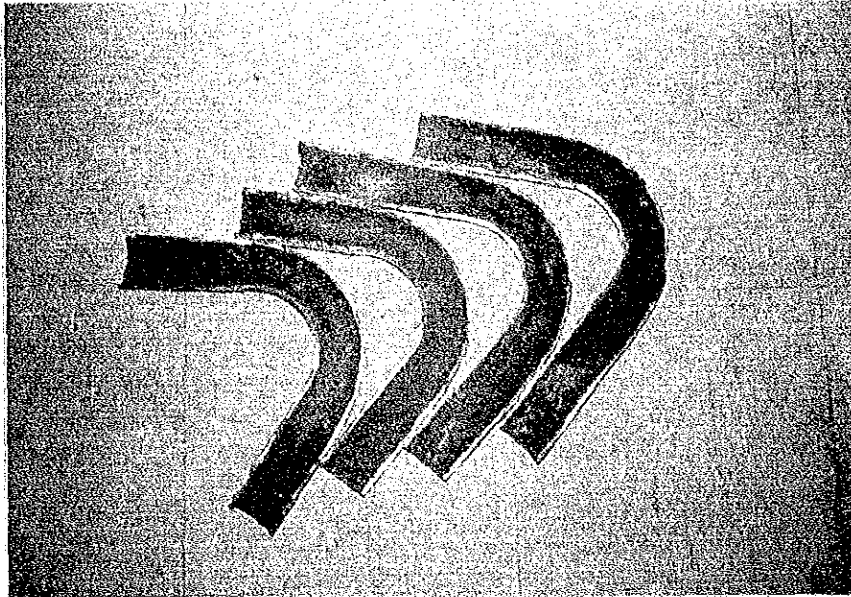
SECTION OF  
G-2 R/H BENT  
TUBES (Inside  
corrosion)

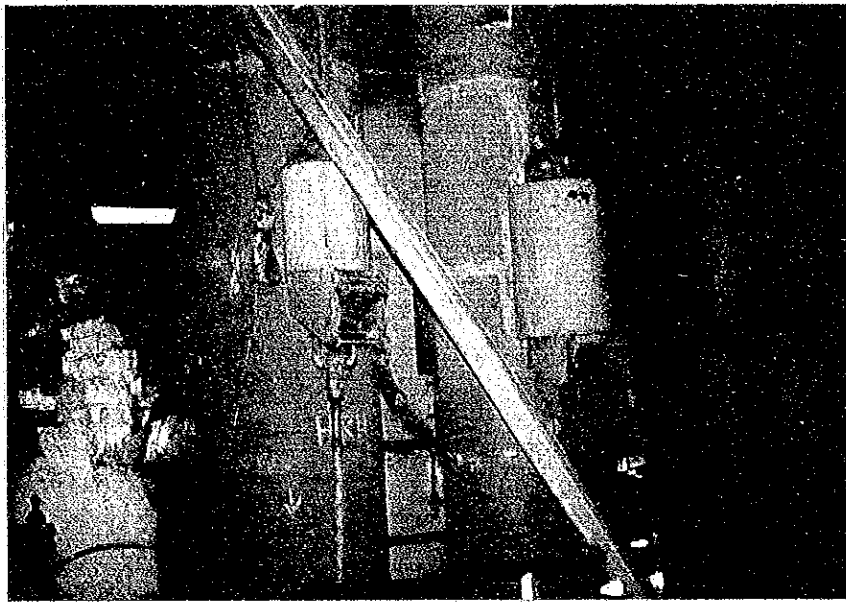
NON-FUNCTIONING CONSTANT LOAD HANGERS OF S-1 MAJOR PIPES

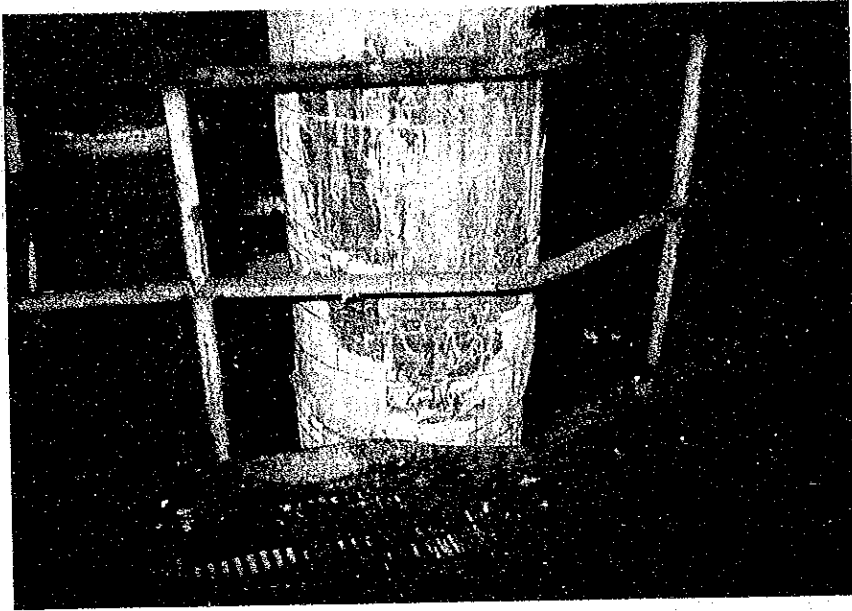
S-1 CRH PIPE & DAMAGED GRATING AT MEZZANINE FLOOR

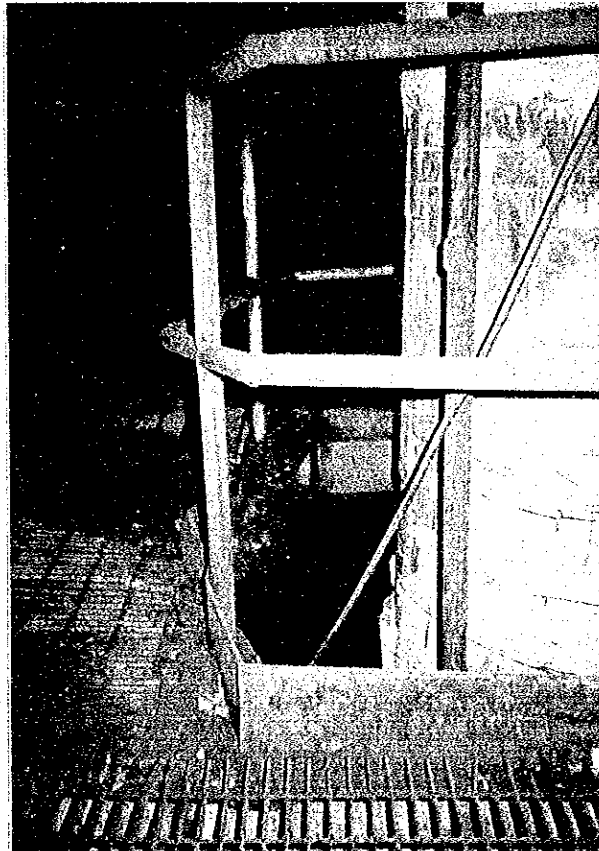
ANOTHER VIEW OF DAMAGED GRATING

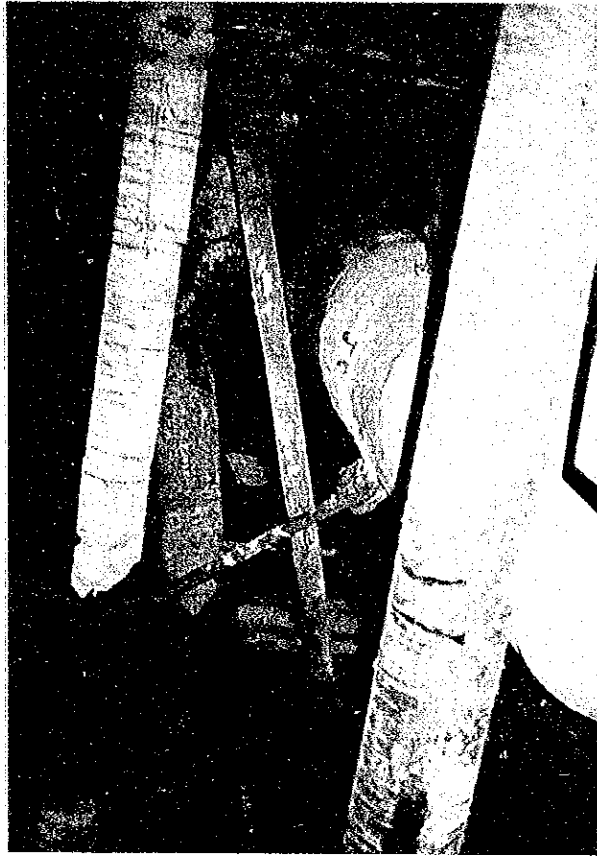
BENT I-BEAM OF S-1  
MEZZANINE FLOOR  
NEAR CRH PIPE

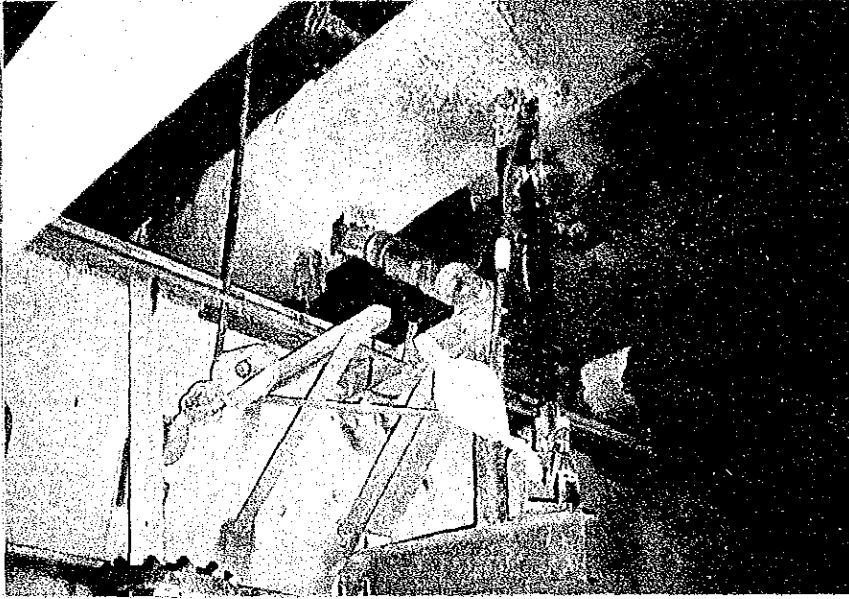
S-2 CRH  
PIPE  
TEMPORARY  
HANGER

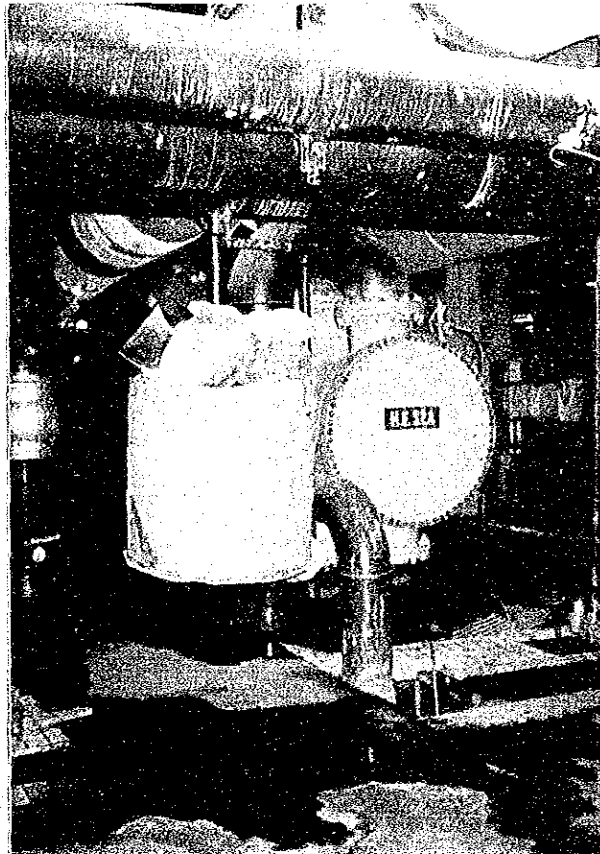
S-2 CRH PIPE  
TEMPORARY  
HANGER

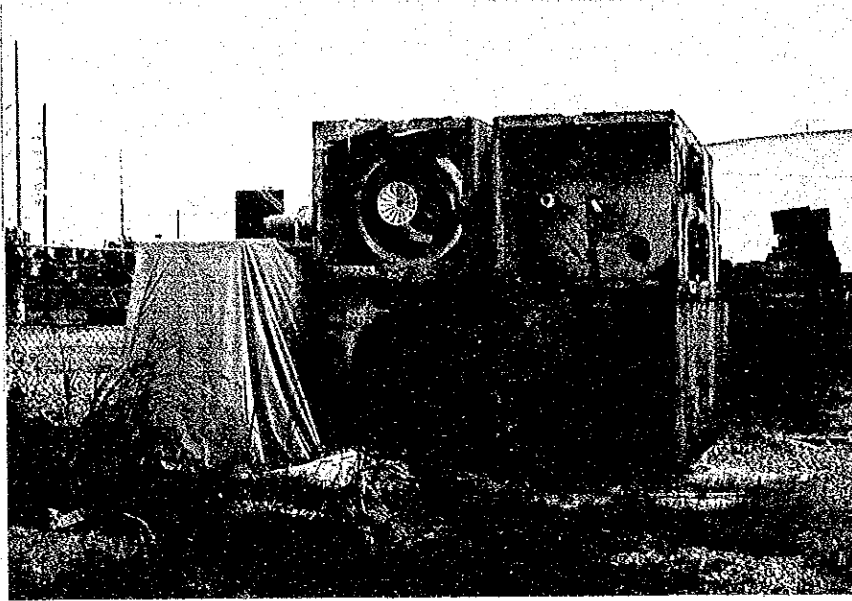
SITUATION AT MATERIALS/EQUIPMENT OUTDOOR STORAGE  
AREA

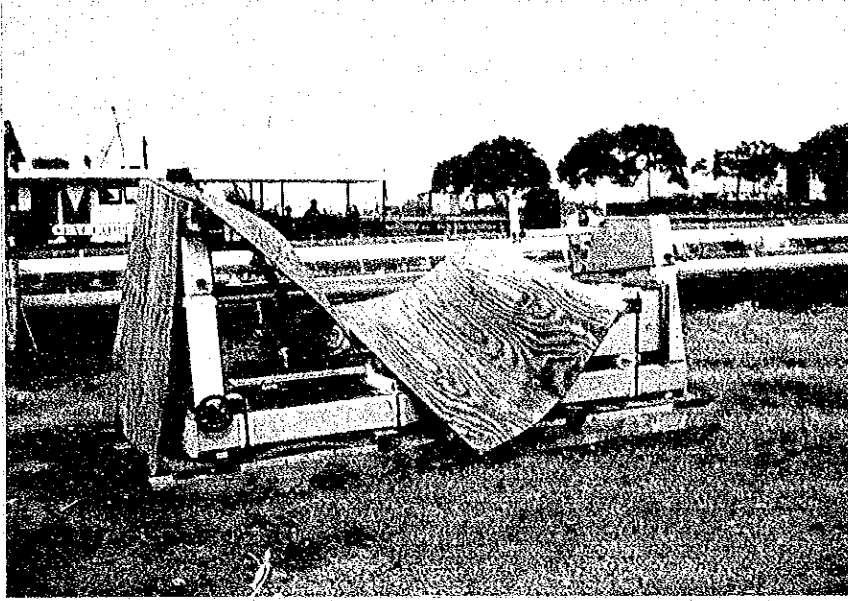
SITUATIONS AT THE  
MATERIALS/EQUIP-  
MENT OUTDOOR  
STORAGE AREA

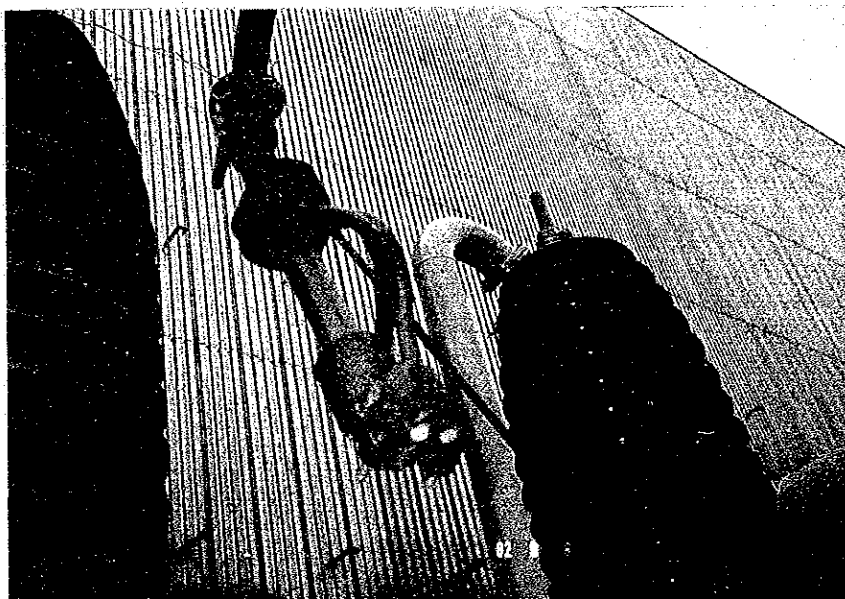
Temporary transformer is connected to the emergency transformer. Dangerous!

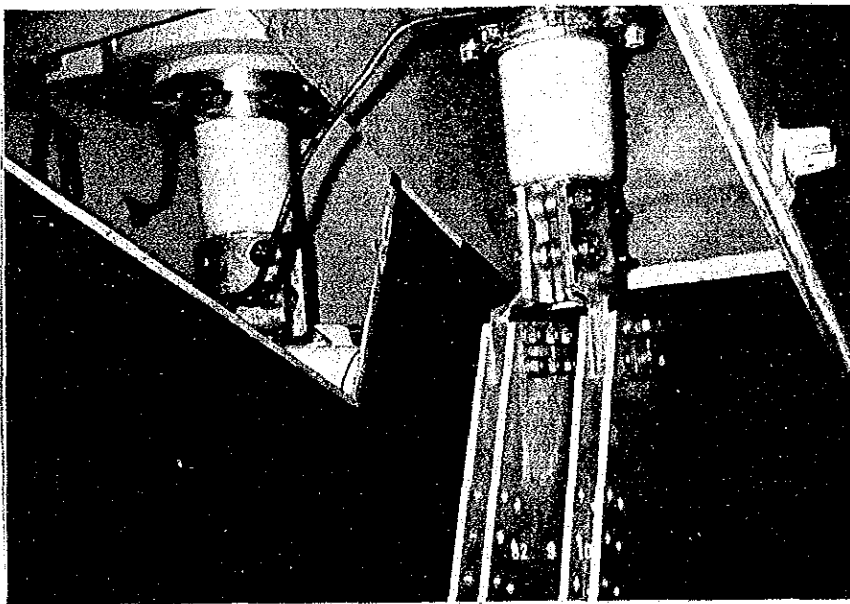
G - 2 Power for overhauling is taken from another unit which is in operation. Dangerous!

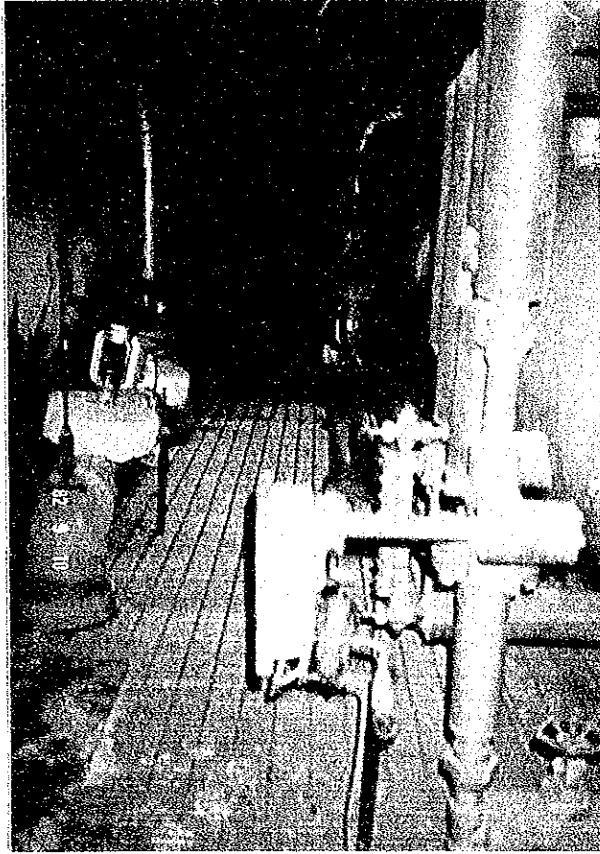
G-1 L.P.H. drain  
valve. No by-pass  
valve is installed.

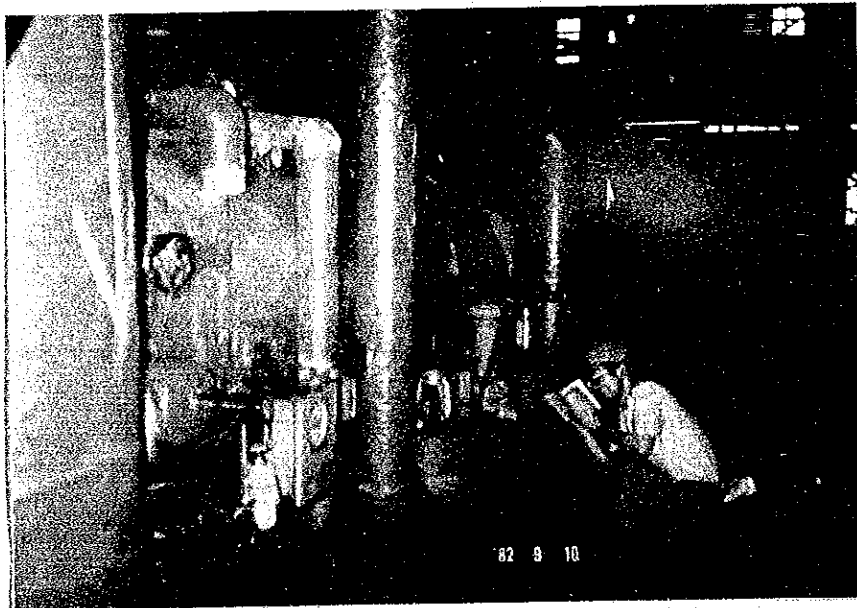
G-1 Auxiliary steam under manual operation.

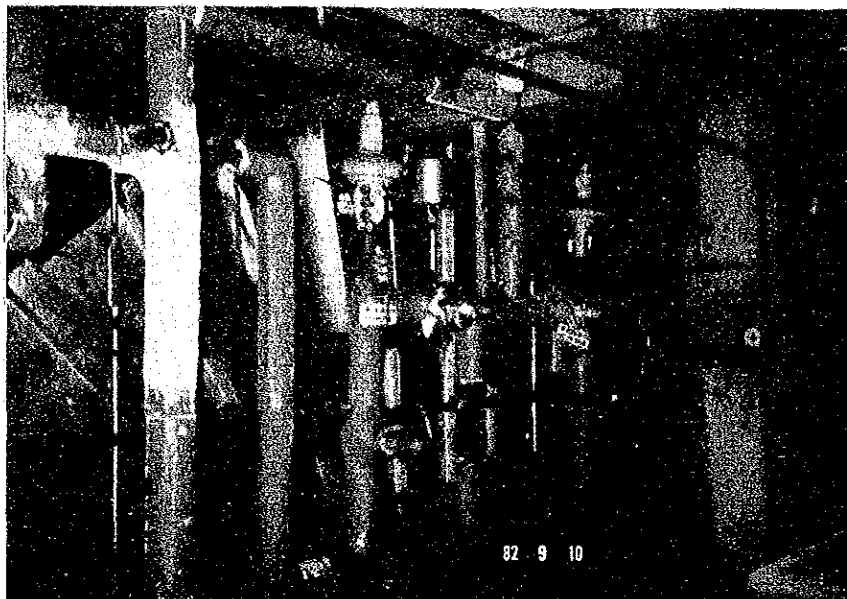
G-1 Boiler feed pump minimum flow valve is locked at open position. Save energy!

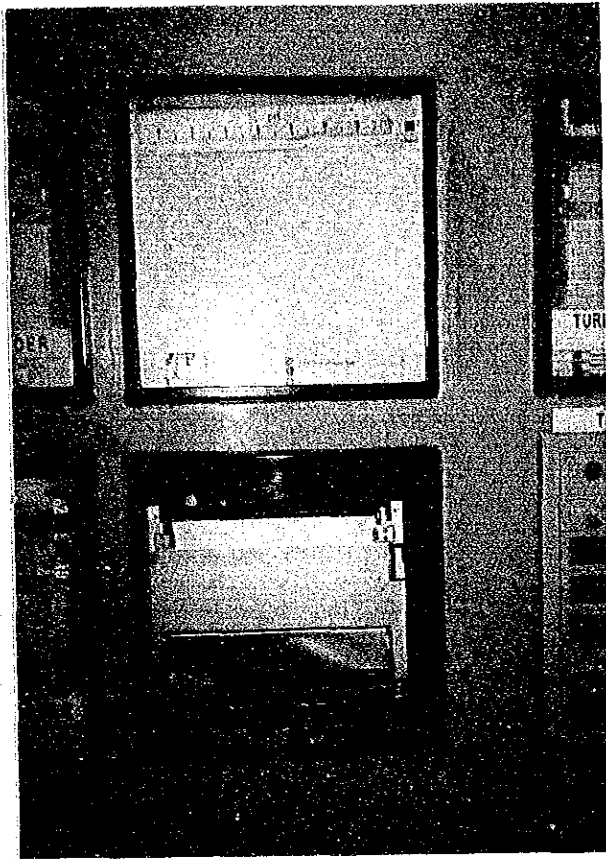
All parts have been removed from pH meter. Important recorder! S-1

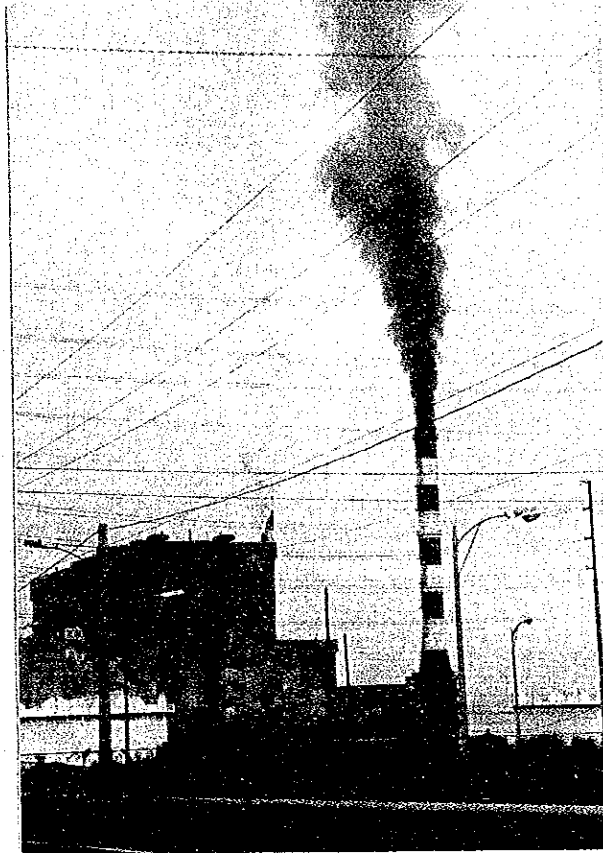
Black smoke due to low excess air caused by air heater clogging during load-up.

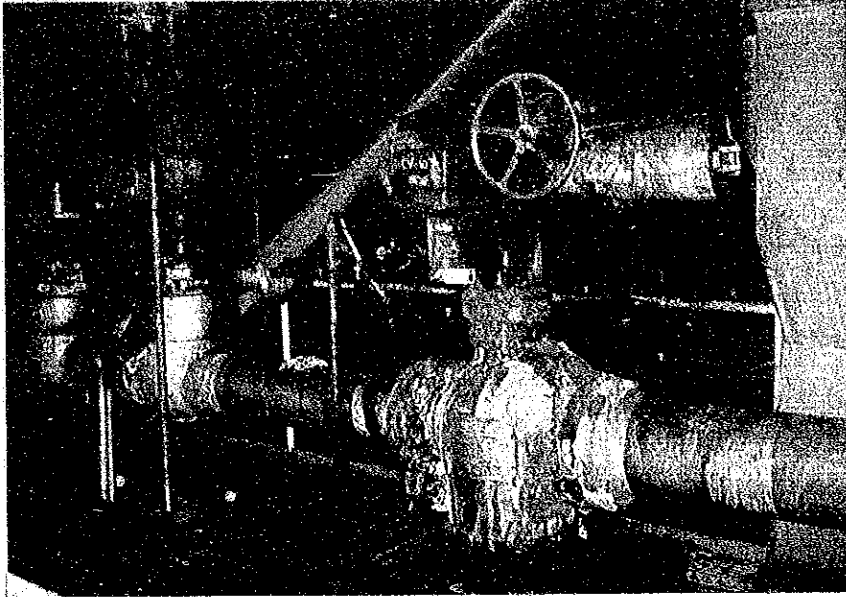
M - 1 CV-103

Valve and its accessories are corroded  
by flue gas leak

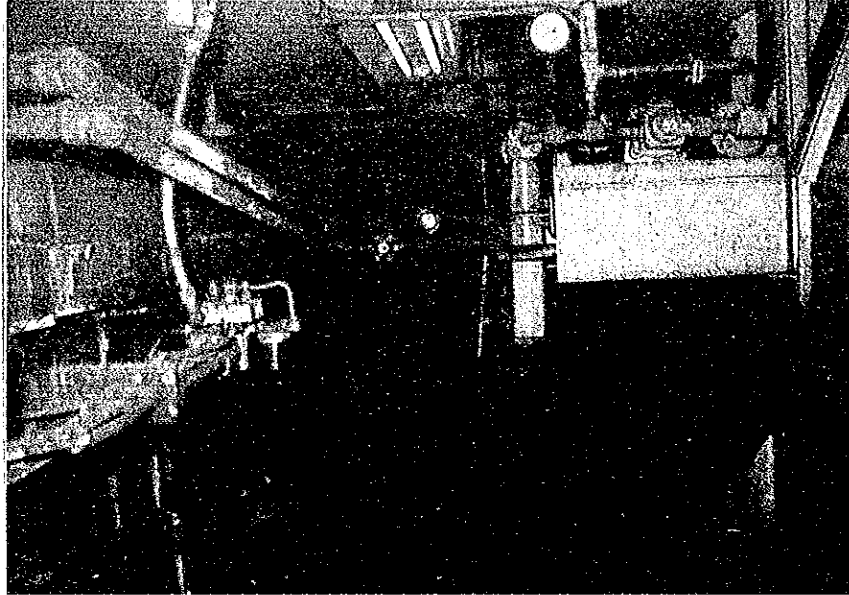
M - 2 Surrounding air heater is filled with flue gas.  
M - 2

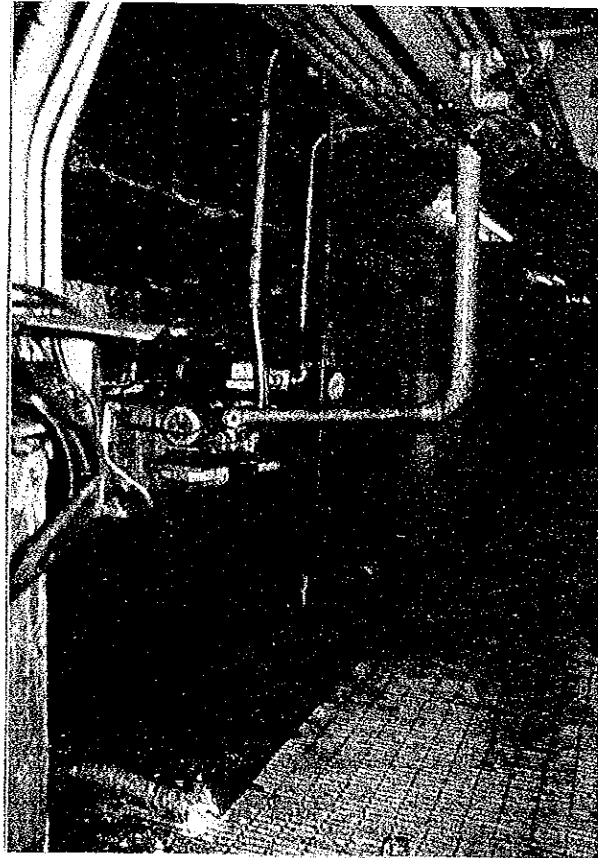
M - 2 2A-AH

Corroded AH accessories

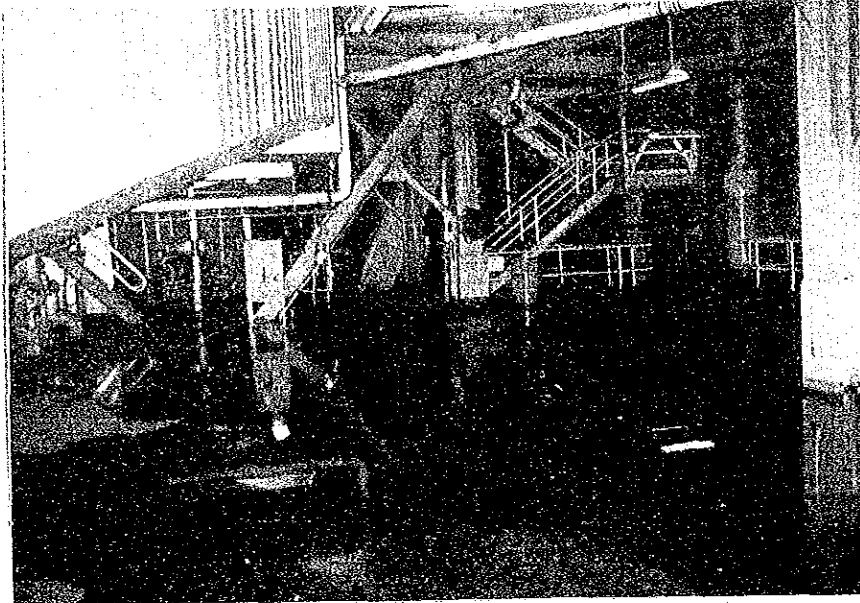
M - 2 3FL Right side of boiler

There are much gas leak but also roof drain leak

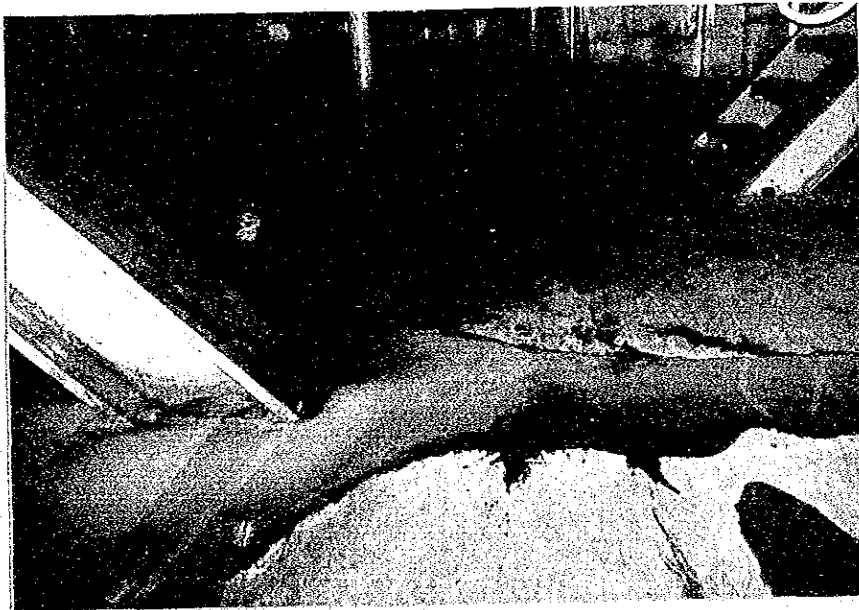
Around air heater with brownish and corrosive water coming from roof drain leak

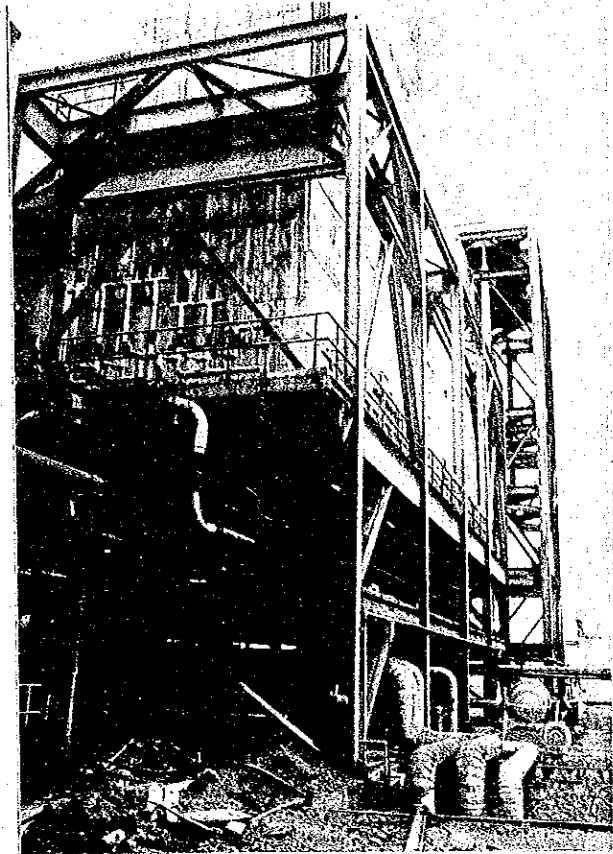
M - 1 Dust Collector

Flue gas leaks attack also  
the dust collector

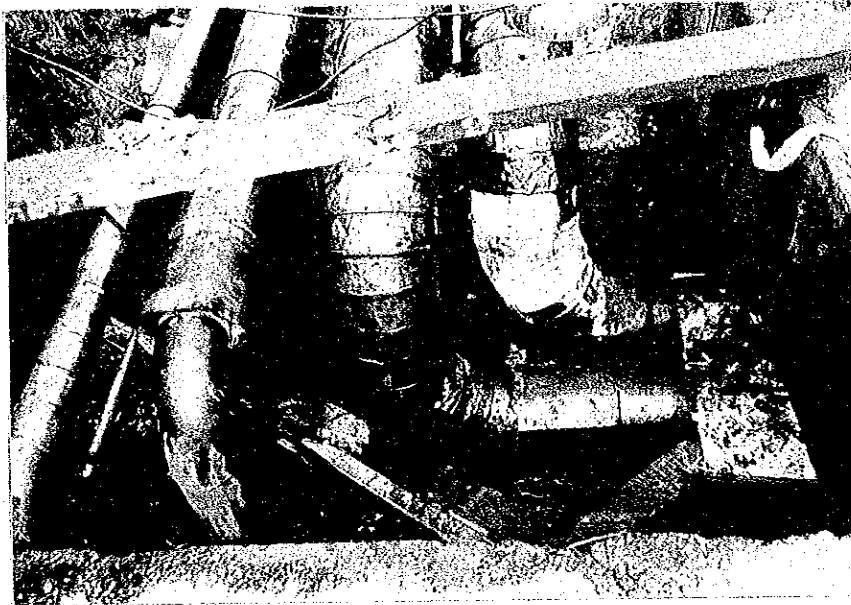
Out door Residual oil supply pipe  
Oil drain pipe is leaking

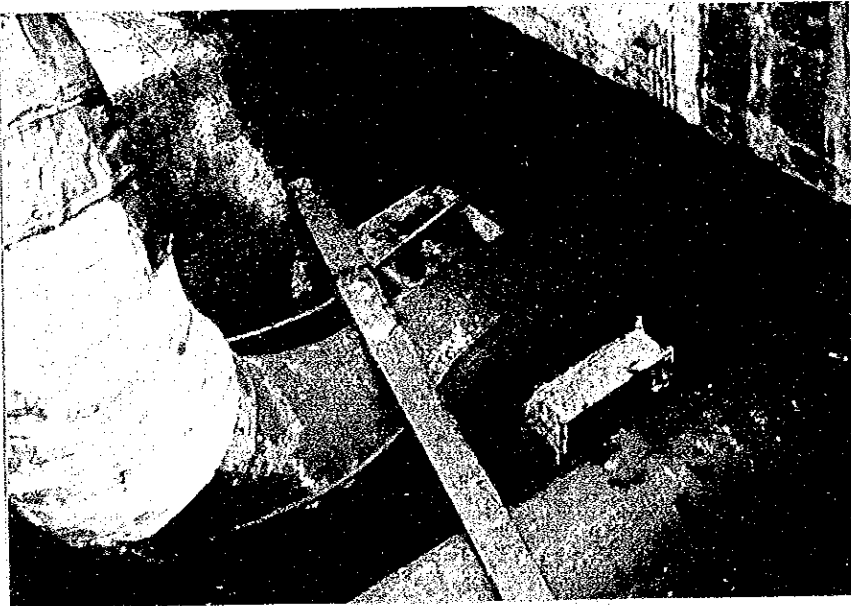
Leaking point was covered by box
