EXECUTIVE SUMMARY

STUDY REPORT FOR REHABILITATION OF THERMAL POWER PLANTS  
IN METRO MANILA IN THE REPUBLIC OF THE PHILIPPINES

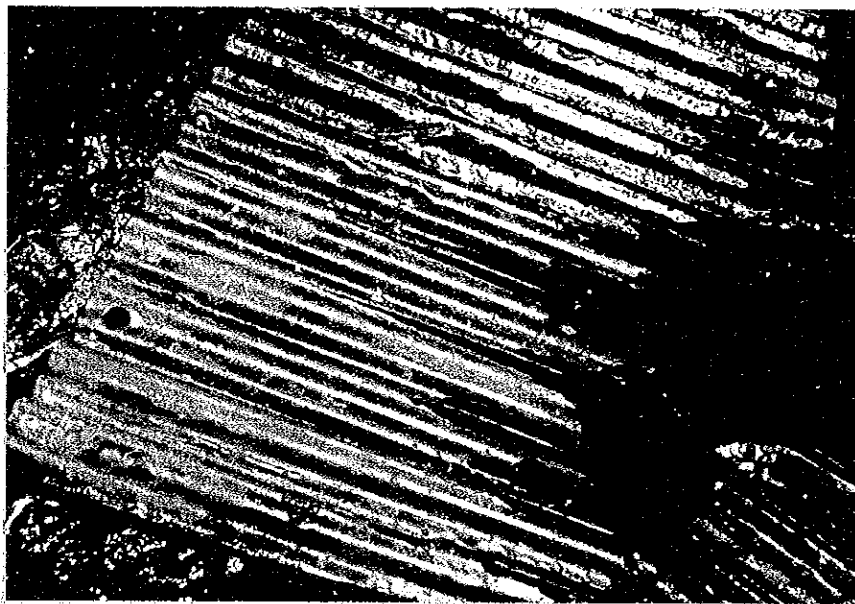
M - 2 AH COLD - END ELEMENT

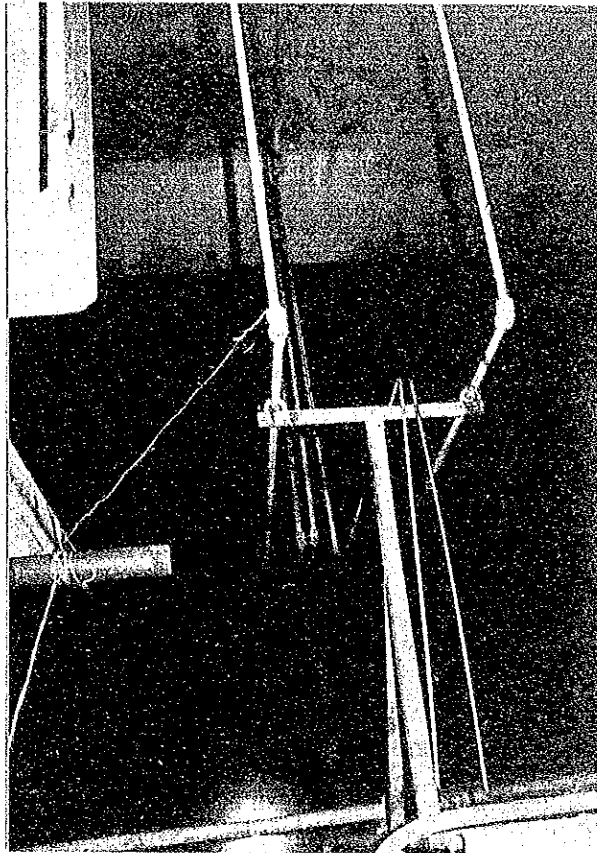
PH-35

M - 2 Sampling pump for condenser leak detector was submerged.

Condenser leak detector system protect the equipment from corrosion.

Corrosion of this system will eventually influence other equipment into corrosion .

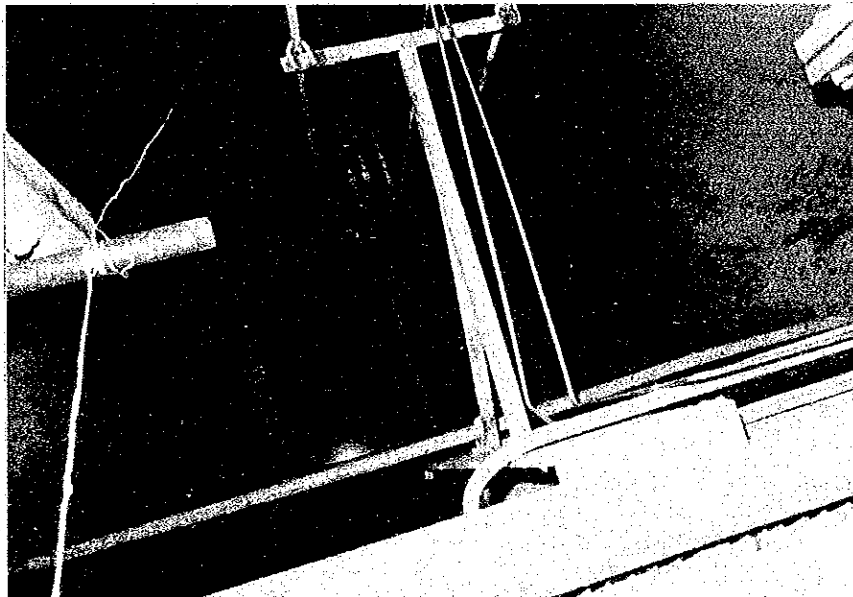
M - 2 Sampling  
After draining, sampling equipment surfaced, but can not be used anymore.

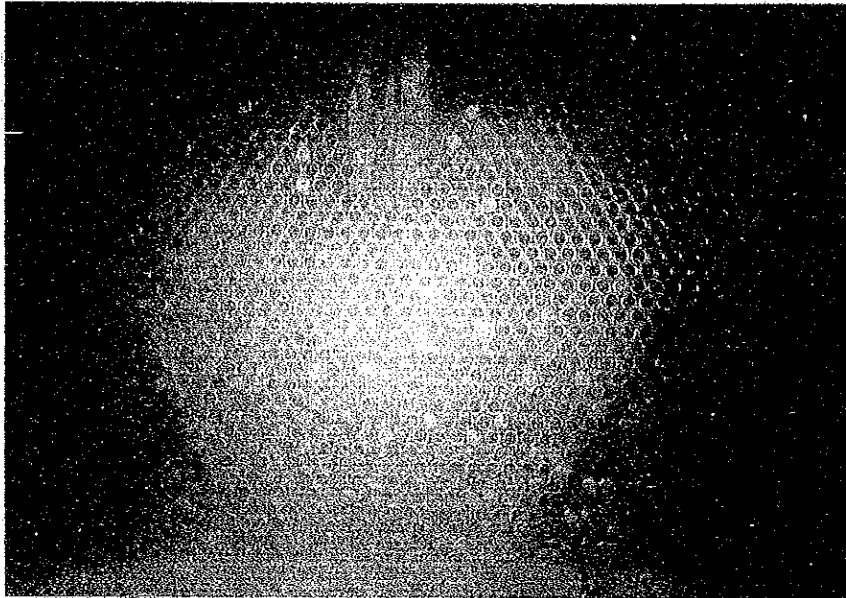
PH-36

M - 2 CONDENSER TUBE LEAK

There are plenty of leaks on condenser tubes. Cause of this matter is not yet clear. But sampling of condensate water must be done during operation frequently and carefully.

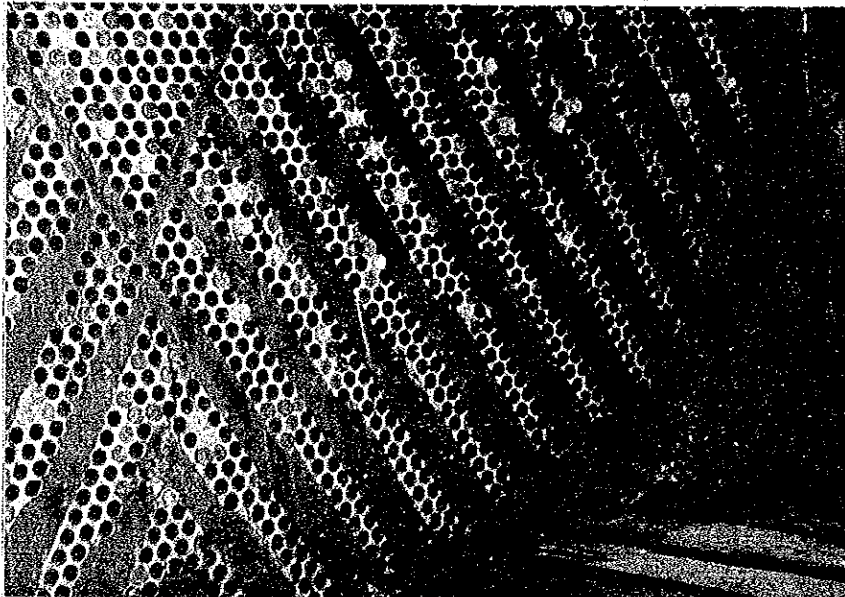
M - 2 CONDENSER (out side) There are some rust.

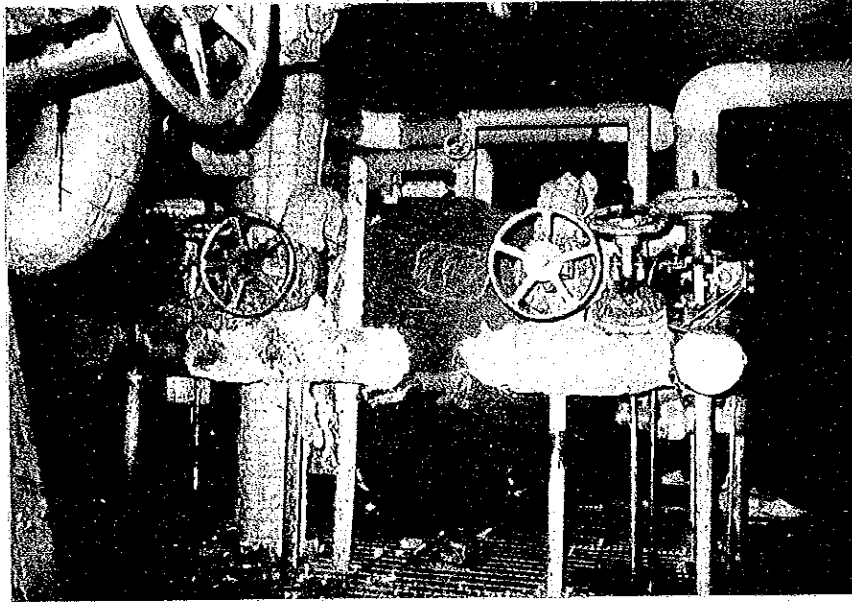
PH-37

M - 1 LP - No. 3 HTR  
Two drain pipes are led to # 3 LPH.

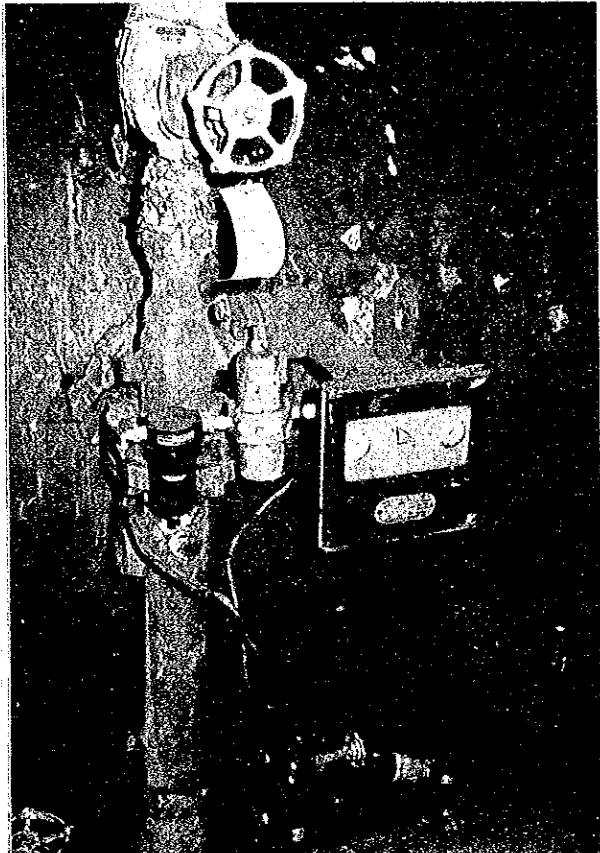
M - 1 There are plenty tube  
leaks on feed water heater

One of these causes, defective  
level control is pointed out.

M - 1 MP - No. 613 HTR LEVEL CONTROL  
Defective level controller is isolated

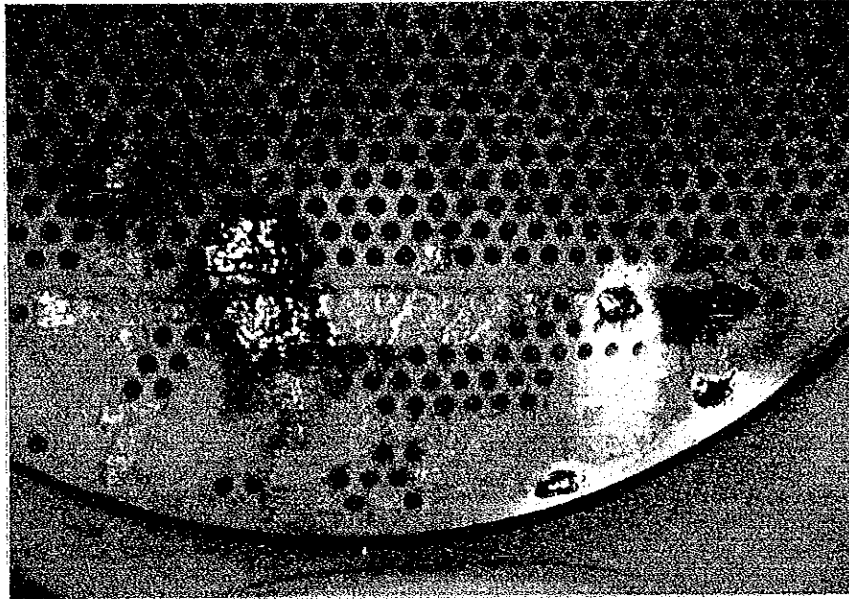
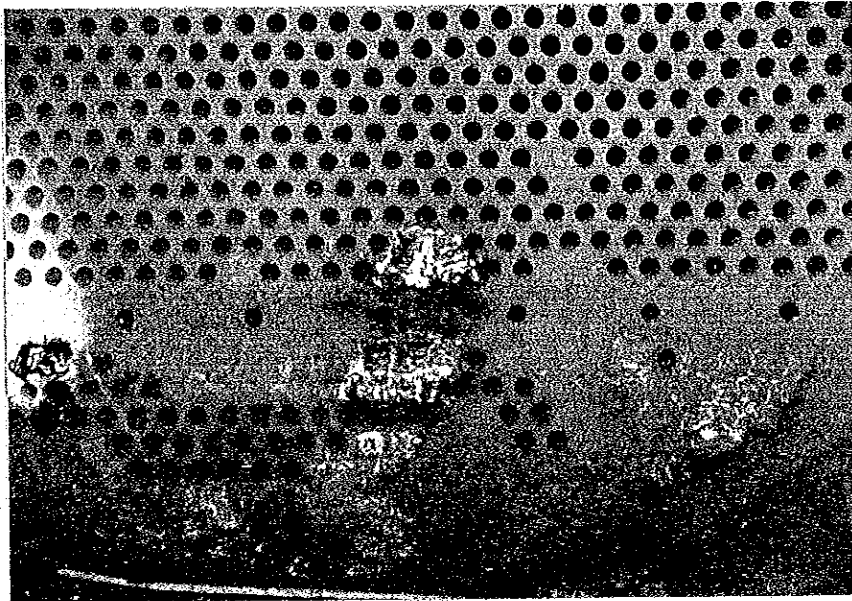
PH-38

Improper plugging is observed in this picture.  
Rough surface causes corrosion probably.

M-1 HP - 5B Heater

M-1 High Pressure - 5B Heater

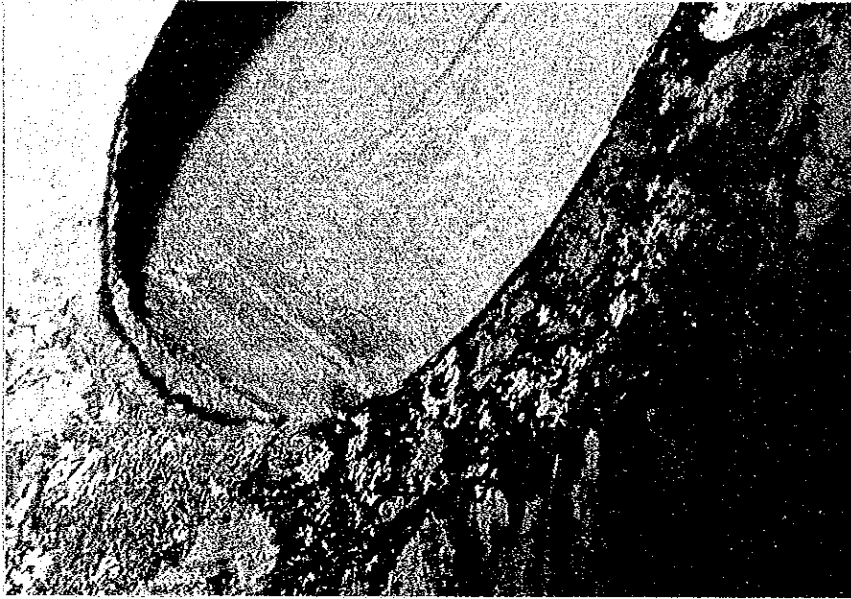
PH-39

There is corrosion on water wall chamber. Needs painting.

M-2 Water Chamber (Outlet side)

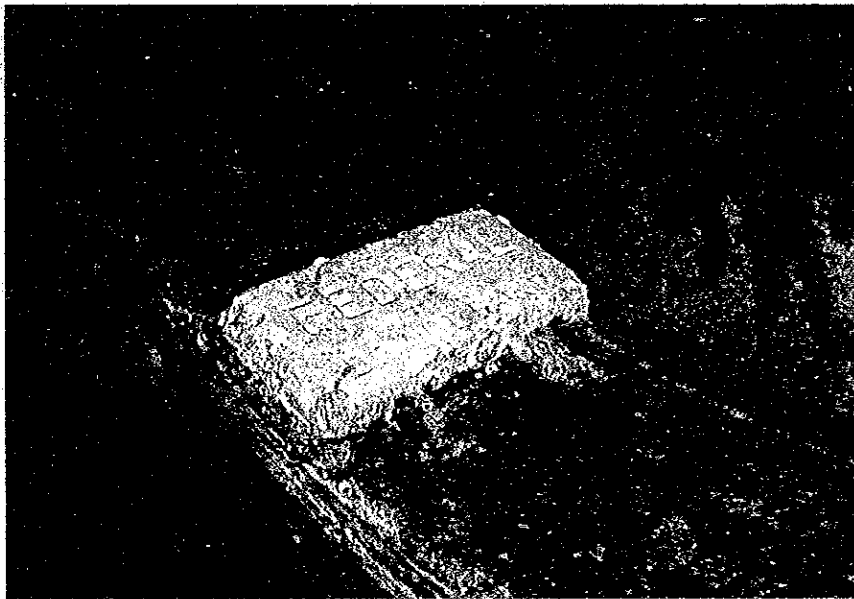
M-2 Heat Exchanger

Zinc plate

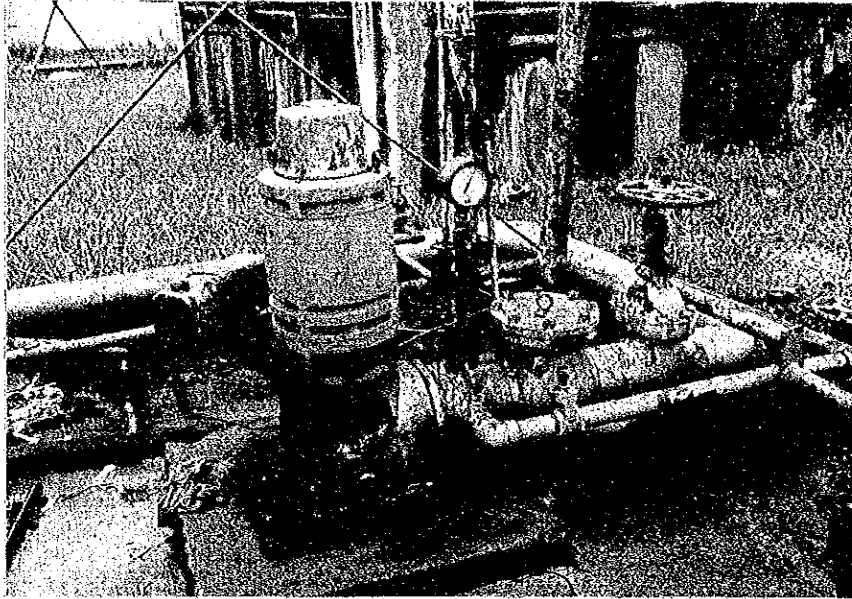
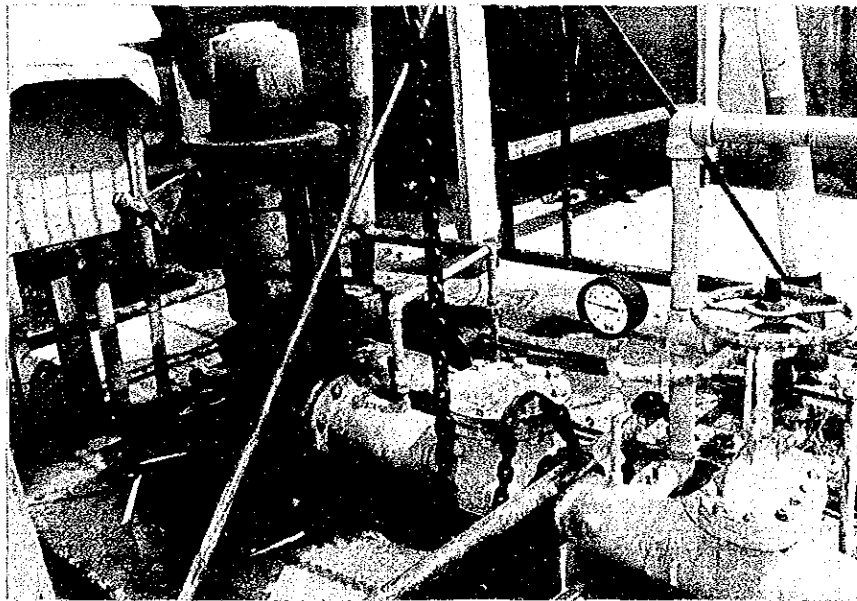
PH-40

Malaya is affected by water supply shortage. Three deep well pumps are running and one deep well is under construction. But water level is going low.

No. 2 Deep Well Pump - Discharge valve is slightly opened.

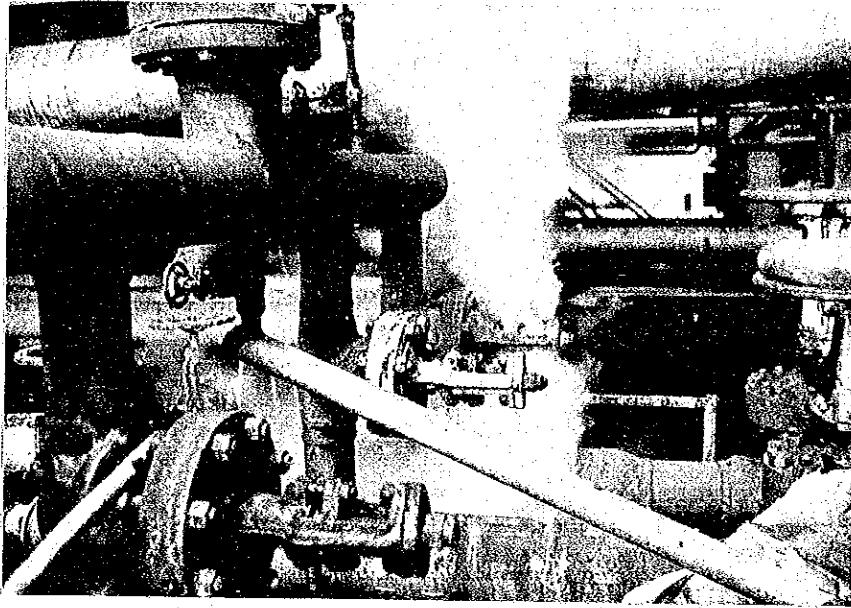
PH-41

Inspite of water supply shortage, there are plenty of steam leaks which need immediate maintenance.

M-1 Steam leak at outdoor piping

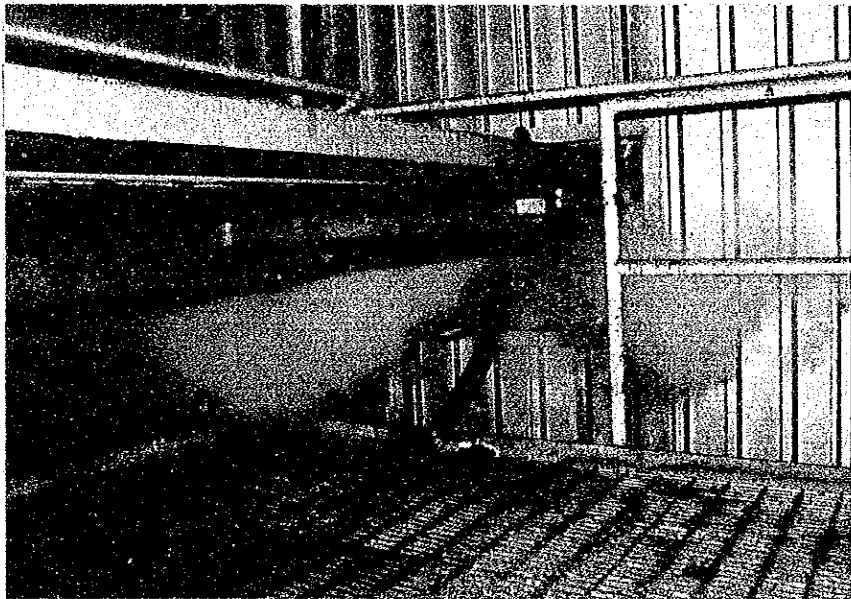
M-1 Sootblower

Steam leaks at soot blower

Broken Drain  
Funnel

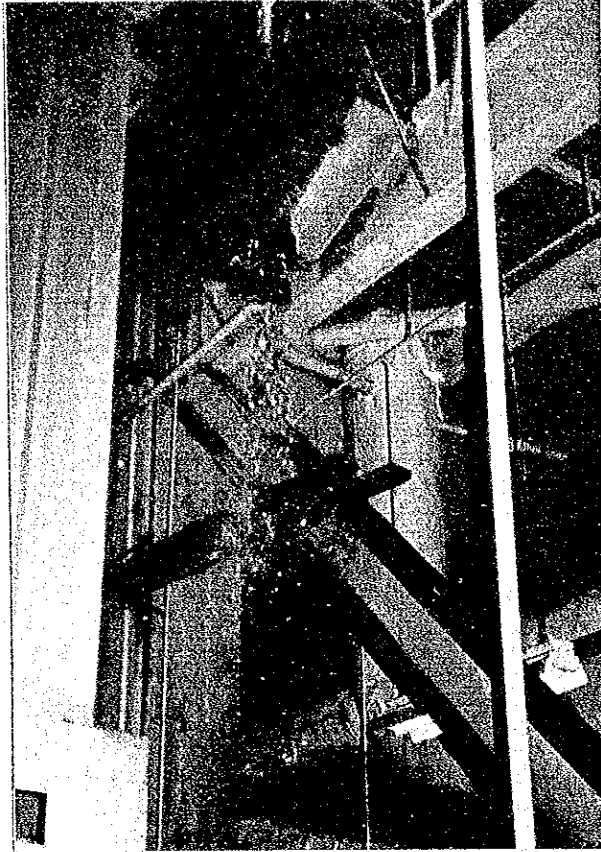
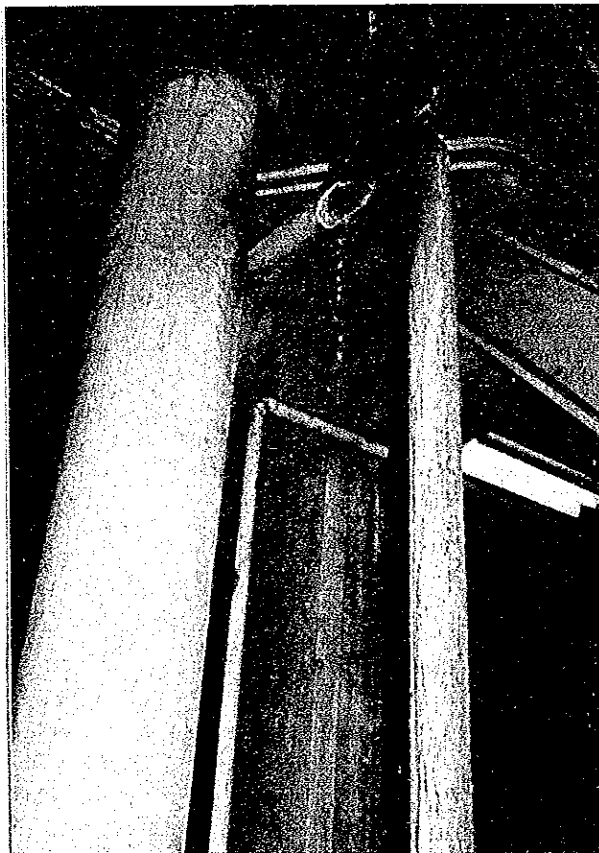
There are plenty  
of leaks not only  
steam but also  
water.

Water leaks  
attack and  
corrode equipment.

M-1 corroded water  
piping

Corroded water pipe

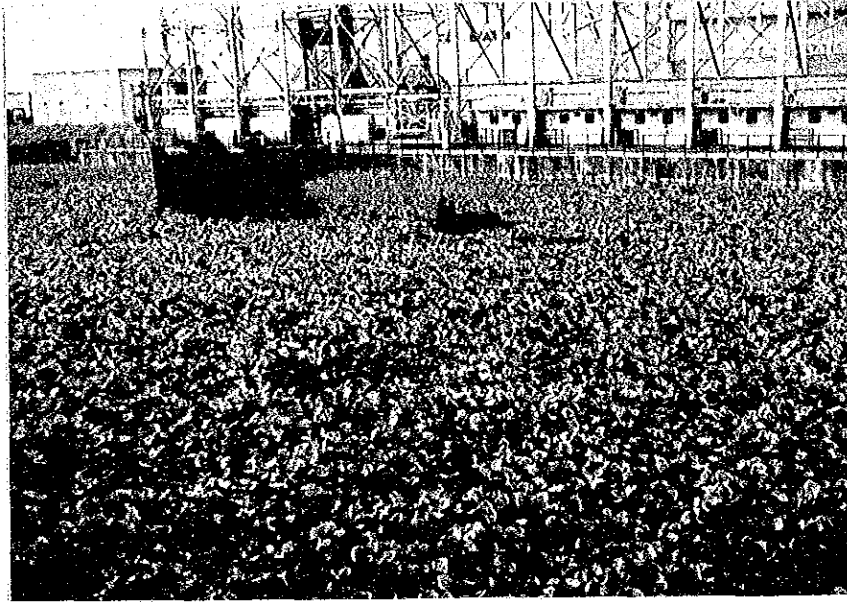
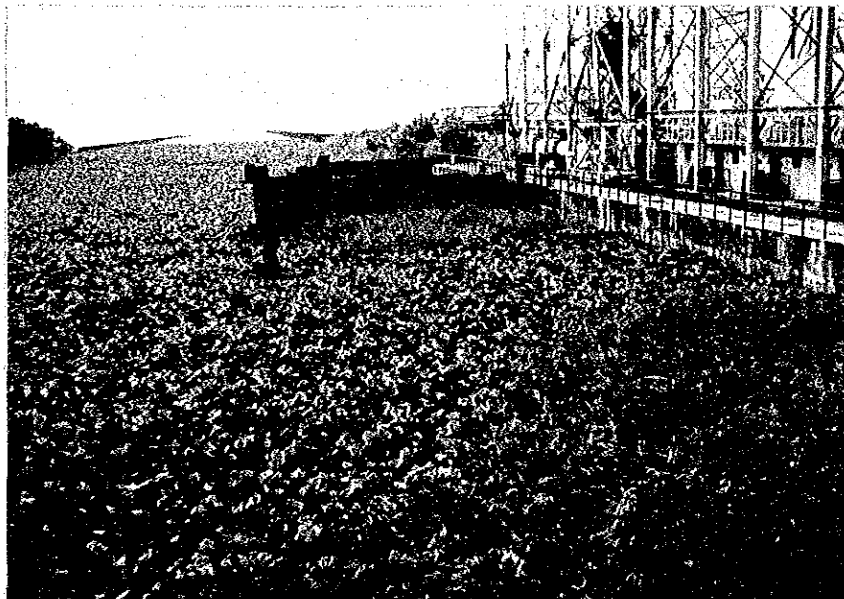
PH-43

Circulating water intake, needs removal of water lilies.

Water intake . There are plenty of water lilies

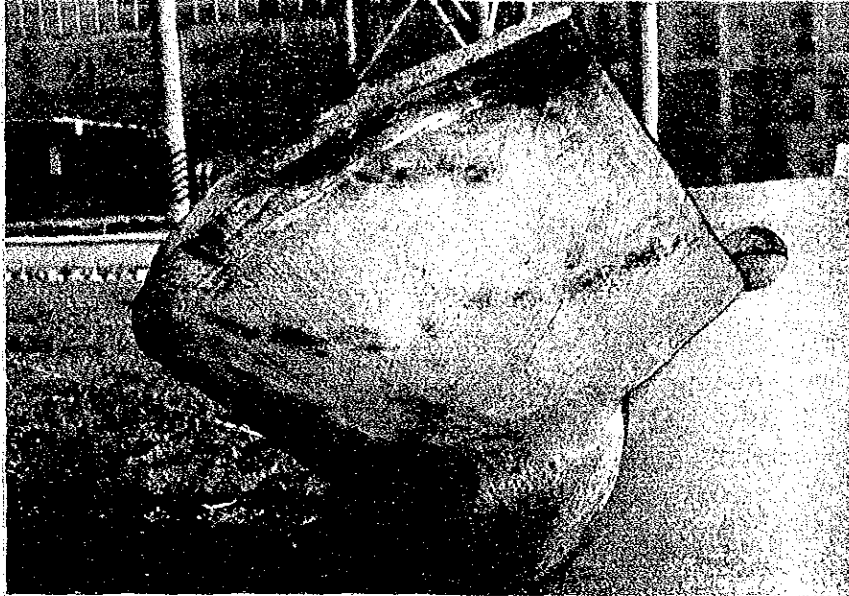
PH-44

M-2 2A-CWP impellar  
Stainless steel is corroded.

Enlarged view

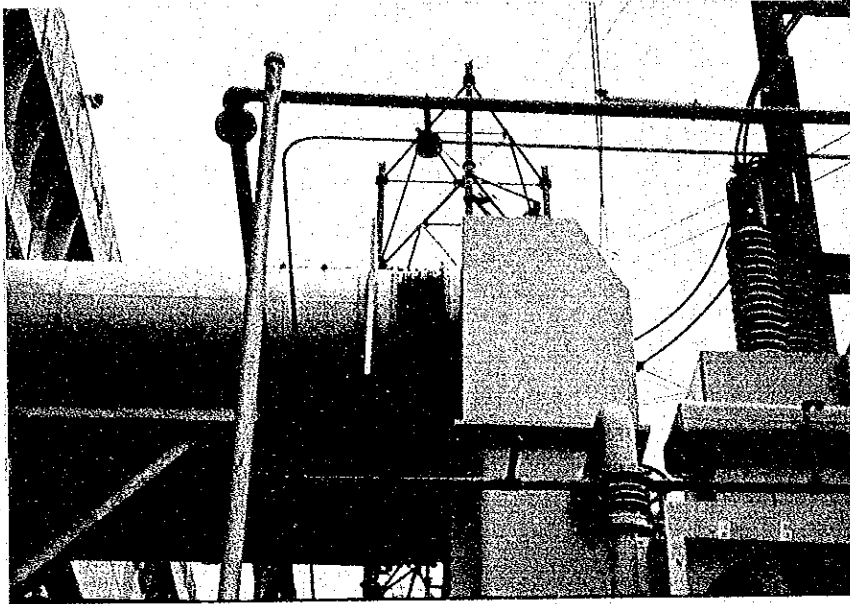
M-1

There is mis-alignment between the isolated phase bus and main transformer

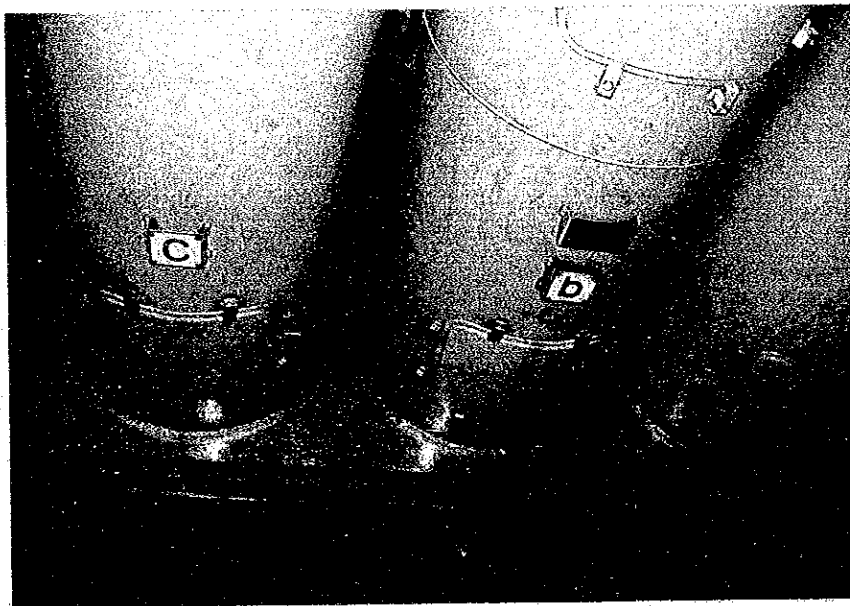
M-1

Oil leak is observed at generator bottom

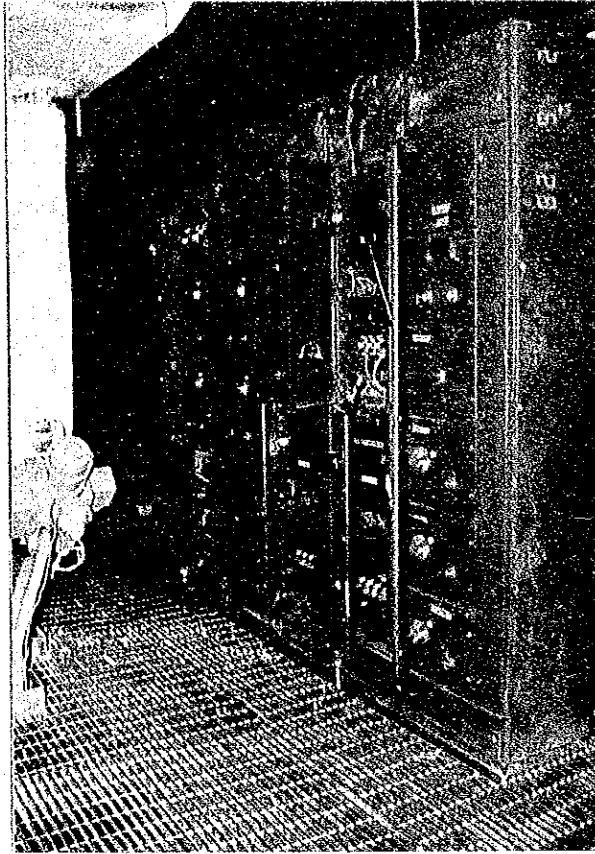
M-1

Dirty control  
center

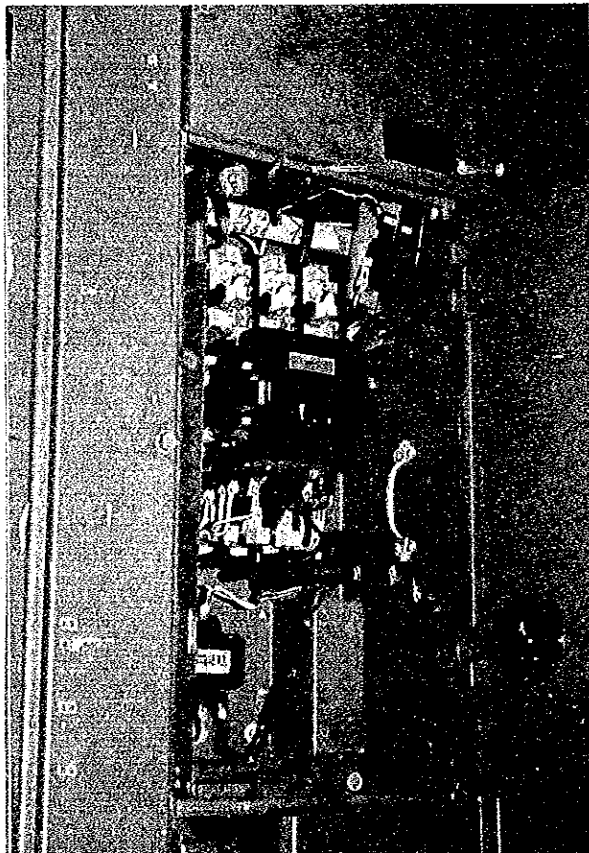
M-1

Parts have been removed.

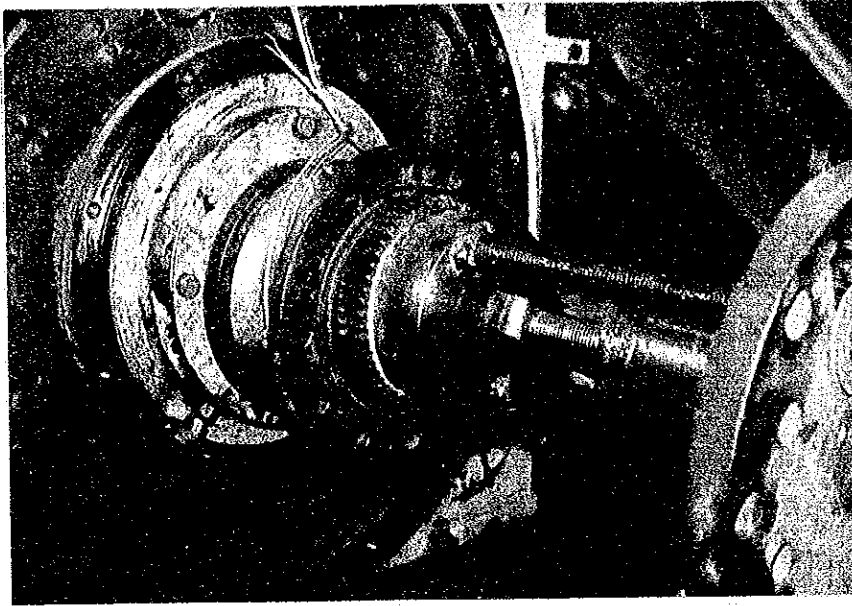
M-2

Drawing out of coupling gear using improper tools at T-BFP booster pump. Bolts are welded to the the coupling gear

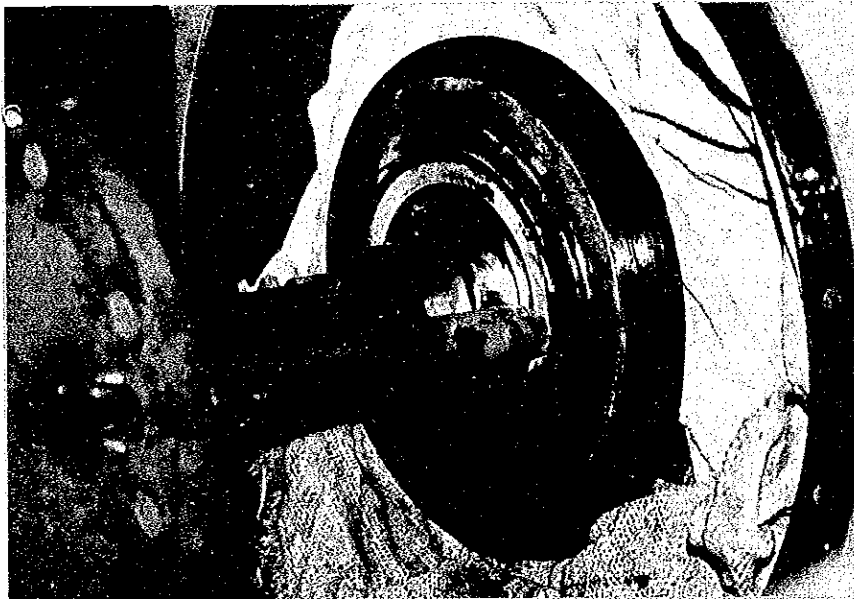
M-2

Drawing out of bearing inner race by improper tools

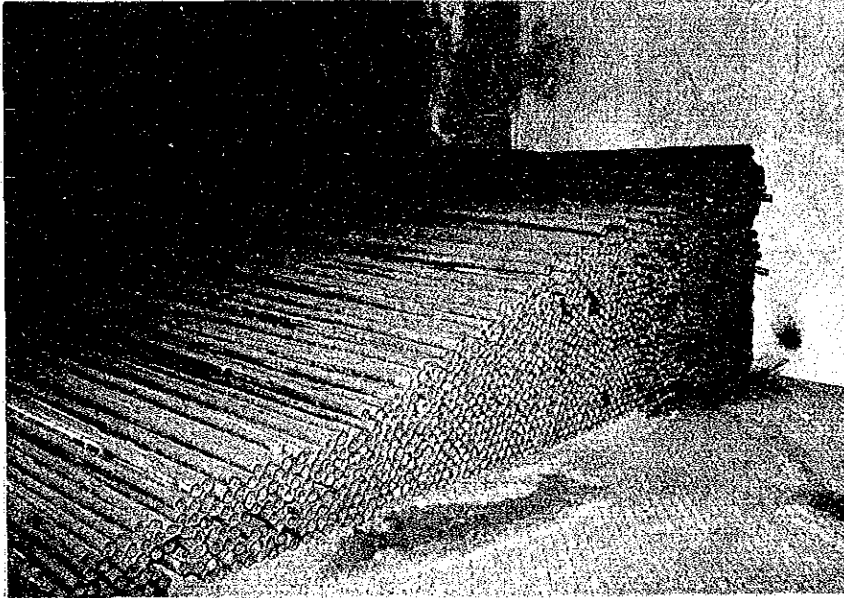
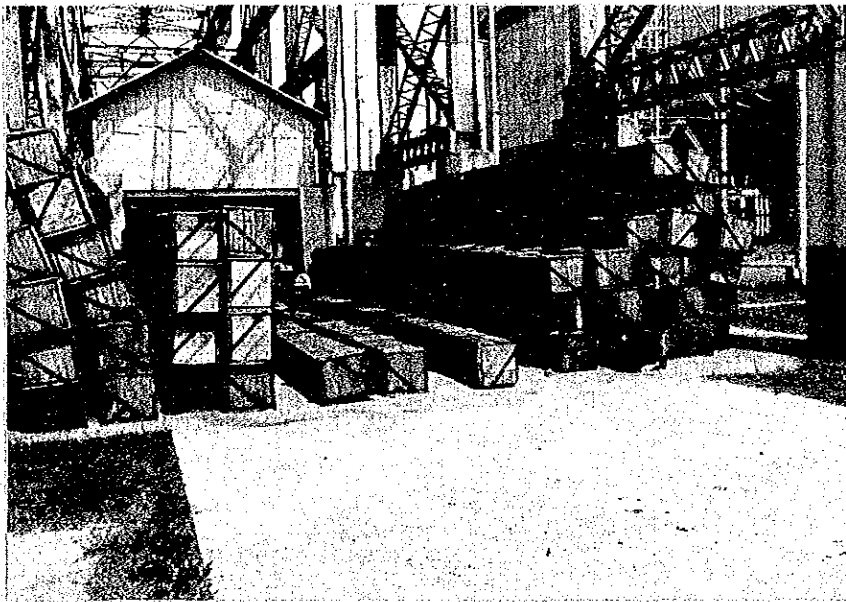
Poor management of spare parts is found such that new spares are left outside and turbine floor, and some of them are broken. Spare parts and materials are not properly arranged in the warehouse, unnecessary parts and equipments are being left behind.

M-2 Condenser Spare Tube

Intake Screen

M-2 spare condenser tube is left outside.

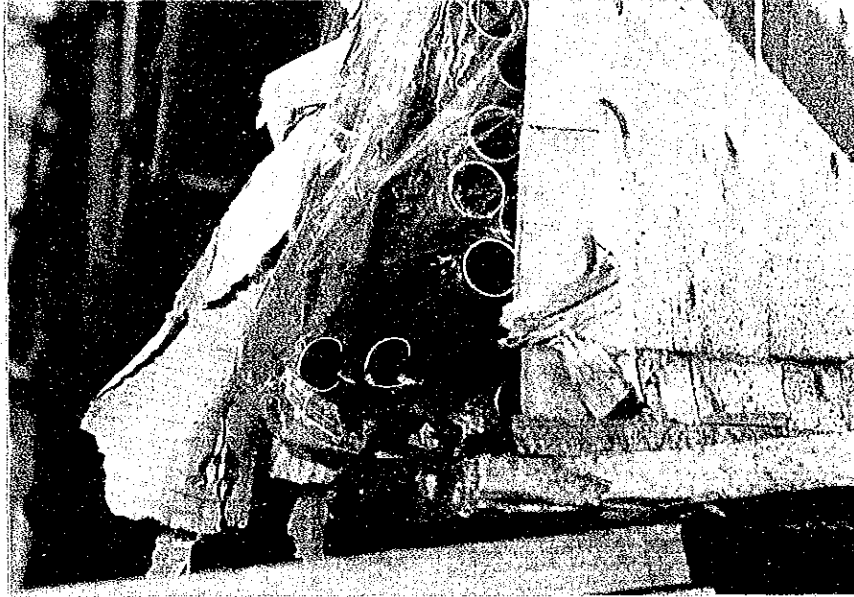
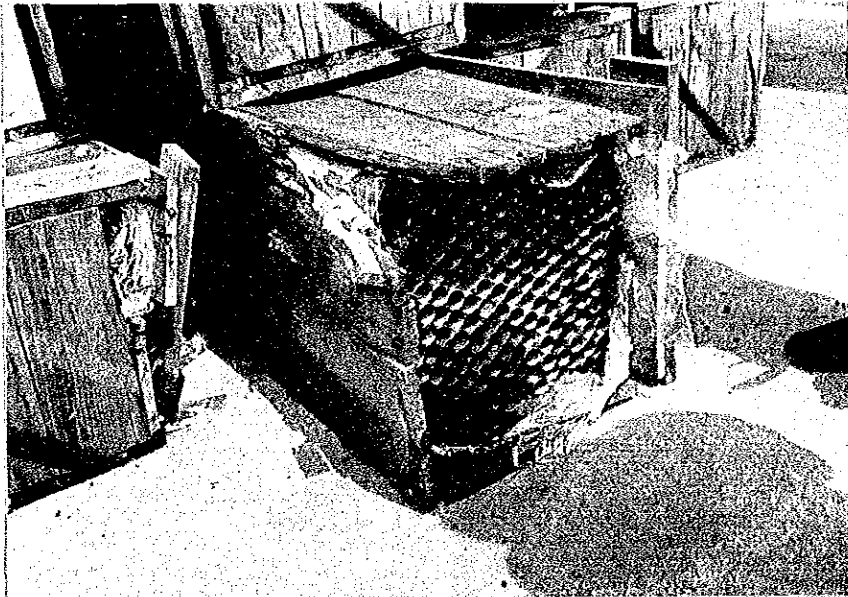
PH-49

M-2 condenser spare tube.

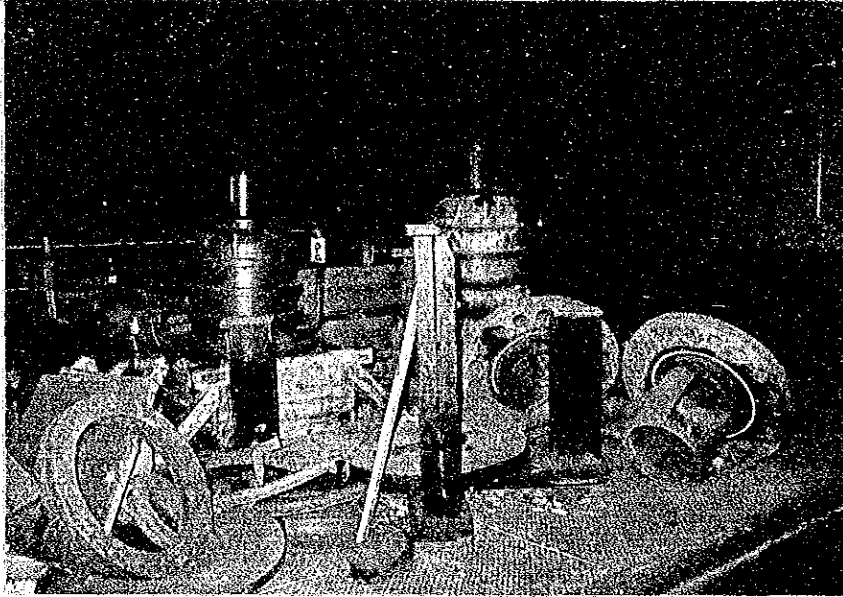
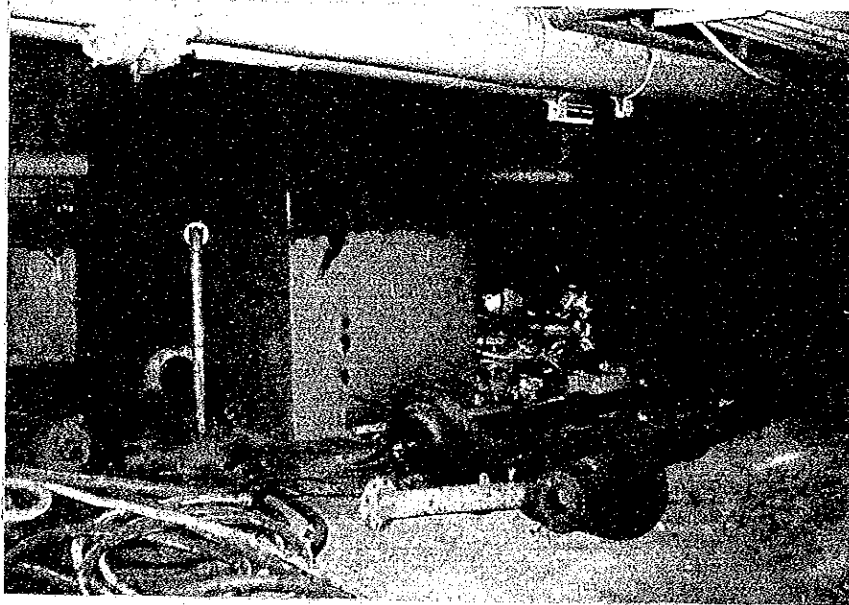
PH-50

Turbine floor is being used as warehouse.

Auxiliary equipment room in which unusefull parts are being left.

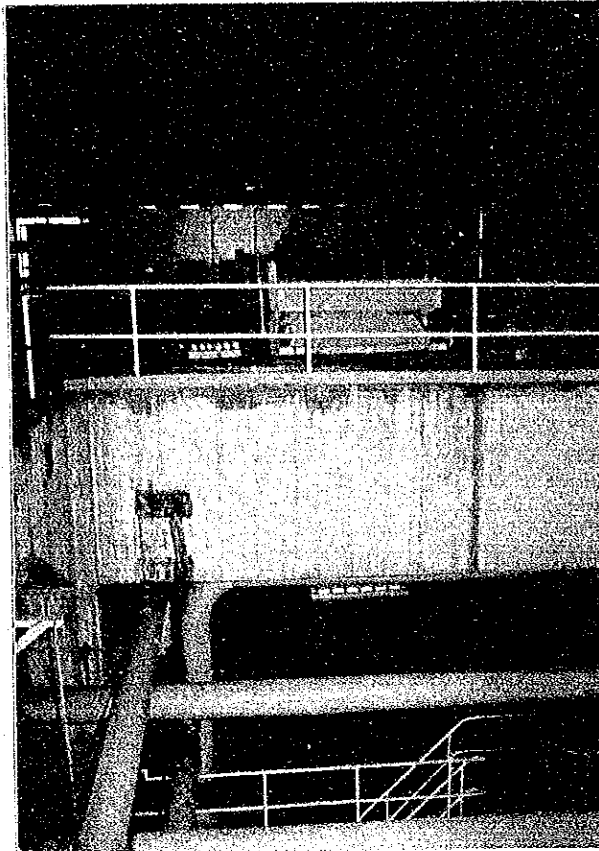
Upper floor

Turbine floor is partially sinking due to heavy spare equipment are stored. This is very dangerous condition.

Beneath the floor.

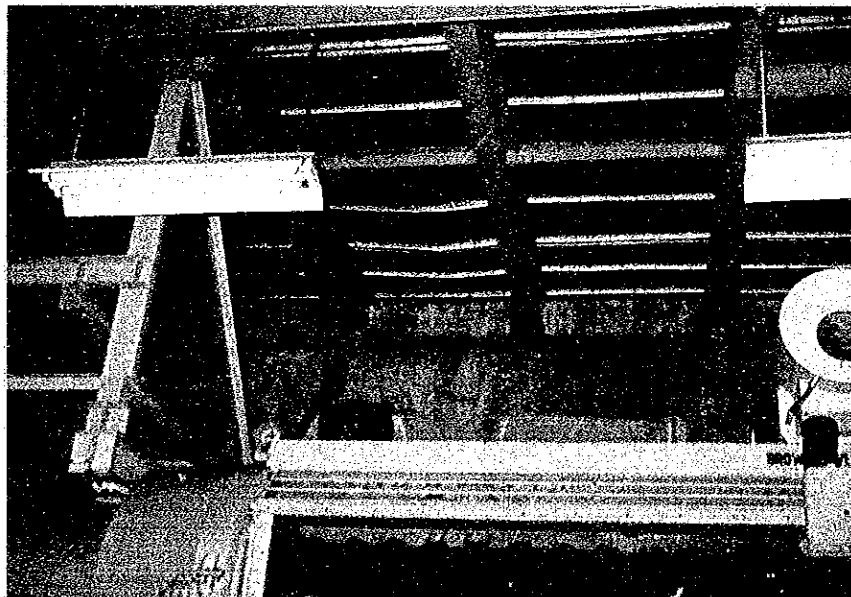
Above the isolated phase bus, floor is sinking.

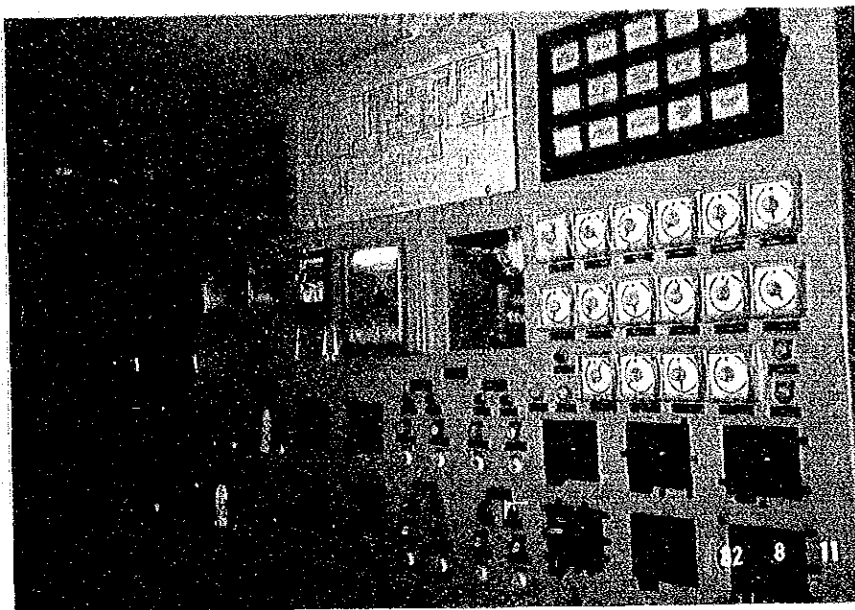
S-1 Ammonex Control Panel  
Not working

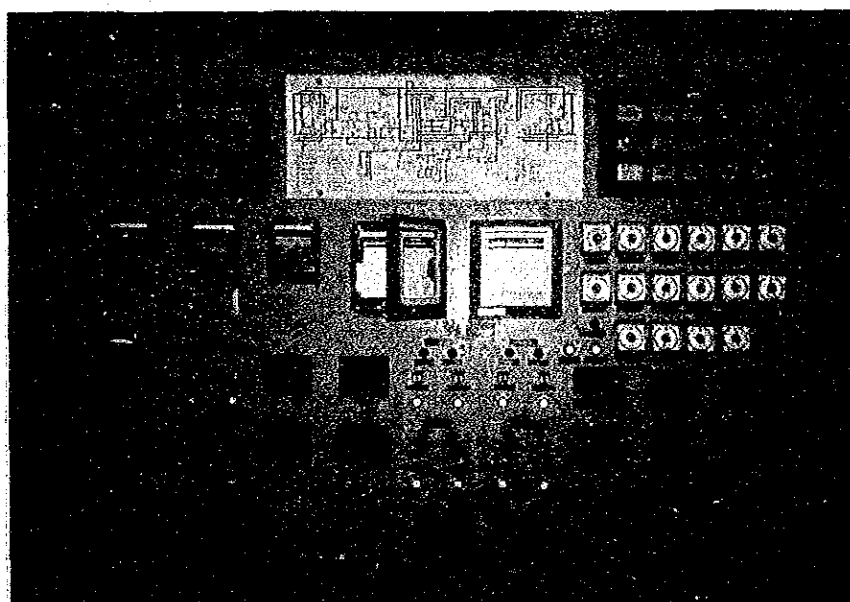
M-1 Ammonex Control Panel  
Not working
