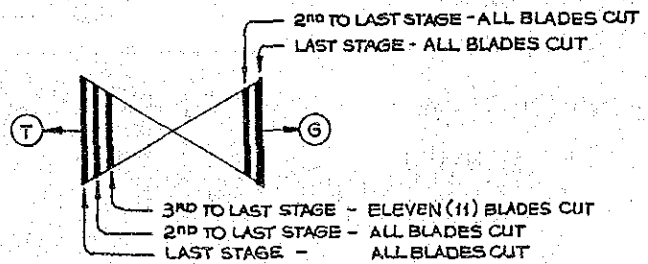
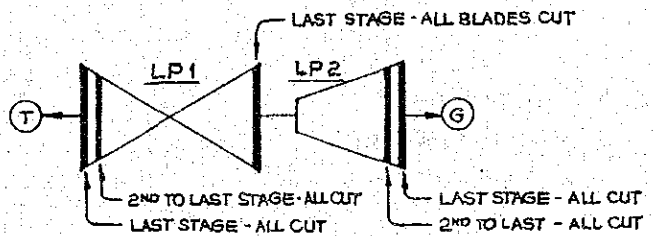
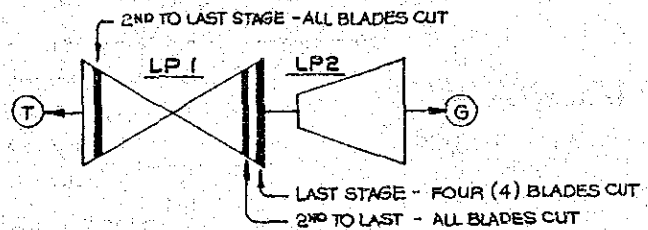
Fig. 2-1 PRESENT CONDITION OF LP TURBINE

- HP turbine blade failure. One (1) impulse blade missing while all other remaining blades were badly battered and deformed at the trailing edges. Replaced all blades of HP turbine in 1971.
- Thrust bearing failure. Bearing was replaced.
- Blade failures at LP last stage. Cut broken blades and corresponding opposite blades.
- Present Condition - A total of six (6) blades at LP last stage (turbine end) were cut.

- A series of blade failures occurred at the LP last stage on both turbine and generator sides. Cut the broken blades and their corresponding opposite blades.
- The existing X22CrMoV12 1 blade material of LP last stage was replaced by X20Cr13 with hardened edge in 1978.
- Again a series of blade failures occurred at the LP last and second to last stage plus damages to other turbine parts. Cause of blade failures were allegedly due to stress corrosion.
- Present Condition
 - LP last stage (turb. & gen. side) - all blades have cuts.
 - LP 2nd to last (turb. & gen. side) - all blades have cuts.
 - LP 3rd to last (turb. side) - ten (10) blades have cut and one (1) blade vacant.

During the 1981 overhauling, many blades with crack were found at the LP 1 and LP 2 last and second to last stages. Cut all blades at said portion.

For a period of eighteen days, the unit was shutdown seven (7) times due to turbine balancing. Later inspection revealed a broken blade at LP1 last stage (gen. side) and

four(4) broken bellows at the expansion joints in the cross over pipe to LP2. Cut broken blades and replaced damaged bellows with new ones.

- i. It is necessary for NAPOCOR to obtain some data from the manufacturer regarding the damage on the last stage blades and its adjacent blade stages. For instance, dehardening method of the blades, effect of its dehardening, etc. Furthermore, these data must be made available to the maintenance personnel.

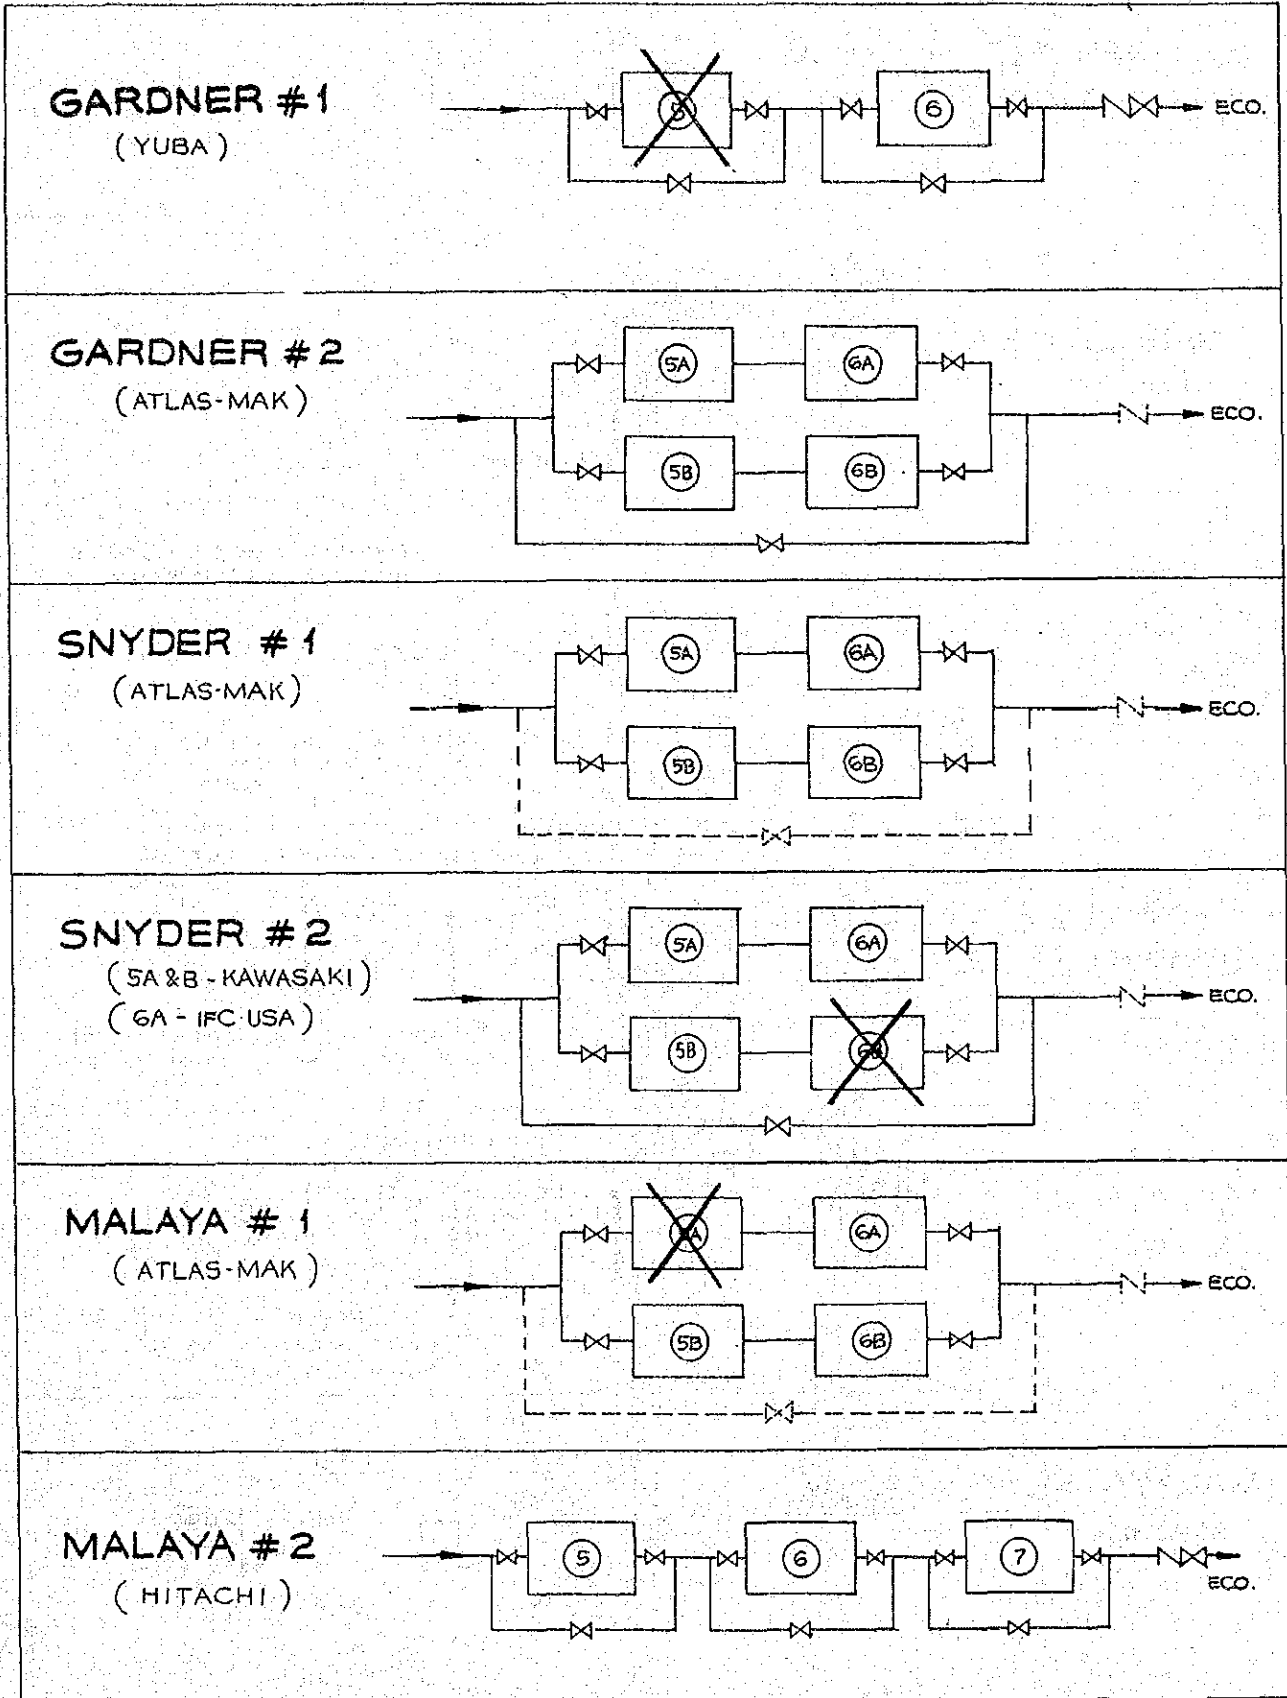
Fig. 2-2 PRESENT CONDITION OF HP HEATERS

HP Heater #6B replaced by straight pipe.

M - 1 High percentage of tube leaks at HP heater #5A and #5B. HP heater #5A is isolated. Install a new heat exchanger.

M - 2 Frequent failure of main condenser tubes (SUS). Many tubes of 2A heat exchanger are plugged.
