Fire fighting alarm in Gardner/Snyder Thermal Power Station is centralized at S-1 & S-2 central control room, however, almost all the alarm are defective.

i. Existing Condition of M-1 Boiler

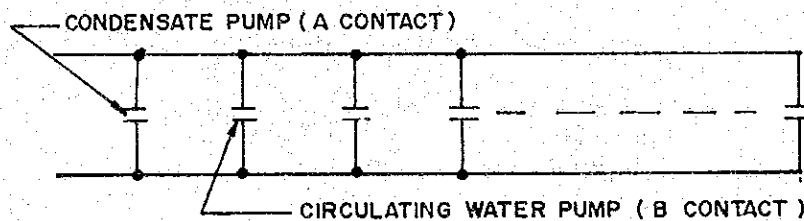
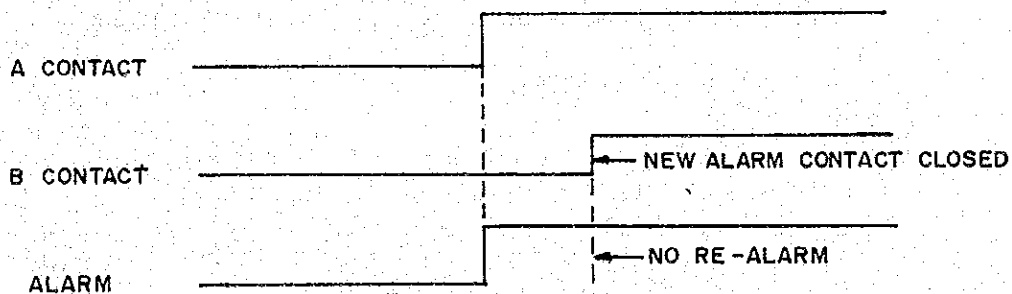
Fig. 5E-22 MULTI-POINTS ALARM

Present alarm system for multi-points is unadequate because the system does not re-alarm repeatedly when another alarm contact is closed.

In this alarm system, operators can not acknowledge new trouble at all.

Re-alarm system should be applied to alarm having parallel contacts to let operators acknowledge new trouble occurrence immediately.

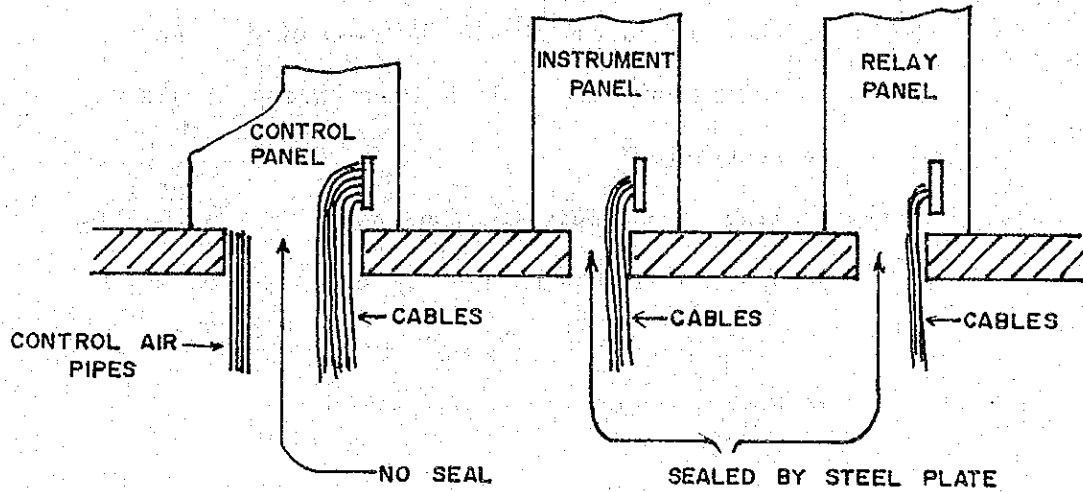
Fig. 5E-23 CENTRAL CONTROL ROOM PANELS

On the other hand, under the central control room and cubicle room and floor access of central control panel and relay panel in S-1 and S-2 are opened. Therefore, central control room temperature is very high because the rooms allow hot dust and soot to enter freely into the room and because two package type air conditioners installed in the room are frequently defective. Result of room temperature measurements are as follows:

However, there still exists important problem. It is urgently required to prevent hot gas and dust, having bad influence upon the health of operators and instrument devices, and entering into the room.

To improve the central control room for S-1 and S-2 units in same condition as that of G-1 and G-2 units, following measures are recommended:

In addition to the additional installation of airconditioners, fan and fresh air duct should be newly installed to introduce fresh air from outside of the boiler area because the air conditioner allows the same air recirculation in the room.

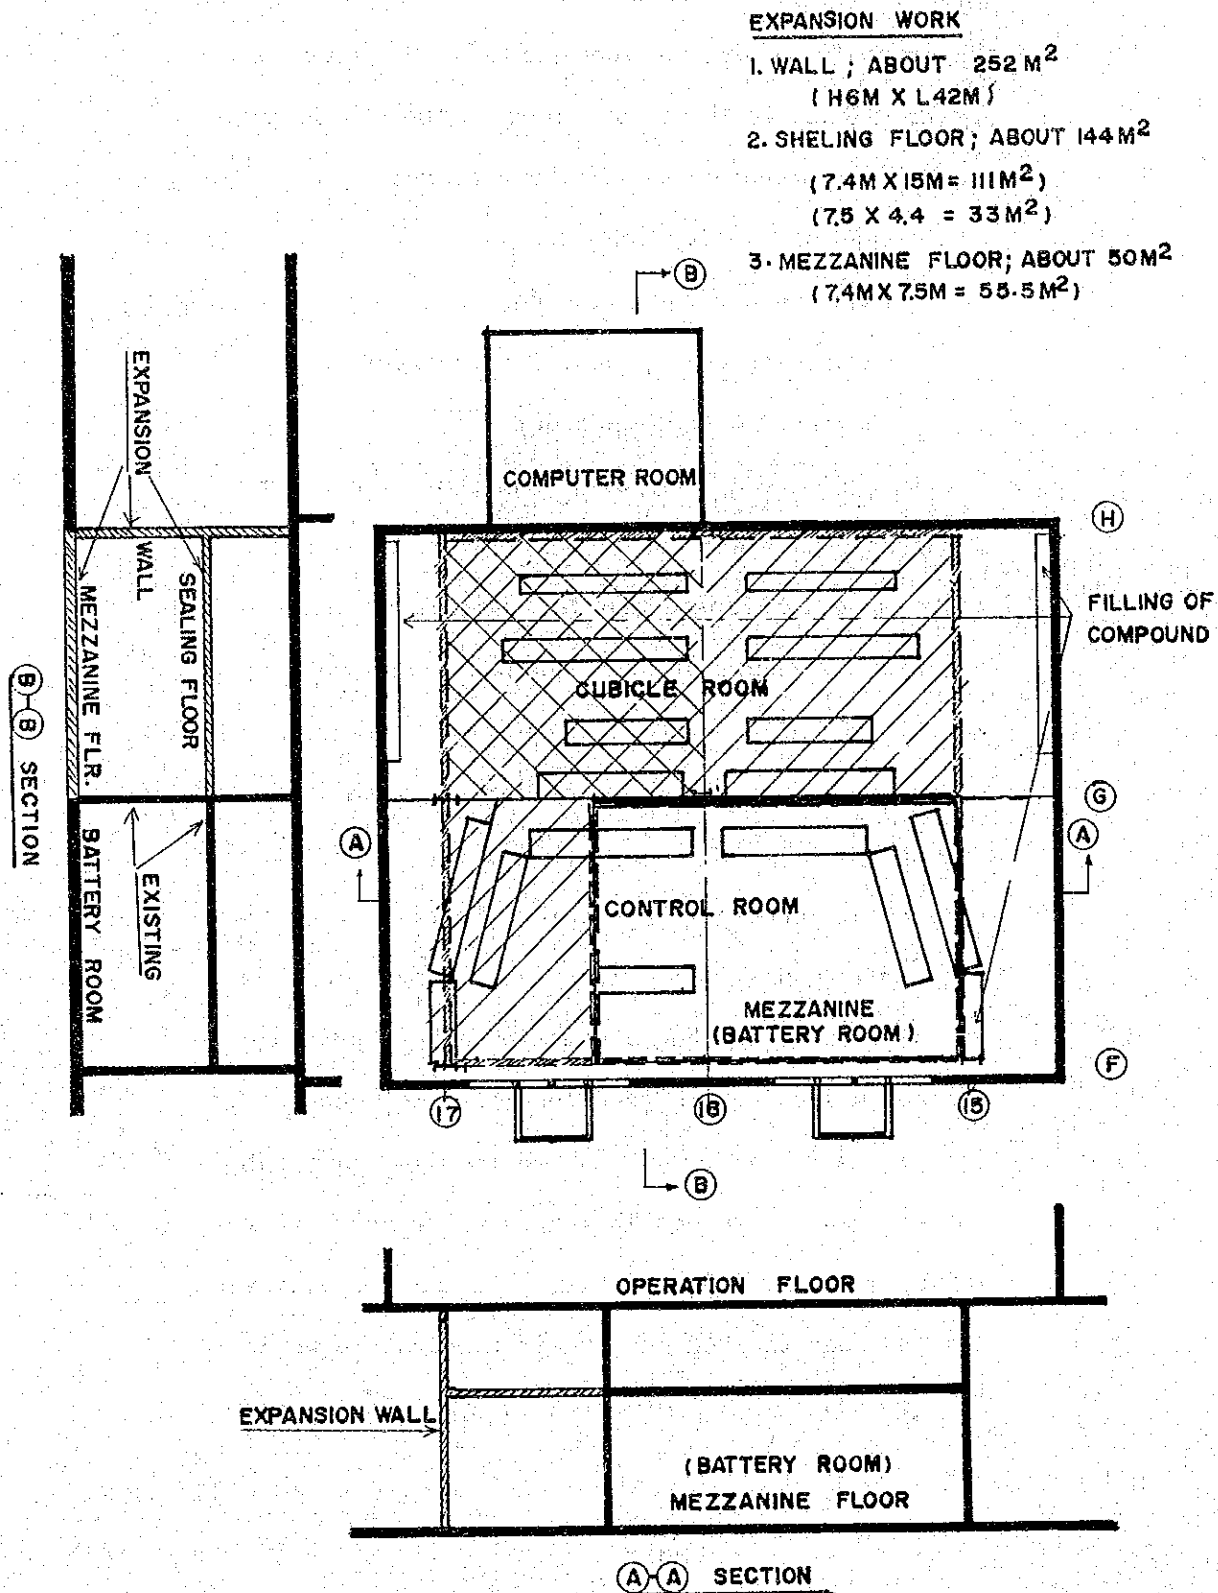
Fig. 5E-24 SEALING PLAN OF CABLE HOLE IN
S-1, S-2 CONTROL ROOM

Sealing of openings only by steel plate is incomplete, and so the gap should be filled up with a compound easily treated.

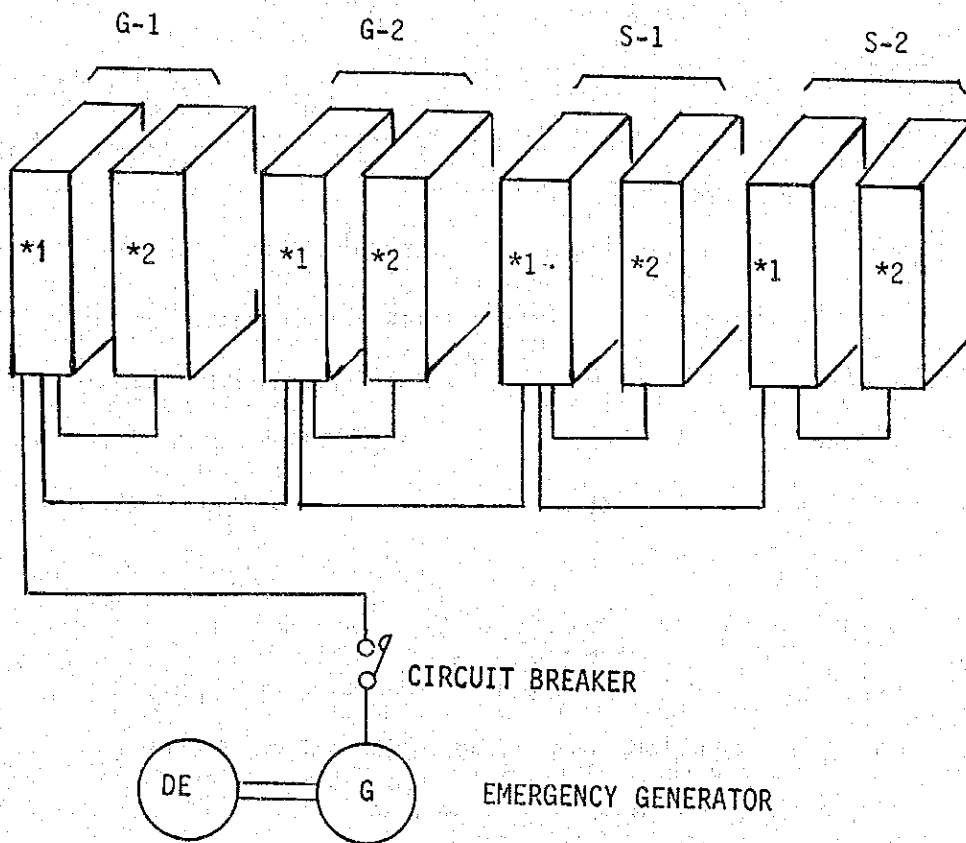
In the event of emergency like black-out of power plant, when the auxiliary power source transferred to emergency transformer successfully, there arises no problem. But taking unsuccessful automatic bus transfer into consideration, emergency control center units should be additionally installed near the existing control centers and stable auxiliary power should be supplied from the unit to each equipment for the purpose of safe plant shutdown. Refer to the following sketch.

*1 shows additional emergency control centers

*2 shows the existing control centers

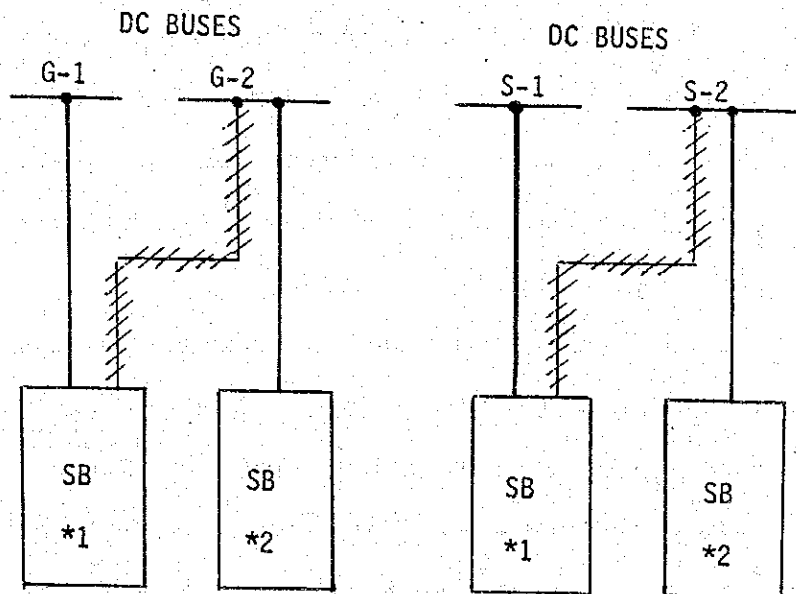
Fig. 5E-26 STATION BATTERY SYSTEM

Two station battery systems are provided for G-1 & G-2 and S-1 & S-2 units each in 1967 and in 1970 respectively. As it had passed about 15 years since installation of battery system for G-1 & G-2, battery casing cracks and flaking of electrodes are noted. Therefore, the defective existing batteries should be replaced with new ones.

In addition to the above, station battery system should be unitized for each generating unit as follows:

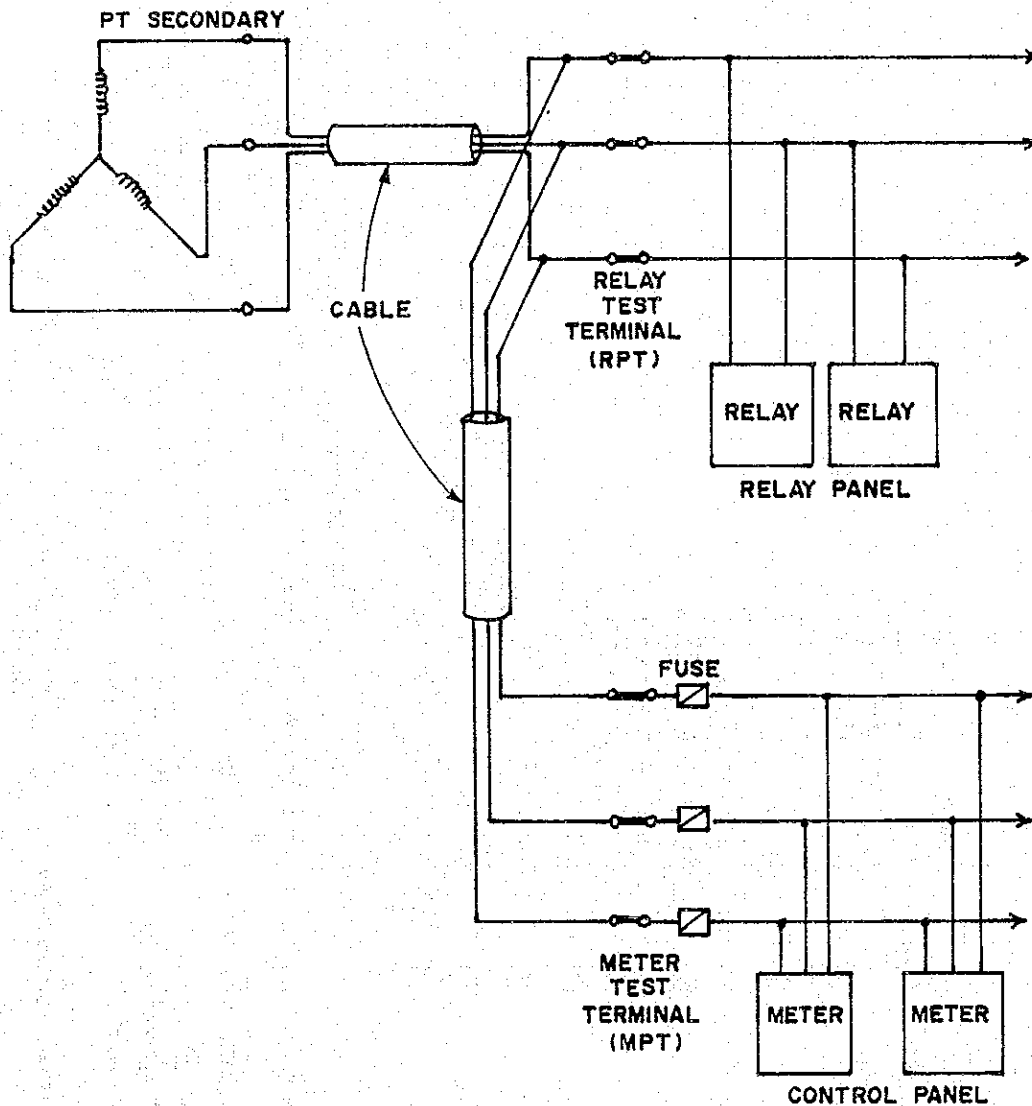
Fig. 5E-29 PT SECONDARY CIRCUIT CONNECTION

In the existing PT secondary connection only one circuit for protective relays and metering instrument is commonly used. Connection of PT secondary for protective relays and metering is recommendable to be divided into two circuits as follows:

- * Inspection, repair and re-adjustment of meters can be carried out only by removal of MPT keeping protective relays placed into service under normal operation.
- * In the event of short circuit accident in metering circuit, malfunction of protection relays such as under voltage relays and distance relays can be avoided.

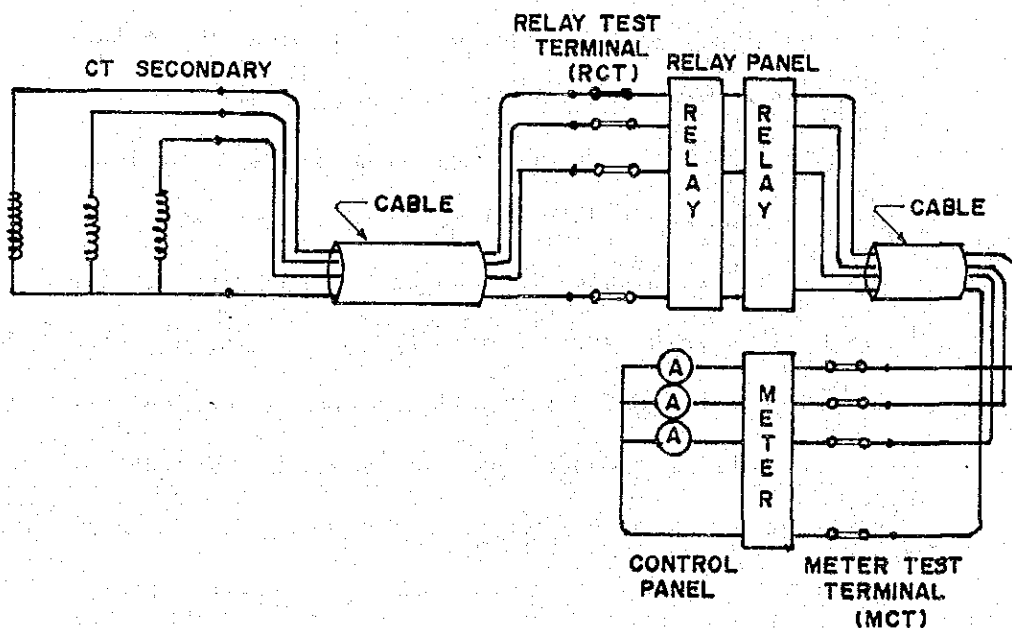
Fig. 5E-30 CT SECONDARY CIRCUIT CONNECTION

It is in principle desirable to install two CTs for meters and protection relays, respectively. However, in case of one CT, following circuit should be considered for easy maintenance and safe plant operation.

- * Inspection, repair and readjustment of meters can be carried out only by short-circuit of MCT keeping protection relays placed into service under normal operation.
- * In the event of short-circuit accident in metering circuit, malfunction of protection relays (differential percentage relays) can be avoided.

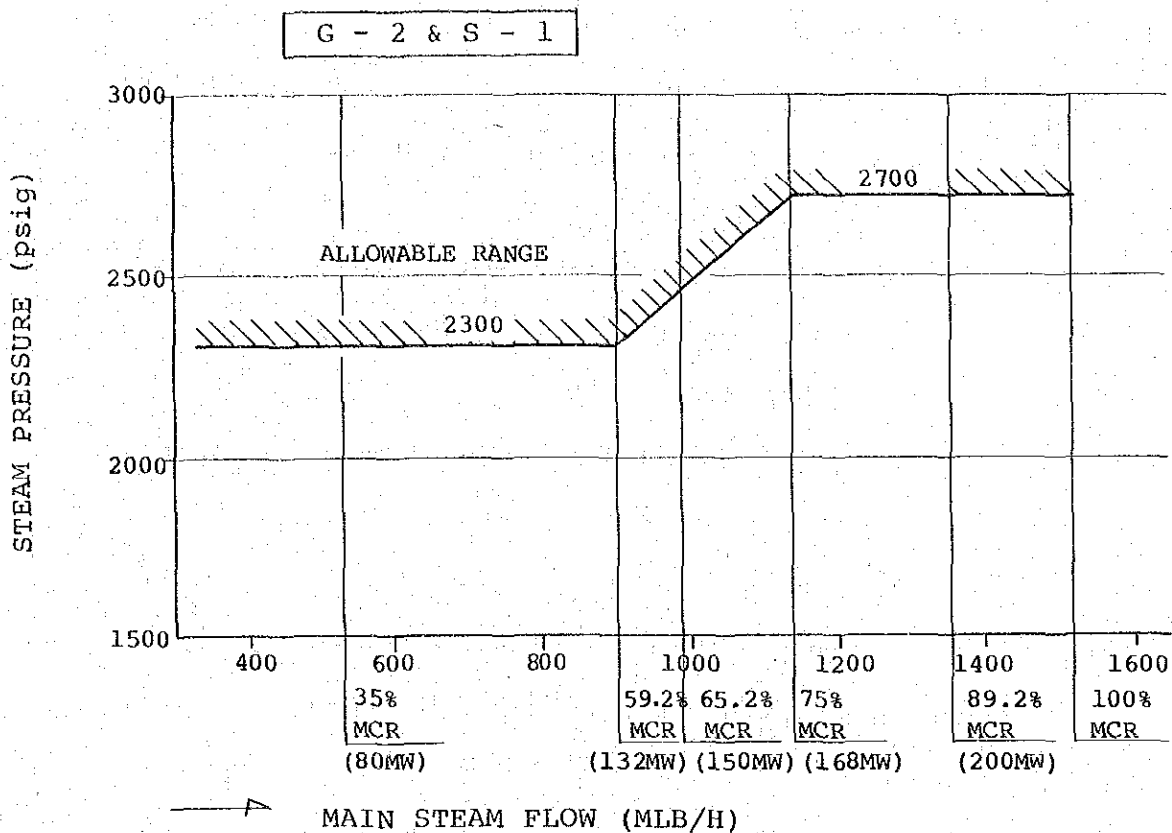
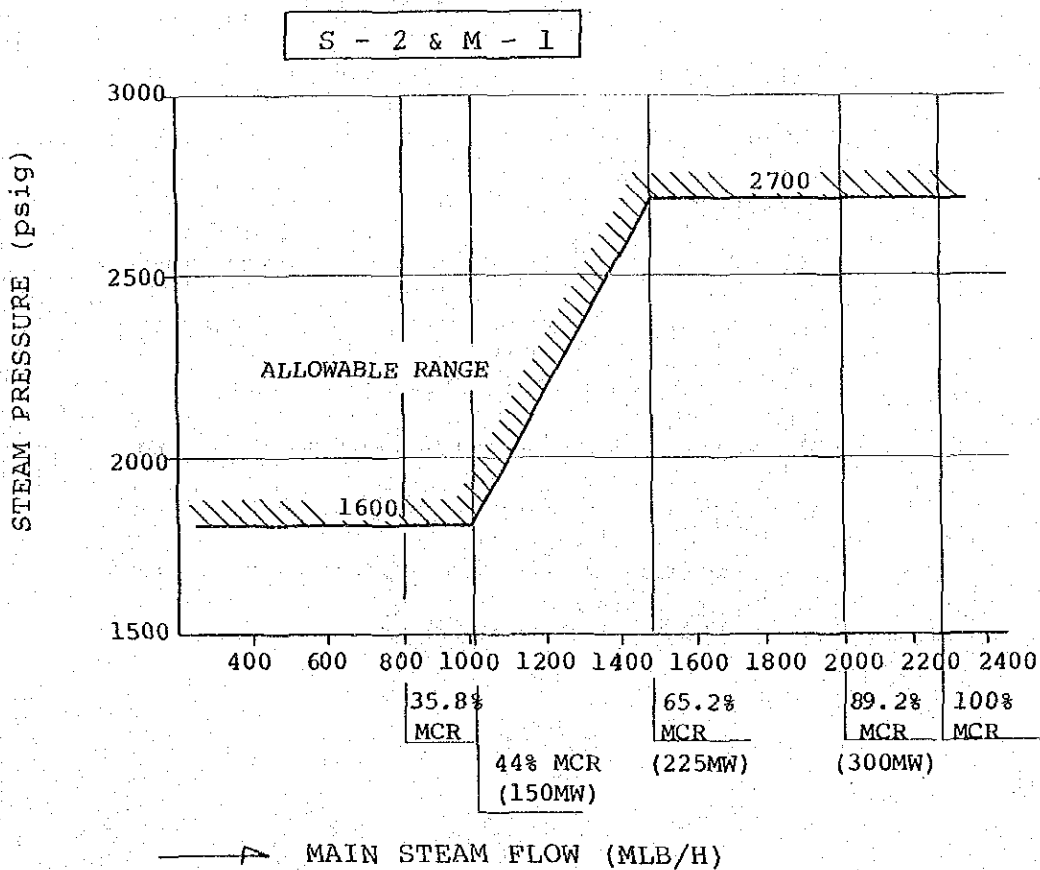
Fig. 5M-23 VARIABLE PRESSURE OPERATION

For once-through boiler, NAPOCOR should be extra careful for the flow of fluid in the boiler tubes. According to the manufacturer's report on variable pressure operation, correlation between boiler pressure and steam flow is very important. If NAPOCOR carries out a careless operation under a variable pressure operation, the boiler will suffer a serious damage.

In the case of M-1 is on variable pressure operation at 2100 psig and a maximum load of 240 MW. Under this pressure the maximum load must be kept less than 175 MW in accordance with the manufacturers recommendation.

Therefore, JICA team would like to recommend for NAPOCOR to strictly carry out and follow the recommendations for variable pressure operation by the manufacturer.

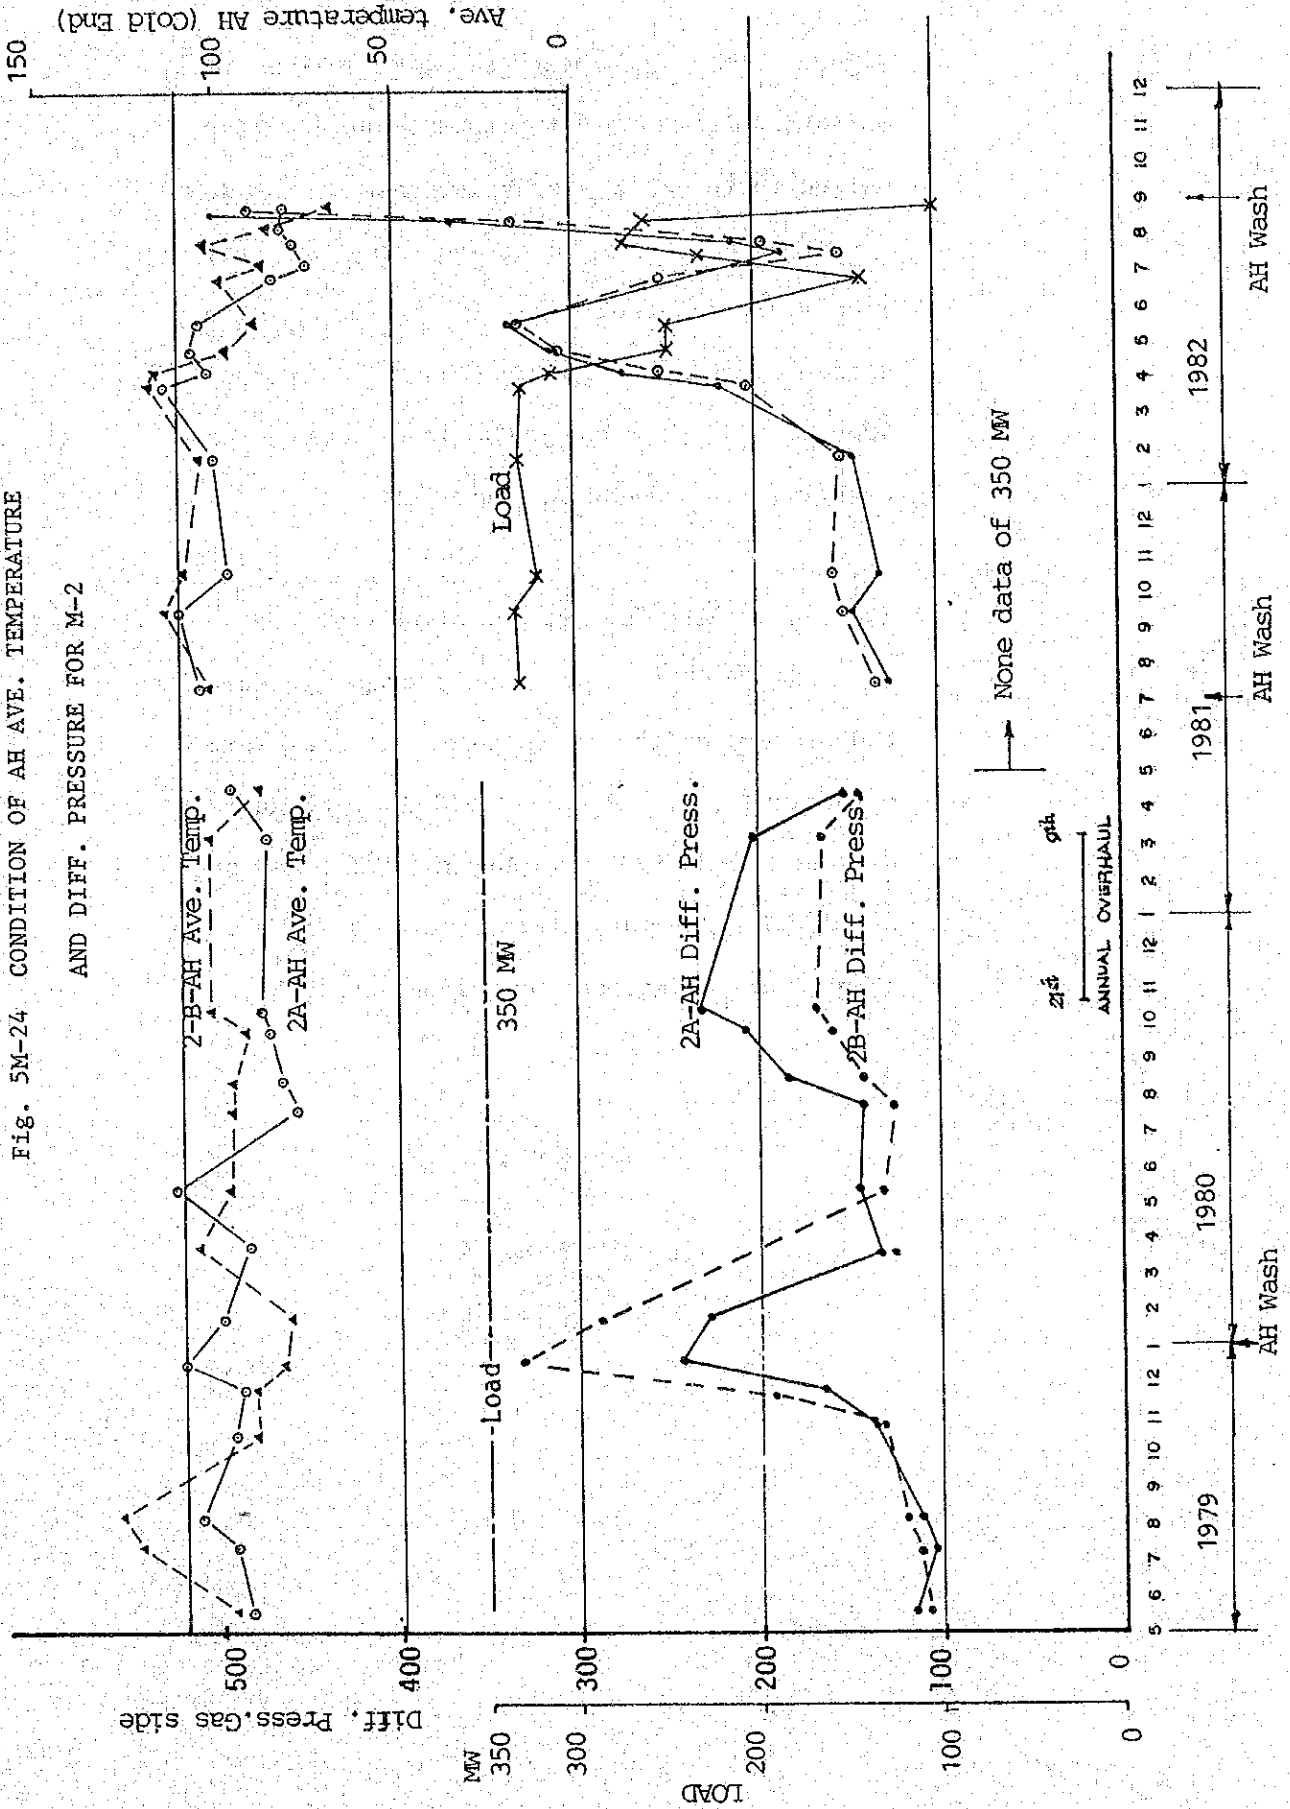
Fig. 5M-24 CONDITION OF AH AVE. TEMPERATURE AND DIFF. PRESSURE FOR M-2

M1 and M2 has a very big air preheater corrosion problem. Most especially M-2 which is in a very critical condition as shown in Fig. 5M-24.

The period where the average gas-air temperature of the AH cold-end elements were maintained to more than 110°C is very short between May 1979 to August 1982. Most especially 2A-side which operated at low temperature condition for a long period.

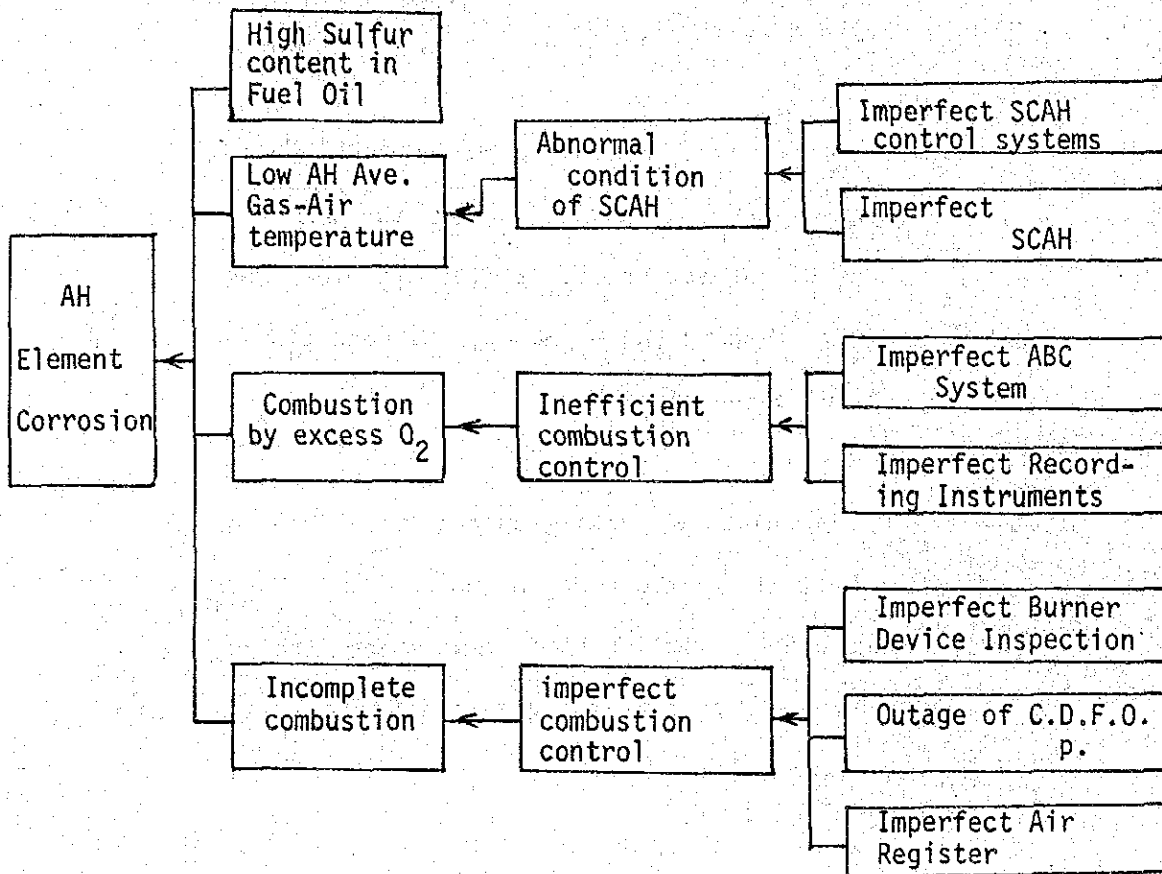
Fig. 5M-25 CAUSE OF AH CORROSION

For Malay-2 the process of AH element corrosion is shown as follows:

(i) To perfectly clean the burners on a routine basis and to provide ample data as to the diameter and thickness of the sprayer plates. This way, all worn-out parts could be replaced with a new set.

(ii) To repair the automatic combustion control system to be able to operate the air flow control automatically. Boiler operators must always observe the O_2 meter, the condition of burner combustion, etc.

(iii) To immediately repair/replace the CDFOP of M-2. If combustion without the CDFOP continues, the boiler equipment (boiler tubes, air preheaters, gas ducts, etc.) will receive a death blow.

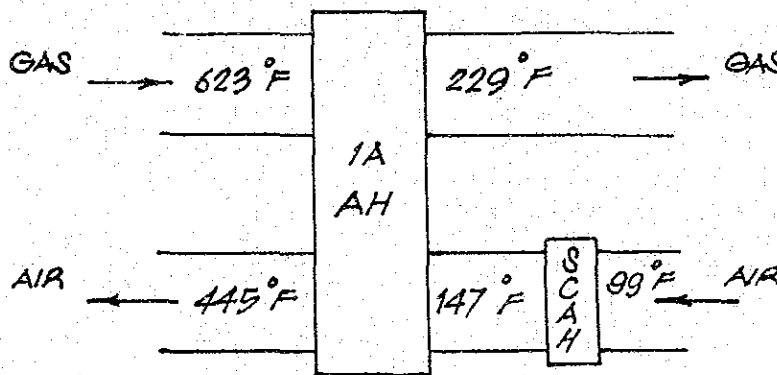
Fig. 5M-26 AIR AND GAS TEMPERATURE OF M-1

$$\text{Gas-Air Average Temperature} = \frac{229 + 147}{2} = 188^{\circ}\text{F}$$

The AH cold-end elements need an average Gas-Air temperature of more than 240°F to prevent sulfur corrosion attack.

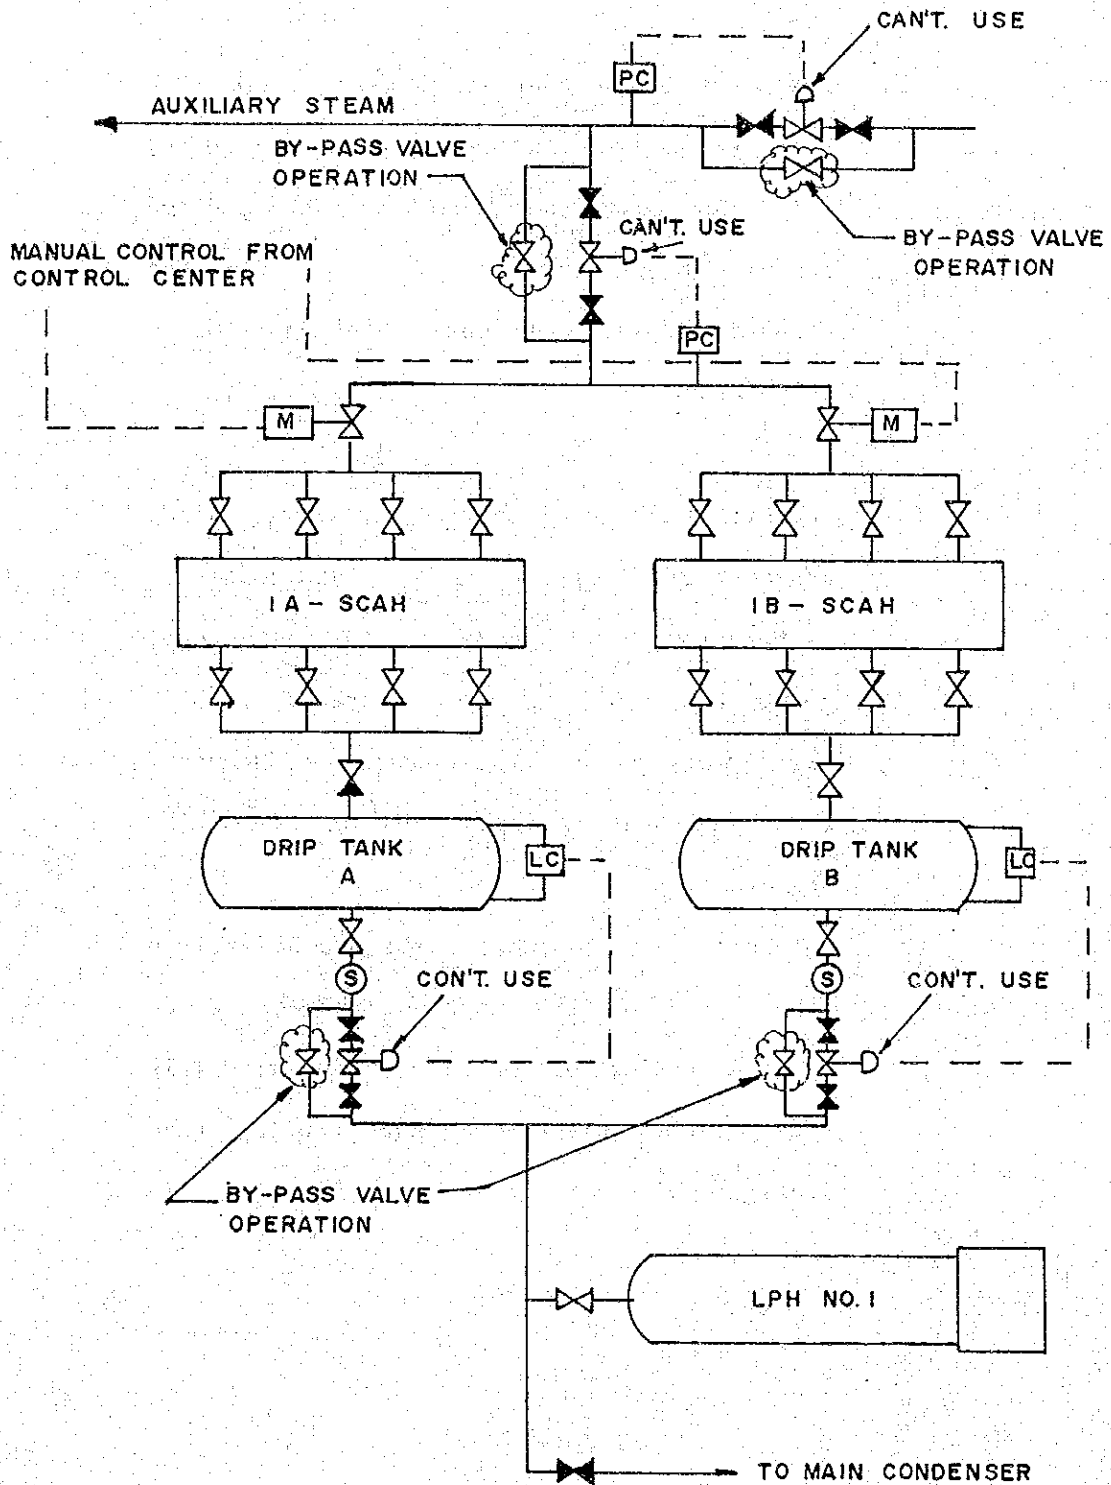
Fig. 5M-27 EXISTING M-1 SCAH OPERATION

- (i) Two pressure control valves, of the auxiliary steam supply to SCAH, are both isolated from the system. Hence, the auxiliary steam supply pressure is not controlled automatically.

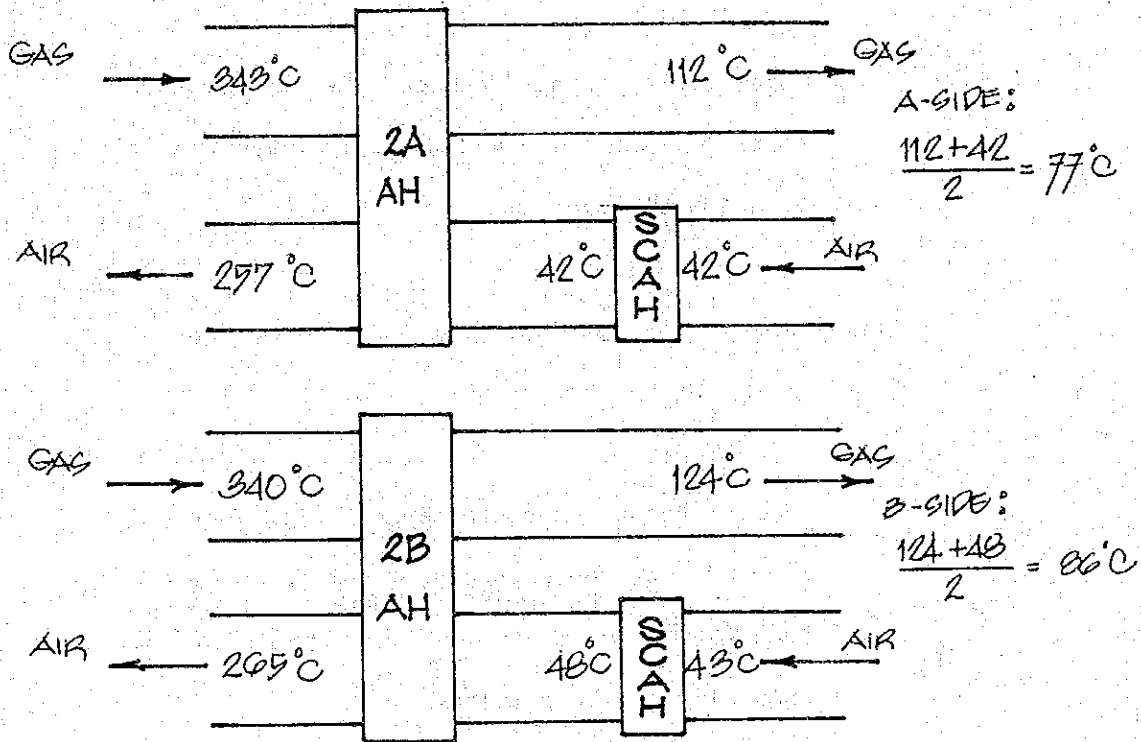
Fig. 5M-28 AIR AND GAS TEMPERATURE OF M-2

The AH cold-end elements, need an average gas-air temperature of more than 110°C to prevent sulfur corrosion attack. To clarify the description, an example is given on the existing state of the SCAH of M-2. The present operation of M-2 SCAH is shown on the figure:

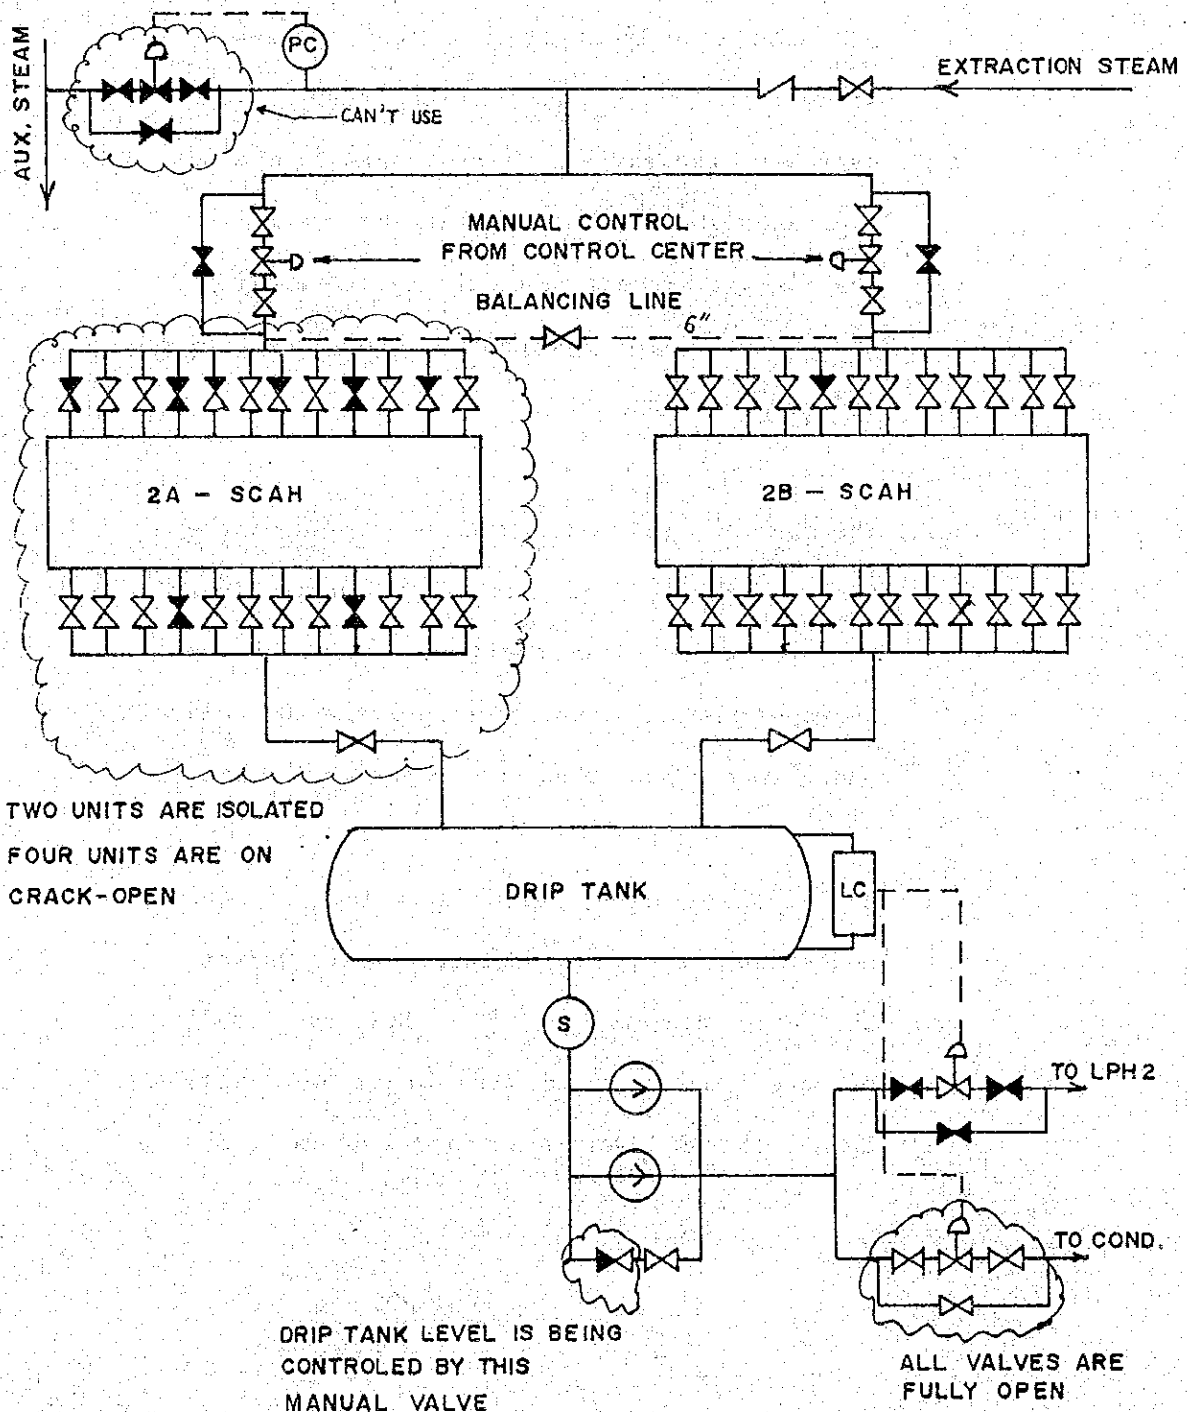
Fig. 5M-29 EXISTING M-2 SCAH OPERATION

(i) The SCAH of M-2 has two heating sources. One is from the extraction steam (from turbine) and the other is from the auxiliary steam (boiler). However, the auxiliary steam line is isolated due to its defective pressure control system. Hence, the heating source of M-2 SCAH is only supplied by the extraction steam from the turbine. If the turbine load decrease, the extraction steam pressure also decreases and without the back-up steam from the auxiliary steam line, the steam supply to the SCAH also decreases, reducing the efficiency of the SCAH.

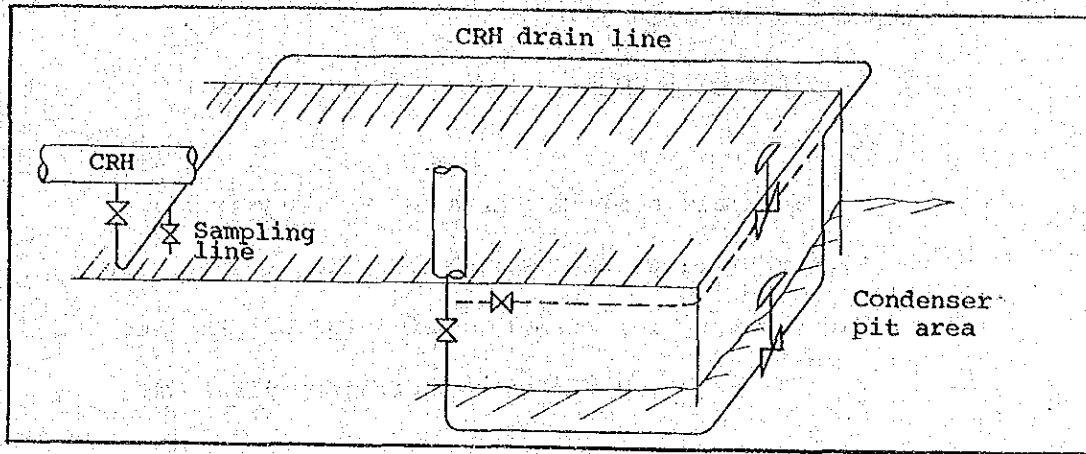
Fig. 5M-31 CRH DRAIN LINE

This proposal will eliminate corrosion of the CRH drain line with contaminated water in the condenser gets too high.

- (i) To replace chlorine detector system with new one. (M-2)
- (ii) To always keep the condenser pit clean (M-1 & M-2)
- (iii) To carry out routine preventive maintenance for condenser sump pumps. (M-1 & M-2)
- (iv) To install chloride detector system on M-1 hotwell tank.
- (v) To improve the condition of the CRH drain line by adopting the following; (M-1)

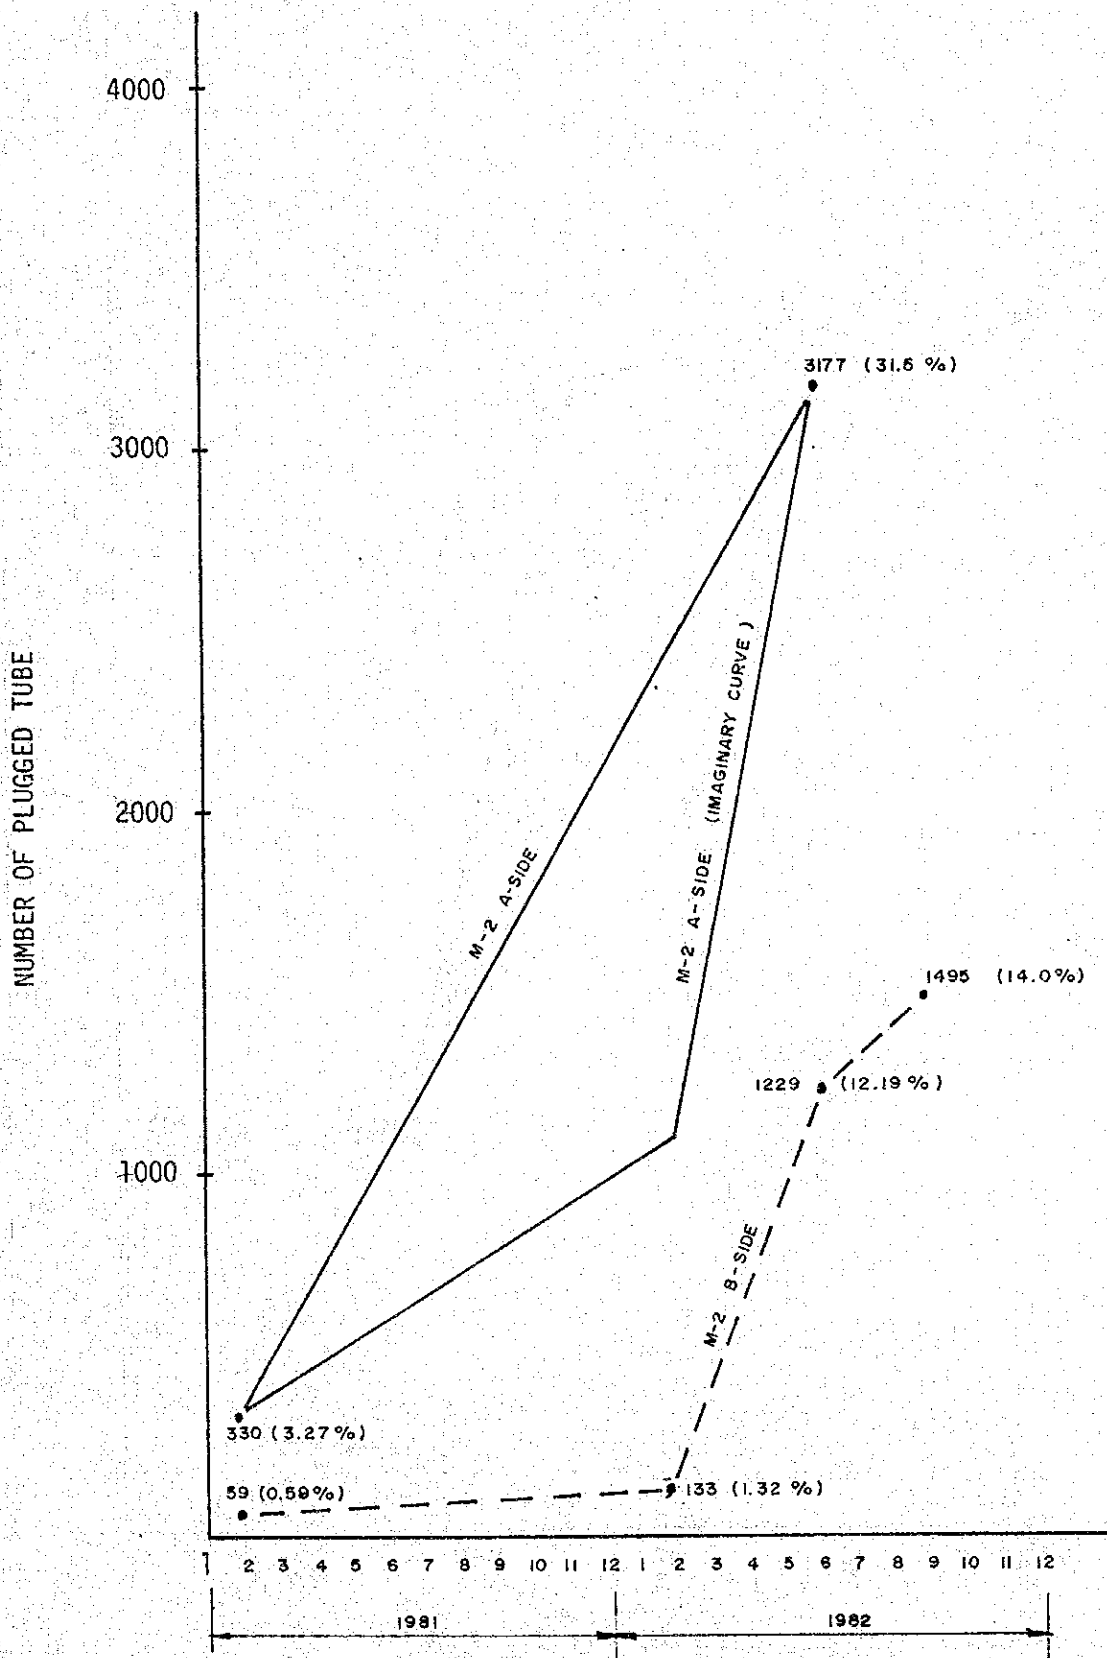
Fig. 5M-33 CONDITION OF CONDENSER TUBES FOR M-2

(iii) The rate of plugged tubes on the B side has abruptly increased between February and June, 1982. This means that M-2 has an alarming condition now.

We will presume that M-2 will encounter a big problem in the near future due to condenser tube leakage as shown in Figure 5M-33. To this problem, NAPOCOR planned to re-tube all condenser tubes to aluminum alloy tubes.

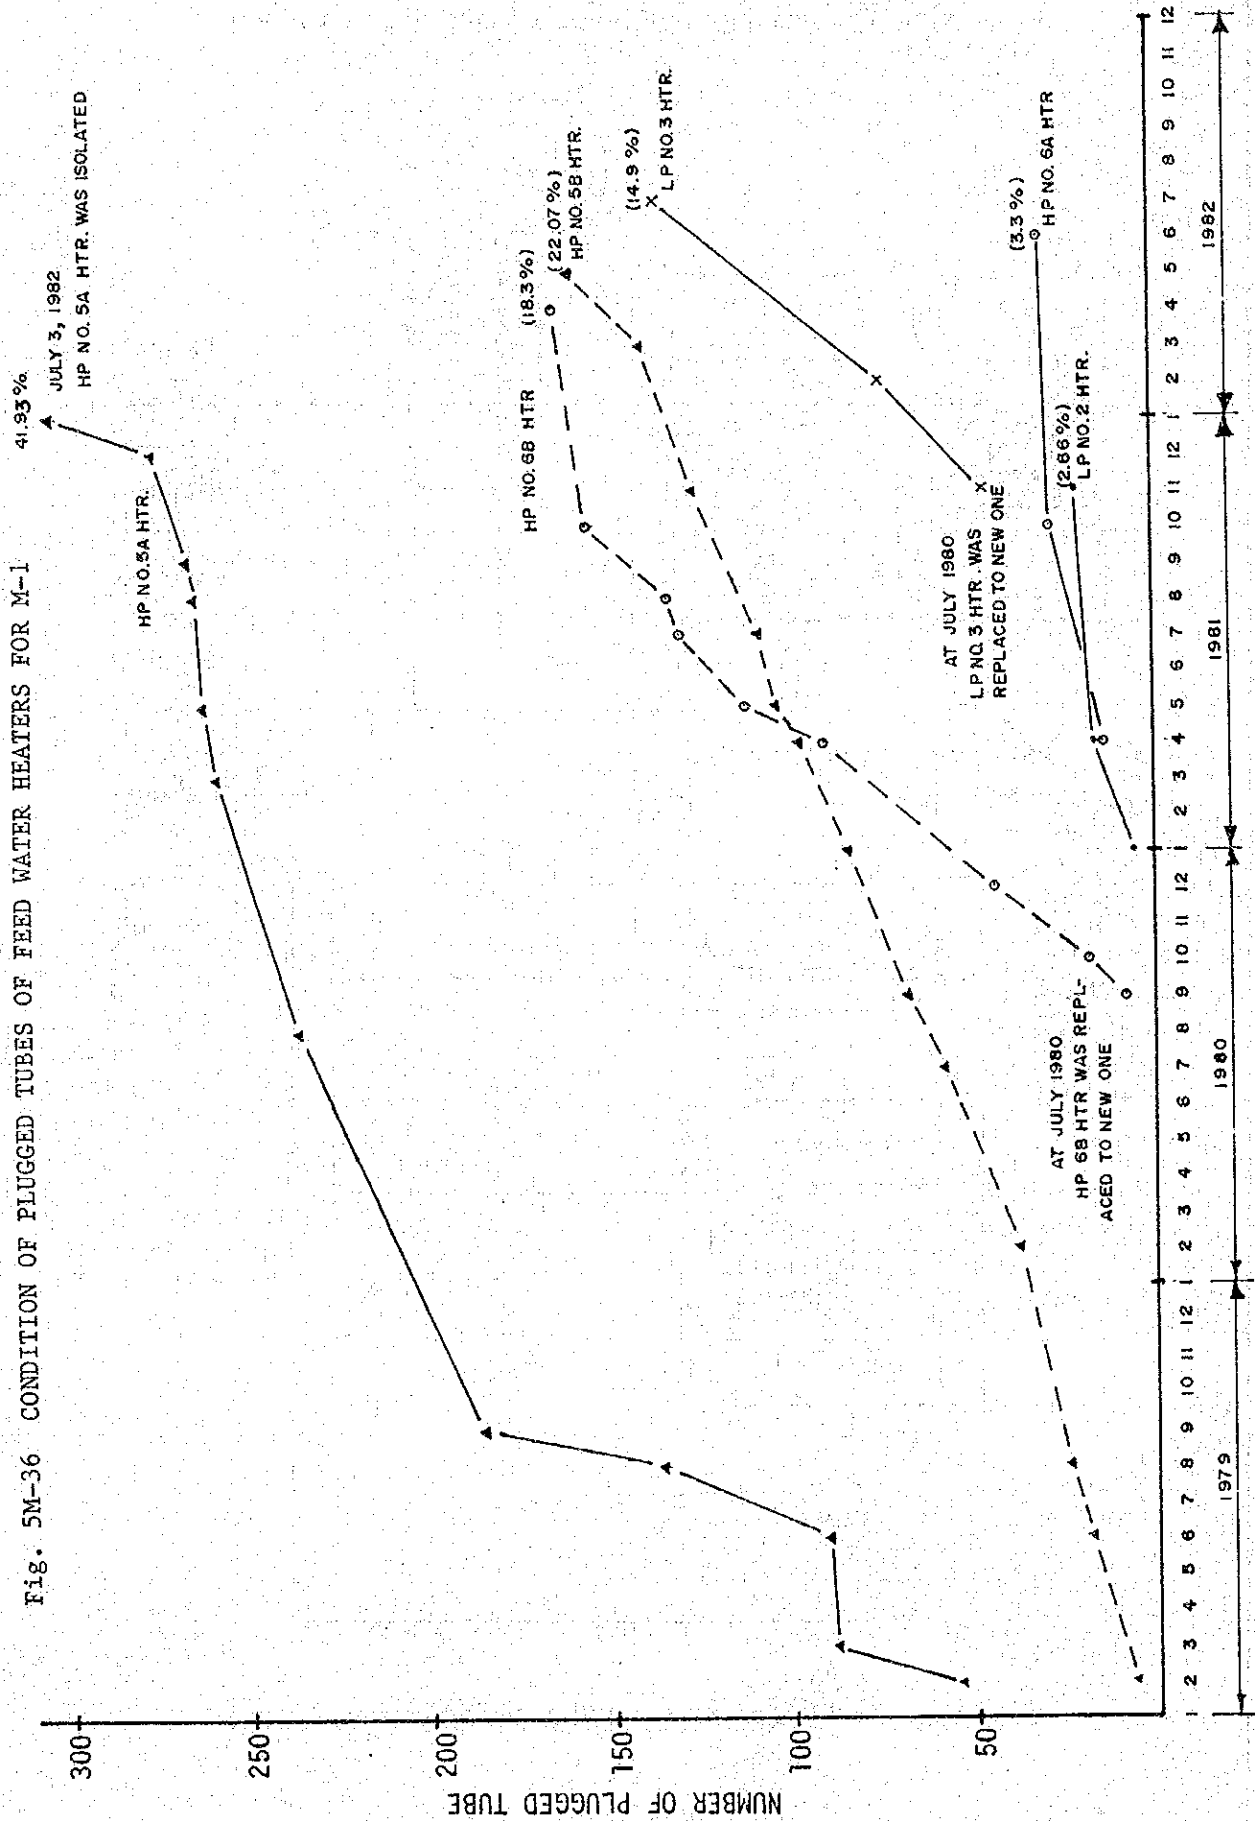
HPH #6B was newly replaced only last July, 1980 but the percentage of plugged tubes is a high 13.3% as of April, 1982. This particular heater also experienced a high rate of tube failure.

The difference of the total number of plugged tube between HPH #6A and HPH #6B will be described by another data.
