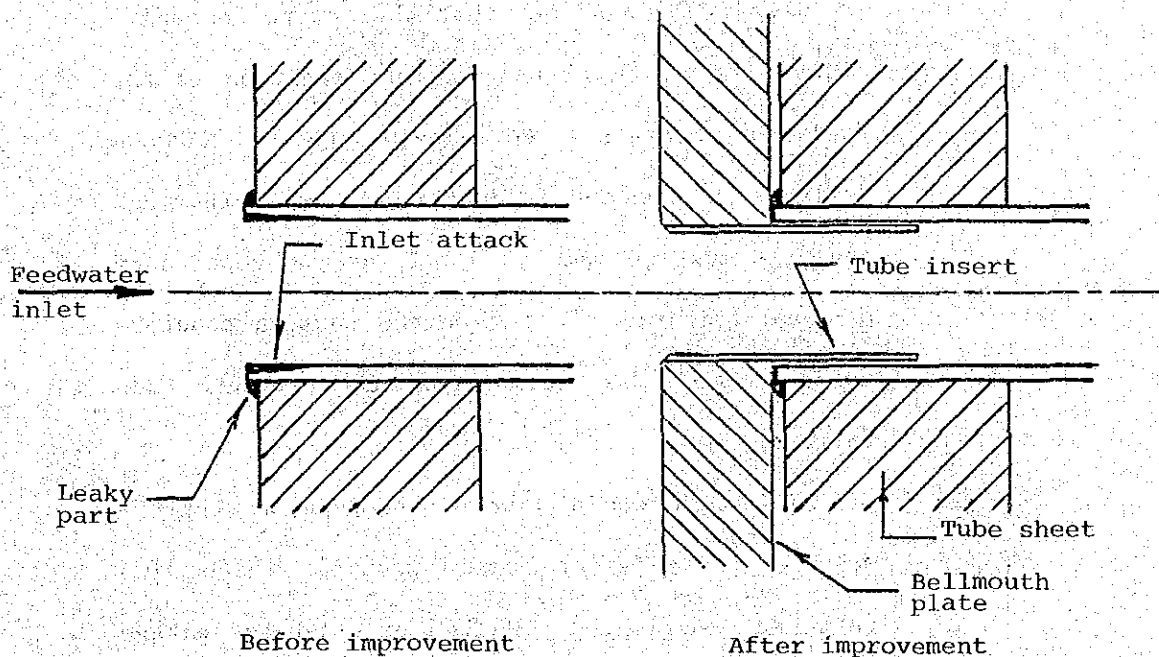
Fig. 5M-38 COUNTERMEASURES FOR FEED WATER HEATER LEAKAGE

JICA team would like to propose a countermeasure on feedwater heater problems which JICA team had experienced. We had experienced leakage

of many tubes at the feedwater inlet part, causes of which are as follows:

- (i) Eddy current of the feedwater which occurs at the feedwater inlet in the water box.
- (ii) High velocity of feedwater in the tubes and solid matters in the feedwater.
- (iii) Material of the tube and method of preservation to prevent corrosion during unit shutdown.
- (iv) pH, temperature, and dissolved oxygen of feedwater

A straightening vane of the bell-mouth type and stainless steel insert in the feedwater inlet of tubes are installed sometimes.

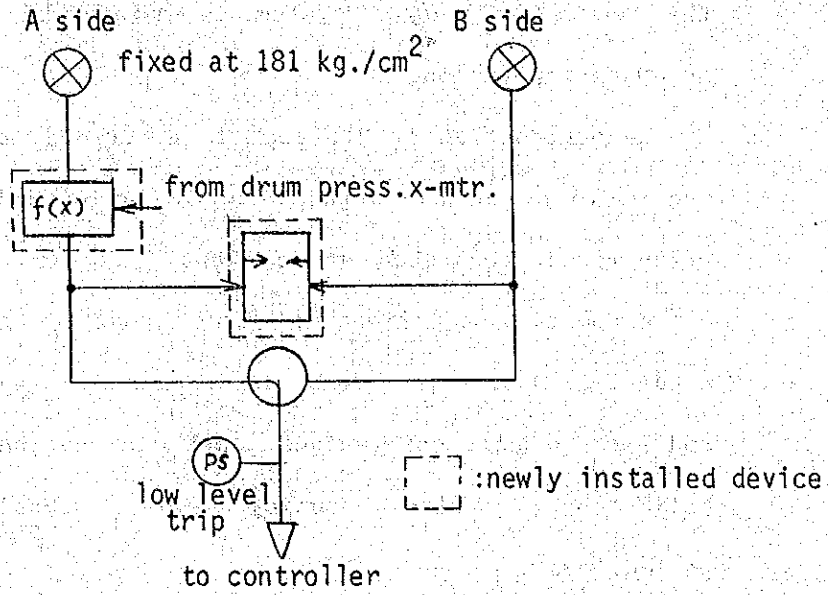
Fig. 5E-31 COUNTERMEASURE FOR DRUM LEVEL TRANSMITTER

Previously, feedwater control system was on manual operation due to drum level transmitter is defective and there were occurence of drum level low trip sometimes. After taking the countermeasure recommended by utility consultant

B side has now no response, therefore it also has to be modified same as A side.

Recommendation of UTL team is described later and it is reasonable method and similar method is performed in the recent power plant.

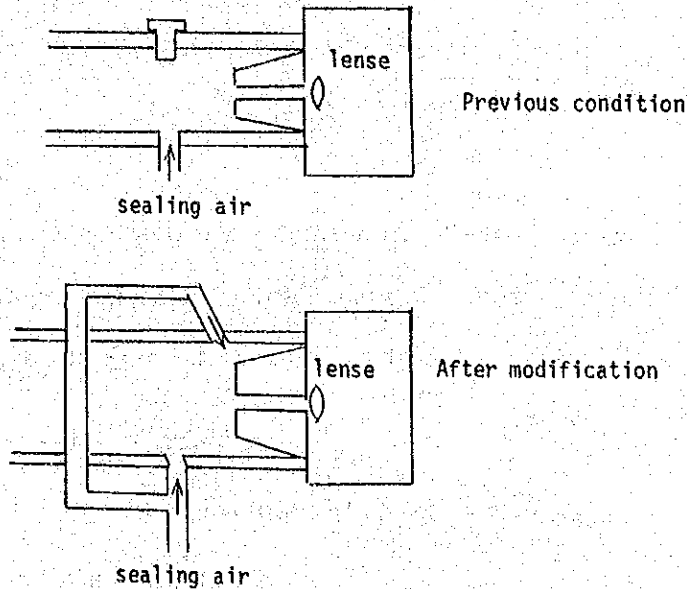
Fig. 5E-33 MODIFICATION OF COOLING

- (i) All flame detectors have been out of order.
- (ii) Countermeasures for overheating and lens misting were taken as follows but result was not satisfactory for continuous monitoring.

(i) All burner control systems including flame detector should be inspected in detail with manufacturer's engineer(s) and necessary countermeasure should be taken completely.

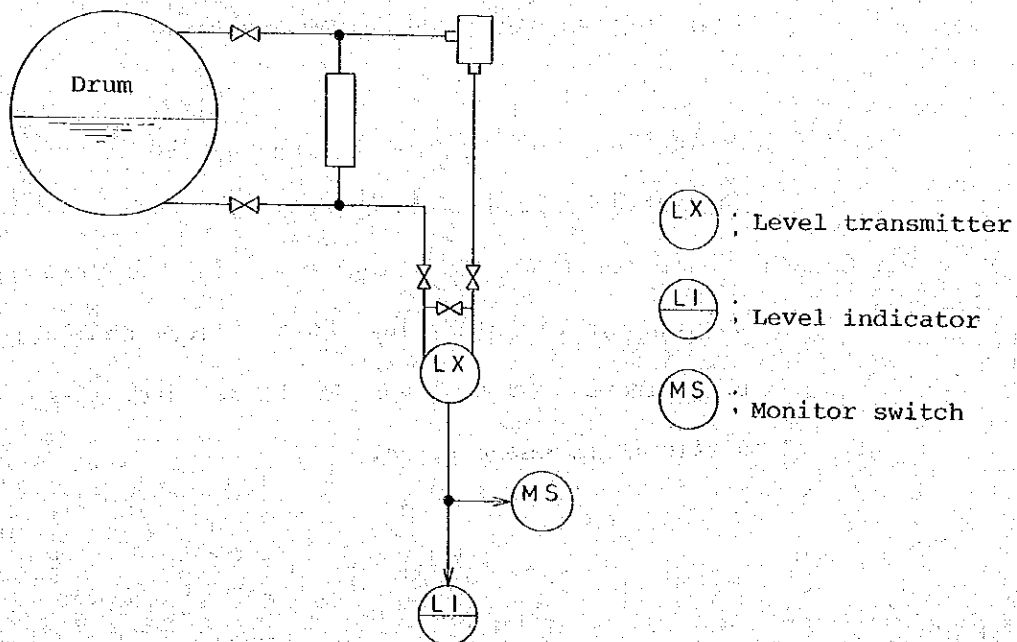
(i) Regarding drum level low trip. Ideally, the switch must be provided in the drum level detecting line, not on the transmitter signal line, but level switch is not available for high pressure steam vessel, therefore, another electrical level transmitter for trip interlock and indication should be recommended to be installed as follows:

In this case power source of transmitter and relay circuit for trip interlock should be one circuit to avoid faulty operation during power failure.
