Table 5C-36 DAILY WATER ANALYSIS REPORT REGARDING TO HOUSE SERVICE CLOSED CYCLE (Malaya Plant)

Table 5C-37 ANALYSIS DATA OF HOUSE SERVICE COOLING SYSTEM REQUESTED BY JICA TEAM (GSTP)

b. Condenser Cooling Water

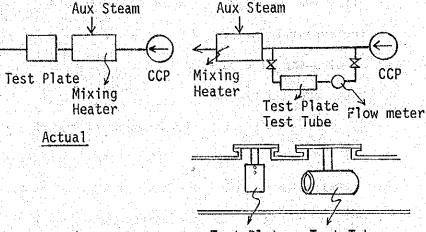
Test Plate Test Tube <u>Recommendation</u>

JICA team observed that the test plate was installed after the mixing heater. Its condition was different from the water wall tube so that the effect is not conclusive. JICA team recommends test plate and tube should be installed before the mixing heater with corresponding flowmeter so that velocity is the same as that of the water wall tube.

In case of Gardner-2, the test plate was installed after the mixing heater. In this case, the test plate was exposed to a fast velocity wherein corrosion rate is high. Procedure for Mixing the Chemicals

To determine the effectiveness of the chemical cleaning process, JICA team recommends installation of the test tube and plate during acid cleaning. The operating condition where the test materials are installed should be the same as that of the waterwall tube.

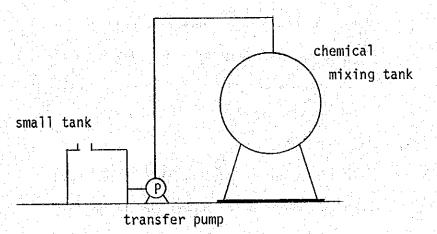
During the preparation of the acid cleaning chemicals, JICA team observed that 55 gals drums were individually being lifted with the use of a chain block. the procedure was dangerous, we are recommending that 250 gals rubber lined tank and transfer pump be used in mixing the chemicals. Please refer to the diagram below:

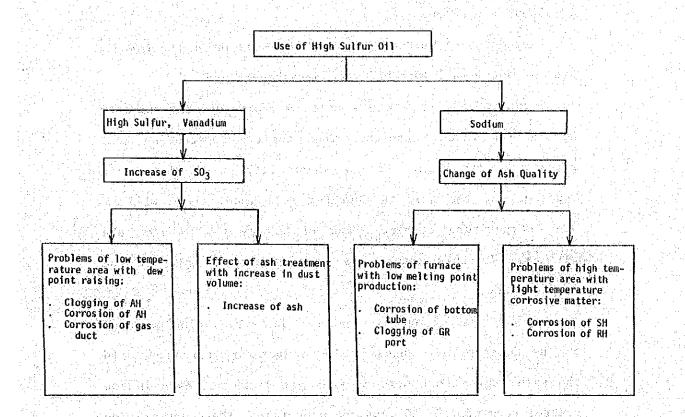
Table 5C-46 EFFECT OF HIGH SULFUR OIL

High temperature corrosion is due to the presence of sodium sulfate which causes sulfidation attack on the tube surfaces. It could be protected by following the protection method stated below. But in spite of implementing the necessary protection method, the system could not be protected completely if there is no careful inspection during overhauling and advance maintenance.

Low temperature corrosion is caused by oxidation of SO_2 to SO₃ and ultimately formation of H_2SO_4 . With the increase in SO₃ concentration, the corresponding dew paint decreases, thus H_2SO_4 is produced which caused corrosion of air heater, gas duct and stack. The H_2SO_4 condensation will cause presence of sticky ash. Below is the protection of low temperature corrosion.

- (1) Low excess air operation should always be maintained.
- (2) Control of exhaust gas temperature
- (3) Injection of ammonia gas after multicyclone
- (4) Anti-corrosion material should be used, for instance corten steel
- (5) Steam coil air heater should be used to increase the metal temperature of the air heater.

JICA team recommends measurement of SO_2 , SO_3 analysis and the corresponding dew point, so that proper treatment could be done. In this regard JICA team recommends implementation of Items (2) and (5) of the protection method.
