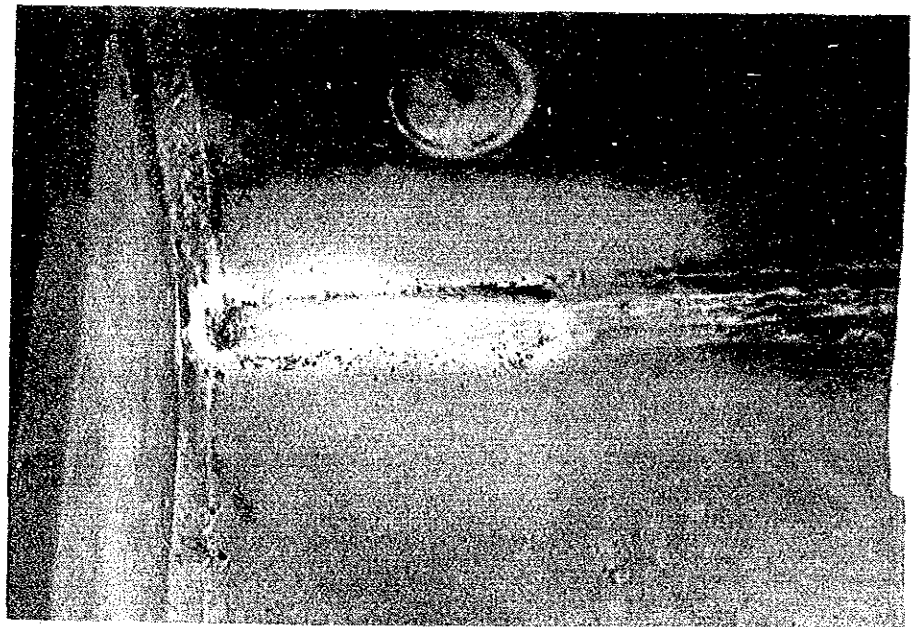
FILM NO.		MEGA NO.	4
DATE		DATA	1.9.3
PLACE	Yoke		
Dye penetrant test at weld zone of inside of yoke

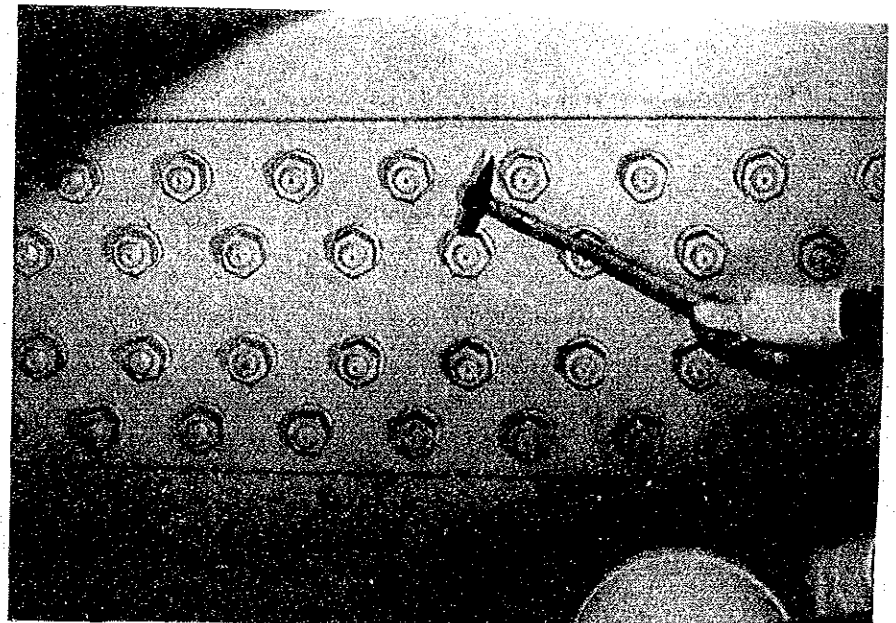
FILM NO.		MEGA NO.	13
DATE		DATA	1.9.4
PLACE	Yoke		
Connection area of inside of yoke

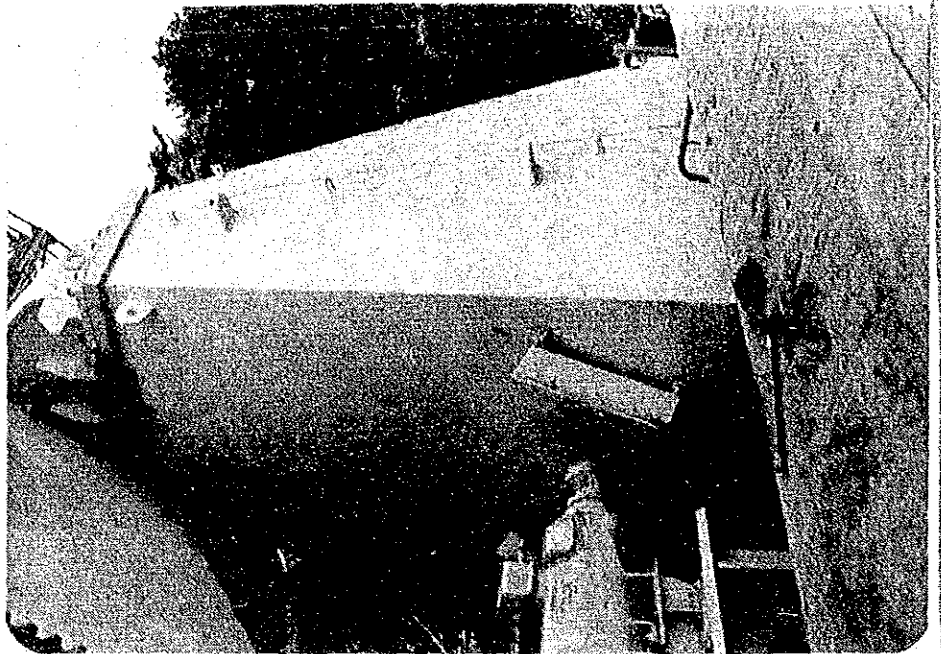
FILM NO.		MEGA NO.	
DATE	22	DATA	1.9.5
PLACE	Yoke		
Outside of Yoke

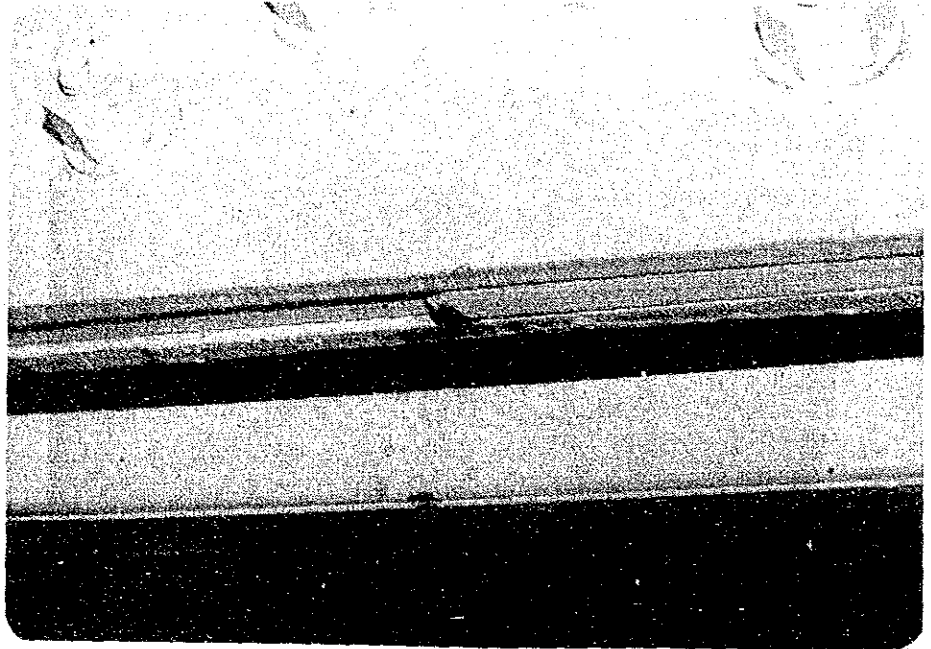
FILM NO.		MEGA NO.	9
DATE		DATA	1.9.6
PLACE	Yoke		
Connection area of inside of yoke

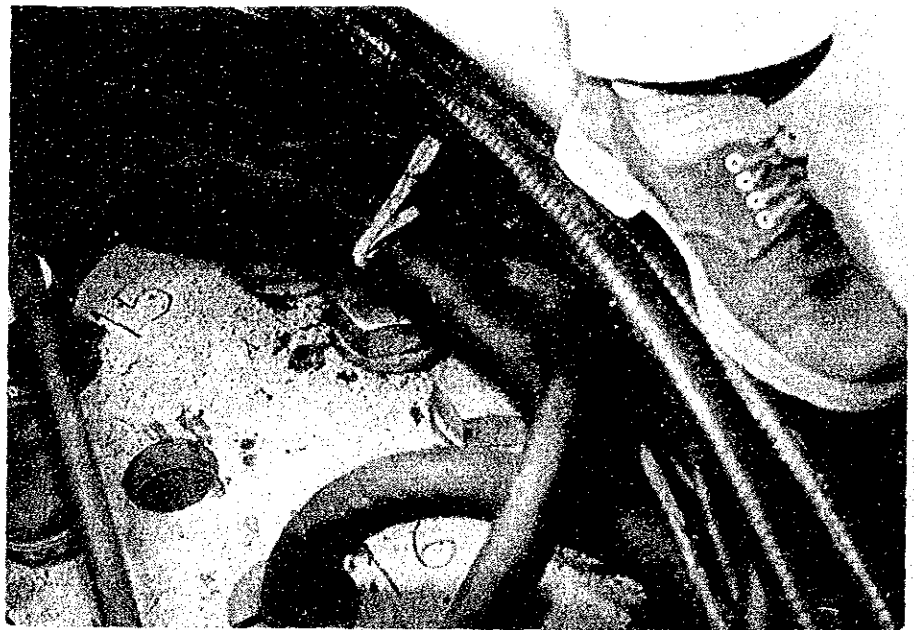
FILM NO.		MEGA NO.	31
DATE		DATA	1.9.7
PLACE	Yoke		
Connection area with AZ Bearing

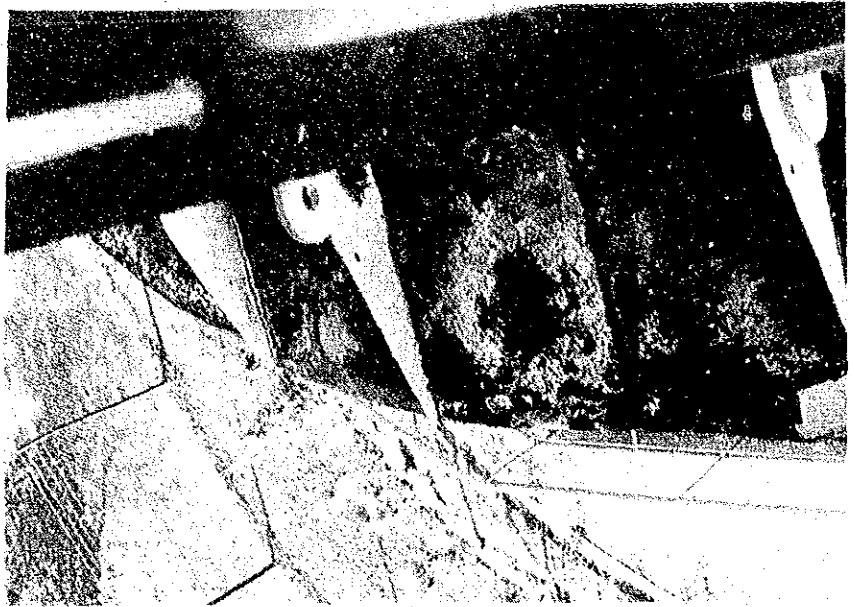
FILM NO.		MEGA NO.	13
DATE		DATA	1.9.8
PLACE	Yoke		
Cover of AZ bearing

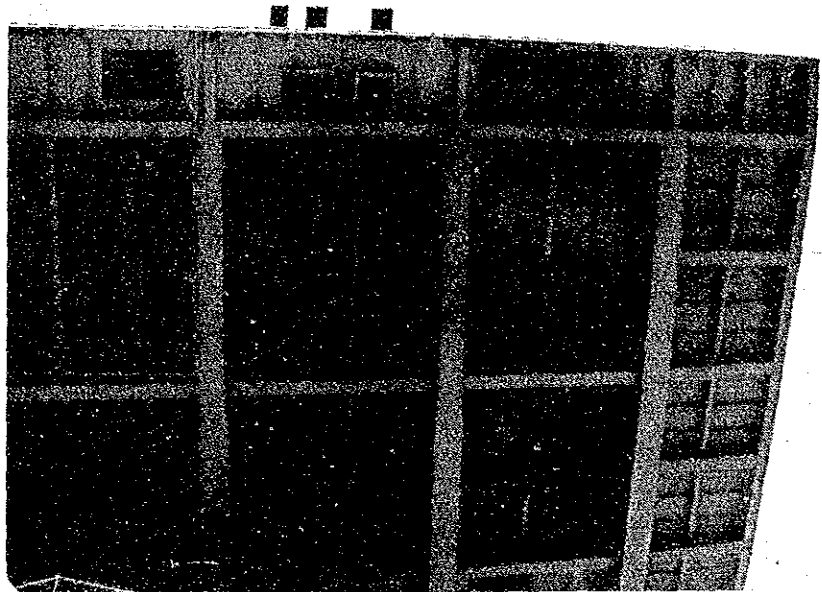
FILM NO.		MEGA NO.	26
DATE		DATA	1.10.1
PLACE	HPA Room		
Bottom surface of floor

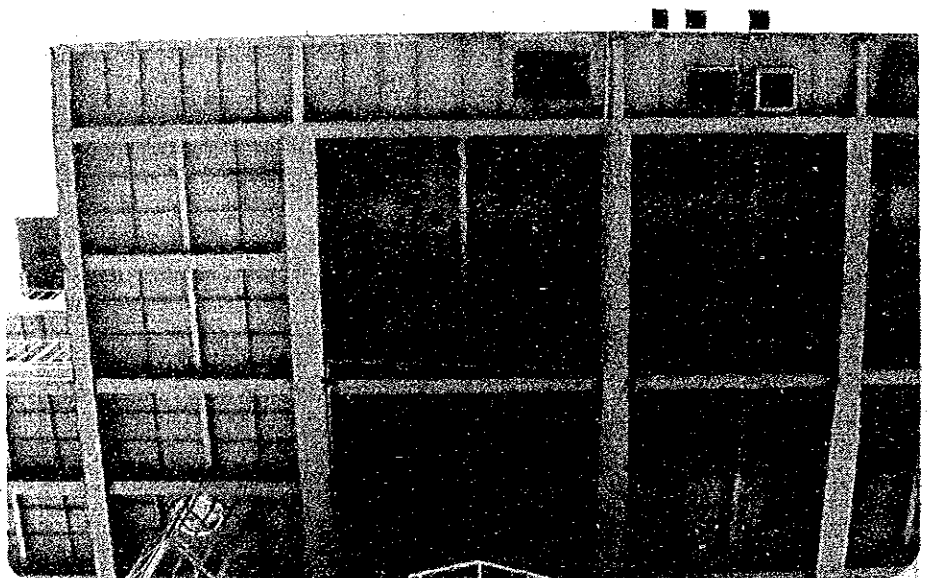
FILM NO.		MEGA NO.	25
DATE		DATA	1.10.2
PLACE	HPA Room		
Bottom surface of floor

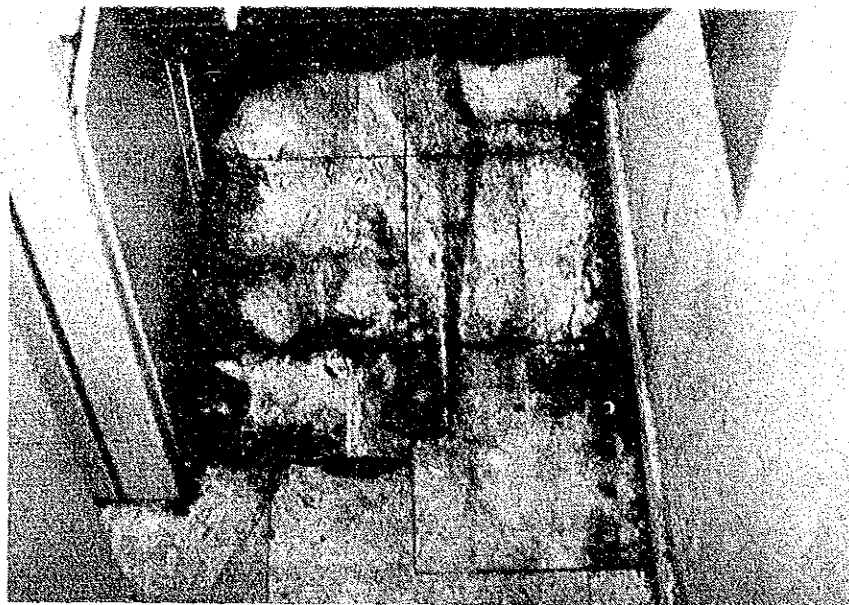
FILM NO.		MEGA NO.	20
DATE		DATA	1.10.3
PLACE	HPA Room

Inside of floor

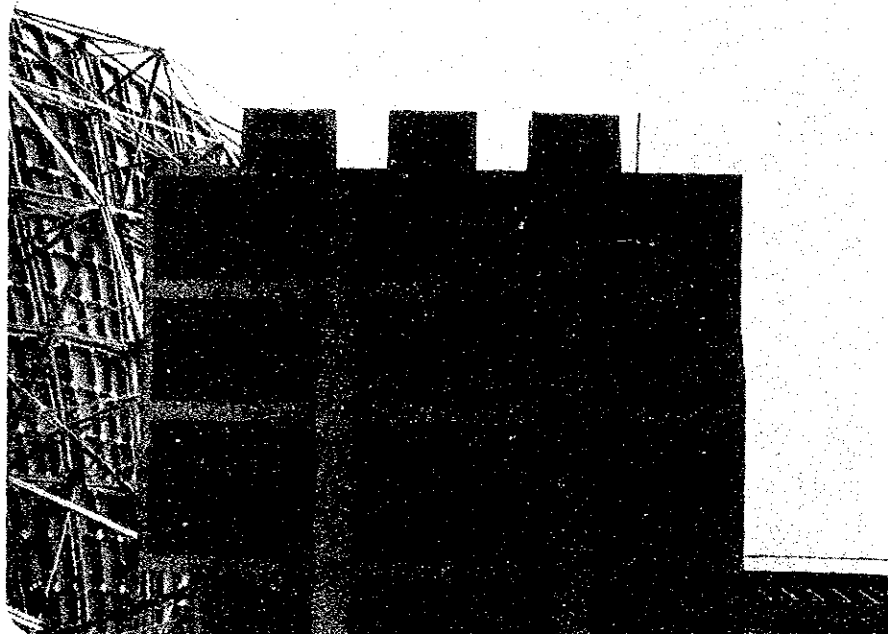
FILM NO.		MEGA NO.	19
DATE		DATA	1.11.1
PLACE	Feed Room

Bottom surface of floor

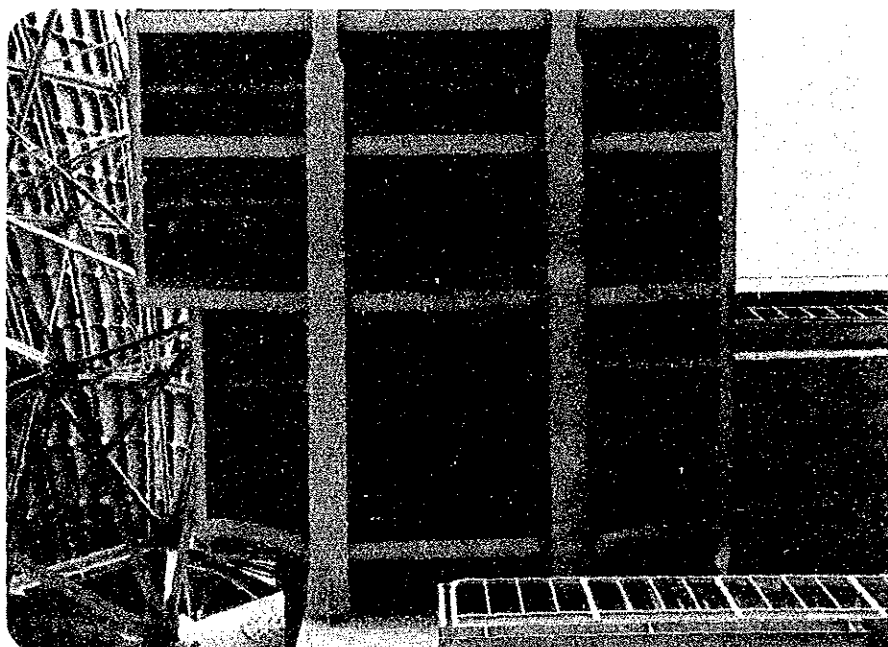
FILM NO.		MEGA NO.	20
DATE		DATA	1.11.2
PLACE	Feed Room

Bottom surface of floor

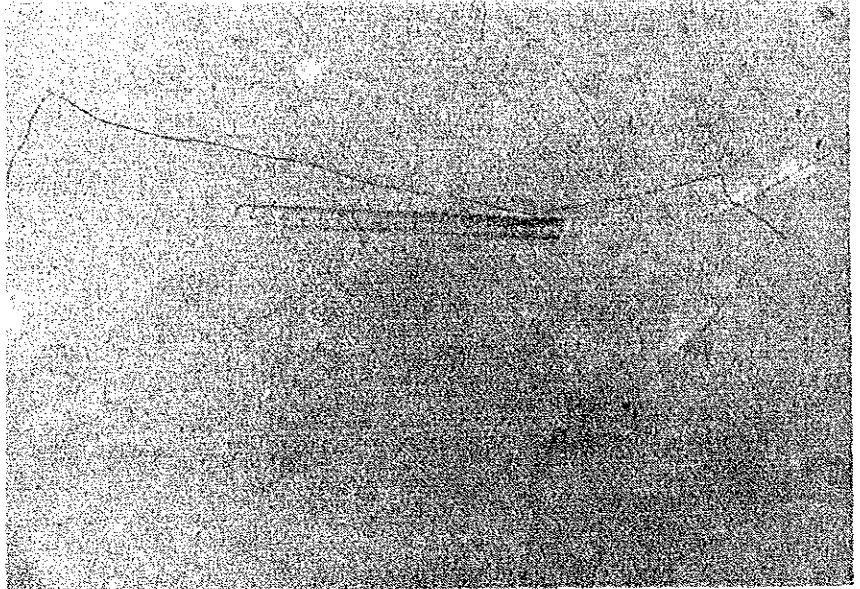
FILM NO.		NEGA NO.	25
DATE		DATA	1.12.1
PLACE	Concrete Tower		
Hair crack on floor

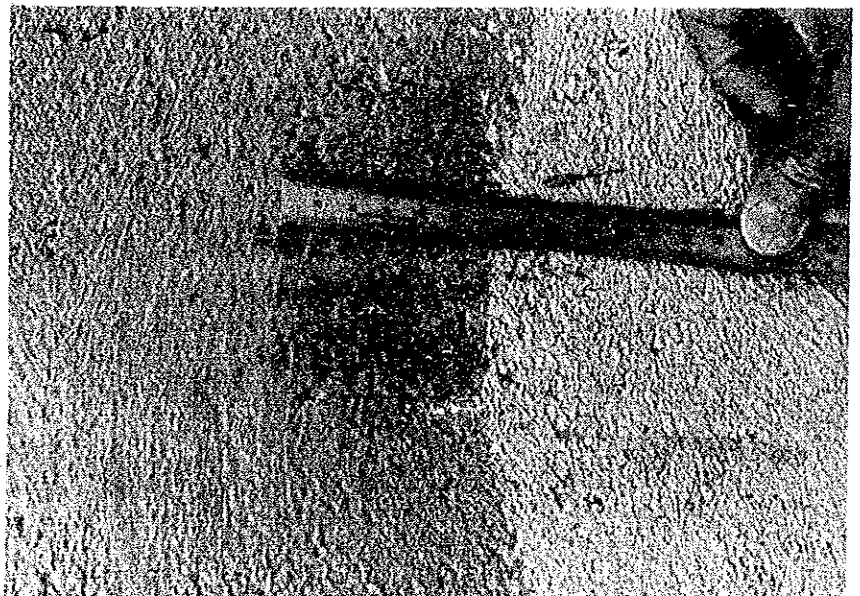
FILM NO.		NEGA NO.	4
DATE		DATA	1.12.2
PLACE	Concrete Tower		
Hair crack on wall

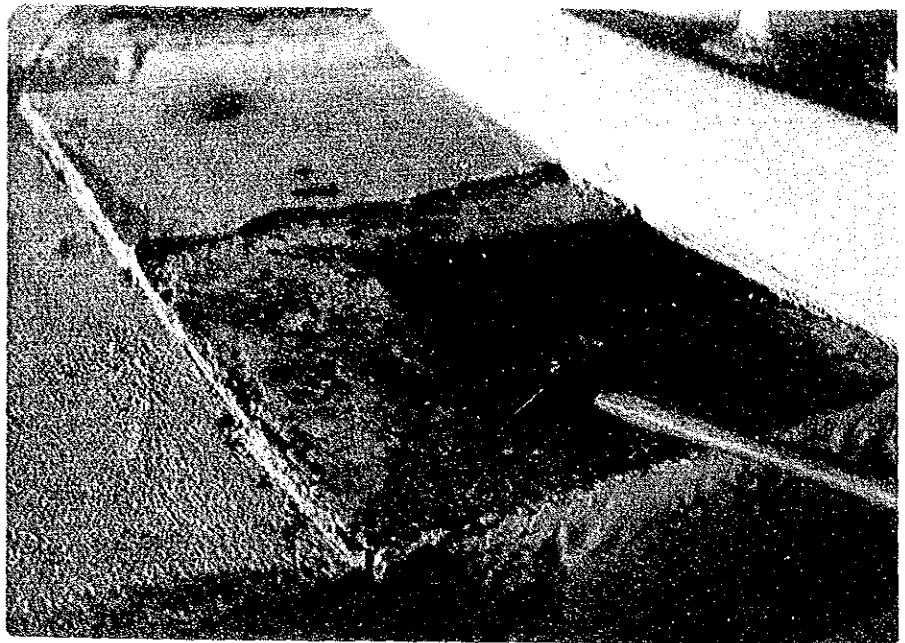
FILM NO.		MEGA NO.	11
DATE		DATA	1.12.3
PLACE	Concrete Tower		
Top of concrete tower

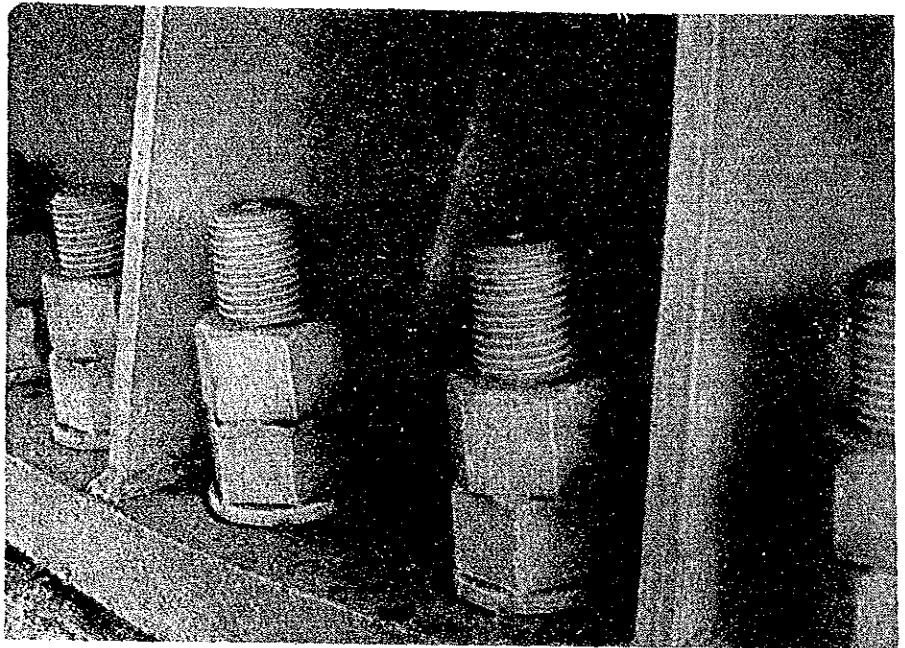
FILM NO.		MEGA NO.	15
DATE		DATA	1.12.4
PLACE	AZ Bearing base

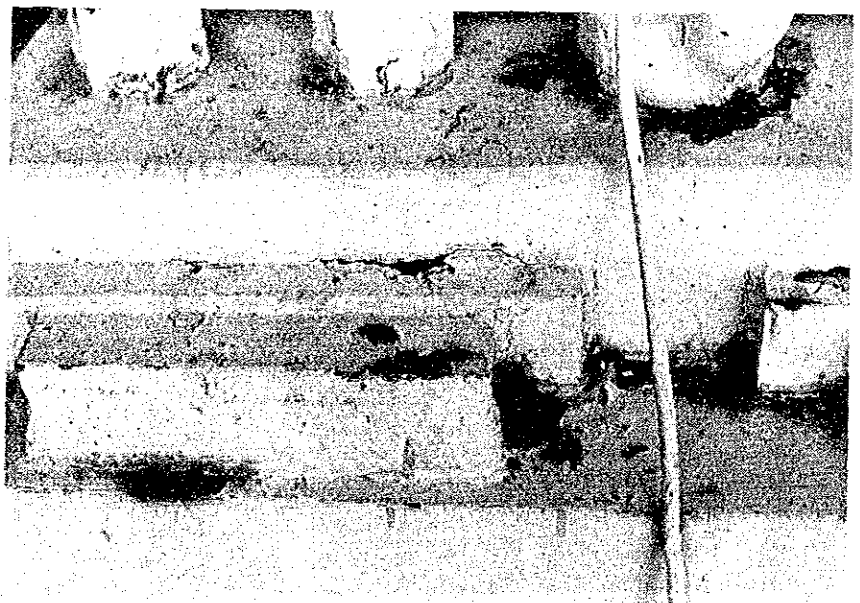
FILM NO.		MEGA NO.	29
DATE		DATA	1.13.1
PLACE	EL Bearing & Plummer Block		
Plummer Block

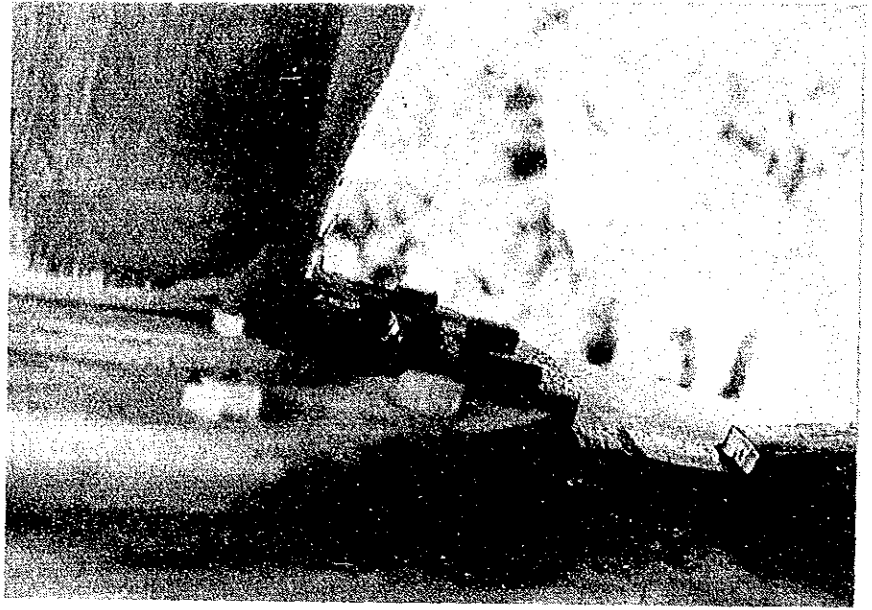
FILM NO.		NEGA NO.	30
DATE		DATA	1.13.2
PLACE	EL Bearing		
Oil leakage from oil seal

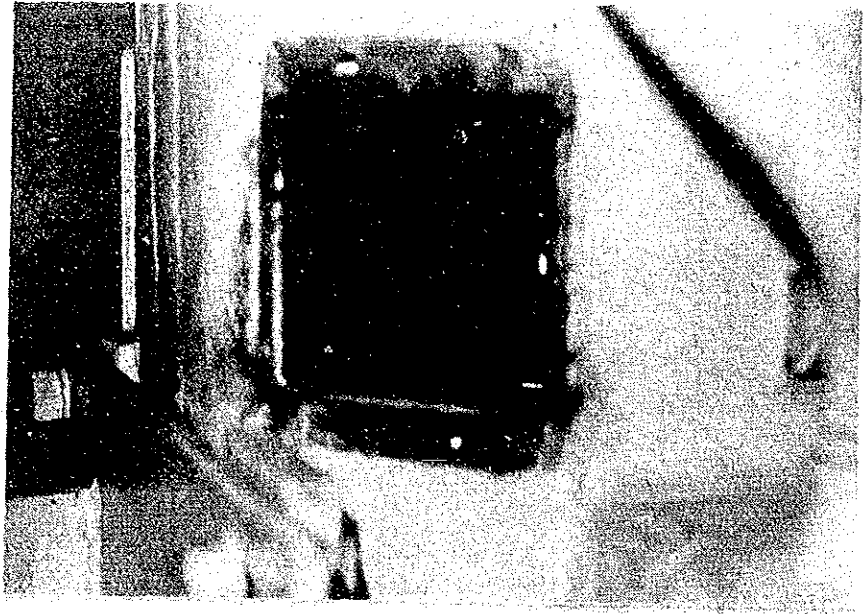
FILM NO.	Y	3	MEGA NO.	20
DATE			DATA	2.1.2
PLACE				
<p>Commutator surface AZ No. 1 Motor</p>

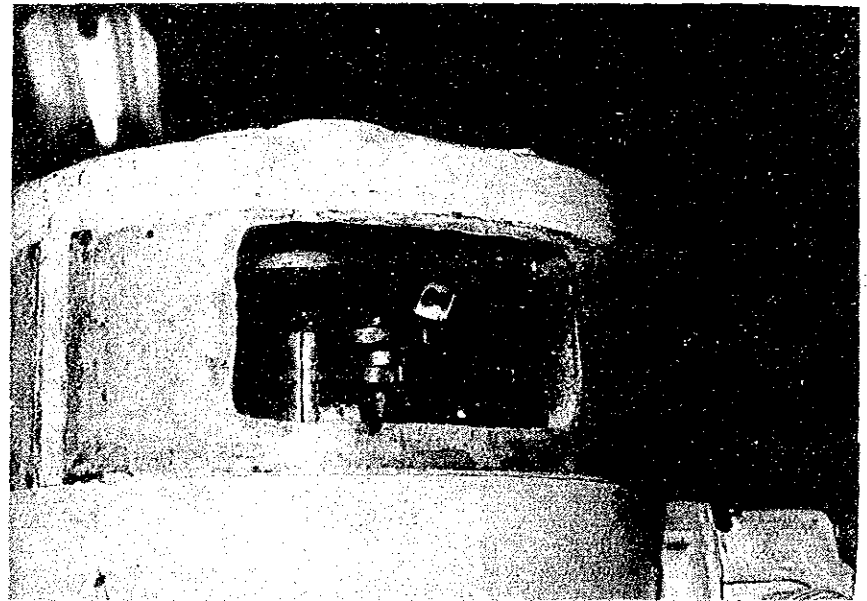
FILM NO.	Y	4	MEGA NO.	5
DATE			DATA	2.1.4
PLACE				
<p>TG Brush for AZ No. 4 Motor</p>

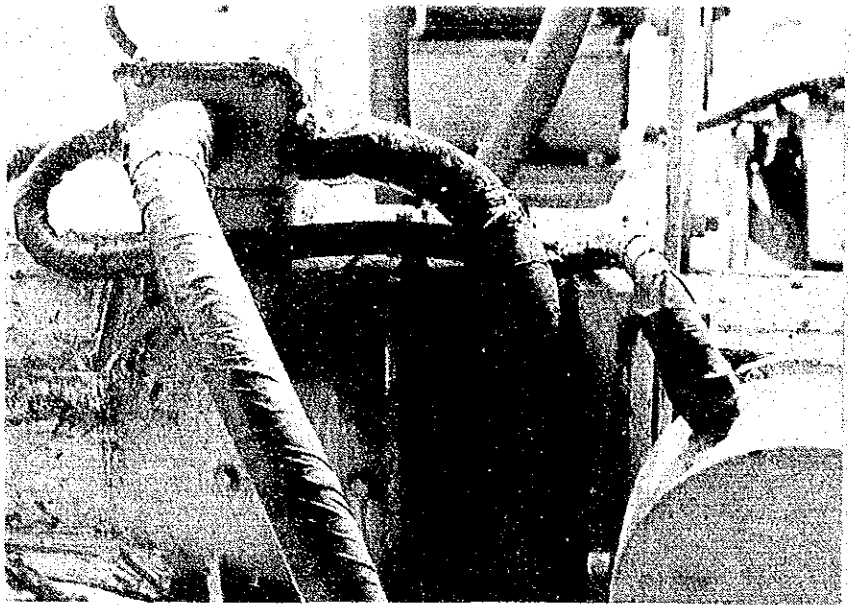
FILM NO.	Y	2	MEGA NO.	37
DATE			DATA	2.2.5
PLACE				
<p>EL No. 2 Motor (rust from Prica tube)</p>
