STUDY REPORT
ON
PLANT RENOVATION PROJECT OF
THE SENTOSA-1 EARTH STATION
IN
THE REPUBLIC OF SINGAPORE

JULY 1986

JAPAN INTERNATIONAL COOPERATION AGENCY (JICA)

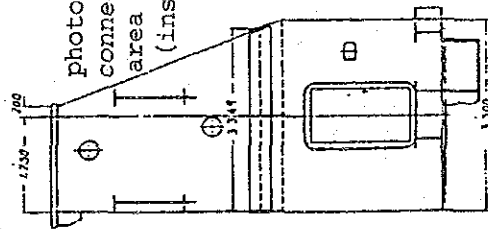
photo 1.9.3  
weld zone

6) Weld zone : no crack (photo 1.9.3)

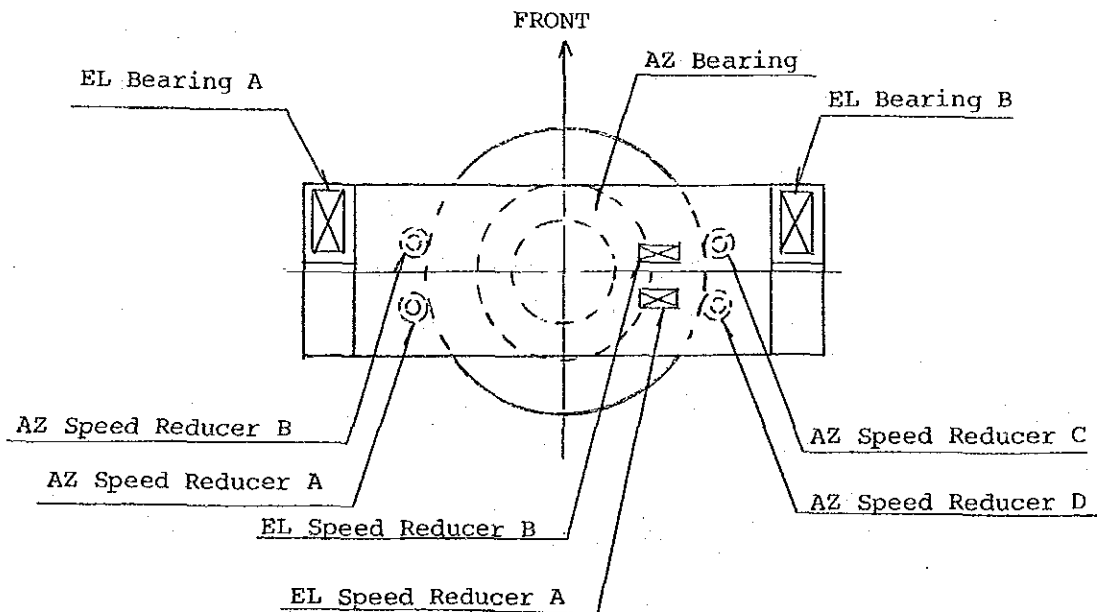
Table 1

We assume that AZ/EL Bearings and speed Reducers are no problem in practical use judging from peak factor in Table 1.

In case of less than 6.2 in peak factor, bearing is judged as normal condition.
