REPORT ON  
THE RAMA VI BRIDGE  
REHABILITATION PROJECT

DECEMBER, 1982

JAPAN INTERNATIONAL COOPERATION AGENCY  
(JICA)

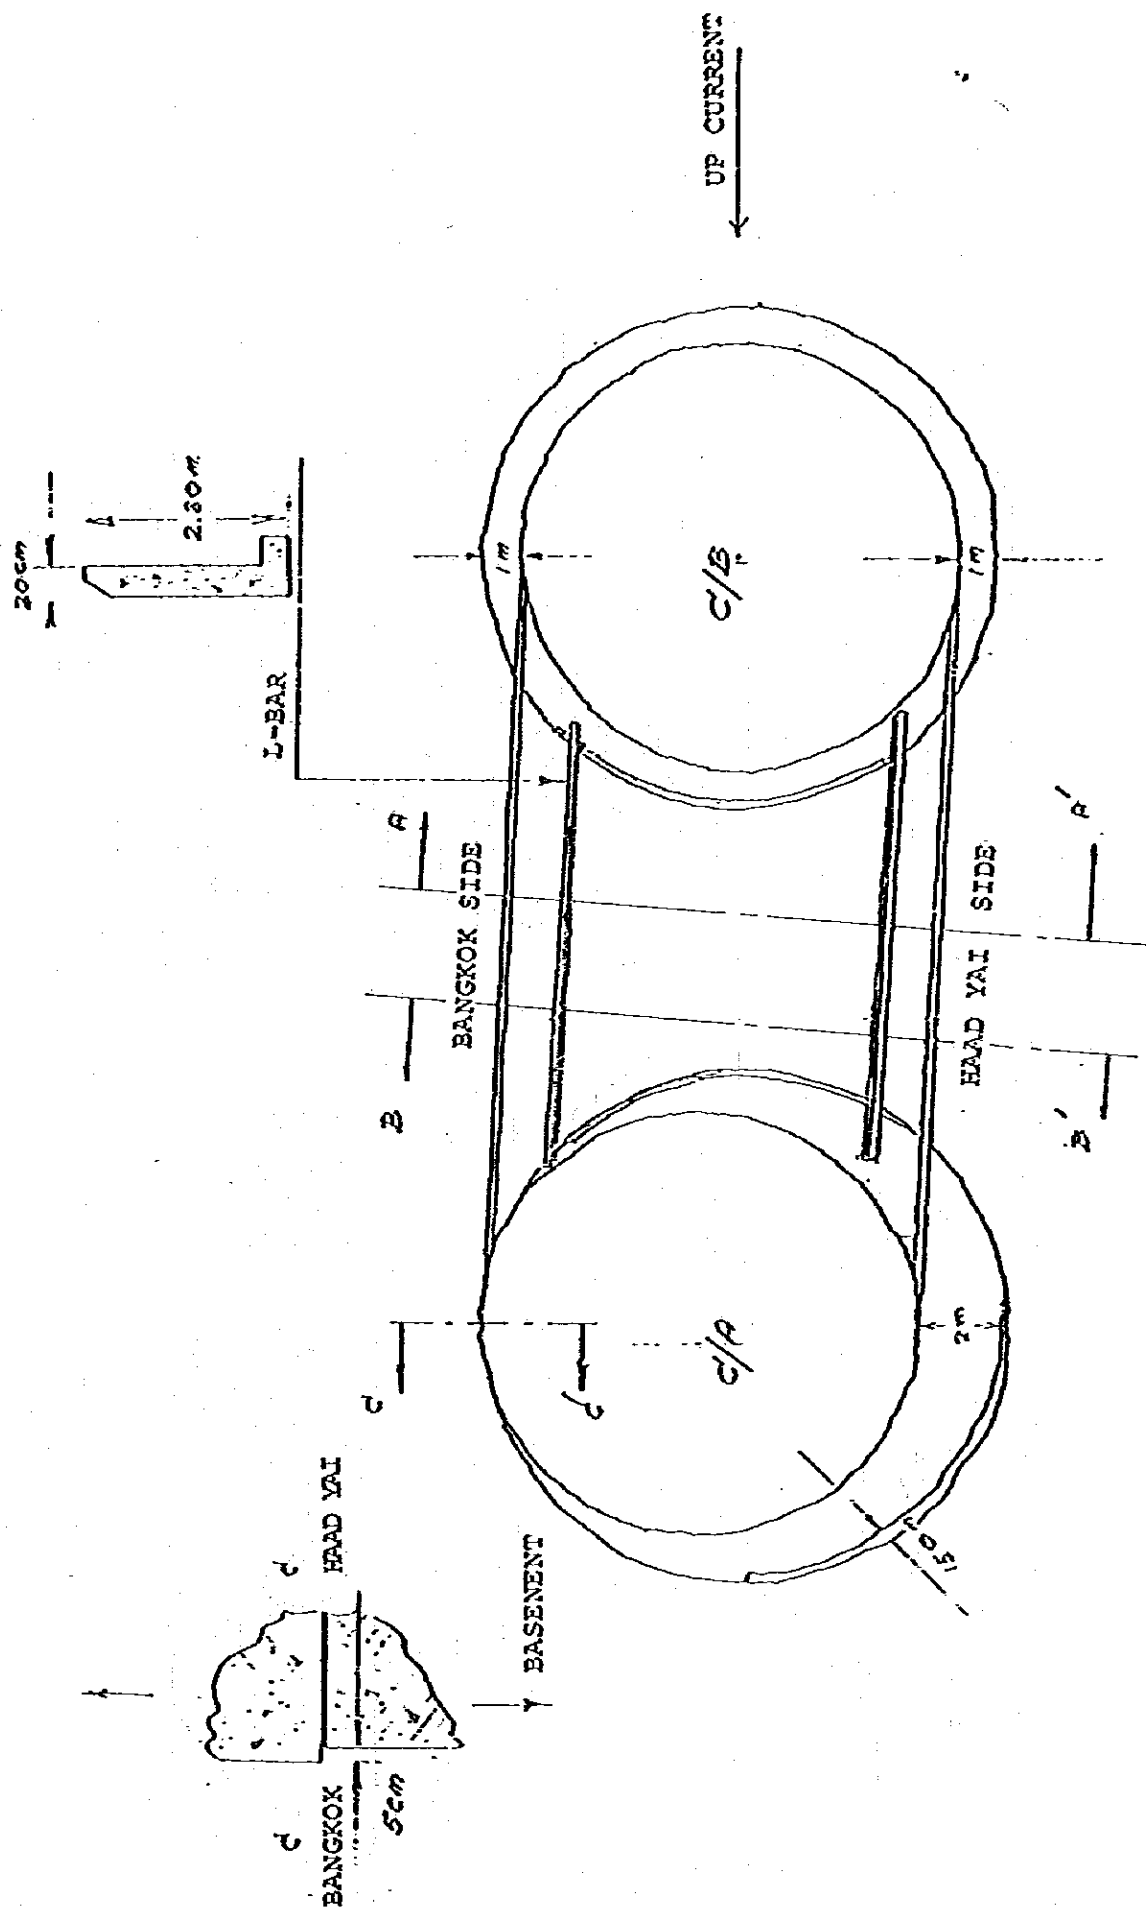
Fig. 1-7 C Pier

From the result of subaqueous survey by divers it was revealed that Piers C and D had hollows and cracks near the boundary between the upper and middle stages and Pier C was eccentric by about 1 m at its upper and middle stages on the upstream side. Although those drawbacks were not immediately influential to the growing deterioration, they appeared with necessity to take any suitable means of repair and remedy.

- (4) As made clear from the result of diver's exploitation, the upper part of Pier C is eccentric on its upstream side by about 1 m toward Bangkok. It is further clarified that horizontal displacement of about 1 cm will arise at the crown of Pier C from eccentric load resulting from such eccentricity. Although such displacement is still limited to a small degree, it exists as long duration load and is considered as a factor to deterioration of the bridge.
- (5) The result of river-bed scouring survey reveals that there exists hardly any difference as compared with the condition at the initial stage of construction. Nothing particular is contained in the cause for deterioration to derive from localized scouring around Pier C, contrary to the original assumption in Japan.

C-PIER, (TOP VIEW) ENCLOSURE 5  
 This drawing shows the off-center placement of the top portion of column A (C/A). The upper portion of column A is approximately 1 M off-center as compared with column B (C/B).

However, it is considered desirable in a long run that repair work should be done for the underwater portions of Piers C and D.

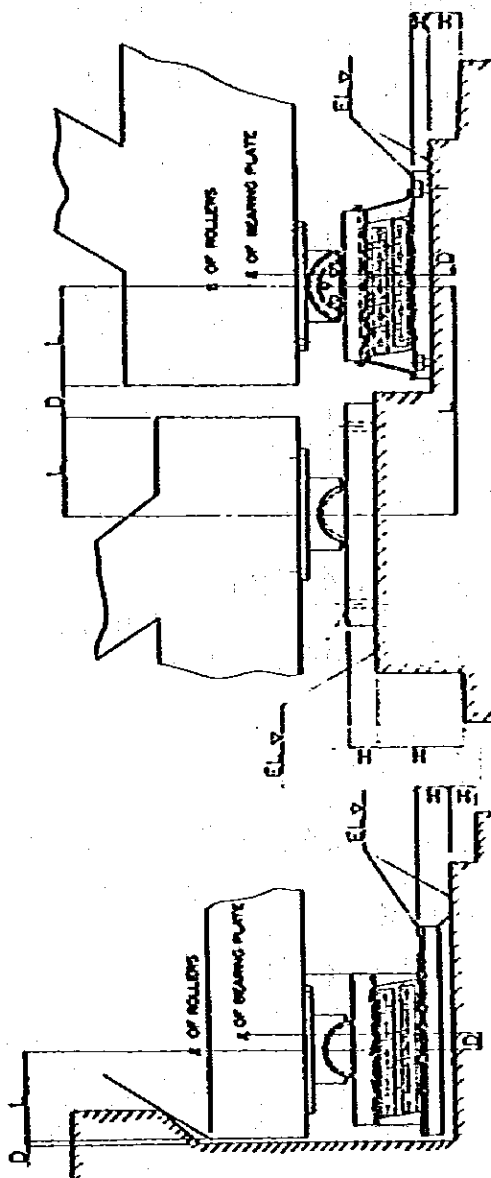
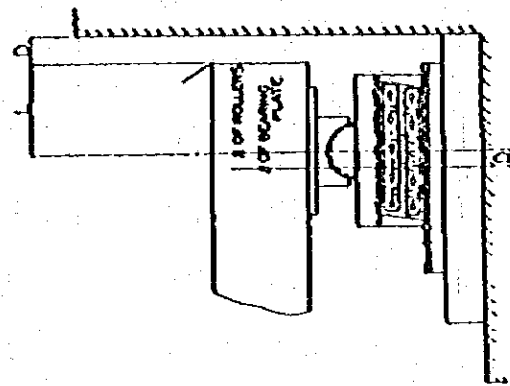
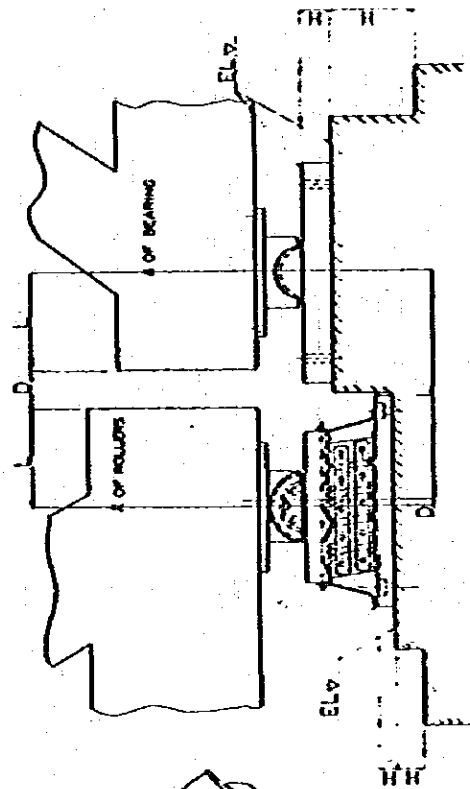
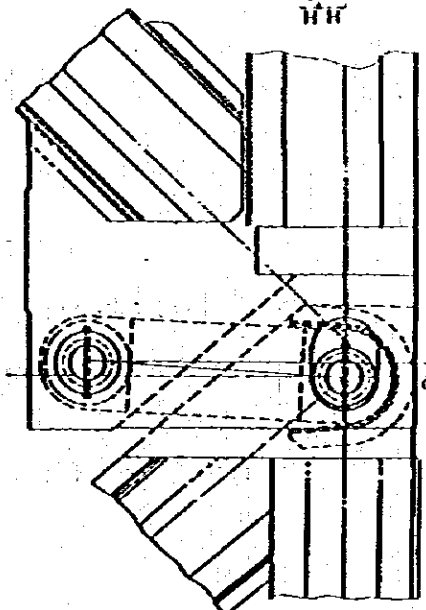
Fig. 1-11 Displacement of Shoes and Links

RAMA VI Bridge presented such deteriorations that Abutments A and F on both sides were moved forward by about 50 to 60 mm and movable shoes of Piers B and D were tilted toward Bangkok by about 50 to 30 mm respectively as may be so determined from relative displacement between

Displacement of shoes and links was varied within a diversified range of 15 to 76 mm depending upon where they were. This result was nearly same as obtained from the result of survey in June 1981. Although this extent of displacement may not immediately affect the growing paces of deterioration, it would impede the normal functioning inherent to shoes and links and it would be desirable that the present condition should be corrected not later than the scheduled timing for conversion into double track.
