BASIC DESIGN STUDY REPORT
ON
THE THA NGON REHABILITATION
AND
RURAL DEVELOPMENT PROJECT
IN
THE LAO PEOPLE'S DEMOCRATIC REPUBLIC

MARCH 1987

JAPAN INTERNATIONAL COOPERATION AGENCY

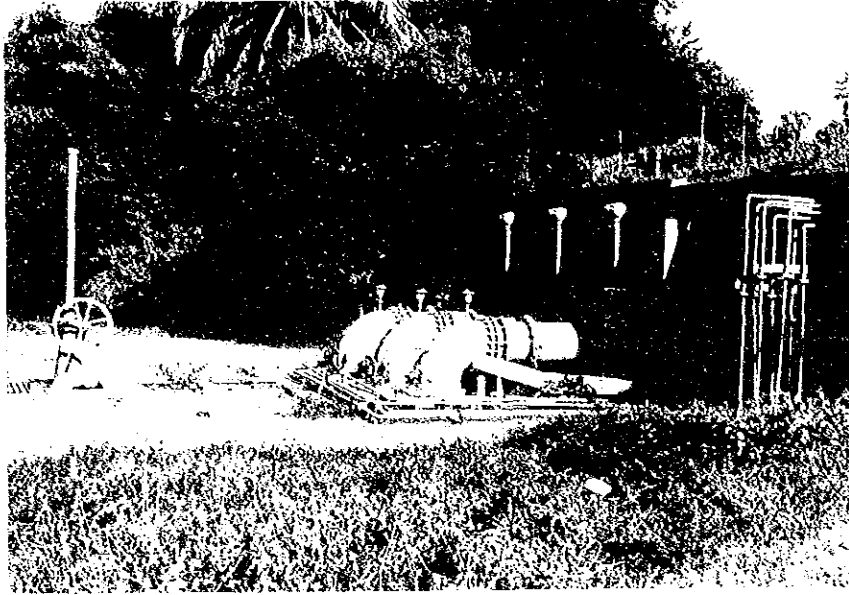
Irrigation Pump Station (Oct. 1986)

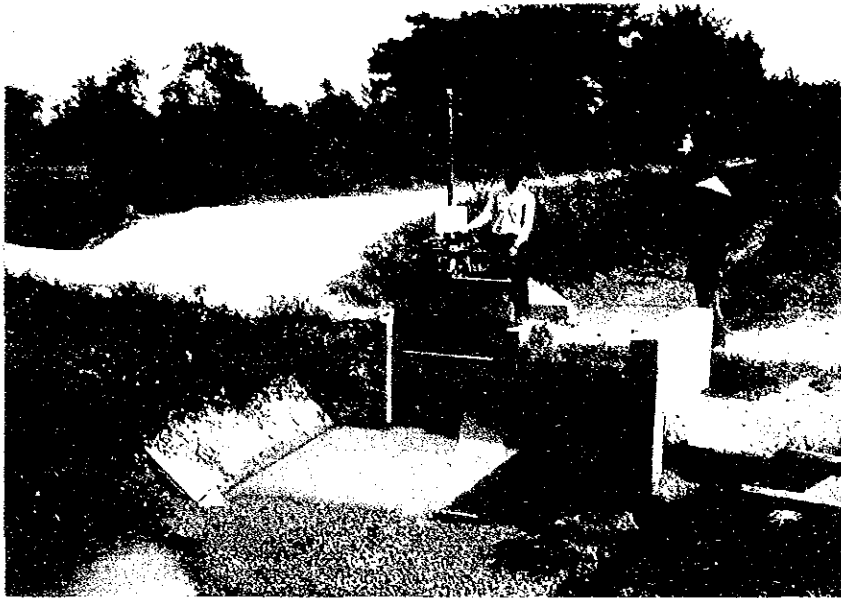
North Main Irrigation Canal and Related Structure
(Oct. 1986)
