APPENDIX 5.3-2 ROAD DISASTER DIAGRAM

APPENDIX 6.5-1 CONDITION OF DISASTER AND
SELECTED COUNTERMEASURES

CONDITION OF DISASTER AND SELECTED COUNTERMEASURES

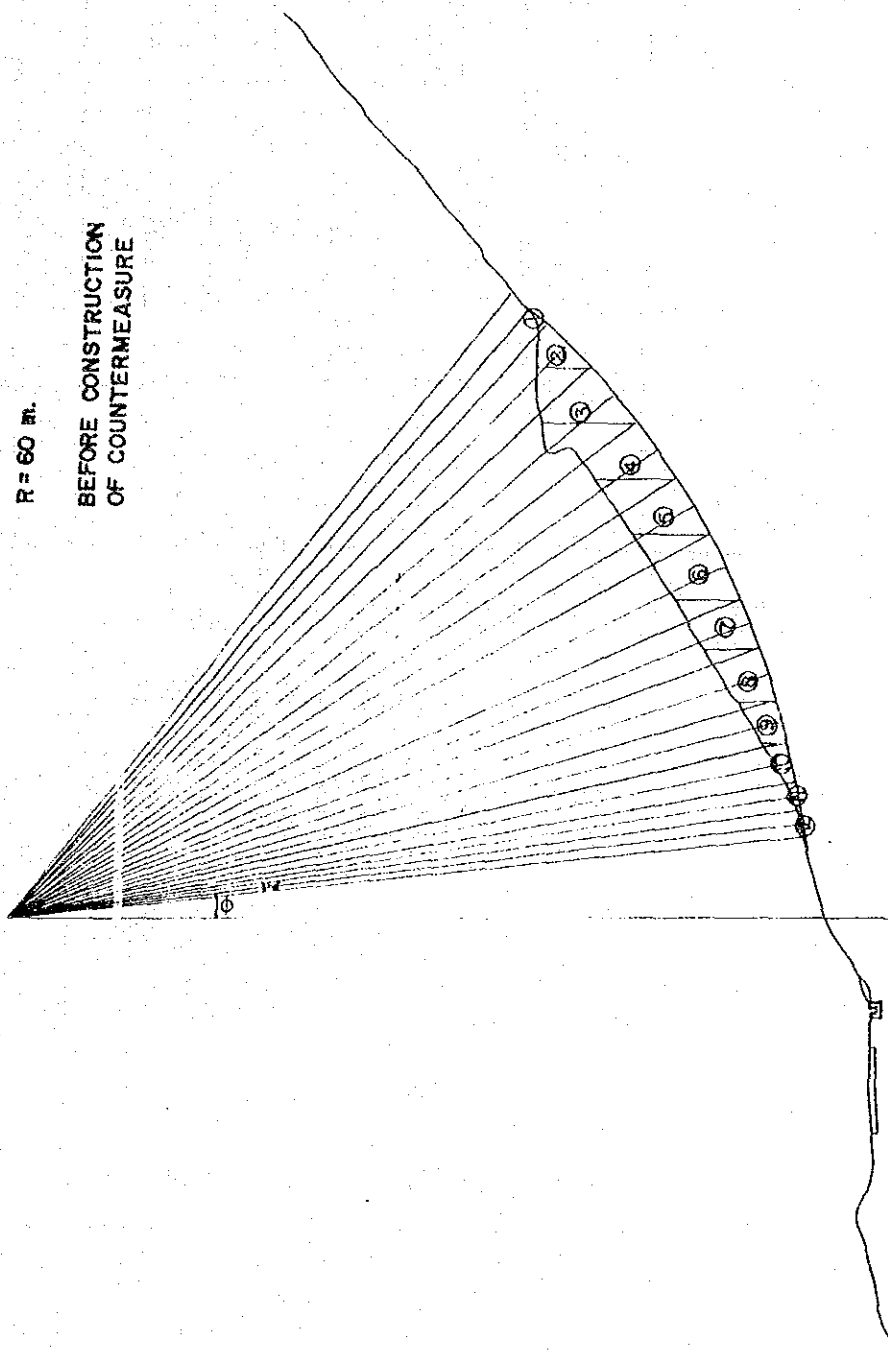
It was observed that landslide is likely to occur at Spot No. IVA-20 in the Lucena - Calauag Section.

It is assumed that landslide may not occur when earth removal will be applied.

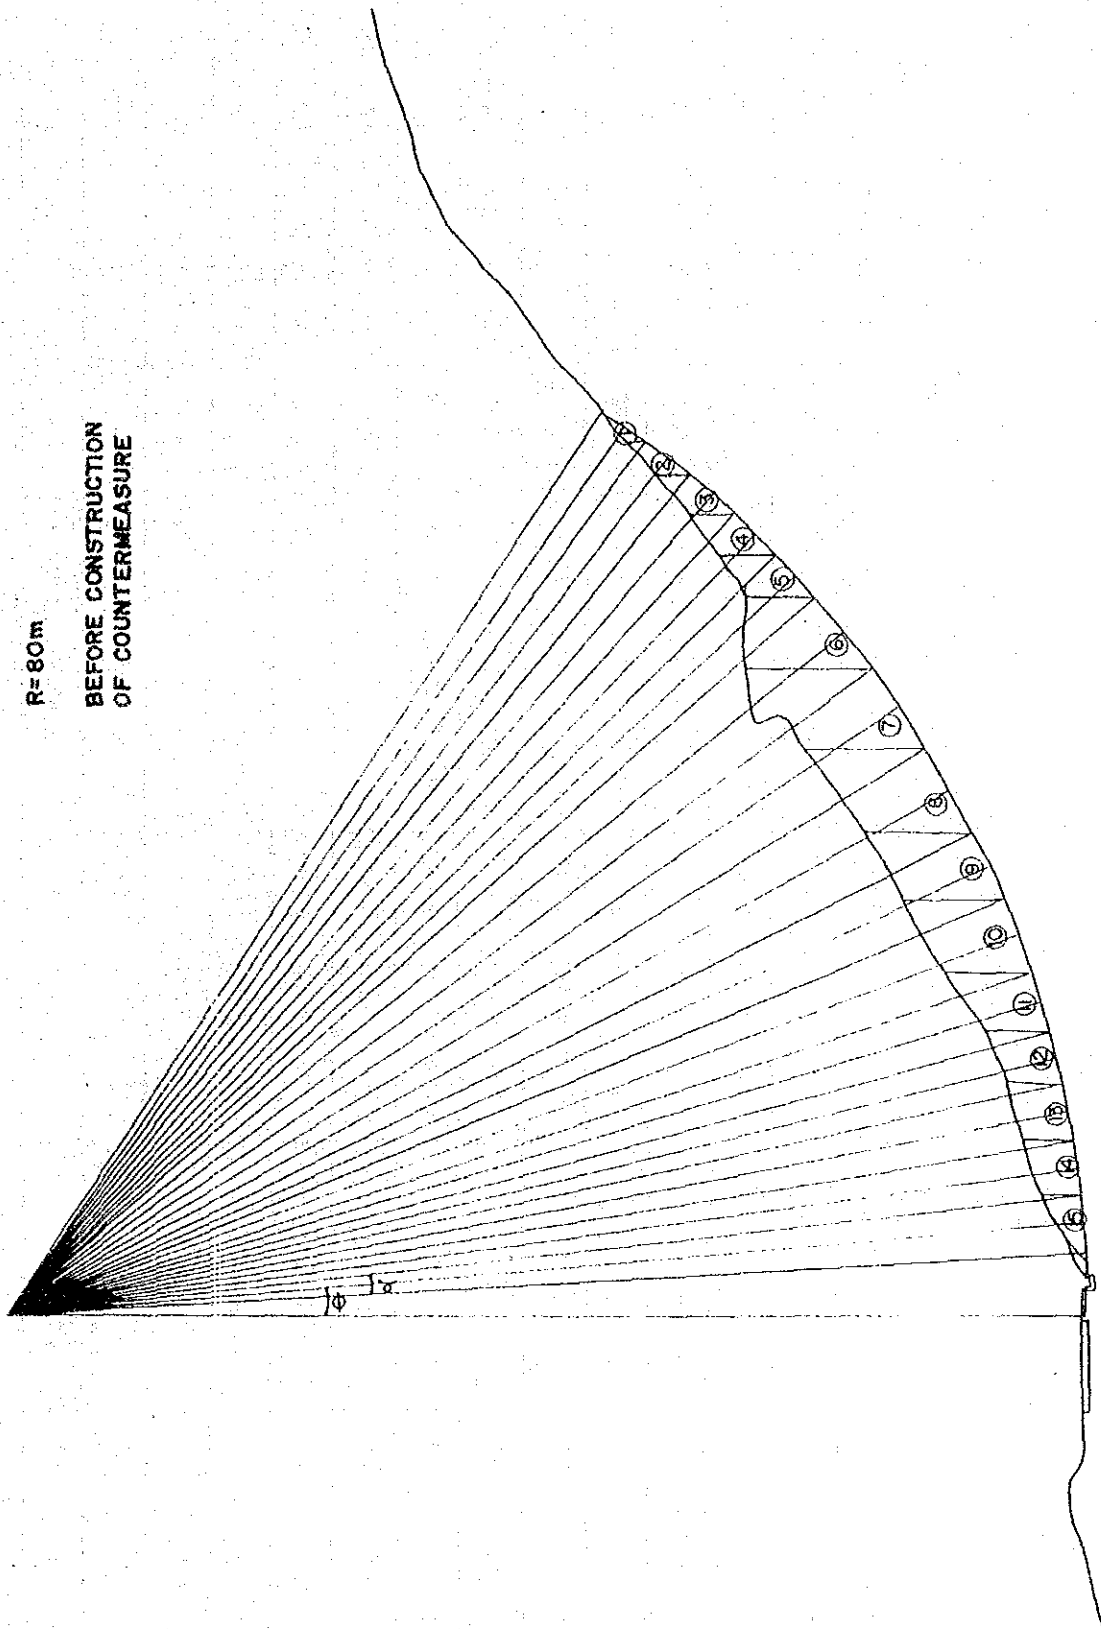
BEFORE CONSTRUCTION
OF COUNTERMEASURE

R = 80 m $\gamma = 1.8 \text{ t/m}^3$ $\phi = 10^\circ$ $c = 1.5 \text{ t/m}^2$ (BEFORE COUNTERMEASURE)													
Slice No.	(1) Area of Trapezium A (m ²)	(2) Unit Weight of Soil (t/m ³)	(3) Weight of Slices W = $\gamma \cdot A$ (t/m)	(4) ϕ (degrees)	(5) $\cos \phi$	(6) $\sin \phi$	(7) W cos ϕ	(8) tan ϕ	(9) W cos $\phi \cdot \tan \phi$	(10) W sin ϕ	(11) α	(12) $\frac{\alpha}{360^\circ} \cdot 2\pi r$	(13) C.d (t/m)
1	$\frac{1}{2} \times (1.2 \times 3.0) = 1.80$	1.8	3.24	55	0.5736	0.8192	1.858	.3249	0.604	2.554	3.0	4.19	6.285
2	$\frac{1.2 + 2.4}{2} \times 3.0 = 5.40$	1.8	9.72	52	0.6156	0.7860	5.984	.3249	1.944	7.659	3.0	4.19	6.285
3	$\frac{2.4 + 3.2}{2} \times 3.0 = 8.40$	1.8	15.12	49	0.6550	0.7547	9.919	.3249	3.222	11.411	3.0	4.19	6.285
4	$\frac{3.2 + 4.0}{2} \times 3.0 = 10.80$	1.8	19.44	46	0.6946	0.7193	13.503	.3249	4.387	13.983	3.0	4.19	6.285
5	$\frac{4.0 + 5.0}{2} \times 3.0 = 13.50$	1.8	24.30	43	0.7314	0.6820	17.773	.3249	5.774	16.573	3.0	4.19	6.285

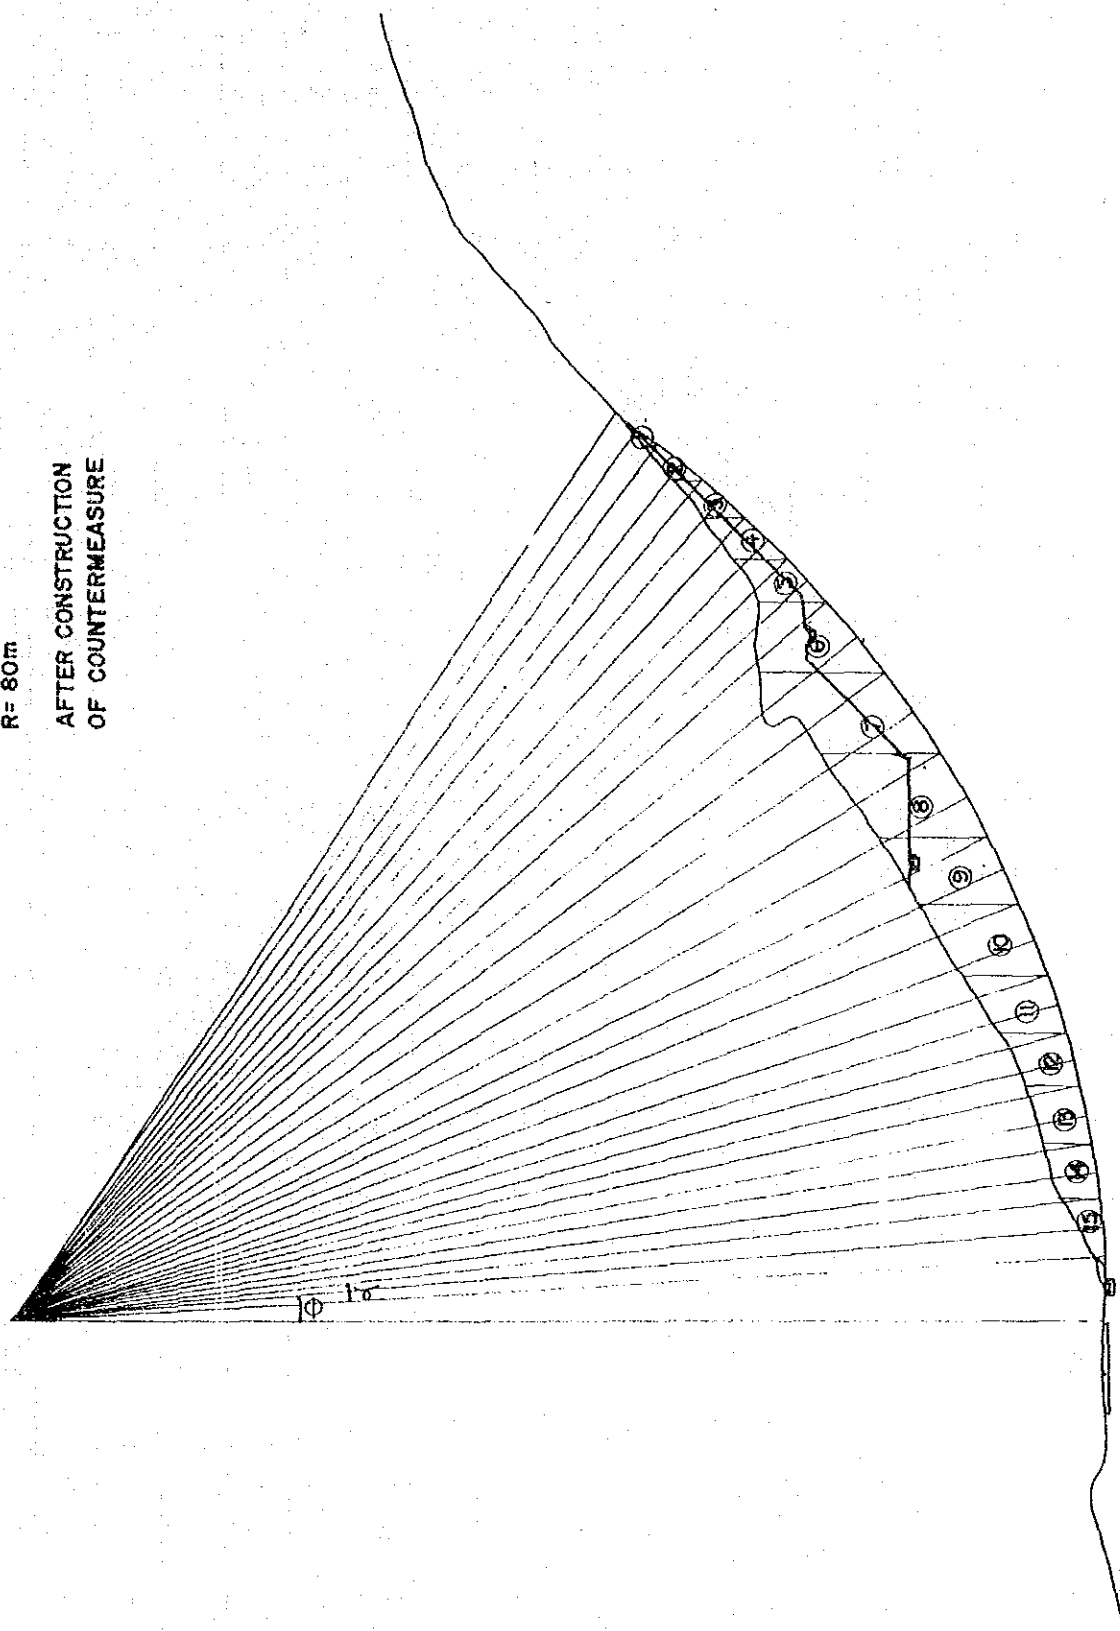
AFTER CONSTRUCTION
OF COUNTERMEASURE

R = 80 m $\gamma = 1.8 \text{ t/m}^3$ $\phi = 18^\circ$ C = 1.5 t/m^2 (AFTER COUNTERMEASURE)													
Slice No.	(1) Area of Trapezium A (m ²)	(2) Unit Weight of Soil (t/m ³)	(3) Weight of Slices W = $\gamma \cdot A$ (t/m)	(4) ϕ (degree)	(5) cos ϕ	(6) sin ϕ	(7) W cos ϕ	(8) tan ϕ	(9) W cos $\phi \cdot \tan \phi$	(10) W sin ϕ	(11) $\alpha = \frac{1}{2} \frac{W \sin \phi}{360^\circ}$	(12) $\alpha = \frac{1}{2} \frac{W \sin \phi}{360^\circ}$	(13) C $\cdot \frac{1}{r}$ (t/m)
1	$\frac{1}{2} \times (0.6 \times 3.0) = 0.90$	1.8	1.62	55	0.5736	0.8192	0.929	.3249	0.302	1.327	3.0	4.19	6.285
2	$\frac{0.6 + 1.2}{2} \times 3.0 = 2.70$	1.8	4.86	52	0.6156	0.7880	2.992	.3249	0.972	3.830	3.0	4.19	6.285
3	$\frac{1.2 + 1.6}{2} \times 3.0 = 4.20$	1.8	7.56	49	0.6560	0.7547	4.959	.3249	1.611	5.706	3.0	4.19	6.285
4	$\frac{1.6 + 1.6}{2} \times 3.0 = 4.80$	1.8	8.64	46	0.6946	0.7193	6.001	.3249	1.950	6.215	3.0	4.19	6.285

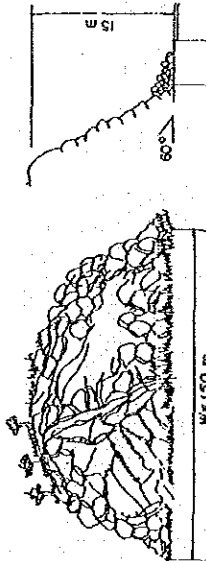
No.	Spot No.	Km. Type of Disaster	Existing Slope Condition		Geological Condition	Water Condition	Factor for Selection of Countermeasures	Countermeasures
			Dimension of Slope					
1	IVA-6	153 + 900 C-F

<ul style="list-style-type: none">Hard Rock.Sandstone.Slightly weathered and developed crack.	<ul style="list-style-type: none">Surface water flows on the slope.	<ul style="list-style-type: none">Slope is steeper than optimum and stable.Progress of weathering may not be remarkable.Detached rocks exist on the slope.Fallen rock size: 30~57cmBig cracks developed.	<ul style="list-style-type: none">Removal.Anchor wire net.	
2	IVA-7	154 + 100 C-F

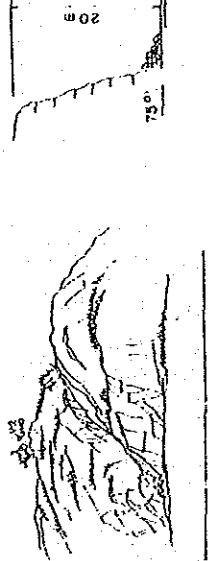
<ul style="list-style-type: none">Hard Rock.Sandstone.Slightly weathered and developed crack.Cracks slightly developed.	<ul style="list-style-type: none">A little concentration of slope surface water.	<ul style="list-style-type: none">Slope is steep but stable.Progress of weathering may be remarkable.Fallen rock size: 30~75cmSmall cracks, not so developed.	<ul style="list-style-type: none">Removal.Concrete spraying, t = 10cm

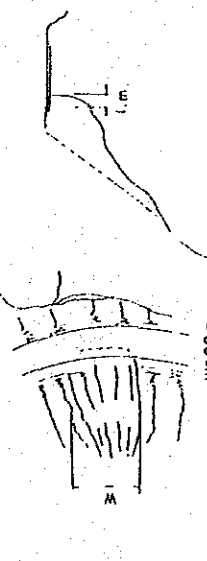
3	IVA-8	155 + 100 E-D, F

<ul style="list-style-type: none">Embankment material	<ul style="list-style-type: none">Concentration of road surface water.Road surface water also saturates into the embankment materials.	<ul style="list-style-type: none">Embankment slope is steep.No existing slope protection.Poor drainage facilities exist on the roadway.	<ul style="list-style-type: none">Re-filling.Stone masonry retaining wall.Side ditch.Vertical ditch.	
4	IVA-13 -1	156 + 700 E-D, F

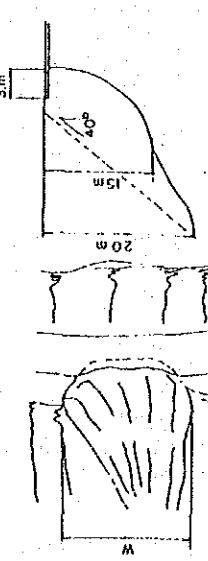
<ul style="list-style-type: none">Embankment material. (Sandy Soil)	<ul style="list-style-type: none">Road surface water saturates into the embankment materials.	<ul style="list-style-type: none">Slope is not so steep.Poor drainage facilities exist on the roadway.Embankment materials were saturated by road surface water.	<ul style="list-style-type: none">Under construction.

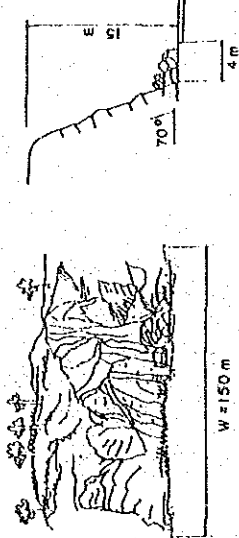
No.	Spot No.	Km. Type of Disaster	Existing Slope Condition			Factor for Selection of Countermeasures	Countermeasures
			Dimension of Slope	Geological Condition	Water Condition		
5	IVA-15	157 + 600 C-F

<ul style="list-style-type: none"> Soft Rock. Limestone. Highly weathered and developed crack. 	<ul style="list-style-type: none"> Surface water flows on the slope and a little concentration of surface water from hinterland. 	<ul style="list-style-type: none"> Slope is steep but not so high. Progress of weathering is anticipated on weak soft rock. Fallen rock size: 0.50~1.00m 	<ul style="list-style-type: none"> Re-alignment. Re-cutting (left portion). Catch wall. Top slope ditch. Berm ditch. Side ditch.
6	IVA-17	158 + 500 C-D.F

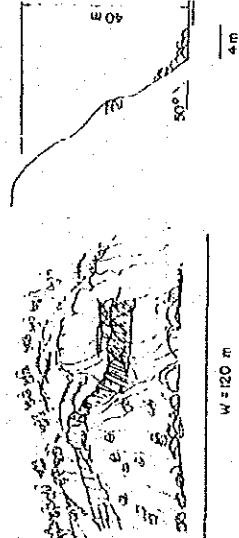
<ul style="list-style-type: none"> Soft Rock. Limestone. Highly weathered and developed crack. 	<ul style="list-style-type: none"> Surface water flows on the slope. 	<ul style="list-style-type: none"> Slope is a little bit steep. More progress of weathering occurs due to surface water. Very weak soft rock. Detached rock exist on the slope. Fallen rock size: 30~75cm 	<ul style="list-style-type: none"> Re-alignment. Re-cutting. Removal. Catch wall. Side ditch.

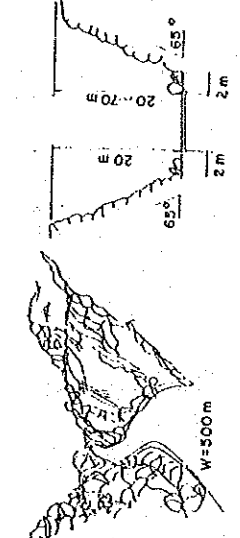
7	IVA-18	158 + 900 C-F

<ul style="list-style-type: none"> Soft Rock. Limestone. Highly weathered and developed crack. 	<ul style="list-style-type: none"> Slope surface water flows on the slope and a little concentration of surface water from hinterland. 	<ul style="list-style-type: none"> Slope is steep and high. Progress of weathering is anticipated on weak soft rock. Fallen rock. 	<ul style="list-style-type: none"> Re-alignment. Concrete spraying (t = 15cm) Re-cutting (left portion). Removal (right portion). Catch wall. Top slope ditch (left portion). Berm ditch (left portion). Side ditch.
8	IVA-20	160 + 800 L.S.

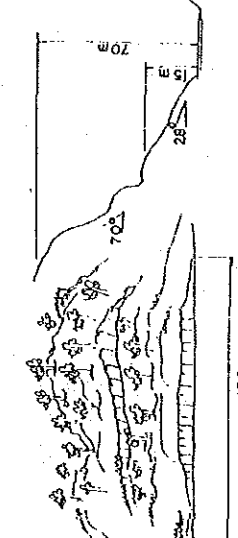
<ul style="list-style-type: none"> Cohesive soil. 	<ul style="list-style-type: none"> Surface and seepage water flows on the slopes. 	<ul style="list-style-type: none"> Top slope is steep. Cliff is susceptible to slide. Treatment of water. 	<ul style="list-style-type: none"> Removal (Cliff). Re-cutting (lower portion). Vegetation. Stone pitching waterway. Pipe culvert (1000 mm Ø). Berm ditch. Side ditch. (Case Study)

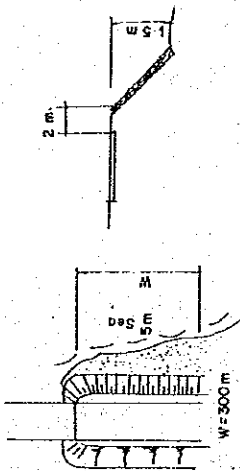
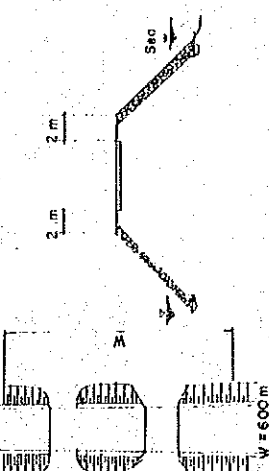
No.	Spot No.	Km. Type of Disaster	Existing Slope Condition		Geological Condition	Water Condition	Factor for Selection of Countermeasures	Countermeasures
			Dimension of Slope					
1	VIII-1	664 + 400 E-D.F

<ul style="list-style-type: none">Riprapped embankment slope.	<ul style="list-style-type: none">Existing slope protection by riprap.Scouring by sea waves during high tide.		<ul style="list-style-type: none">Spots excluded from the study.Overflow of sea water should be remedied as riparian project.
2	VIII-2	681 + 700 E-D.F

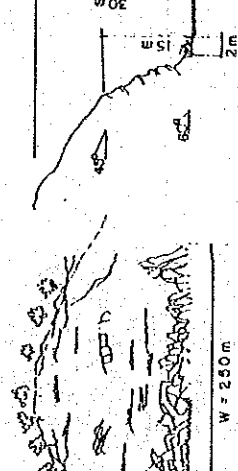
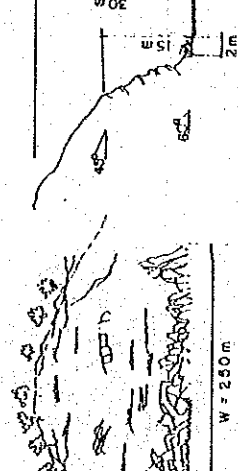
<ul style="list-style-type: none">Soft rock.Sandstone.Slightly weathered and developed crack.	<ul style="list-style-type: none">Surface water flows on the slope and a little concentrated.	<ul style="list-style-type: none">Slope is steep but not so high.Progress of weathering may not be remarkable.Detached rocks exist on the slope.Failed rock size: 30 75cm	<ul style="list-style-type: none">Removal.Concrete spraying t = 15cm for lower portion of slope.Anchor wire net for upper portion of slope.Side ditch.Top slope ditch.Vertical ditch.

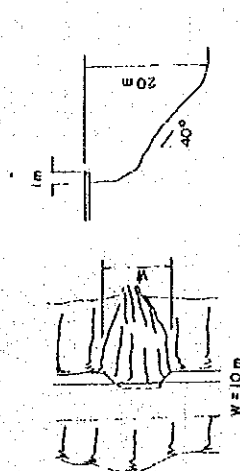
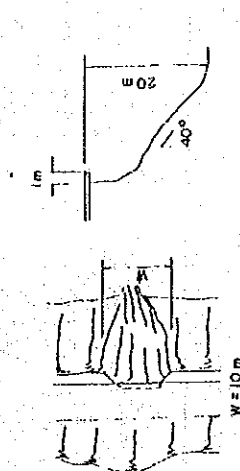
4	VIII-15-1	694 + 700 E-D.F

<ul style="list-style-type: none">Embankment materials. (Gravelly Soil)	<ul style="list-style-type: none">Concentration of road surface water.Road surface water saturates into embankment materials.	<ul style="list-style-type: none">Slope is steep and high.Poor drainage facilities exist on the roadway.	<ul style="list-style-type: none">Re-filling.Stone masonry retaining wall.Pipe culvert (1000 mm Ø)

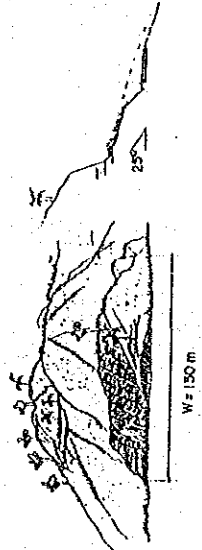
No.	Spot No.	Km. Type of Disaster	Existing Slope Condition			Factor for Selection of Countermeasures	Countermeasures
			Dimension of Slope	Geological Condition	Water Condition		
5	VIII-16	698 + 300 D-F

<ul style="list-style-type: none"> Water from hinterland concentrates at this place. Groundwater is high. 	<ul style="list-style-type: none"> Cliff is susceptible to slide. Control of water flow. High groundwater. Slope is steep. Vegetation can grow. 	<ul style="list-style-type: none"> Debris Flow. Re-cutting. Vegetation. Stone pitching waterway. Close conduit with open ditch. Horizontal drain hole (60 mm Ø). Cut Slope. Re-cutting. Vegetation. (Case Study)
6	VIII-18	701 + 200 E-D, F

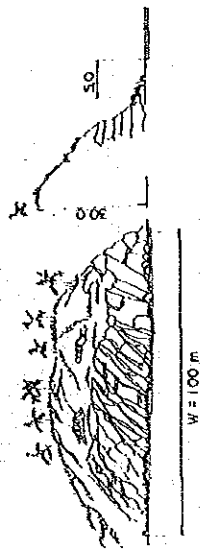
7	VIII-21	703 + 800 C-F

<ul style="list-style-type: none"> Hard rock. Sandstone. Slightly weathered and regular crack. 	<ul style="list-style-type: none"> Water from hinterland flows on the slope. 	<ul style="list-style-type: none"> Slope is not so steep but high. Progress of weathering may be remarkable. 	<ul style="list-style-type: none"> Concrete spraying. (t = 10cm) Re-cutting (spot portion). Top slope ditch. Side ditch. Vertical ditch. (Case Study)
8	VIII-21	705 + 200 C-F

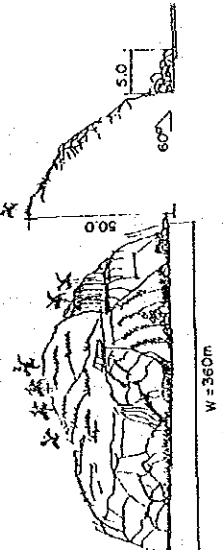
<ul style="list-style-type: none"> Soft rock. Sandstone. Highly weathered and developed crack. 	<ul style="list-style-type: none"> Water from hinterland flows on the slope and a little concentrated. 	<ul style="list-style-type: none"> Slope is little bit steep and high. Progress of weathering is anticipated. Weak earth pressure is expected because of soft rock. 	<ul style="list-style-type: none"> Re-alignment. Removal. Excavation. Catch wall. Side ditch.

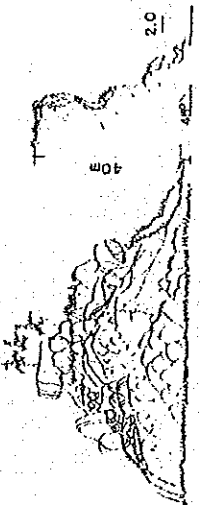
W = 180 m	<ul style="list-style-type: none"> Hard and soft rock. Limestone and sandstone. Highly weathered and developed crack. 	<ul style="list-style-type: none"> Surface water flows on the slope. 	<ul style="list-style-type: none"> Slope is almost optimum but high. More progress of weathering occurs due to surface water. Detached rock exist on the slope. Weak earth pressure is expected. 	<ul style="list-style-type: none"> Re-alignment. Removal. Catch wall. Side ditch.

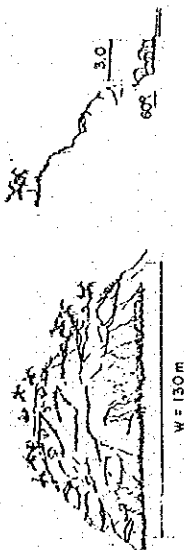
11	VIII-30	708 + 600 C-F

W = 130 m	<ul style="list-style-type: none"> Hard rock. Sandstone. Slightly weathered and regular crack. 	<ul style="list-style-type: none"> Water from hinterland flows on the slope. 	<ul style="list-style-type: none"> Slope is a little bit steep but not so high. Progress of weathering may be remarkable. Detached rock exist on the slope. 	<ul style="list-style-type: none"> Concrete spraying. (t = 10cm). Re-cutting. Catch wall. Top slope ditch. Berm ditch. Side ditch.
12	VIII-31	708 + 650 C-F

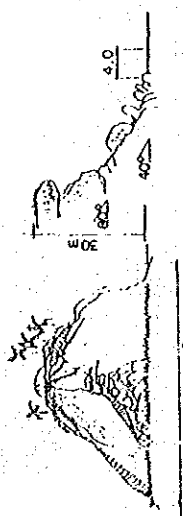
W = 60 m	<ul style="list-style-type: none"> Soft rock. Sandstone, shale. Slightly weathered and developed crack. 	<ul style="list-style-type: none"> Water from hinterland flows on the slope and a little concentrated. 	<ul style="list-style-type: none"> Slope is a little bit steep but not so high. Progress of weathering may be remarkable. 	<ul style="list-style-type: none"> Re-cutting. Berm ditch. Top slope ditch. Side ditch.

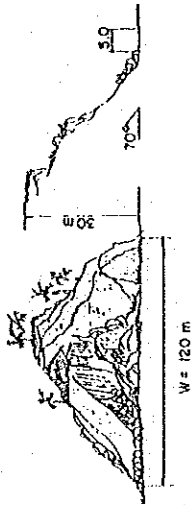
No.	Spot No. of Disaster	Existing Slope Condition			Factor for Selection of Countermeasures	Countermeasures
		Dimension of Slope	Geological Condition	Water Condition		
13	VIII-32 709 + 600 C-F

<ul style="list-style-type: none"> Soft rock. Sandstone, shale. Slightly weathered and developed crack. Cracks inclined to road. Weak portion exist in the slope between the strata. 	<ul style="list-style-type: none"> Water from hinterland flows on the slope. 	<ul style="list-style-type: none"> Slope is steep but not so high. More progress of weathering occurs due to surface water. Detached rock exist on the slope. 	<ul style="list-style-type: none"> Re-aligning. Removal. Re-cutting (spot portion). Catch wall. Side ditch. (Case Study)
14	VIII-33 717 + 700 C-S-F

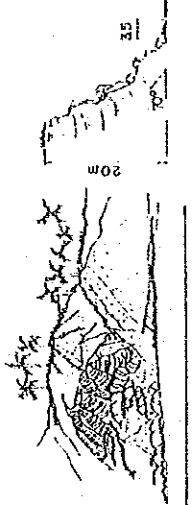
<ul style="list-style-type: none"> Hard and soft rock. Sandstone, and shale. Highly weathered and developed crack. 	<ul style="list-style-type: none"> Water from hinterland flows on the slope. 	<ul style="list-style-type: none"> Slope is steep but not so high. Progress of weathering is anticipated. Weak earth pressure is expected. 	<ul style="list-style-type: none"> Re-cutting. Top slope ditch. Berm ditch. Side ditch.

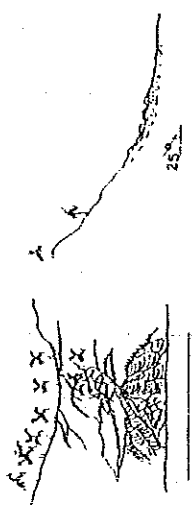
15	VIII-36 718 + 100 D.F

<ul style="list-style-type: none"> Concentration of slope surface water from hinterland. 	<ul style="list-style-type: none"> Slope is stable and covered by tree and grasses. Protection of slope is not reasonable. Wide shoulder. Control of water flow. 	<ul style="list-style-type: none"> Re-cutting. Catch wall. Stone pitching waterway. Berm ditch. Side ditch.
16	VIII-37 712 + 500 C-F

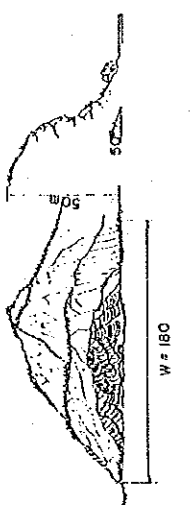
<ul style="list-style-type: none"> Hard rock. Andesite. Highly weathered and developed crack. 	<ul style="list-style-type: none"> Surface water flows on the slope. 	<ul style="list-style-type: none"> Slope is a little bit steep and high. Progress of weathering is anticipated. Weak earth pressure is expected. 	<ul style="list-style-type: none"> Re-aligning. Removal. Excavation. Catch wall. Side ditch.

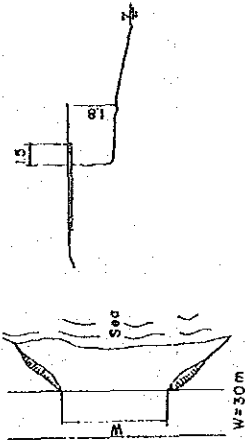
No.	Spot No.	Km. Type of Disaster	Existing Slope Condition			Factor for Selection of Countermeasures	Countermeasures
			Dimension of Slope	Geological Condition	Water Condition		
17	WIII-39-1	721 + 800 E-D.F.

<ul style="list-style-type: none"> Embankment material - (Sand) 	<ul style="list-style-type: none"> No existing slope protection. Scouring by the sea wave during high tide. 		<ul style="list-style-type: none"> Under construction.

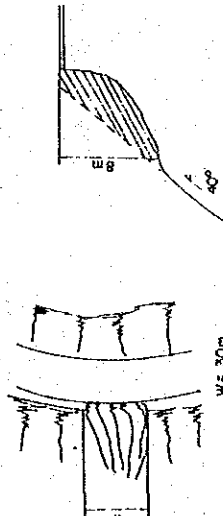
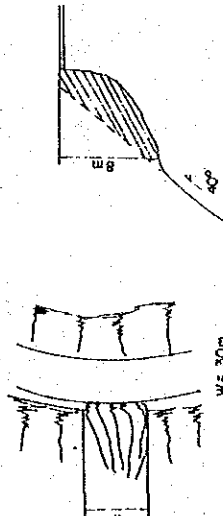
No.	Spot No.	Km. Type of Disaster	Existing Slope Condition		Geological Condition	Water Condition	Factor for Selection of Countermeasure	Countermeasures
			Dimension	Slope Condition				
1	IN-3-2	276 + 550 E-O.F

<ul style="list-style-type: none"> Embankment material. (Cohesive Soil) 	<ul style="list-style-type: none"> Concentration of road surface water. Road surface water saturates into embankment materials. 	<ul style="list-style-type: none"> Embankment slope is steep. No existing slope protection. Poor drainage facilities exist on the roadway. 	<ul style="list-style-type: none"> Re-filling. Stone masonry R.W. Side ditch.
2	IN-4-1	281 + 500 C-O.F

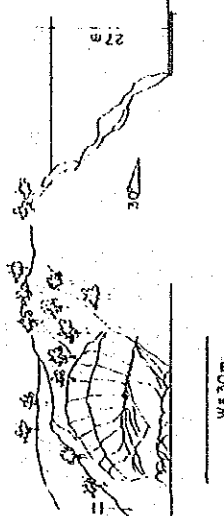
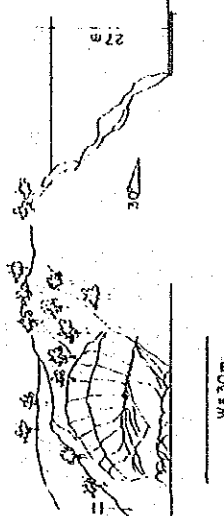
<ul style="list-style-type: none"> Soft rock. Sandstone. Gravelly Soil. Highly weathered and developed crack. 	<ul style="list-style-type: none"> Concentration of slope surface water from hinterland. A little seepage of water occurs. 	<ul style="list-style-type: none"> Treatment of water. Vegetation can grow. Slope is gentle. 	<ul style="list-style-type: none"> Removal. Vegetation. Stone pitching waterway. Berm ditch. Side ditch. Pipe culvert. (1000 mm Ø) (Case Study)

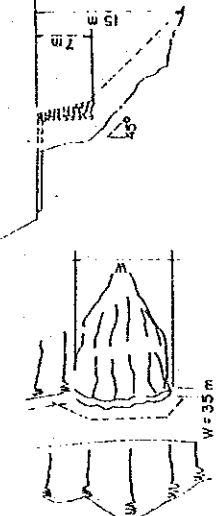
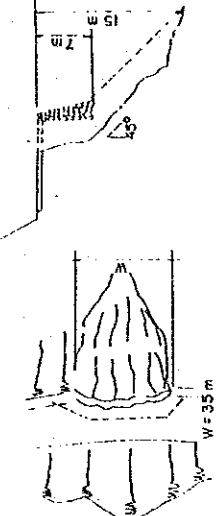
3	IN-4-4	286 + 600 E-O.F

<ul style="list-style-type: none"> Embankment material. (Cohesive Soil) 	<ul style="list-style-type: none"> Concentration of road surface water. Road surface water saturates into embankment materials. 	<ul style="list-style-type: none"> Embankment slope is steep. Poor drainage facilities. 	<ul style="list-style-type: none"> Re-filling. Stone masonry R.W. Side ditch.
4	IN-4-5	287 + 800 E-O.F

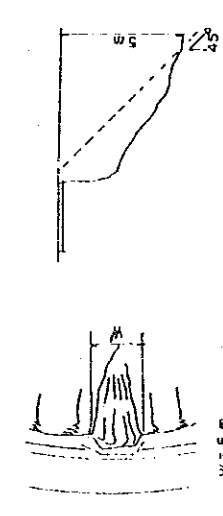
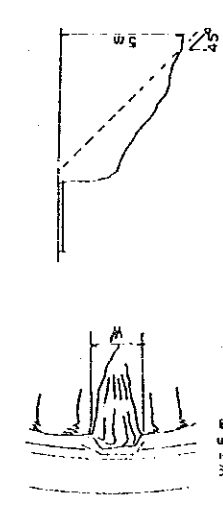
<ul style="list-style-type: none"> Embankment material. (Cohesive Soil) 	<ul style="list-style-type: none"> Concentration of road surface water. Road surface water saturates into embankment materials. 	<ul style="list-style-type: none"> Embankment slope is steep. No existing slope protection. Poor drainage facilities. 	<ul style="list-style-type: none"> Re-filling. Stone masonry R.W. Side ditch.

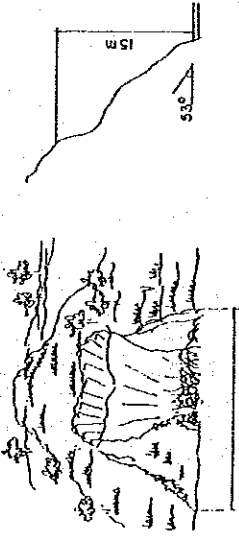
No.	Spot No.	Km. Type of Disaster	Existing Slope Condition			Factor for Selection of Countermeasures	Countermeasures
			Dimension of Slope	Geological Condition	Water Condition		
5	IN-5	288 + 300 C-F

<ul style="list-style-type: none"> Soft rock. Tuff. Highly weathered and developed crack. 	<ul style="list-style-type: none"> Surface water flows on the slope. 	<ul style="list-style-type: none"> Slope gradient is a little bit steep but not so high. More progress of weathering occurs due to surface water. Rock has many cracks and joints. Vegetation can not grow. 	<ul style="list-style-type: none"> Removal. Concrete spraying. (t = 15cm) Side ditch. Vertical ditch. Top slope ditch.
6	IN-7	288 + 700 C-F

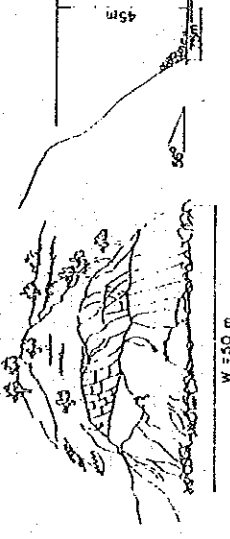
<ul style="list-style-type: none"> Hard rock. Tuff. Slightly weathered and developed crack. 	<ul style="list-style-type: none"> Surface water flows on the slope. 	<ul style="list-style-type: none"> Slope gradient is optimum but very steep above 20m thereafter. Progress of weathering is may not be remarkable. Wide shoulder. Utilized as quarry. 	<ul style="list-style-type: none"> Re-cutting (above 20m) at top portion. Stone masonry catch wall. Side ditch.

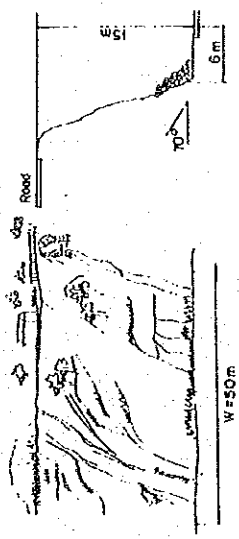
7	IN-8-4	291 + 000 C-S.F

<ul style="list-style-type: none"> Soft rock. Tuff. Highly weathered and developed crack. 	<ul style="list-style-type: none"> A little concentration of slope surface water. 	<ul style="list-style-type: none"> Slope gradient is steep but not so high. More progress of weathering occurs due to surface water. There is a road at the top of slope. 	<ul style="list-style-type: none"> Re-filling. Gravity type R.W. (lower portion) Stone masonry R.W. (upper portion) Berm ditch. Side ditch.
8	IN-8-5	291 + 050 E-O.F

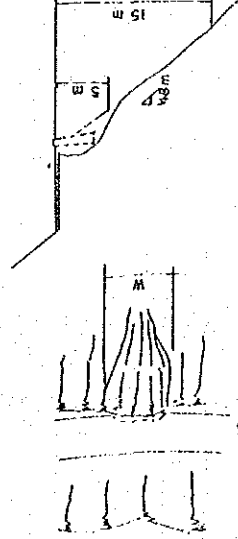
<ul style="list-style-type: none"> Embankment material. (Cohesive Soil) 	<ul style="list-style-type: none"> Concentration of road surface water. Road surface water also saturates into the embankment materials. 	<ul style="list-style-type: none"> Embankment slope is steep. Poor drainage facilities. 	<ul style="list-style-type: none"> Re-filling. Stone masonry retaining wall. Side ditch. Berm ditch. <p>(Case Study)</p>

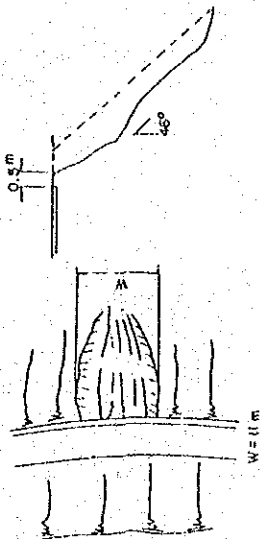
No.	Spot No.	Km. Type of Disaster	Existing Slope Condition			Geological Condition	Water Condition	Factor for Selection of Countermeasures	Countermeasures
			Dimension of Slope						
17	IN-19-1	301 + 600 E-D.F.

Embankment material. (Gravelly Soil)	Concentration of road surface water. Road surface water saturates into embankment material.		Under construction.	
18	IN-23-1	301 + 500 E-D.F.
