#### APPENDIX 7.1-2 CHECK TABLE

LUCENA ~ ATIMONAN SECTION

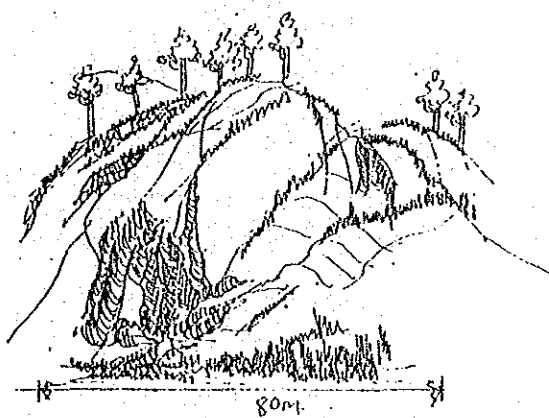
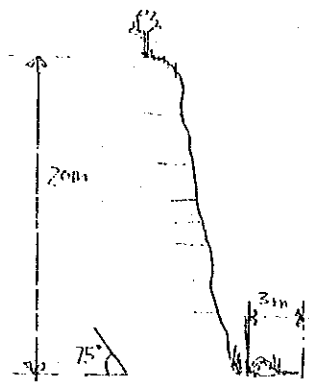
Route		MH (WA-7)		Km. Post	157.100	Width	80 M	Sheet No.	S-6	
								Region	WA	
Evidence of Falls	1	Kind of Slope	(1) <input checked="" type="checkbox"/> Cut Slope		(2) Natural Slope					
	2	Type of Fall	(1) Debris Fall		(2) <input checked="" type="checkbox"/> Rock Fall					
	3	Fallen Rock Size	(1) 20 <sup>cm</sup> >		(2) 20 <sup>cm</sup> ~ 50 <sup>cm</sup>		(3) <input checked="" type="checkbox"/> 50 <sup>cm</sup> <			
	4	Date Occured	Day		Month		Year			
	5	Traffic Interruption Period	(1) 1 day >		(2) 1 day ~ 7 days		(3) 7 days <			
	6	Counter Measure Taken	(1) Structure ( )		(2) Removal of Fallen Rock		(3) Others			
	7	Rainfall Intensity/Day	(1) 100 <sup>mm</sup> >		(2) 100 <sup>mm</sup> ~ 200 <sup>mm</sup>		(3) 200 <sup>mm</sup> ~ 300 <sup>mm</sup>		(4) 300 <sup>mm</sup> <	
Existing Slope Condition	8	Slope Height	(1) 10 <sup>m</sup> >		(2) <input checked="" type="checkbox"/> 10 <sup>m</sup> ~ 30 <sup>m</sup>		(3) 30 <sup>m</sup> ~ 50 <sup>m</sup>		(4) 50 <sup>m</sup> <

9	Slope Gradient	(1) 45° >		(2) 45° ~ 60°		(3) <input checked="" type="checkbox"/> 60° <		(4) Overhung	
	10	Degree of Saturation	(1) Dry		(2) Wet		(3) Seepage		(4) Spring	
	11	Surface Water Concentration	(1) <input checked="" type="checkbox"/> None		(2) Low		(3) High			
	12	Berm	(1) Existing Number ( ) With ( )		(2) <input checked="" type="checkbox"/> Nothing					
	13	Slope Protection	(1) Structure ( )		(2) Vegetation		(3) <input checked="" type="checkbox"/> Nothing			
	14	Drainage Facilities	(1) Existing ( )		(2) <input checked="" type="checkbox"/> Nothing					
Geological Condition	Debris Fall	15	Matrix Condition	(1) <input checked="" type="checkbox"/> Hard		(2) Soft		(3) Loose (4) Loose with detached cabbie		
		16	Gully	(1) Rare		(2) Common		(3) Frequently		
	Rock Fall	17	Detached Rock or cabbie	(1) <input checked="" type="checkbox"/> Nothing		(2) Supported Stably		(3) Supported Unstably		
		18	Rock Name	(1) Granite (2) Diorite (3) Diabase (4) Andesite (5) Dacite (6) Schist (7) Slate (8) Limestone (9) Schalstein (10) Tuff (11) Tuffbreccie (12) <input checked="" type="checkbox"/> Sandstone (13) Shale (14) Mudstone (15) Conglomerate (16) Masa (17) Volcaniclasties

19	Weathering Condition	(1) Fresh		(2) <input checked="" type="checkbox"/> Slightly Weathered		(3) Highly Weathered		
		20	Condition of Crack	(1) Sparse		(2) Regular		(3) <input checked="" type="checkbox"/> Developed		
		21	Direction of Crack	(1) <input checked="" type="checkbox"/> Inclined to Mountain		(2) Irregular Inclination		(3) Inclined to Slope		
Engi- neering Judge- ment	22	Impact to Road	(1) Low		(2) <input checked="" type="checkbox"/> Average		(3) High			
	23	Cause of Fall								
	24	Counter Measure								
Sketch, etc.							Photo No.

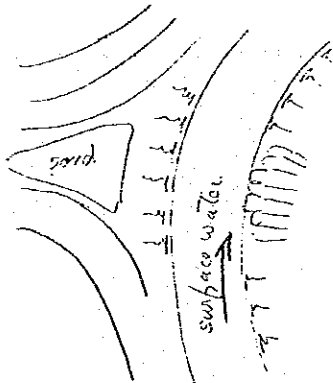
Sheet No.	S-7	
Route	M.H (TV4-8)	Km. Post	155.100	Width 20 M
		Region	TV4	
Evidence of Failure	1	Kind of Slope	(1) <input checked="" type="checkbox"/> Embankment Slope (2) Natural Slope (3) Overflow Section (5) Others	
	2	Location	(1) Approach of Bridge (2) Adjacent to River or Sea (3) <input checked="" type="checkbox"/> Inside of Curve (4) Others	
	3	Size of Disaster	(1) <input checked="" type="checkbox"/> 50 <sup>m3</sup> > (2) 50 <sup>m3</sup> ~ 100 <sup>m3</sup> (3) 100 <sup>m3</sup> <	
	4	Date Occured	Day Month Year 1983 (Bebenz)	
	5	Traffic Interruption Period	(1) 1 day > (2) 1 day ~ 7 days (3) 7 days <	
	6	Counter Measure Taken	(1) <input checked="" type="checkbox"/> Only Fill (2) Riprap (3) Other Structure ( )	
	7	Rainfall Intensity/Day	(1) 100 <sup>mm</sup> > (2) 100 <sup>mm</sup> ~ 200 <sup>mm</sup> (3) 200 <sup>mm</sup> ~ 300 <sup>mm</sup> (4) 300 <sup>mm</sup> <	
Existing Slope Condition	8	Slope Height	(1) 5 <sup>m</sup> > (2) <input checked="" type="checkbox"/> 5 <sup>m</sup> ~ 10 <sup>m</sup> (3) 10 <sup>m</sup> <

9	Slope Gradient	(1) <input checked="" type="checkbox"/> 45° > (2) 45° ~ 60° (3) 60° <	
	10	Surface Water Concentration	(1) None (2) Low (3) <input checked="" type="checkbox"/> High	
	11	Slope Protection	(1) Nothing (2) <input checked="" type="checkbox"/> Vegetation (3) Riprap (4) Other Structure ( )	
Engl-neering Judge-ment	12	Drainage Facilities	(1) <input checked="" type="checkbox"/> Nothing (2) Existing	
	13	Impact to Road	(1) Low (2) <input checked="" type="checkbox"/> Average (3) High	
	14	Cause of Disaster	(1) <input checked="" type="checkbox"/> Concentration of Surface Water (2) River Stream (3) Sea Wave (4) Others	
	15	Counter Measure		
Sketch, etc.			Photo No.

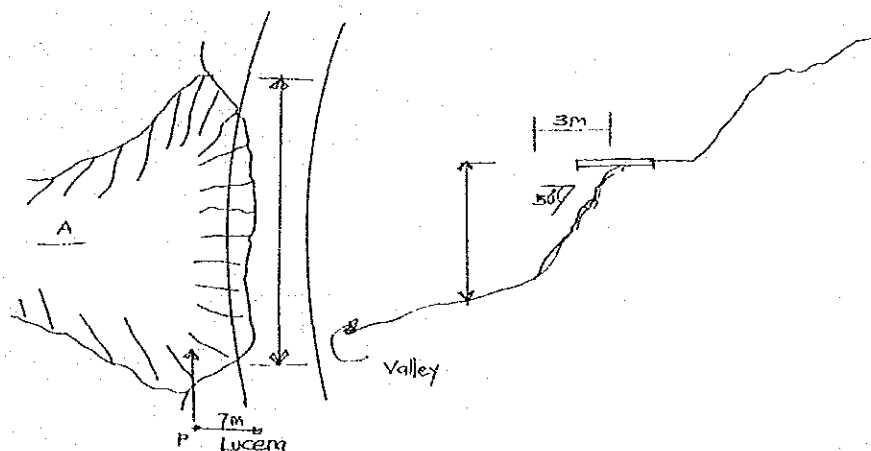
Route		M.H (VA-13-1)	Km. Post	156.700	Width	40 M	Sheet No.	S-10-1
							Region	IVA
Evidence of Failure	1	Kind of Slope	(1) <input checked="" type="checkbox"/> Embankment Slope (2) Natural Slope (3) Overflow Section (5) Others					
	2	Location	(1) Approach of Bridge (2) Adjacent to River or Sea (3) Inside of Curve (4) <input checked="" type="checkbox"/> Others					
	3	Size of Disaster	(1) $50^{\text{m}^3} >$ (2) $50^{\text{m}^3} \sim 100^{\text{m}^3}$ (3) <input checked="" type="checkbox"/> $100^{\text{m}^3} <$					
	4	Date Occured	Day 21 Month Oct. Year 1984					
	5	Traffic Interruption Period	(1) 1 day > (2) <input checked="" type="checkbox"/> 1 day ~ 7 days (3) 7 days <					
	6	Counter Measure Taken	(1) <input checked="" type="checkbox"/> Only Fill (2) Riprap (3) Other Structure ( )					
	7	Rainfall Intensity/Day	(1) $100^{\text{mm}} >$ (2) $100^{\text{mm}} \sim 200^{\text{mm}}$ (3) <input checked="" type="checkbox"/> $200^{\text{mm}} \sim 300^{\text{mm}}$ (4) $300^{\text{mm}} <$

Existing Slope Condition	8	Slope Height	(1) $5^{\text{m}} >$ (2) $5^{\text{m}} \sim 10^{\text{m}}$ (3) <input checked="" type="checkbox"/> $10^{\text{m}} <$					
	9	Slope Gradient	(1) <input checked="" type="checkbox"/> $45^\circ >$ (2) $45^\circ \sim 60^\circ$ (3) $60^\circ <$					
	10	Surface Water Concentration	(1) None (2) <input checked="" type="checkbox"/> Low (3) High					
	11	Slope Protection	(1) Nothing (2) <input checked="" type="checkbox"/> Vegetation (3) Riprap (4) Other Structure ( )					
Engineering Judgment	12	Drainage Facilities	(1) <input checked="" type="checkbox"/> Nothing (2) Existing					
	13	Impact to Road	(1) Low (2) Average (3) <input checked="" type="checkbox"/> High					
	14	Cause of Disaster	(1) <input checked="" type="checkbox"/> Concentration of Surface Water (2) River Stream (3) Sea Wave (4) Others					
	15	Counter Measure						
Sketch, etc.							Photo No.

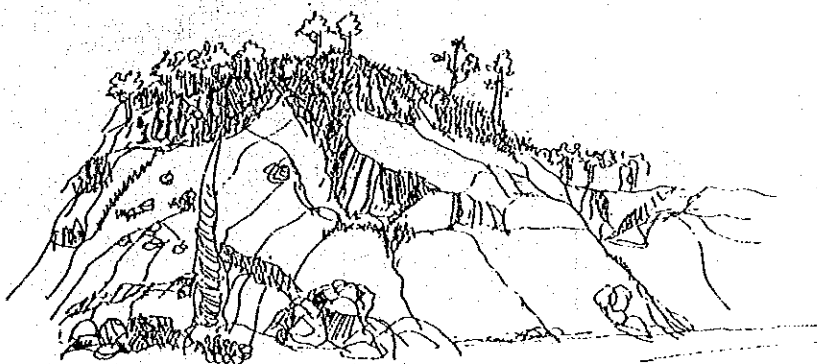
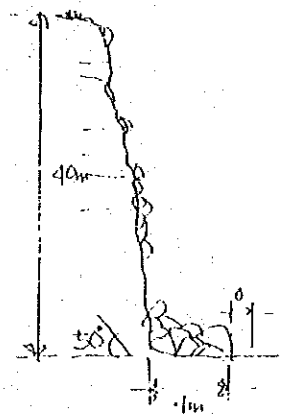
Route		Km. Post	Width	Region	Sheet No.	
17-H (NA-17)		158.500	120M	IV A	S-12	
Evidence of failure	1 Kind of Slope	( <input checked="" type="checkbox"/> ) Cut Slope	(2) Natural Slope			
	2 Kind of Failure	(1) Nothing	(2) Surface Failure ( <del>(3) Deep Failure</del> )			
	3 Size of Failure	(1) $50^{m^3} >$	(2) $50^{m^3} \sim 500^{m^3}$	(3) $500^{m^3} \sim 2,000^{m^3}$	(4) $2,000^{m^3} <$	
	4 Date Occured	Day	Month	Year		
	5 Traffic Interruption Period	(1) 1 day >	(2) 1 day $\sim$ 7 days	(3) 7 days <		
	6 Counter Measure Taken	(1) Structure ( )	(2) Removal of Slide Materials		(3) Others	
	7 Rainfall Intensity/Day	(1) 100 mm >	(2) $100^{mm} \sim 200^{mm}$	(3) $200^{mm} \sim 300^{mm}$	(4) $300^{mm} <$	
Existing Slope Condition	8 Height	(1) $10^m >$	(2) $10^m \sim 30^m$	(3) $30^m \sim 50^m$	(4) $50^m <$	
	9 Gradient	(1) $45^\circ >$	(2) $45^\circ \sim 60^\circ$	(3) $60^\circ <$	(4) Overhung	
	10 Berm	(1) Existing	Number ( )	Width ( )	(2) Nothing

Geological Condition	11 Slope Protection	(1) Structure ( )	(2) Vegetation	(3) Nothing		
	12 Hardness	(1) Hard Rock	(2) Soft Rock			
	13 Name	(1) Granite (2) Diorite (3) Diabase (4) Andesite (5) Basalt (6) Schist (7) Slate ( <del>(8) Limestone</del> ) (9) Schalstein (10) Turf (11) Tuffbreccia (12) Sandstone (13) Shale (14) Mudstone (15) Conglomerate (16) Masa (17) Volcaniclastics				
		14 Weathering Condition	(1) Fresh	(2) Slightly Weathered	(3) Highly Weathered (4) Nearly Soil	
		15 Condition of Crack	(1) Sparse	(2) Regular	(3) Developed	
		16 Direction of Crack	(1) Inclined to Mountain ( <del>(2) Irregular Inclination</del> ) (3) Inclined to Slope			
		17 Thickness	(1) $5^m >$	(2) $5^m \sim 10^m$	(3) $10^m \sim 20^m$	(4) $20^m <$
	Soil	18 Compactness	(1) Tight	(2) Slightly loose	(3) Loose	
		19 Degree of Saturation	( <input checked="" type="checkbox"/> ) Dry	(2) Wet	(3) Seepage	(4) Spring
		20 Surface Water Concentration	( <input checked="" type="checkbox"/> ) None	(2) Low	(3) High

Water Condition	21 Drainage Facilities	(1) Existing ( )	(2) Nothing			
	22 Impact to Road	(1) Low	(2) Average	(3) High		
Engineering Judgment	23 Cause of Disaster					
	24 Counter Measure					
Sketch, etc.			Photo No.

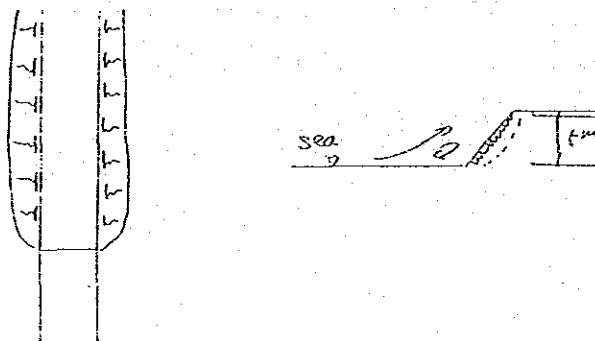
Sheet No. S-54	
Route	M.H. (VII - 1 - )	Km. Post	664.400	Width	300 M
		Region	VII		
Evidence of Failure	1	Kind of Slope	(✓) Embankment Slope (2) Natural Slope (3) Overflow Section (5) Others		
	2	Location	(✓) Approach of Bridge (2) Adjacent to River or Sea (3) Inside of Curve (4) Others		
	3	Size of Disaster	(1) 50 <sup>m3</sup> > (✓) 50 <sup>m3</sup> ~ 100 <sup>m3</sup> (3) 100 <sup>m3</sup> <		
	4	Date Occured	Day Month 12 Year 1981. 1974		
	5	Traffic Interruption Period	(1) 1 day > (2) 1 day ~ 7 days (3) 7 days < 2 times destroyed riprap		
	6	Counter Measure Taken	(1) Only Fill (✓) Riprap (3) Other Structure ( )		
	7	Rainfall Intensity/Day	(1) 100 <sup>mm</sup> > (2) 100 <sup>mm</sup> ~ 200 <sup>mm</sup> (3) 200 <sup>mm</sup> ~ 300 <sup>mm</sup> (4) 300 <sup>mm</sup> <		
Existing Slope Condition	8	Slope Height	(1) 5 <sup>m</sup> > (✓) 5 <sup>m</sup> ~ 10 <sup>m</sup> (3) 10 <sup>m</sup> <		
	9	Slope Gradient	(1) 45° > (✓) 45° ~ 60° (3) 60° <

10	Surface Water Concentration	(1) None (✓) Low (3) High		
	11	Slope Protection	(1) Nothing (2) Vegetation (✓) Riprap (4) Other Structure ( )		
Engi- neering Judge- ment	12	Drainage Facilities	(✓) Nothing (2) Existing		
	13	Impact to Road	(1) Low (2) Average (✓) High		
	14	Cause of Disaster	(1) Concentration of Surface Water (2) River Stream (✓) Sea Wave (4) Others		
	15	Counter Measure			
Sketch, etc.				Photo No.

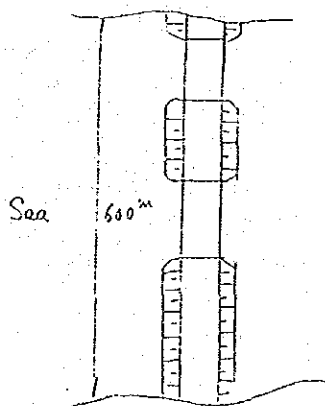
Route		NH (VII - 2)	Km. Post	681.700	Width	600 M	Sheet No.	S-55
							Region	VII
Evidence of Failure	1	Kind of Slope	<input checked="" type="checkbox"/> Embankment Slope (2) Natural Slope (3) Overflow Section (5) Others					
	2	Location	<input checked="" type="checkbox"/> Approach of Bridge (2) Adjacent to River or Sea (3) Inside of Curve (4) Others					
	3	Size of Disaster	(1) $50\text{m}^3 >$ (2) $50\text{m}^3 \sim 100\text{m}^3$ (3) $100\text{m}^3 <$					
	4	Date Occured	Day Month Year Heavy Tides in area					
	5	Traffic Interruption Period	(1) 1 day > (2) 1 day ~ 7 days (3) 7 days < none					
	6	Counter Measure Taken	(1) Only Fill <input checked="" type="checkbox"/> Riprap (3) Other Structure ( )					
	7	Rainfall Intensity/Day	(1) $100\text{mm} >$ (2) $100\text{mm} \sim 200\text{mm}$ (3) $200\text{mm} \sim 300\text{mm}$ (4) $300\text{mm} <$					
Existing Slope Condition	8	Slope Height	<input checked="" type="checkbox"/> $5\text{m} >$ (2) $5\text{m} \sim 10\text{m}$ (3) $10\text{m} <$

9	Slope Gradient	(1) $45^\circ >$ <input checked="" type="checkbox"/> $45^\circ \sim 60^\circ$ (3) $60^\circ <$					
	10	Surface Water Concentration	<input checked="" type="checkbox"/> None (2) Low (3) High					
	11	Slope Protection	(1) Nothing (2) Vegetation <input checked="" type="checkbox"/> Riprap (4) Other Structure ( )					
Engi- neering Judge- ment	12	Drainage Facilities	<input checked="" type="checkbox"/> Nothing (2) Existing					
	13	Impact to Road	(1) Low (2) Average <input checked="" type="checkbox"/> High					
	14	Cause of Disaster	(1) Concentration of Surface Water (2) River Stream <input checked="" type="checkbox"/> Sea Wave (4) Others					
	15	Counter Measure						
Sketch, etc.							Photo No.

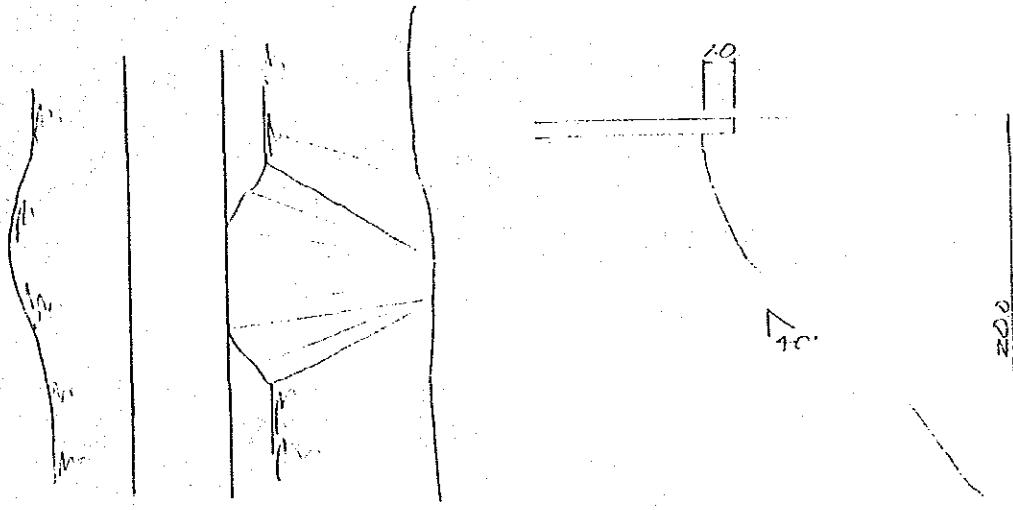
Route		111(111-13-1)	Km. Post	699-700	Width	10 M	Sheet No.	S-57-2
							Region	VII
Evidence of Failure	1	Kind of Slope	(1) <input checked="" type="checkbox"/> Embankment Slope (2) <input type="checkbox"/> Natural Slope (3) <input type="checkbox"/> Overflow Section (5) <input type="checkbox"/> Others					
	2	Location	(1) <input type="checkbox"/> Approach of Bridge (2) <input checked="" type="checkbox"/> Adjacent to River or Sea (3) <input type="checkbox"/> Inside of Curve (4) <input type="checkbox"/> Others					
	3	Size of Disaster	(1) $50^{m^3} >$ (2) $50^{m^3} \sim 100^{m^3}$ (3) <input checked="" type="checkbox"/> $100^{m^3} <$					
	4	Date Occured	Day                      Month                      Year					
	5	Traffic Interruption Period	(1) 1 day > (2) 1 day ~ 7 days (3) 7 days <					
	6	Counter Measure Taken	(1) <input type="checkbox"/> Only Fill (2) <input checked="" type="checkbox"/> Riprap (3) <input type="checkbox"/> Other Structure (    )

7	Rainfall Intensity/Day	(1) $100^{mm} >$ (2) $100^{mm} \sim 200^{mm}$ (3) $200^{mm} \sim 300^{mm}$ (4) $300^{mm} <$					
Existing Slope Condition	8	Slope Height	(1) $5^m >$ (2) $5^m \sim 10^m$ (3) <input checked="" type="checkbox"/> $10^m <$					
	9	Slope Gradient	(1) $45^\circ >$ (2) $45^\circ \sim 60^\circ$ (3) <input checked="" type="checkbox"/> $60^\circ <$					
	10	Surface Water Concentration	(1) <input checked="" type="checkbox"/> None (2) <input type="checkbox"/> Low (3) <input type="checkbox"/> High					
	11	Slope Protection	(1) <input type="checkbox"/> Nothing (2) <input type="checkbox"/> Vegetation (3) <input checked="" type="checkbox"/> Riprap (4) <input type="checkbox"/> Other Structure (    )					
	12	Drainage Facilities	(1) <input checked="" type="checkbox"/> Nothing (2) <input type="checkbox"/> Existing					
Engi- neering Judge- ment	13	Impact to Road	(1) <input type="checkbox"/> Low (2) <input checked="" type="checkbox"/> Average (3) <input type="checkbox"/> High

14	Cause of Disaster	(1) <input checked="" type="checkbox"/> Concentration of Surface Water (2) <input type="checkbox"/> River Stream (3) <input type="checkbox"/> Sea Wave (4) <input type="checkbox"/> Others					
	15	Counter Measure						
Sketch, etc.							Photo No.

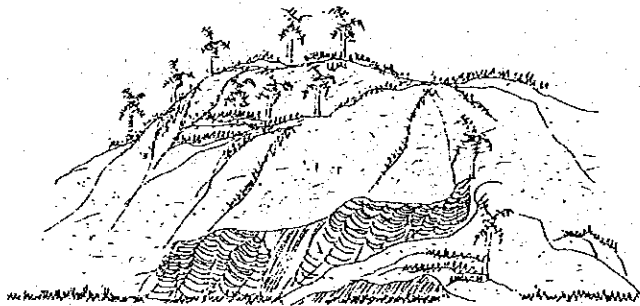
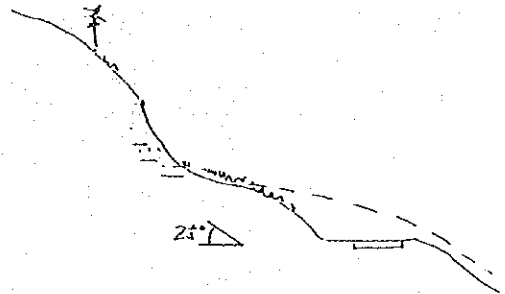
Route		M. H (VIII-16)	Km. Post	698.300	Width	150 M	Sheet No.	S-58	
							Region	VIII	
Evidence of Debris Flow	1	Existence of Depositional Toe	(1) Nothing	(✓) Existing					
	2	Size of Disaster	(1) 50 <sup>m3</sup> >	(2) 50 <sup>m3</sup> ~ 500 <sup>m3</sup>	(✓) 500 <sup>m3</sup> ~ 2,000 <sup>m3</sup>		(4) 2,000 <sup>m3</sup> <		
	3	Date Occured	Day	Month	Year Every year small Failure at typhoon				
	4	Traffic Interruption Period	(1) 1 day >	(2) 1 day ~ 7 days (3) 7 days <					
	5	Counter Measure Taken	(1) Structure ( )	(✓) Removal of Deposit Materials			(3) Others		
	7	Rainfall Intensity/Day	(1) 100 mm >	(2) 100 <sup>mm</sup> ~ 200 <sup>mm</sup>	(3) 200 <sup>mm</sup> ~ 300 <sup>mm</sup>		(4) 300 <sup>mm</sup> <		
Existing Stream Condition	8	Average Gradient	(1) 20° >	(✓) 20° <					
	9	Area of Basin	(✓) 0.24 Km <sup>2</sup> >	(2) 0.24 Km <sup>2</sup> <					
	10	Deposit on River Bed	(1) Nothing	(✓) Rare		(3) Abundance

11	Plant Condition	(1) 50% > Occupancy Rate of Bare Land or Thin Forest (✓) 50% <						
Engineering Judgment	12	Impact to Road	(1) Low	(✓) Average		(3) High			
	13	Cause of Disaster							
	14	Counter Measure							
Sketch, etc.					Photo No.

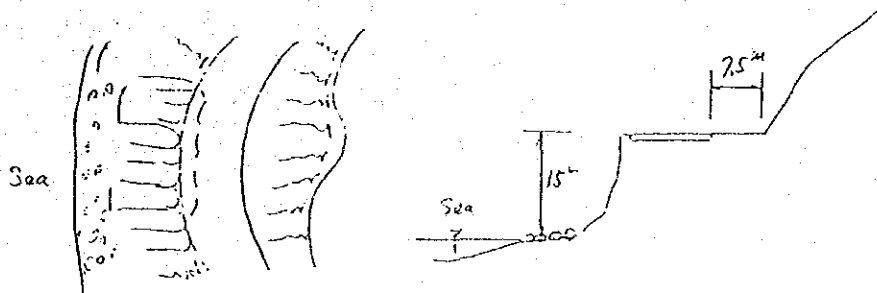
Route		M.H. (7711 - 18 )	Km. Post	701.200	Width	30 M	Sheet No.	S-60
							Region	VIII
Evidence of Failure	1	Kind of Slope	(✓) Embankment Slope (2) Natural Slope (3) Overflow Section (5) Others					
	2	Location	(1) Approach of Bridge (✓) Adjacent to River or Sea (3) Inside of Curve (4) Others					
	3	Size of Disaster	(1) 50 <sup>m3</sup> > (2) 50 <sup>m3</sup> ~ 100 <sup>m3</sup> (✓) 100 <sup>m3</sup> <					
	4	Date Occured	Day Month Year					
	5	Traffic Interruption Period	(1) 1 day > (2) 1 day ~ 7 days (3) 7 days <					
	6	Counter Measure Taken	(1) Only Fill (✓) Riprap (3) Other Structure ( )					
	7	Rainfall Intensity/Day	(1) 100 <sup>mm</sup> > (2) 100 <sup>mm</sup> ~ 200 <sup>mm</sup> (3) 200 <sup>mm</sup> ~ 300 <sup>mm</sup> (4) 300 <sup>mm</sup> <					
Existing Slope Condition	8	Slope Height	(1) 5 <sup>m</sup> > (2) 5 <sup>m</sup> ~ 10 <sup>m</sup> (✓) 10 <sup>m</sup> <					
	9	Slope Gradient	(1) 45° > (2) 45° ~ 60° (✓) 60° <

10	Surface Water Concentration	(✓) None (2) Low (3) High					
	11	Slope Protection	(✓) Nothing (2) Vegetation (3) Riprap (4) Other Structure ( )					
	12	Drainage Facilities	(✓) Nothing (2) Existing					
Engi- neering Judge- ment	13	Impact to Road	(1) Low (✓) Average (3) High					
	14	Cause of Disaster	(1) Concentration of Surface Water (2) River Stream (✓) Sea Wave (4) Others					
	15	Counter Measure						
Sketch, etc.							Photo No.

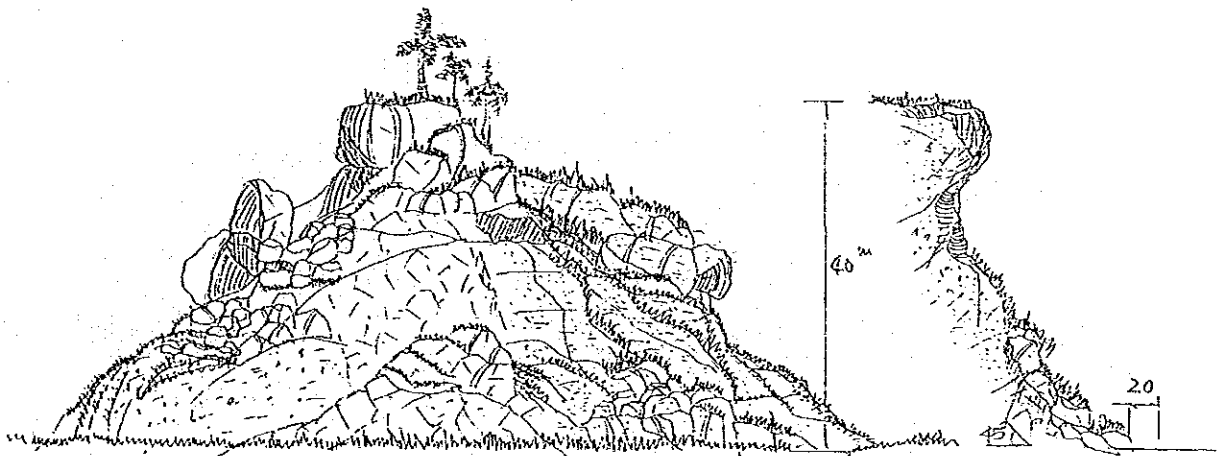
9	Slope Gradient	(1) 45 >		(2) 45 ~ 60		<input checked="" type="checkbox"/> 60 < (4) Overhung			
	10	Degree of Saturation	<input checked="" type="checkbox"/> Dry		(2) Wet		(3) Seepage (4) Spring			
	11	Surface Water Concentration	<input checked="" type="checkbox"/> None		(2) Low		(3) High			
	12	Berm	(1) Existing Number ( ) With ( )		<input checked="" type="checkbox"/> Nothing					
	13	Slope Protection	(1) Structure ( )		(2) Vegetation		<input checked="" type="checkbox"/> Nothing			
	14	Drainage Facilities	(1) Existing ( )		<input checked="" type="checkbox"/> Nothing					
Geological Condition	Debris Fall	15	Matrix Condition	<input checked="" type="checkbox"/> Hard		<input checked="" type="checkbox"/> Soft		(3) Loose (4) Loose with detached cabbles		
		16	Gully	(1) Rare		(2) Common		(3) Frequently		
		17	Detached Rock or cabbles	(1) Nothing		(2) Supported Stably		(3) Supported Unstably		
	Rock Fall	18	Rock Name	(1) Granite (2) Diorite (3) Diabase (4) Andesite (5) Basite (6) Schist (7) Slate (8) Limestone (9) Schalstein (10) Tuff (11) Tuffbreccie (12) Sandstone (13) Shale (14) Mudstone (15) Conglomerate (16) Masa (17) Volcaniclasties

19	Weathering Condition	(1) Fresh		(2) Slightly Weathered		<input checked="" type="checkbox"/> Highly Weathered		
		20	Condition of Crack	(1) Sparse		(2) Regular		<input checked="" type="checkbox"/> Developed		
		21	Direction of Crack	(1) Inclined to Mountain		<input checked="" type="checkbox"/> Irregular Inclination		(3) Inclined to Slope		
Engi- neering Judge- ment	22	Impact to Road	(1) Low		(2) Average		<input checked="" type="checkbox"/> High			
	23	Cause of Fall	Open cracks							
	24	Counter Measure								
Sketch, etc.					Photo No.

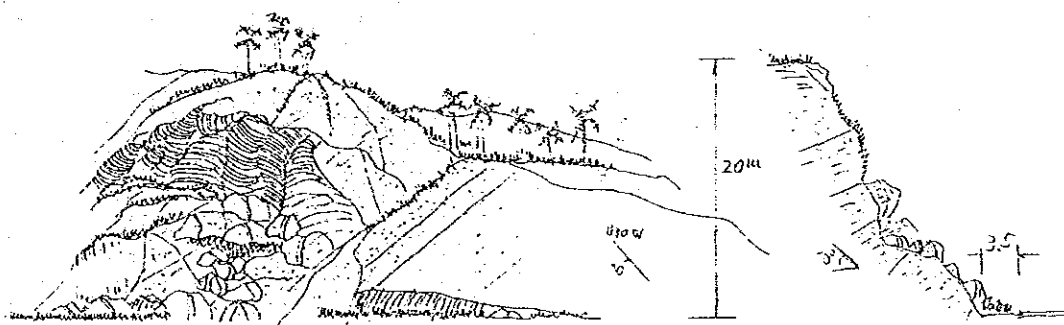
Route		M.H (VIII - 33 )		Km. Post	717.700	Width	120 M	Sheet No.	S-66	
								Region	VIII	
Evidence of Failure	1	Kind of Slope	<input checked="" type="checkbox"/> Cut Slope		(2) Natural Slope					
	2	Kind of Failure	(1) Nothing		<input checked="" type="checkbox"/> Surface Failure		(3) Deep Failure			
	3	Size of Failure	(1) 50 <sup>m3</sup> >		(2) 50 <sup>m3</sup> ~ 500 <sup>m3</sup>		<input checked="" type="checkbox"/> 500 <sup>m3</sup> ~ 2,000 <sup>m3</sup>		(4) 2,000 <sup>m3</sup> <	
	4	Date Occured	Day		Month 12		Year 1982			
	5	Traffic Interruption Period	(1) 1 day >		<input checked="" type="checkbox"/> 1 day ~ 7 days		(3) 7 days <			
	6	Counter Measure Taken	(1) Structure ( )		<input checked="" type="checkbox"/> Removal of Slide Materials		(3) Others			
	7	Rainfall Intensity/ Day	(1) 100 mm >		(2) 100 <sup>mm</sup> ~ 200 <sup>mm</sup>		(3) 200 <sup>mm</sup> ~ 300 <sup>mm</sup>		(4) 300 <sup>mm</sup> <

Existing Slope Condition	8	Height	(1) 10 <sup>m</sup> >		<input checked="" type="checkbox"/> 10 <sup>m</sup> ~ 30 <sup>m</sup>		(3) 30 <sup>m</sup> ~ 50 <sup>m</sup>		(4) 50 <sup>m</sup> <	
	9	Gradient	(1) 45° >		(2) 45° ~ 60°		<input checked="" type="checkbox"/> 60° <		(4) Overhung	
	10	Berm	(1) Existing		Number ( )		Width ( )		<input checked="" type="checkbox"/> Nothing	
	11	Slope Protection	(1) Structure ( )		(2) Vegetation		<input checked="" type="checkbox"/> Nothing			
Geological Condition	Rock	12	Hardness	<input checked="" type="checkbox"/> Hard Rock		<input checked="" type="checkbox"/> Soft Rock				
		13	Name	(1) Granite (2) Diorite (3) Diabase (4) Andesite (5) Dacite (6) Schist (7) Slate (8) Limestone (9) Schalstein (10) Tuff (11) Tuffbreccie <input checked="" type="checkbox"/> Sandstone <input checked="" type="checkbox"/> Shale (14) Mudstone (15) Conglomerate (16) Masa (17) Volcaniclastics

14	Weathering Condition	(1) Fresh		(2) Slightly Weathered		<input checked="" type="checkbox"/> Highly Weathered		(4) Nearly Soil
		15	Condition of Crack	(1) Soarse		(2) Regular		<input checked="" type="checkbox"/> Developed		
	Soil	16	Direction of Crack	<input checked="" type="checkbox"/> Inclined to Mountain (2) Irregular Inclination (3) Inclined to Slope						
		17	Thickness	(1) 5 <sup>m</sup> >		(2) 5 <sup>m</sup> ~ 10 <sup>m</sup>		(3) 10 <sup>m</sup> ~ 20 <sup>m</sup>		(4) 20 <sup>m</sup> <
		18	Compactness	(1) Tight		(2) Slightly loose		(3) Loose		
Water Condition	19	Degree of Saturation	<input checked="" type="checkbox"/> Dry		(2) Wet		(3) Seepage		(4) Spring	
	20	Surface Water Concentration	<input checked="" type="checkbox"/> None		(2) Low		(3) High			
	21	Drainage Facilities	(1) Existing ( )		<input checked="" type="checkbox"/> Nothing					
Engl- neering Judge- ment	22	Impact to Road	(1) Low		<input checked="" type="checkbox"/> Average		(3) High

23	Cause of Disaster	Open cracks							
	24	Counter Measure								
Sketch, etc.						Photo No.

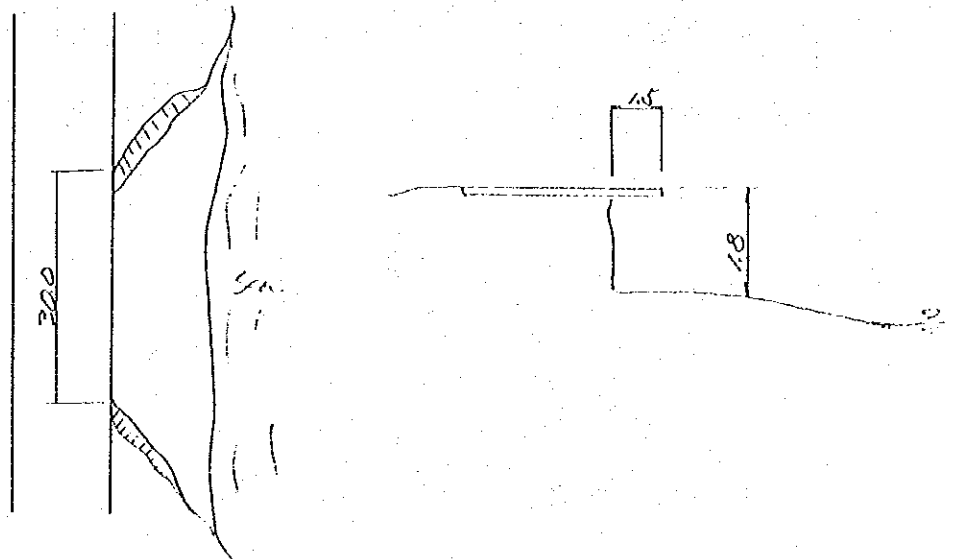
Route		17.11 (VII-39-1)	Km. Post	721.800	Width	65 M	Sheet No.	S-67-1
							Region	VII
Evidence of Failure	1	Kind of Slope	(1) <input checked="" type="checkbox"/> Embankment Slope (2) Natural Slope (3) Overflow Section (5) Others					
	2	Location	(1) Approach of Bridge (2) <input checked="" type="checkbox"/> Adjacent to River or Sea (3) Inside of Curve (4) Others					
	3	Size of Disaster	(1) $50^{m^3} >$ (2) $50^{m^3} \sim 100^{m^3}$ (3) $100^{m^3} <$					
	4	Date Occured	Day                      Month                      Year					
	5	Traffic Interruption Period	(1) 1 day > (2) 1 day ~ 7 days (3) 7 days <					
	6	Counter Measure Taken	(1) <input checked="" type="checkbox"/> Only Fill (2) Riprap (3) Other Structure (    )					
	7	Rainfall Intensity/Day	(1) $100^{mm} >$ (2) $100^{mm} \sim 200^{mm}$ (3) $200^{mm} \sim 300^{mm}$ (4) $300^{mm} <$					
Existing Slope Condition	8	Slope Height	(1) $5^m >$ (2) $5^m \sim 10^m$ (3) $10^m <$

9	Slope Gradient	(1) $45^\circ >$ (2) $45^\circ \sim 60^\circ$ (3) $60^\circ <$					
	10	Surface Water Concentration	(1) <input checked="" type="checkbox"/> None (2) Low (3) High					
	11	Slope Protection	(1) <input checked="" type="checkbox"/> Nothing (2) Vegetation (3) Riprap (4) Other Structure (    )					
	12	Drainage Facilities	(1) <input checked="" type="checkbox"/> Nothing (2) Existing					
Engineering Judgment	13	Impact to Road	(1) Low (2) <input checked="" type="checkbox"/> Average (3) High					
	14	Cause of Disaster	(1) Concentration of Surface Water (2) River Stream (3) <input checked="" type="checkbox"/> Sea Wave (4) Others					
	15	Counter Measure						
Sketch, etc.							Photo No.

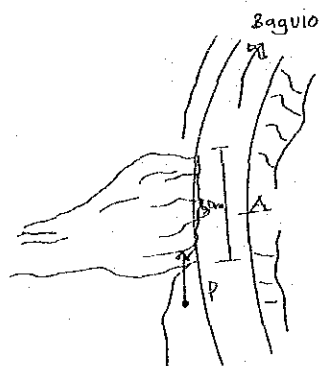
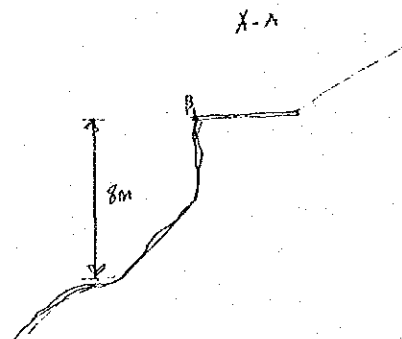
Route		N (1N-3-2)	Km. Post	276,500	Width	30 M	Sheet No.	B-86-1
							Region	I
Evidence of Failure	1	Kind of Slope	(1) <input checked="" type="checkbox"/> Embankment Slope (2) Natural Slope (3) Overflow Section (5) Others					
	2	Location	(1) Approach of Bridge (2) Adjacent to River or Sea (3) Inside of Curve (4) <input checked="" type="checkbox"/> Others					
	3	Size of Disaster	(1) $60^{mm^3} >$ (2) $50^{mm^3} \sim 100^{mm^3}$ (3) $100^{mm^3} <$					
	4	Date Occured	Day 27~30 Month Aug. Year 1984 by Haring					
	5	Traffic Interruption Period	(1) 1 day > (2) 1 day ~ 7 days (3) 7 days <					
	6	Counter Measure Taken	(1) Only Fill (2) Riprap (3) Other Structure ( )					
	7	Rainfall Intensity/Day	(1) $100^{mm} >$ (2) $100^{mm} \sim 200^{mm}$ (3) $200^{mm} \sim 300^{mm}$ (4) $300^{mm} <$					
Existing Slope Condition	8	Slope Height	(1) $5^m >$ (2) $5^m \sim 10^m$ (3) $10^m <$					
	9	Slope Gradient	(1) $45^\circ >$ (2) $45^\circ \sim 60^\circ$ (3) $60^\circ <$

10	Surface Water Concentration	(1) None (2) <input checked="" type="checkbox"/> Low (3) High					
	11	Slope Protection	(1) <input checked="" type="checkbox"/> Nothing (2) Vegetation (3) Riprap (4) Other Structure ( )					
Engi- neering Judge- ment	12	Drainage Facilities	(1) <input checked="" type="checkbox"/> Nothing (2) Existing					
	13	Impact to Road	(1) Low (2) <input checked="" type="checkbox"/> Average (3) High					
	14	Cause of Disaster	(1) <input checked="" type="checkbox"/> Concentration of Surface Water (2) River Stream (3) Sea Wave (4) Others					
	15	Counter Measure						
Sketch, etc.							Photo No.

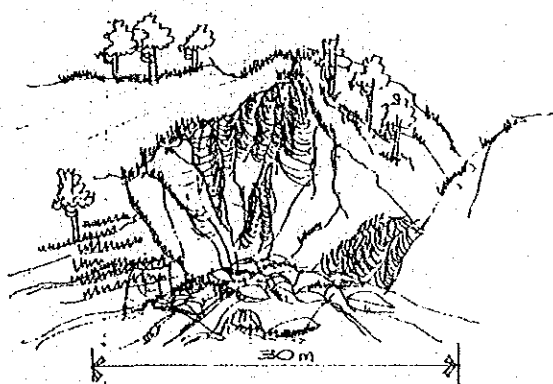
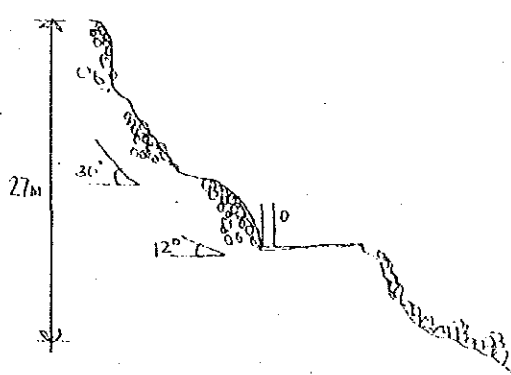
Route		N(1N-4-1)	Km. Post	281.500	Width	30 M	Sheet No.	B-86-2
							Region	I
Evidence of Failure	1	Kind of Slope	(1) <input checked="" type="checkbox"/> Cut Slope (2) Natural Slope					
	2	Kind of Failure	(1) Nothing (2) Surface Failure (3) <input checked="" type="checkbox"/> Deep Failure					
	3	Size of Failure	(1) 50 <sup>m3</sup> > (2) 50 <sup>m3</sup> ~ 500 <sup>m3</sup> (3) <input checked="" type="checkbox"/> 500 <sup>m3</sup> ~ 2,000 <sup>m3</sup> (4) 2,000 <sup>m3</sup> <					
	4	Date Occured	Day 27~30 Month Aug. Year 1984 by Heavy					
	5	Traffic Interruption Period	(1) <input checked="" type="checkbox"/> 1 day > (2) 1 day ~ 7 days (3) 7 days					
	6	Counter Measure Taken	(1) Structure ( ) (2) <input checked="" type="checkbox"/> Removal of Slide Materials (3) Others					
	7	Rainfall Intensity/Day	(1) 100 mm > (2) 100 <sup>mm</sup> ~ 200 <sup>mm</sup> (3) 200 <sup>mm</sup> ~ 300 <sup>mm</sup> (4) <input checked="" type="checkbox"/> 300 <sup>mm</sup> <

Existing Slope Condition	8	Height	(1) 10 <sup>m</sup> > (2) <input checked="" type="checkbox"/> 10 <sup>m</sup> ~ 30 <sup>m</sup> (3) 30 <sup>m</sup> ~ 50 <sup>m</sup> (4) 50 <sup>m</sup> <					
	9	Gradient	(1) <input checked="" type="checkbox"/> 45° > (2) 45° ~ 60° (3) 60° < (4) Overhung					
	10	Berm	(1) Existing Number ( ) Width ( ) (2) <input checked="" type="checkbox"/> Nothing					
	11	Slope Protection	(1) Structure ( ) (2) <input checked="" type="checkbox"/> Vegetation (3) Nothing					
Geological Condition	12	Hardness	(1) Hard Rock (2) <input checked="" type="checkbox"/> Soft Rock					
	13	Name	(1) Granite (2) Diorite (3) Diabase (4) Andesite (5) Dacite (6) Schist (7) Slate (8) Limestone (9) Schalstein (10) Tuff (11) Tuffbreccia (12) <input checked="" type="checkbox"/> Sandstone (13) Shale (14) Mudstone (15) Conglomerate (16) Masa (17) Volcaniclastics					
	14	Weathering Condition	(1) Fresh (2) Slightly Weathered (3) <input checked="" type="checkbox"/> Highly Weathered (4) <input checked="" type="checkbox"/> Nearly Soil

15	Condition of Crack	(1) Sparse (2) Regular (3) <input checked="" type="checkbox"/> Developed					
	16	Direction of Crack	(1) Inclined to Mountain (2) <input checked="" type="checkbox"/> Irregular Inclination (3) Inclined to Slope					
	17	Thickness	(1) <input checked="" type="checkbox"/> 5 <sup>m</sup> > (2) 5 <sup>m</sup> ~ 10 <sup>m</sup> (3) 10 <sup>m</sup> ~ 20 <sup>m</sup> (4) 20 <sup>m</sup> <					
	18	Compactness	(1) Tight (2) Slightly loose (3) <input checked="" type="checkbox"/> Loose					
	19	Degree of Saturation	(1) Dry (2) Wet (3) <input checked="" type="checkbox"/> Seepage (4) Spring					
Water Condition	20	Surface Water Concentration	(1) None (2) Low (3) <input checked="" type="checkbox"/> High					
	21	Drainage Facilities	(1) Existing ( ) (2) <input checked="" type="checkbox"/> Nothing					
Engineering Judgment	22	Impact to Road	(1) Low (2) <input checked="" type="checkbox"/> Average (3) High
