THE FEASIBILITY STUDY
OF
PHILIPPINE ROAD DISASTER PREVENTION PROJECT
STAGE II

FINAL REPORT

(VOLUME II)

JULY, 1985

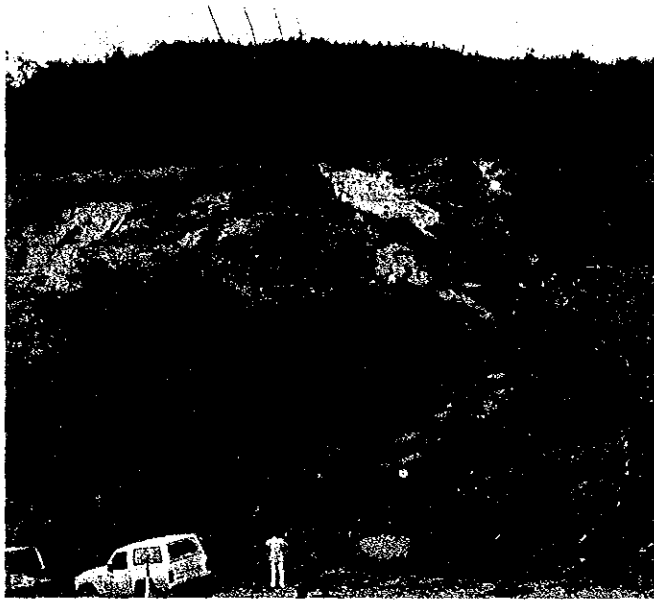
*CUT (NATURAL) SLOPE SURFACE FAILURE
NAGUILIAN ROAD
km 294 + 800*

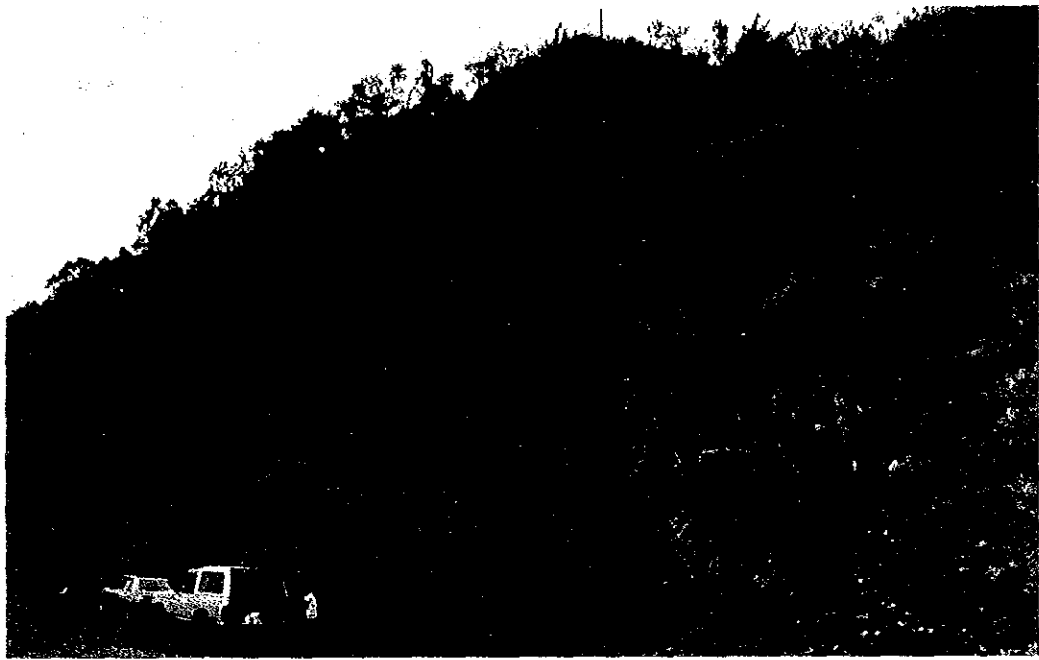
FALLS
NAGUILIAN ROAD
km 294 + 100

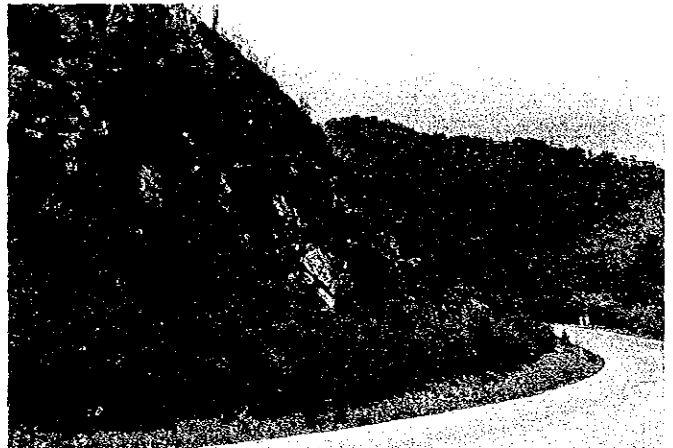
FALLS
LUCENA – CALAUAG SECTION
km 153 + 900

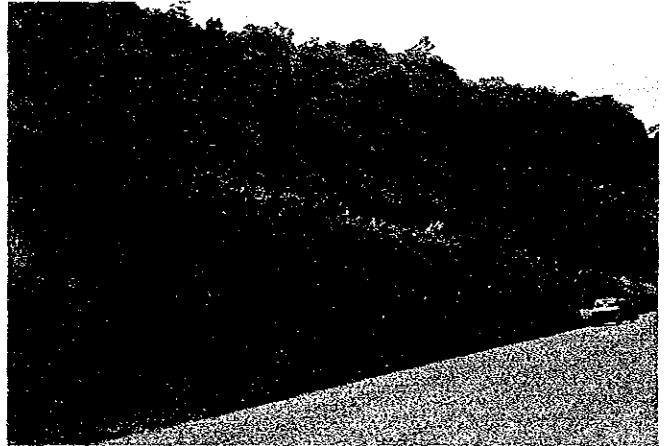
*LANDSLIDE
LUCENA – CALAUAG SECTION
km 160 + 800*

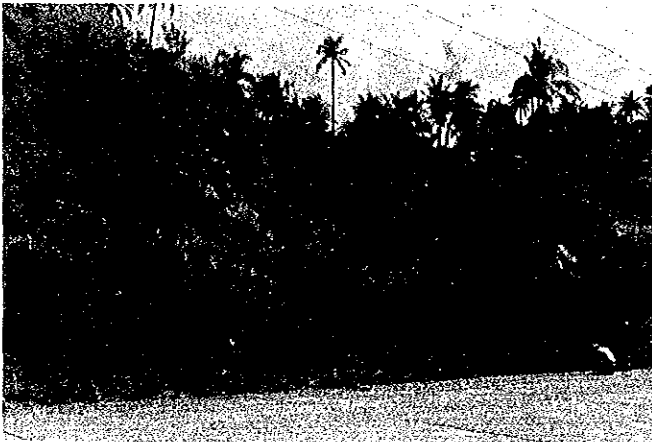
*DEBRIS FLOW
ALLEN – CALBAYOG SECTION
km 718 + 100*
