5.3 EXISTING CONDITIONS OF ROAD DISASTERS

5.3.1 Lucena-Calauag Section, M-10 along Maharlika Highway

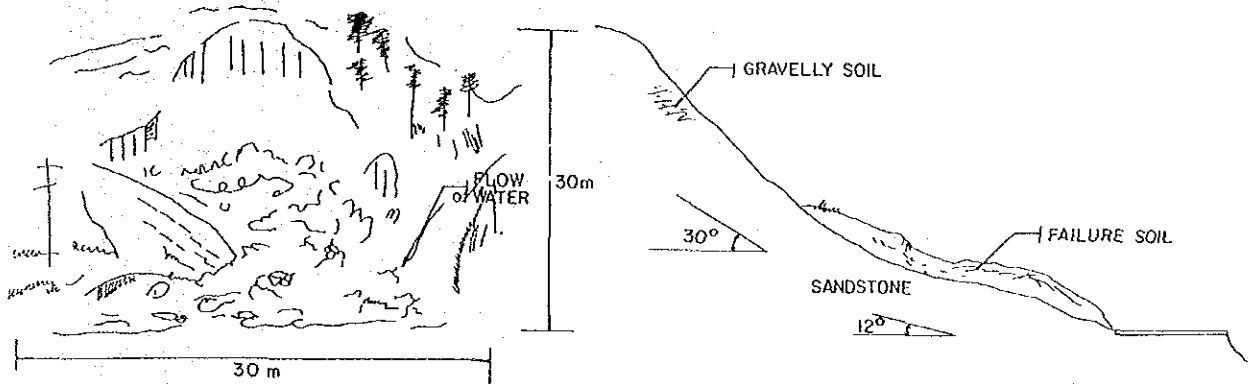
(a) Present Condition

FIGURE 6.4-1 CASE STUDY I CUT SLOPE FAILURE SPOT NO. IN-4-1

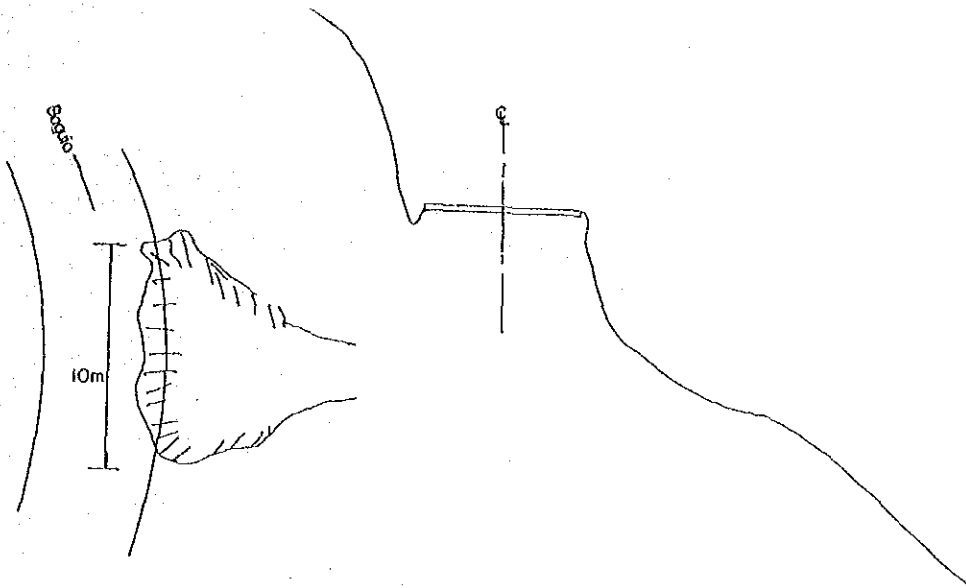
(a) Present Condition

FIGURE 6.4-3 CASE STUDY 2 EMBANKMENT SLOPE FAILURE SPOT NO. IN-8-5

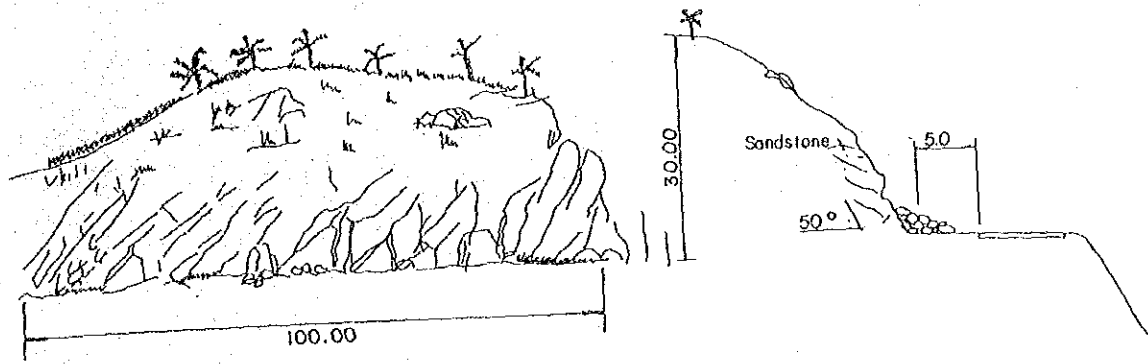
(a) Present Condition

FIGURE 6.4-5 CASE STUDY 3 FALL SPOT NO. VIII-21

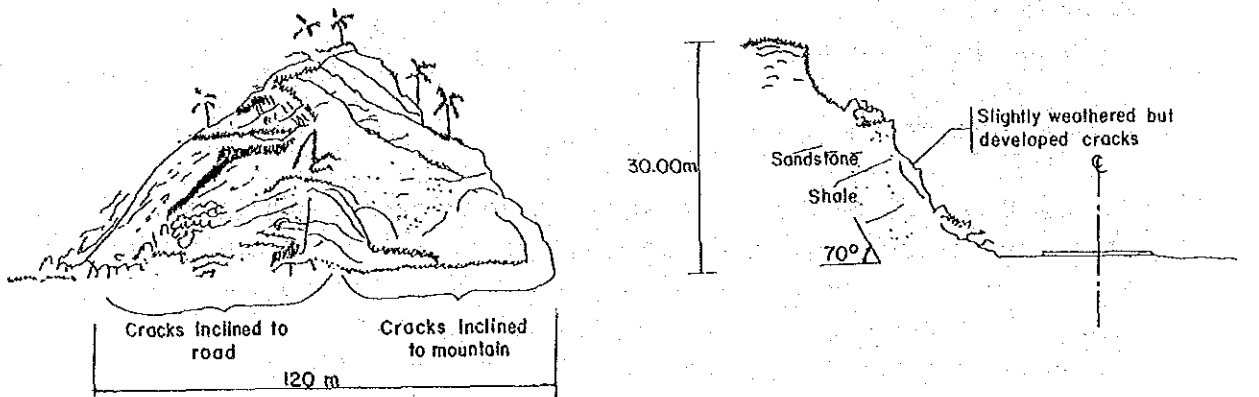
(a) Present Condition

FIGURE 6.4-7 CASE STUDY 4 FALL SPOT NO. VIII-32

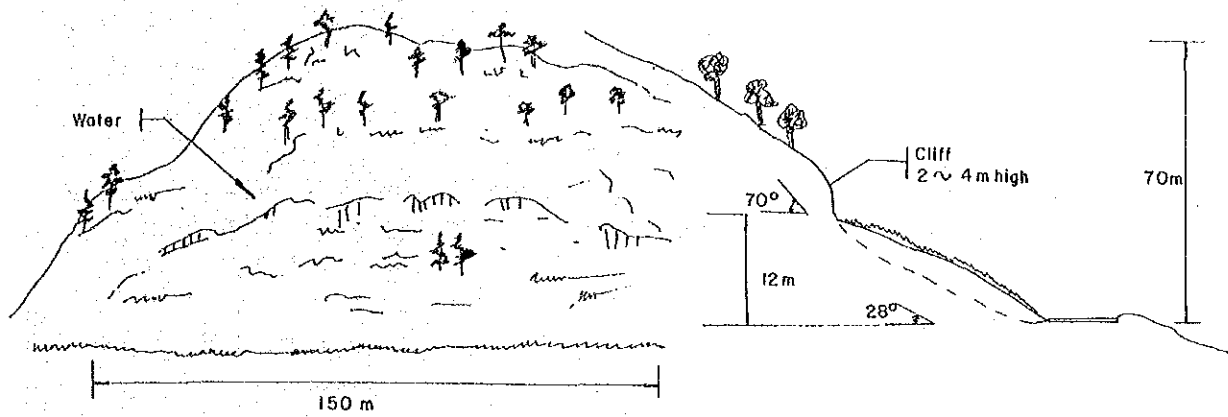
(a) Present Condition

FIGURE 6.4-8 CASE STUDY 5 LANDSLIDE SPOT NO. IV-A-20

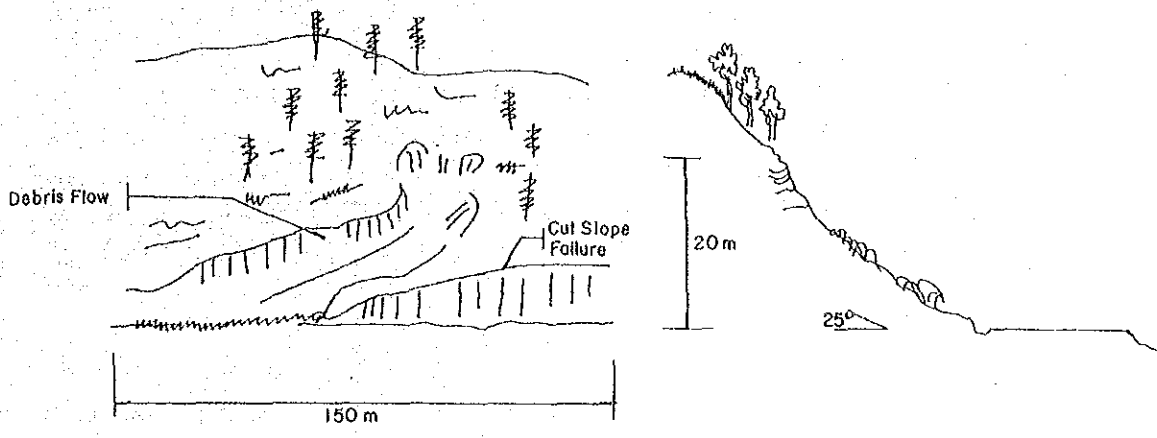
(a) Present Condition

FIGURE 6.4-10 CASE STUDY 6 DEBRIS FLOW SPOT NO. VIII-16
