**THE FEASIBILITY STUDY
OF
PHILIPPINE ROAD DISASTER PREVENTION PROJECT**

FINAL REPORT
EXECUTIVE SUMMARY
(VOLUME I)

JUNE, 1984

JAPAN INTERNATIONAL COOPERATION AGENCY

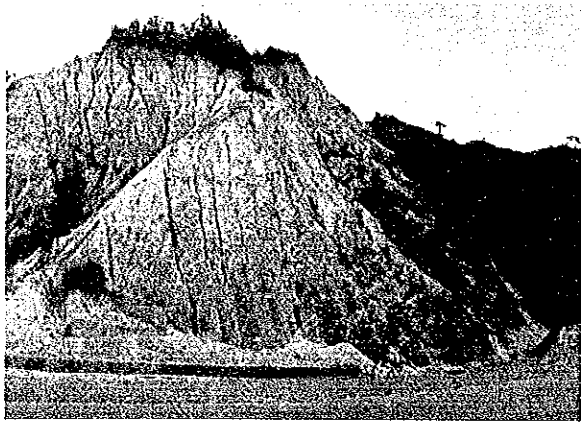
CUT SLOPE
SURFACE FAILURE
(EROSION)
C-S.F (E)

MAHARLIKA HIGHWAY,
NORTH LUZON
km 215 + 600

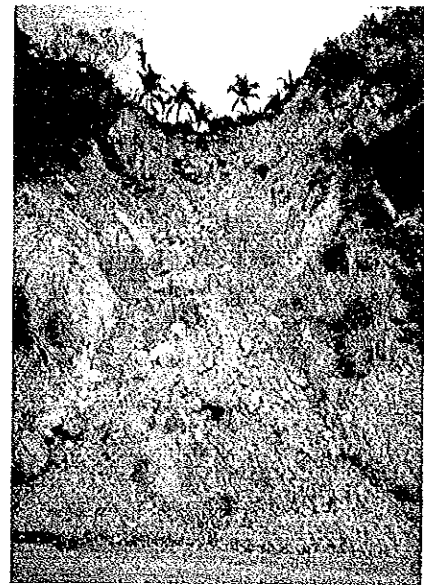
CUT SLOPE
DEEP FAILURE
(SCOURING)
S-D.F (S)

MAHARLIKA HIGHWAY,
LEYTE
km 1019 + 690

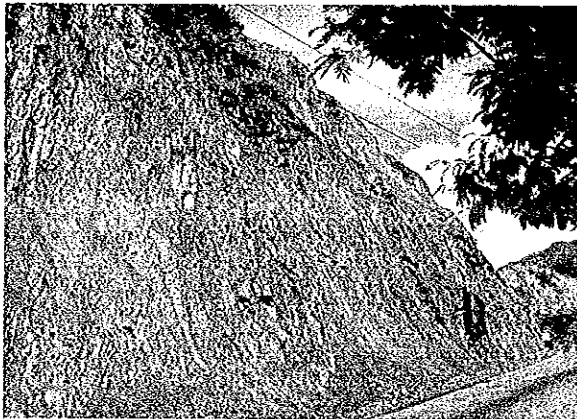
CUT SLOPE
SURFACE FAILURE
(WEATHERING)
C-S.F (W)

KENNON ROAD
km 237 + 800

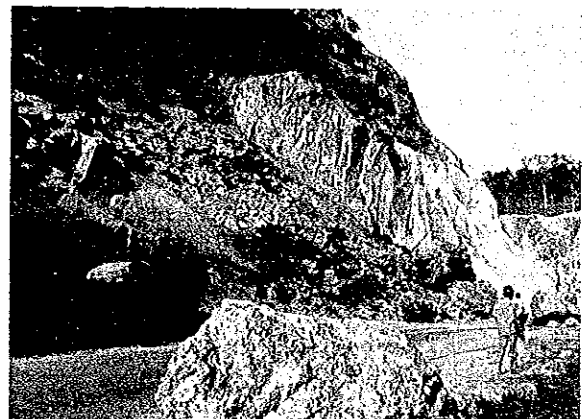
CUT SLOPE
DEEP FAILURE
(ROTATIONAL)
C-D.F (R)

MAHARLIKA HIGHWAY,
SOUTH LUZON
km 158 + 500

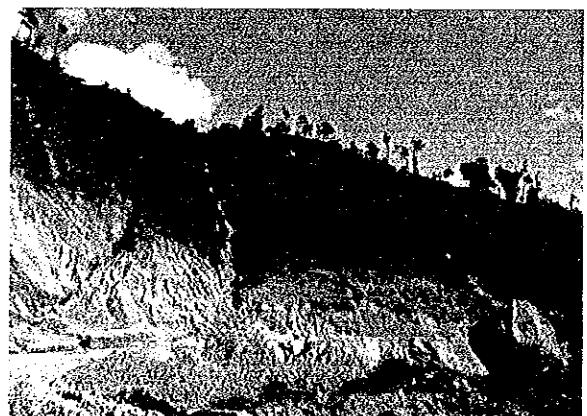
CUT SLOPE
DEEP FAILURE
(TRANSLATIONAL)
C-D.F (T)

MAHARLIKA HIGHWAY,
LEYTE
km 1009 + 600

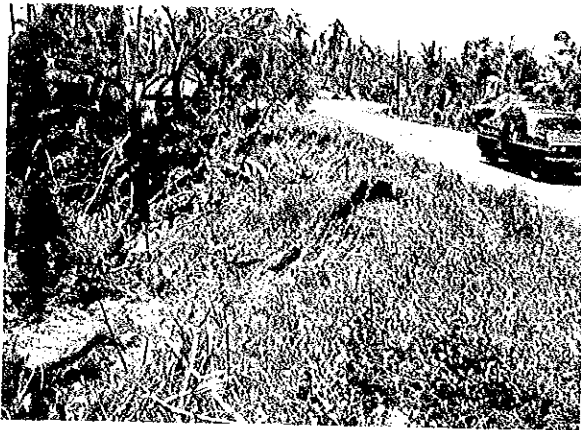
EMBANKMENT SLOPE
SURFACE FAILURE
(EROSION)
E-S.F (E)

MAHARLIKA HIGHWAY,
SOUTH LUZON
km 406 + 490

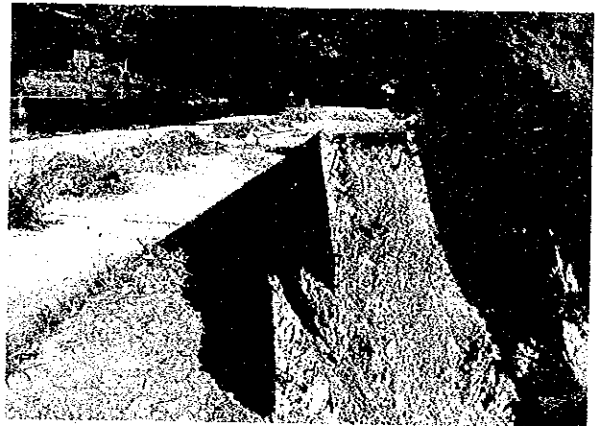
EMBANKMENT SLOPE
DEEP FAILURE
(SATURATION)
E-D.F (P)

KENNON ROAD
km 227 + 750

The embankment slope failures are mainly due to scouring caused by Bued river and surface water concentrated from the road surface and the cut slope. A large scale of embankment slope failure which occurred at kms 227 + 500 in August 1983 is mainly due to the fill material being saturated by seepage water.

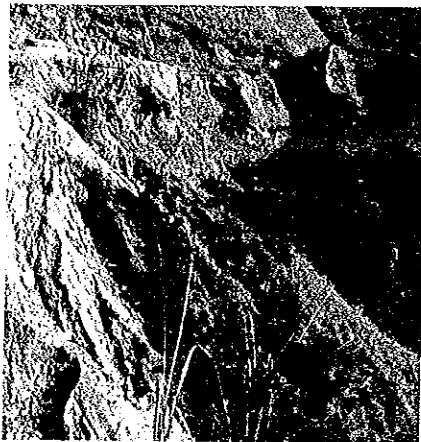
EMBANKMENT SLOPE
DEEP FAILURE
(SCOURING BY
SURFACE WATER)
E-D.F (S)

MAHARLIKA HIGHWAY,
LEYTE
km 1009 + 700

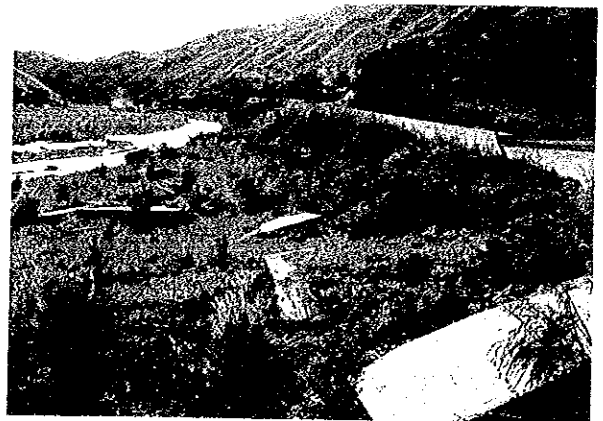
EMBANKMENT SLOPE
DEEP FAILURE
(SCOURING BY RIVER)
E-D.F (S)

MAHARLIKA HIGHWAY,
NORTH LUZON
km 225 + 700

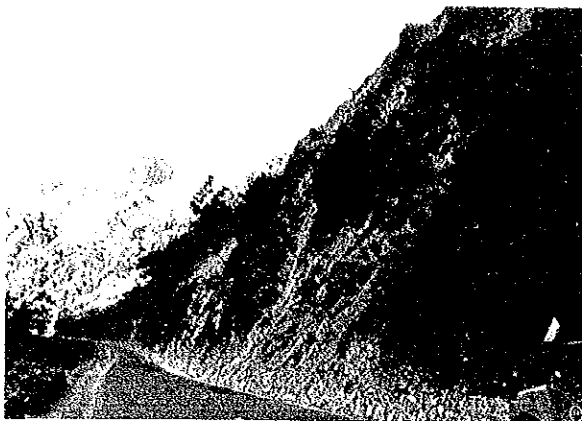
FALLS
ROCK FALL
C-F (R)

KENNON ROAD
km 235 + 800

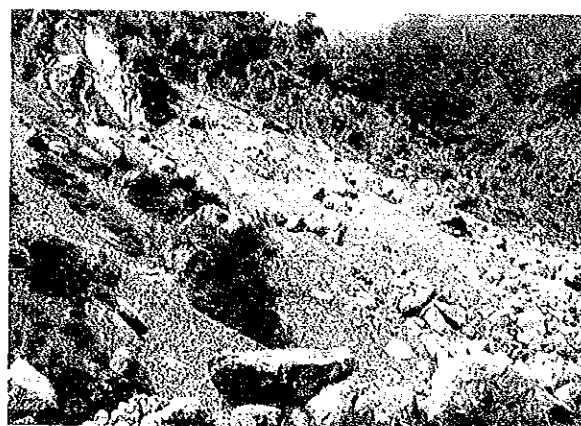
FALLS
DEBRIS FALL
C-F (D)

AGOO-BAGUIO ROAD
km 277 + 600

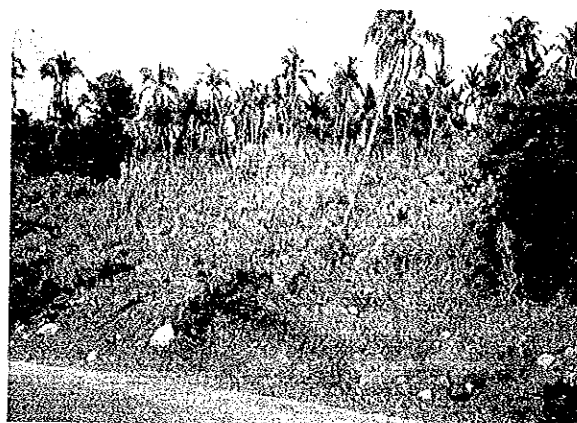
LANDSLIDE
SOIL LANDSLIDE
L.S (S)

MAHARLIKA HIGHWAY,
LEYTE
km 1021 + 100

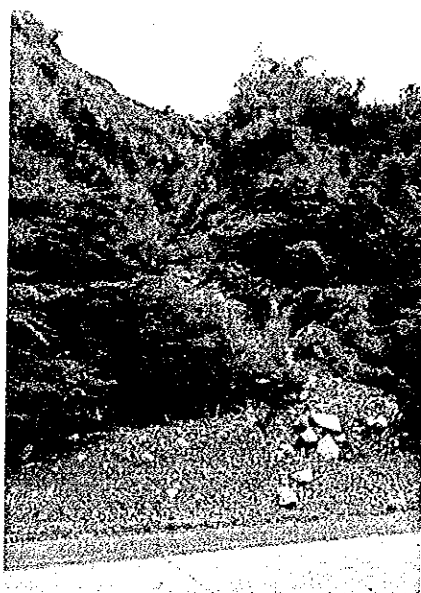
DEBRIS FLOW
DEBRIS FLOW
D.F (D)

MAHARLIKA HIGHWAY,
NORTH LUZON
km 173 + 450

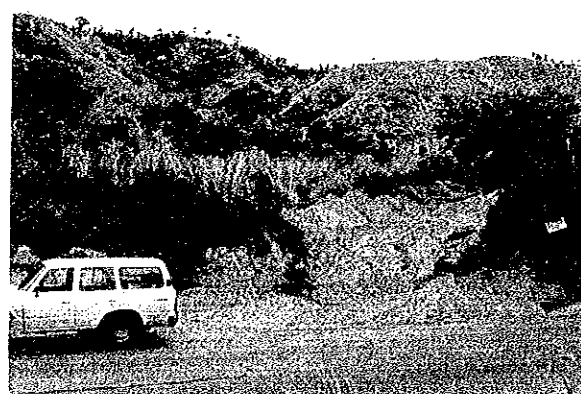
DEBRIS FLOW
MUD FLOW
D.F (M)

MAHARLIKA HIGHWAY,
NORTH LUZON
km 188 + 200
