**THE FEASIBILITY STUDY
OF
PHILIPPINE ROAD DISASTER PREVENTION PROJECT**

STAGE II

FINAL REPORT
EXECUTIVE SUMMARY

JULY, 1985

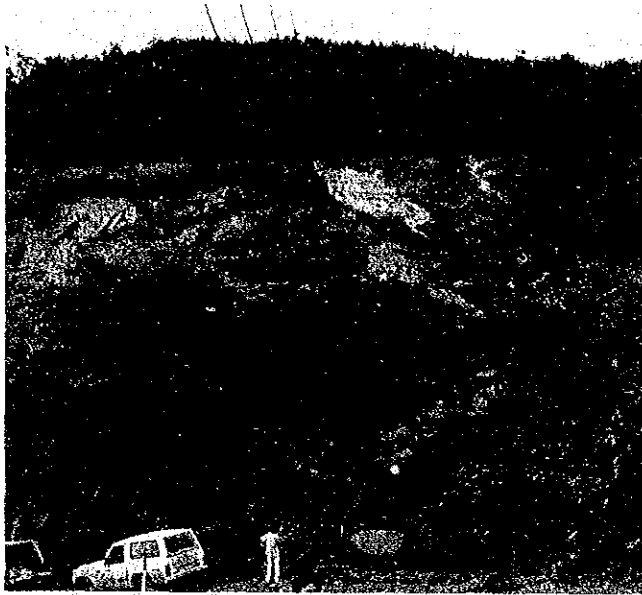
*CUT (NATURAL) SLOPE SURFACE FAILURE
NAGUILIAN ROAD
km 294 + 800*

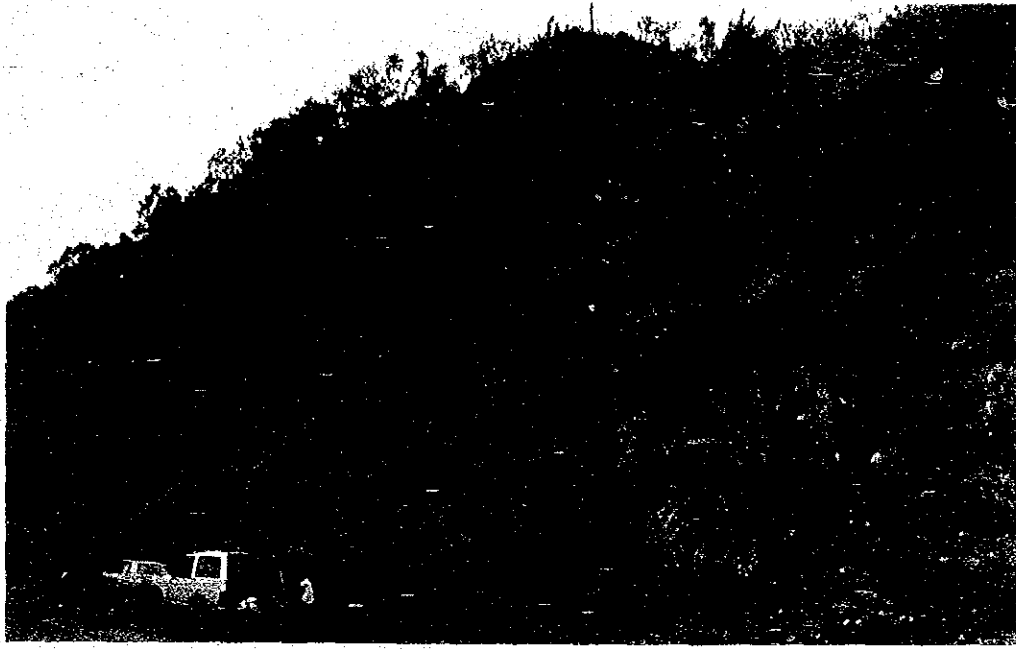
FALLS
NAGUILIAN ROAD
km 294 + 100

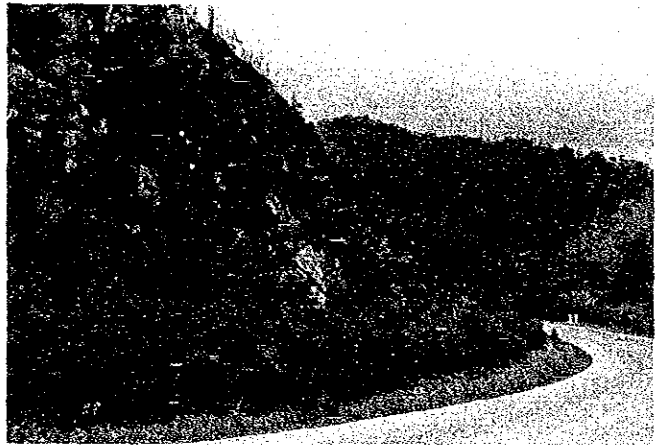
FALLS
LUCENA – CALAUAG SECTION
km 153 + 900

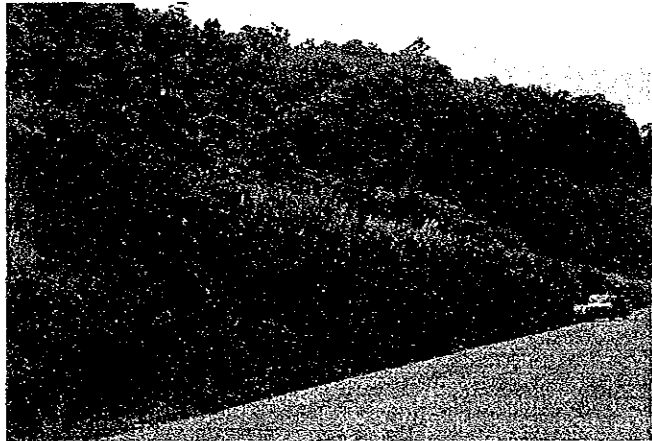
*LANDSLIDE
LUCENA – CALAUAG SECTION
km 160 + 800*

Landslides are classified into soil and rock landslides, but only soil landslide at one spot in the Lucena-Calauag section was noted among the Study sections. The landslide at this spot is a movement of a thick layer of soil covering over the bedrock. Judging from the land formation in which surface water easily concentrates, the landslide is due to the affect of uncontrolled surface water flow.

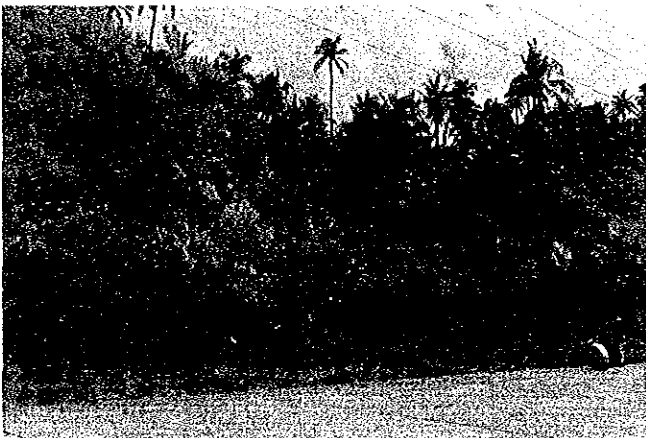
*DEBRIS FLOW
ALLEN – CALBAYOG SECTION
km 718 + 100*

At a spot, a large quantity of spring water was observed at the toe of the slope and, therefore, the debris flow is likely to have been caused by the high level of groundwater. Debris flow at the another spot is caused by torrent due to the absence of countermeasures such as cross drains, water ways, small scale sabo dam etc.
