REPORT ON STUDY

CALIRAYA DAM REHABILITATION PROJECT

SEPTEMBER 1986

JAPAN INTERNATIONAL COOPERATION AGENCY

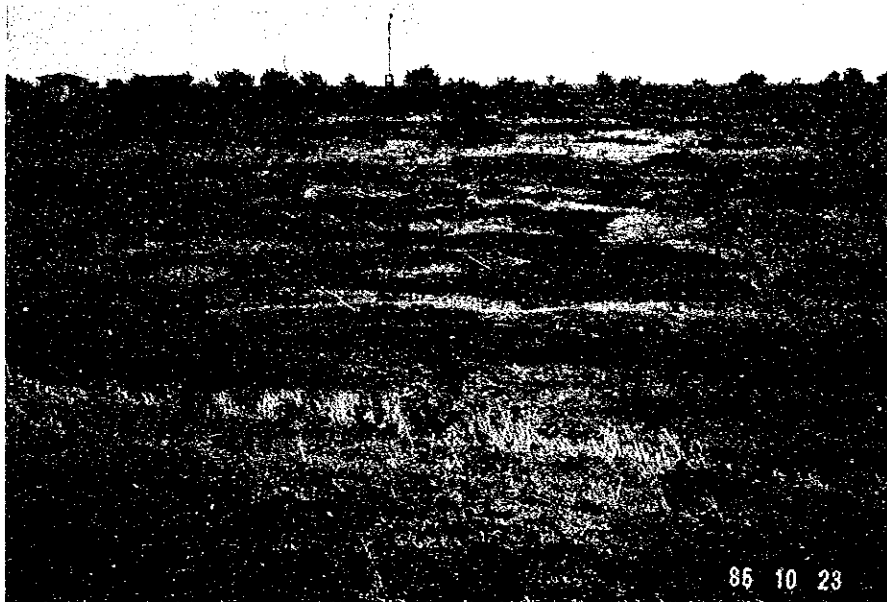
Surface erosion at downstream slope

The most likely cause of sliding is erosion by rainwater over the surface. As described above, the downstream face is turfed. This turfed area is used as a grazing ground for domestic animals such as carabaos and goats belonging to local farmers. In fact, during the field investigation the JICA Survey Team saw carabaos around the downstream face. The Team also noticed some water wallow holes dug by carabaos on the downstream face of the dam. This indicates that carabaos have been grazing this area for some time.

These animals have walked around the face of slope after rain, made footmarks on the surface and caused much damage. This damage gradually extends and develops through erosion from rainwater. Only a few shrinkage cracks from the effects of drying were noticed in the turf soil, but the generation of such cracking was more noticeable in the dam embankment material beneath the turf soil. As mentioned above, this dam embankment material is easily detachable and broken into small pieces. This occurs naturally from gravity and rain-water, and the erosion of the exposed surface is more serious in the vertical direction than in the

- Repair of erosion traces along the dam downstream slope

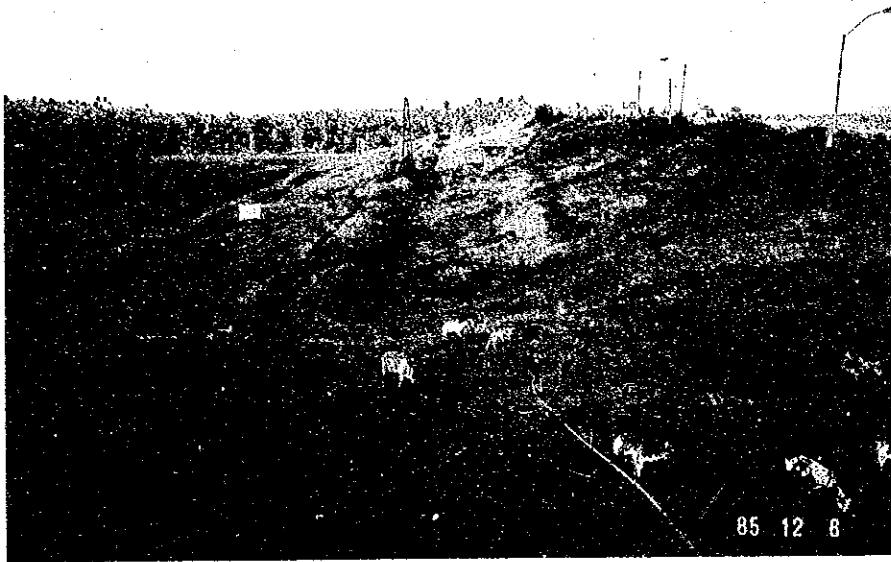
Downstream slope and wandering animals

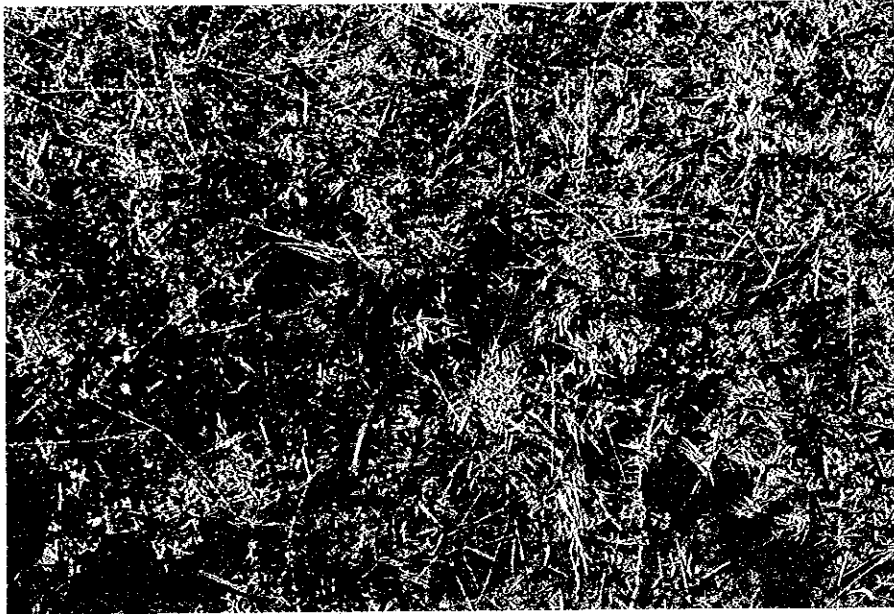
Surface damaged by carabaos.

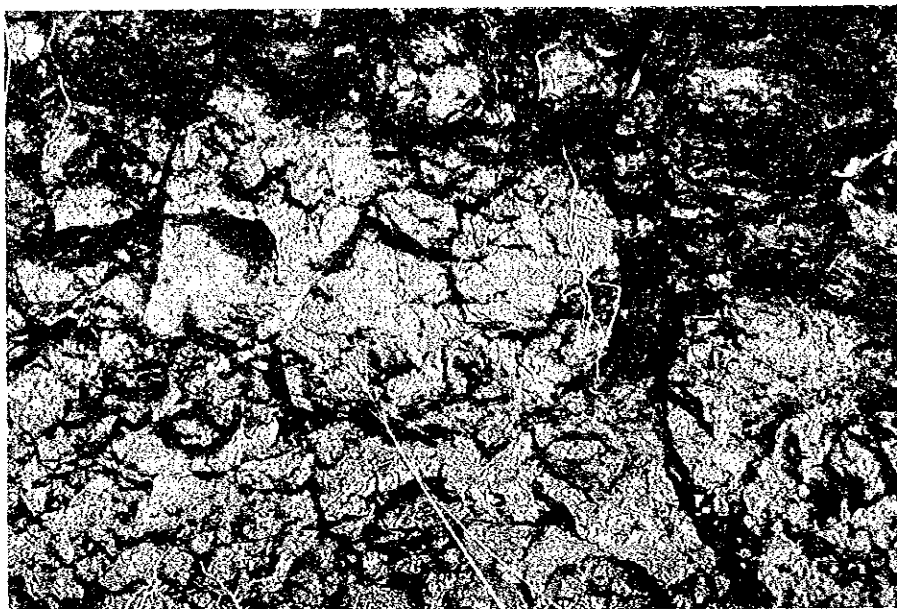
Exposed surface of embankment fill on the
downstream slope
(changed into small pieces by shrinkage cracks)

Innumerable shrinkage cracks appear in this exposed material, which is therefore fragmented in small pieces. These blocks are easy to detach, but the exposed surface itself remains firm. A man's footmarks make no imprint even on the wet exposed surface after rain.

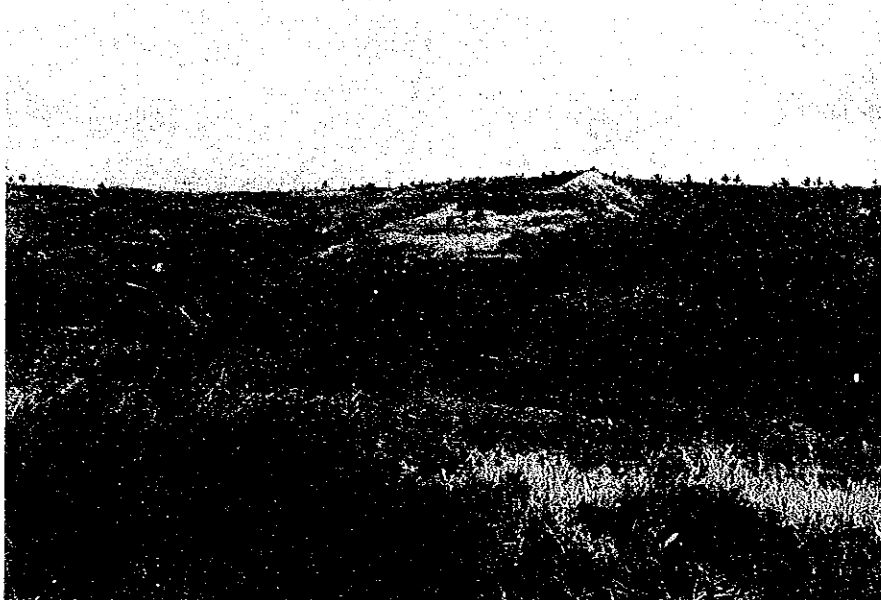
Landslides at the right bank of the upper canal

- 1.4. A landslide occurred during excavation on the right bank of the upper canal leading to the Kalayaan intake. Further sliding here has been temporarily prevented by providing rock embankment and drainage.

However, around the starting point of the landslide, the bed-rock surface is exposed and recurrence of landslide is feared. It is necessary, therefore, to continue monitoring the landslide behavior.

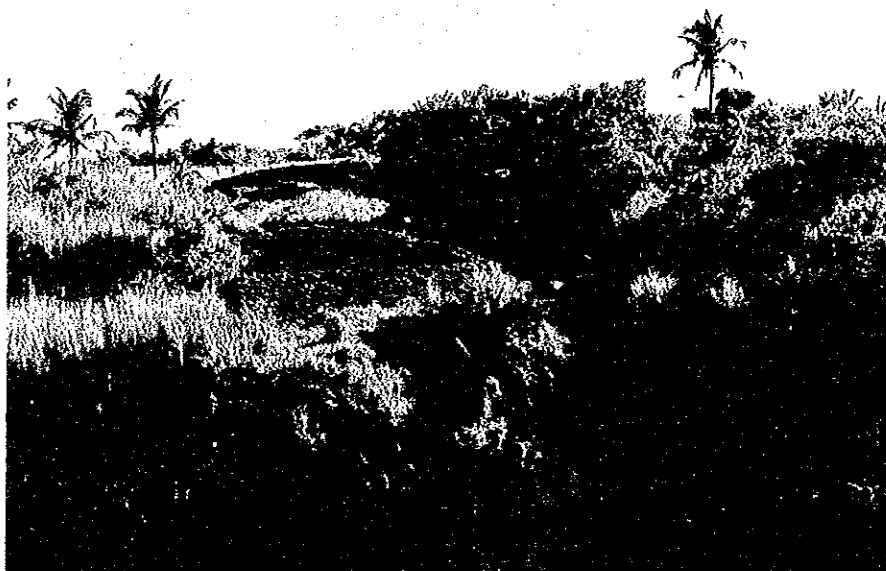
Restoration of landslides by rockfill at
the landslide right bank of the upper canal

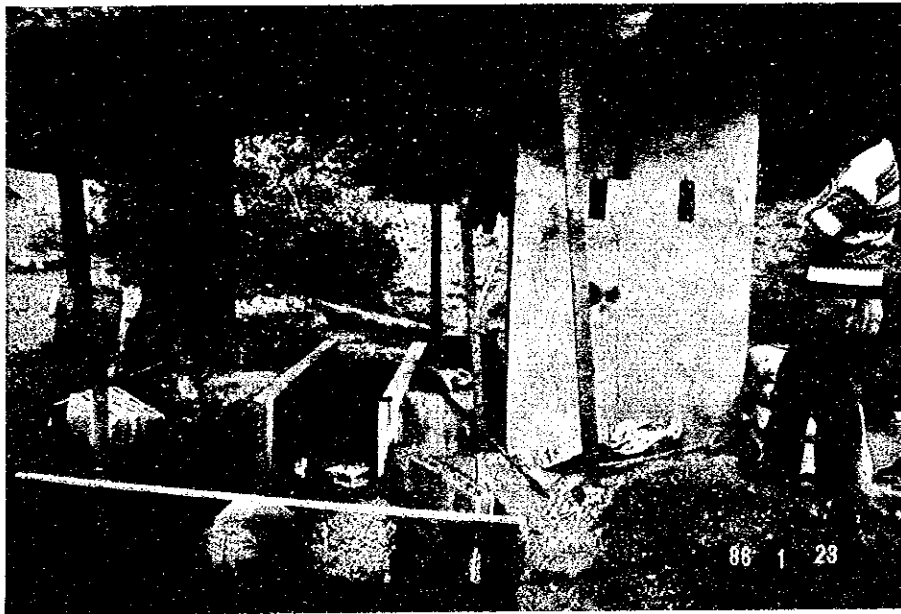
Measuring weir of dam leakage
(under construction)

weir. In this Study, water leakage was found at the weir foundation of the wooden weir, which was rotten already. Since high accuracy of measurement could not be expected with this existing wooden weir, a weir assembled with concrete and steel plate was newly installed for this Study. (See Figs. III-3, III-4 and III-5).
