## 5. Spillway Facilities

CALIRAYA REHABILITATION PROJECT	
SPILLWAY	
LEAK SEALING (1st step)	
PLANS, SECTIONS and DETAILS	
JAN. 1986	CHEP-R-J-1
THE JAPAN INTERNATIONAL COOPERATION AGENCY

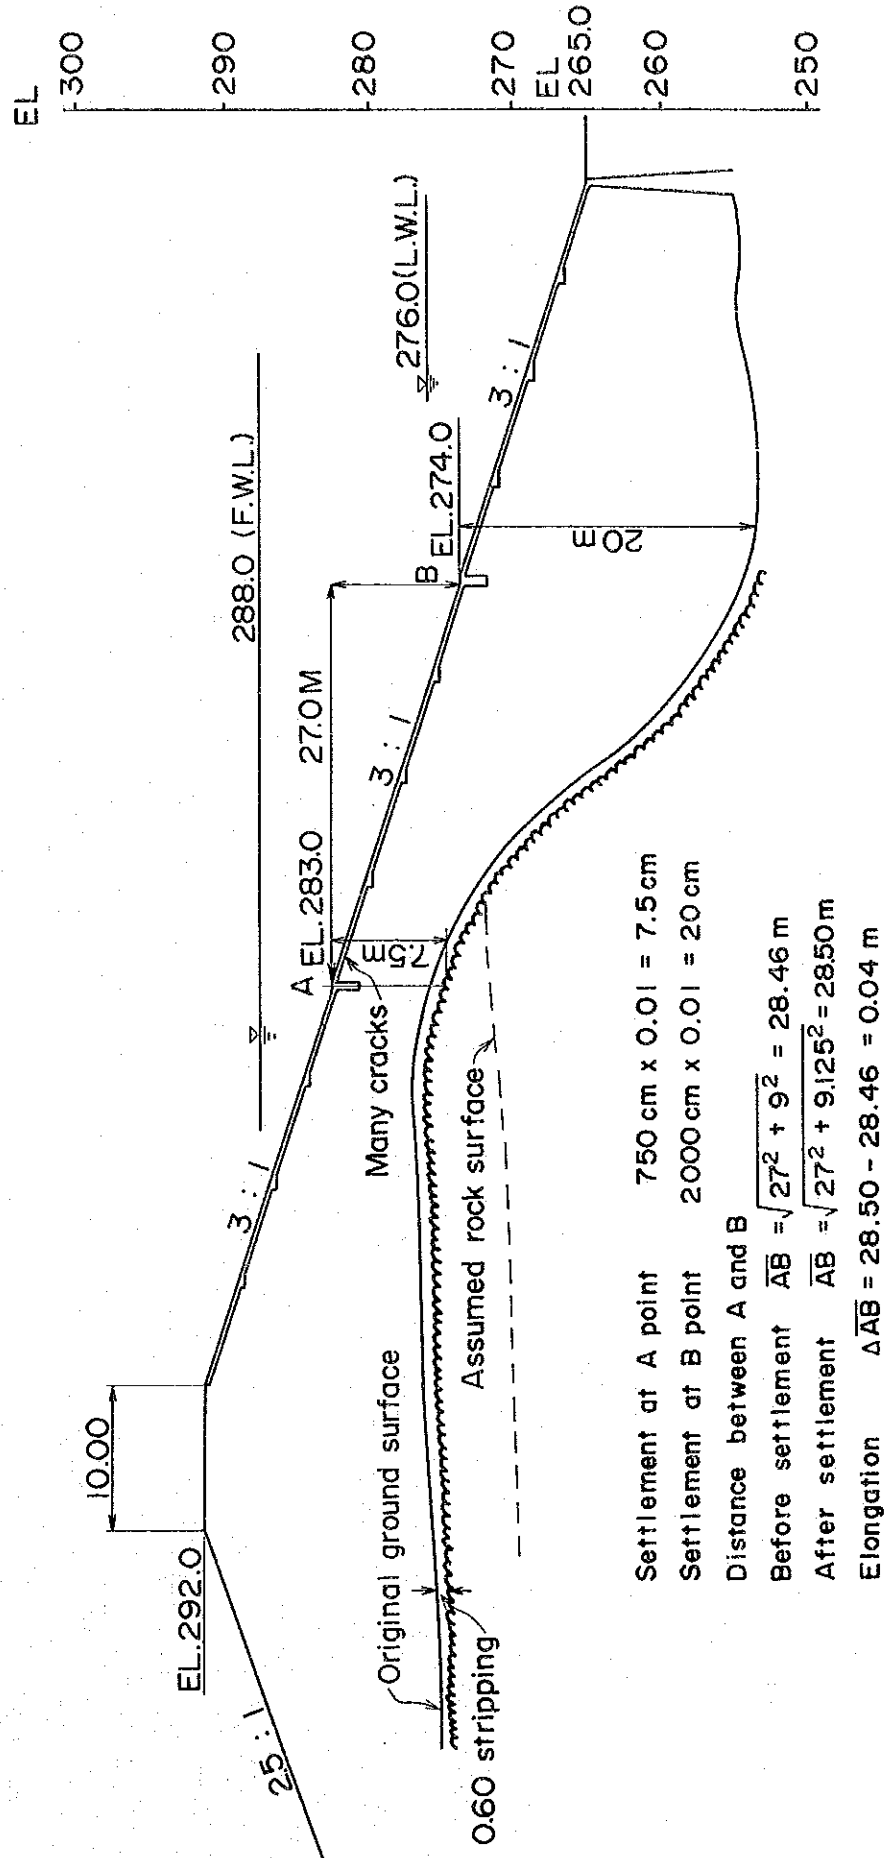
Fig. V-9 Location of Cracks on the Concrete Face Slab  
 (Section STA. 0 + 280)  
 S : 1/500

As reported above, the cracks in the concrete slab of the upstream face are considered to be mainly caused by differential settlement of the embankment fill materials. The embankment having been completed some 40 years ago, it is not considered likely that further settlement will occur or that further cracking will develop. However, the underlying materials will continue to be gradually washed out

through the existing cracks and joints, and voids beneath the slab will thus increase.

The remedial work should be done at a time when the reservoir water level is lowered for instance, at the time of repair of cylinder gate for the service spillway. The cracked areas should be drilled out and the underlying voided areas filled with sand and the larger openings should be backfilled with mortar and broken joints and cracks covered with shotcrete and wire mesh. (the pipes through which the sand was poured shall be remained as a role of drainage).

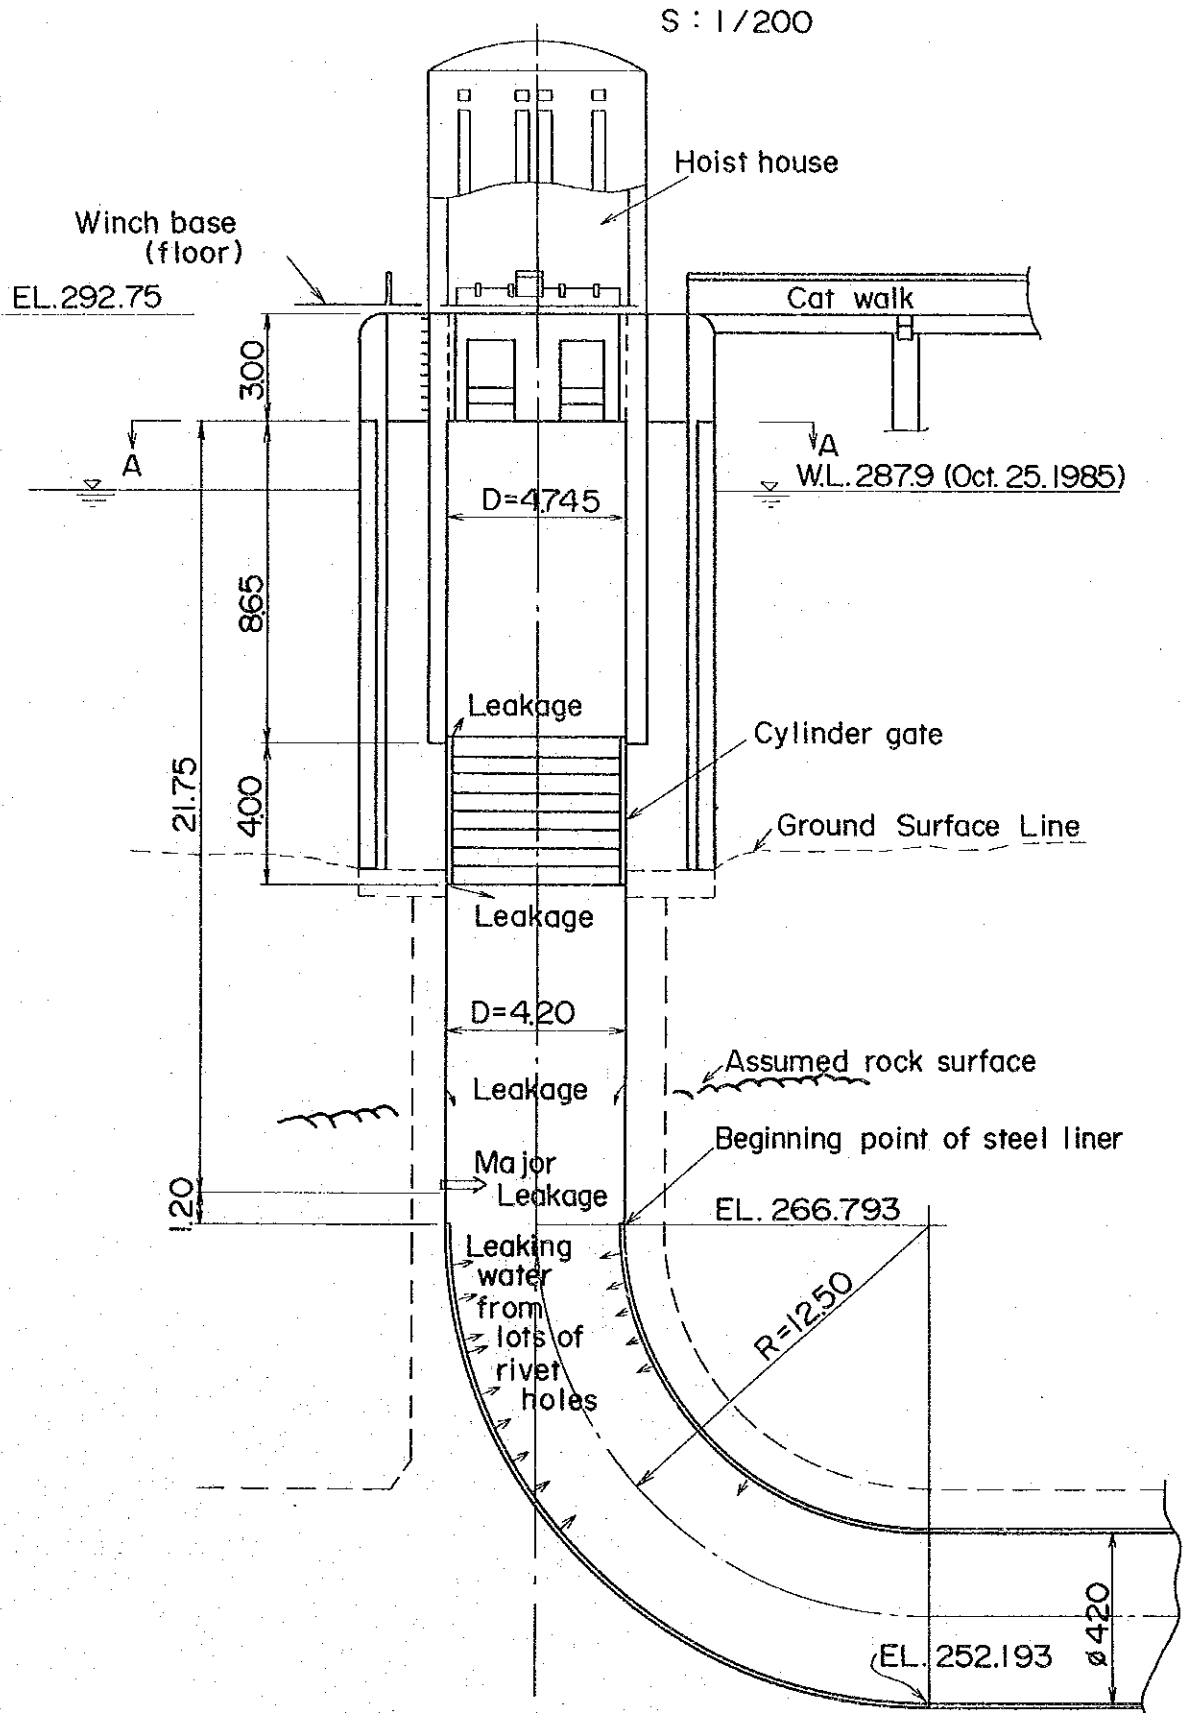
Fig. V-10 Service Spillway (Caliraya Dam)

The intake tower has a cylinder gate of 4.2 m in diameter and 4.0 m in height, located around 10 m below the high water level. Beneath the cylinder gate is a vertical shaft of approx. 10 m with reinforced concrete lining. The vertical shaft and the horizontal tunnel are connected by an elbowshaped rivetted steel liner with 12.5 m curvature radius. The cross section of the horizontal tunnel is round, with 4.2 m internal diameter. (See Fig. V-10)

On October 28, 1985, a member of the JICA Study Team entered the vertical shaft to inspect water leakage. Leakages were found in the following four (4) sections.

No leakage was evident from the gate leaf. However, leakage was occurring through one spot in the upper gate seal and through three spots in the lower gate seal. The water spouting through these leaks was 2-3 cm in diameter.

The reinforced concrete lining between the lower end of the cylinder gate and the steel liner is approx. 9.3 m long and 1.0 m thick. This concrete lining is seriously damaged at many points and has a number of cavities.

The cavities are grouped in 3 cross sections, each group distributed around the circumference of the lining. The largest, about 120 cm long, about 70 cm wide and 60 cm maximum depth, is located in the mid-portion of the lining with reinforcing bars exposed. The water leakage from this cavity is relatively small in connection with the size of the cavity. Water merely seeps through the concrete in droplets.

A more serious leakage occurs about 1.0 m above the steel liner. This damaged portion is of an irregular shape, about 70 cm wide and 20 cm high. Water gushes from the whole damaged area with sufficient power to strike against the opposite concrete lining.

In the damaged portions, coarse aggregate is exposed representing a honeycomb structure. As mentioned above, the damage is aligned around the circumference of the lining. These facts indicate that the damage is not the result of corrosion due to water leakage but has developed as a result of insufficient compaction of the cold joints when the concrete lining was poured.

At least one quarter of the total number of rivets had become detached from the liner plates and water was gushing out of the vacant holes. These empty rivet holes spread over the entire surface but particularly at a point about 3.5 m below the top of the liner. The water spouts from these holes are of similar diameter and velocity, from which we can assume that the voids allowing free passage of water must lie between the steel liner and the backfill concrete, and the continuous cracks and voids in the backfill concrete and surrounding ground must enable easy passage of pressurised water from the reservoir.

The sealing parts of the cylinder gate must be replaced. Since corrosion of the gate leaf is widespread, it is necessary to renew the entire gate. The estimated renewal cost is US\$90,000.-.

Damage to the lining concrete is serious and a considerable amount of leakage is seen. Grouting with mortar or cement milk in the rock surrounding the lining concrete is essential. However, the large cavity in the lining concrete from which a large quantity of water is escaping, should be temporarily blocked, and then grouted. The proposed temporary leakage sealing works are shown in Fig.VIII-3.

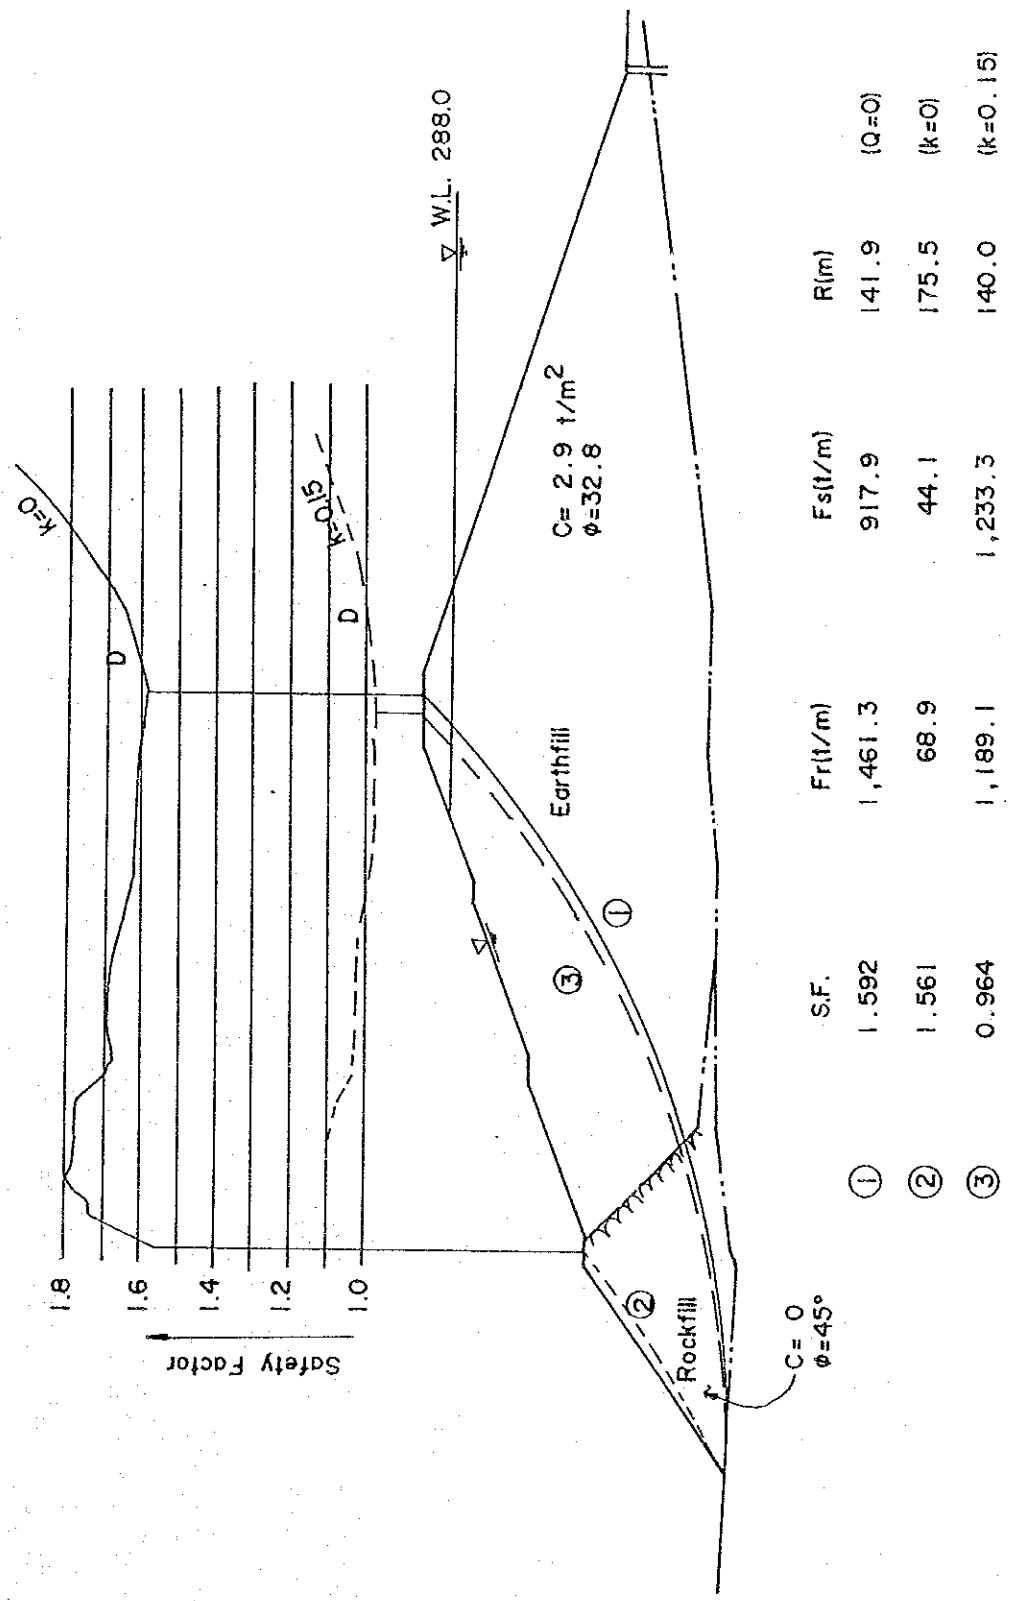
FIG. VII-4 CALIRAYA DAM STABILITY  
 ( Section STA. 0 + 384 )

Fig. VII-4 assumes that the ground water level reaches to the surface of the downstream slope of the dam at an elevation lower than HWL. Even in this case, the stability of the downstream slope of the dam can be maintained at over 1.5, and slightly below 1.0 in the event of seismic condition of  $k=0.15$ .

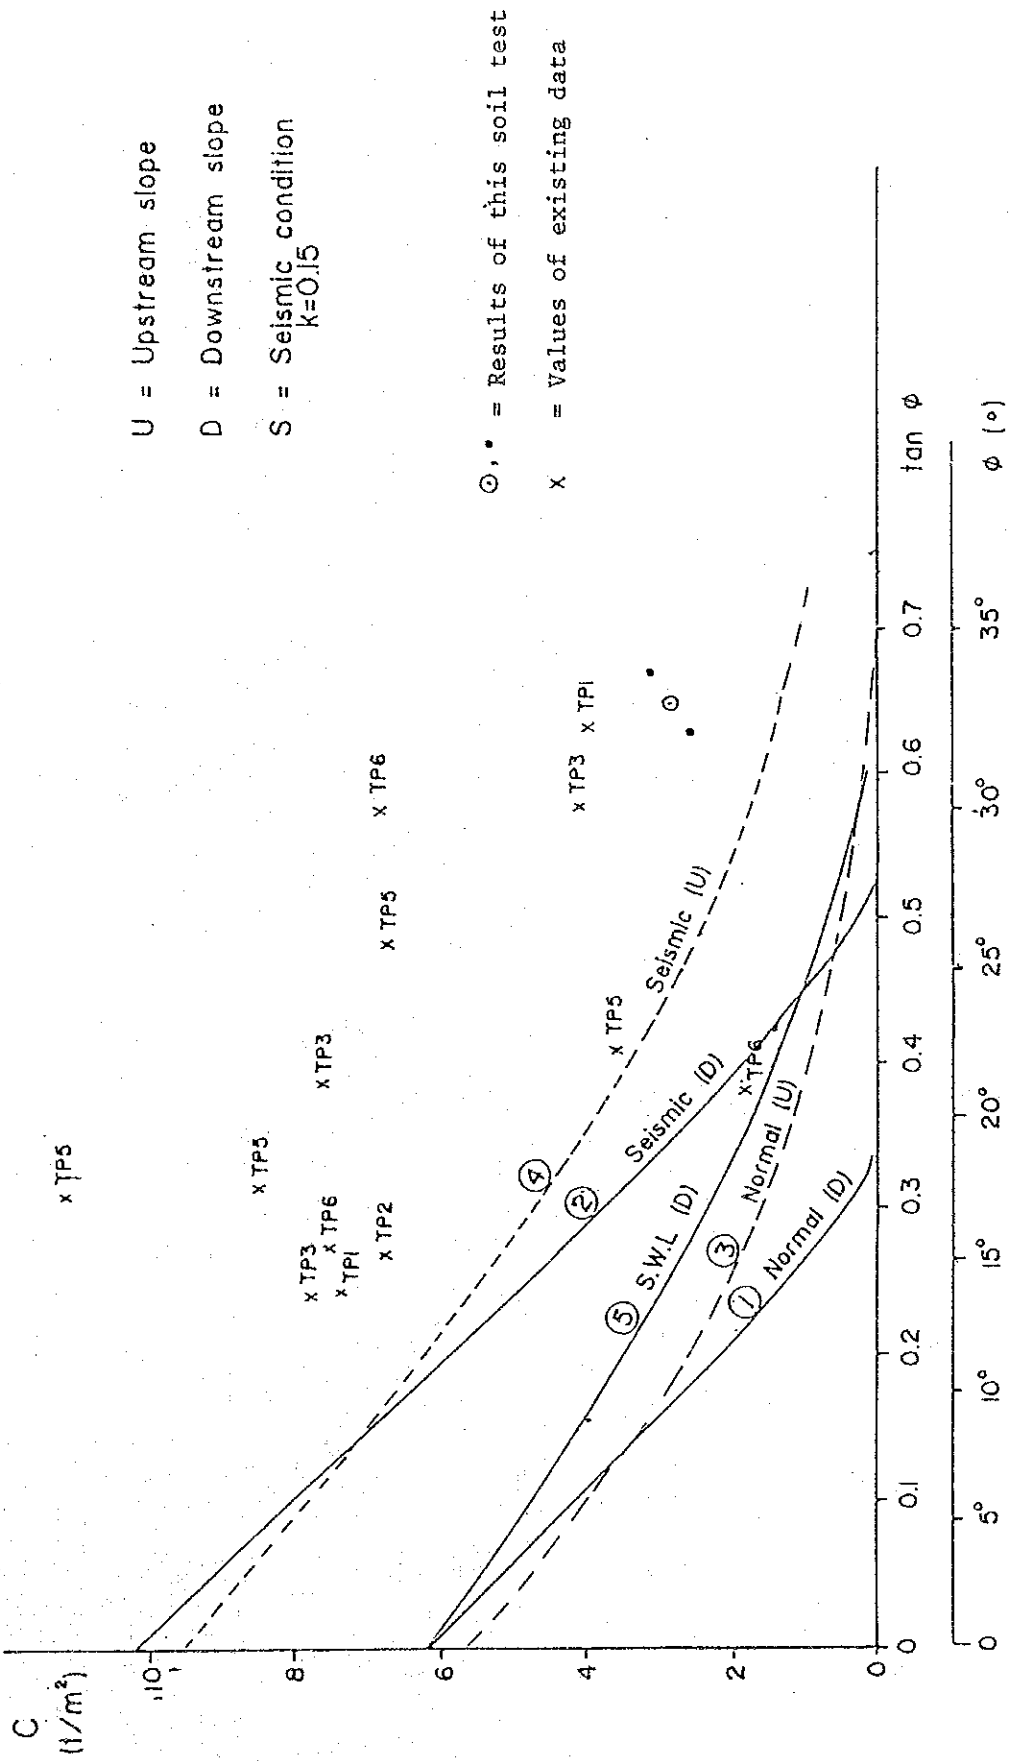
FIG. VII-5 : Range of C &  $\phi$  Values for 1.0 of Sliding Stability

Referring to Fig.VII-5, it is considered that at present no significant landslide is likely to occur on either the upstream slope or the downstream slope of the Caliraya Dam, whether under normal conditions or even in case of a rapid drawdown of the reservoir water level from H.W.L. to L.W.L.

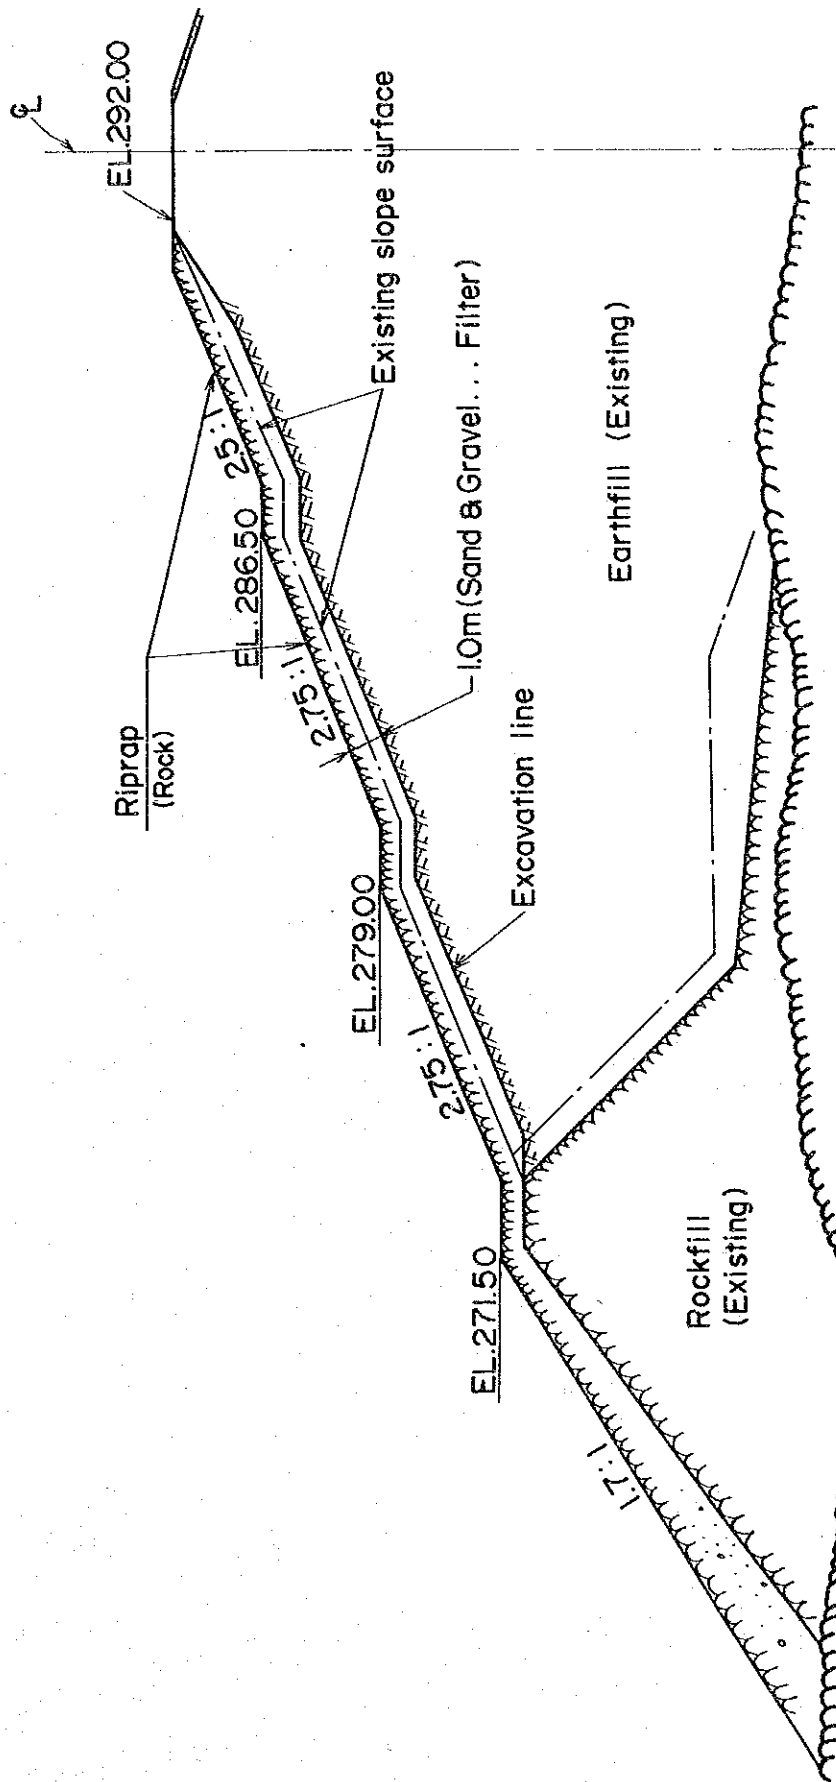
Fig. VIII-1 Remedial Works for Downstream Slope of Dam  
 S : 1 / 500

As reported above, widespread damage caused by rainfall erosion stripping grass and top soil was found on the downstream face of the dam. Without remedial measures it is probable that the damage will rapidly deteriorate. It is therefore recommended that a programme of remedial work is established without delay.

The remedial work proposed would include installation of drainage, and repairing the damaged areas. The damage is spread over a wide area. A systematic remedial scheme is therefore proposed rather than a continuation of the present piecemeal repair work.

The scheme of the permanent repairs plan is shown on Fig. VIII-1.
