CHAPTER 3
PRESENT SITUATION OF
THE PORT

3.1.1 Location

Fig. 3.1.2 shows the site of the Manila South Port Rehabilitation Project. The Study Team made a field reconnaissance throughout the area of Manila North and South Harbors and completed the topographical drawing shown in Fig. 3.1.3.

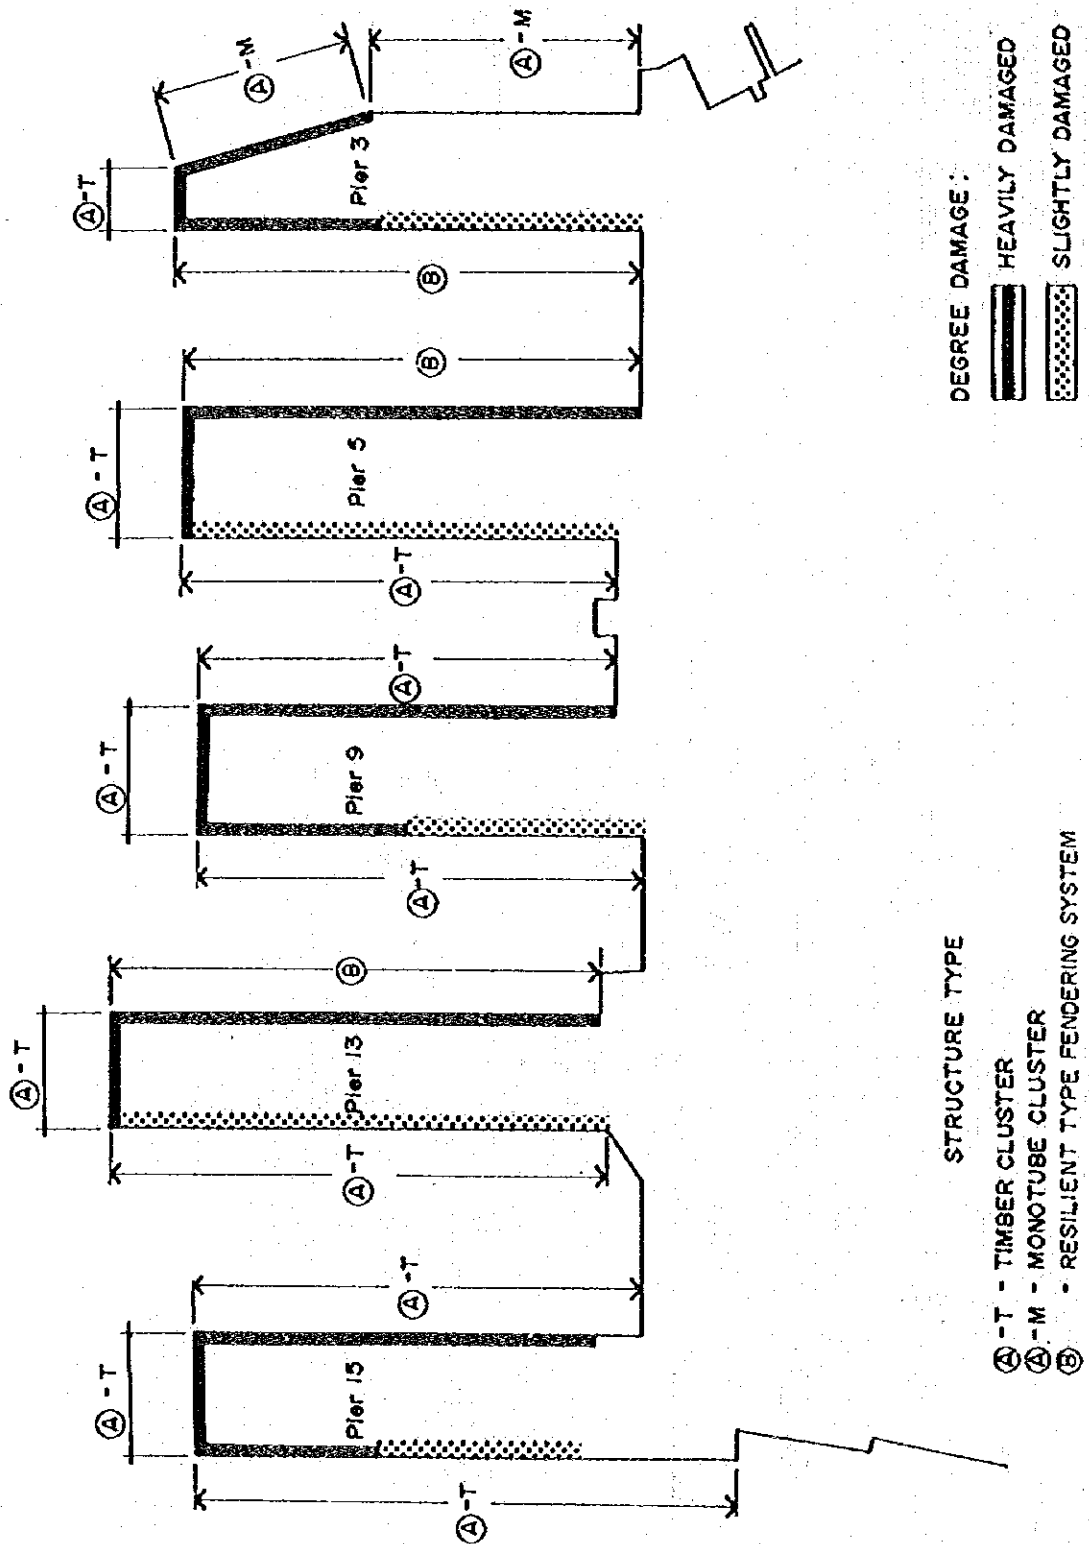
Fig. 3.2.3 Result of Investigation for Fender

The fender types and their present conditions at each pier are shown in Fig. 3.2.3.

Most of the fenders of both types are damaged and do not necessarily function properly in absorbing the berthing energy of vessels.

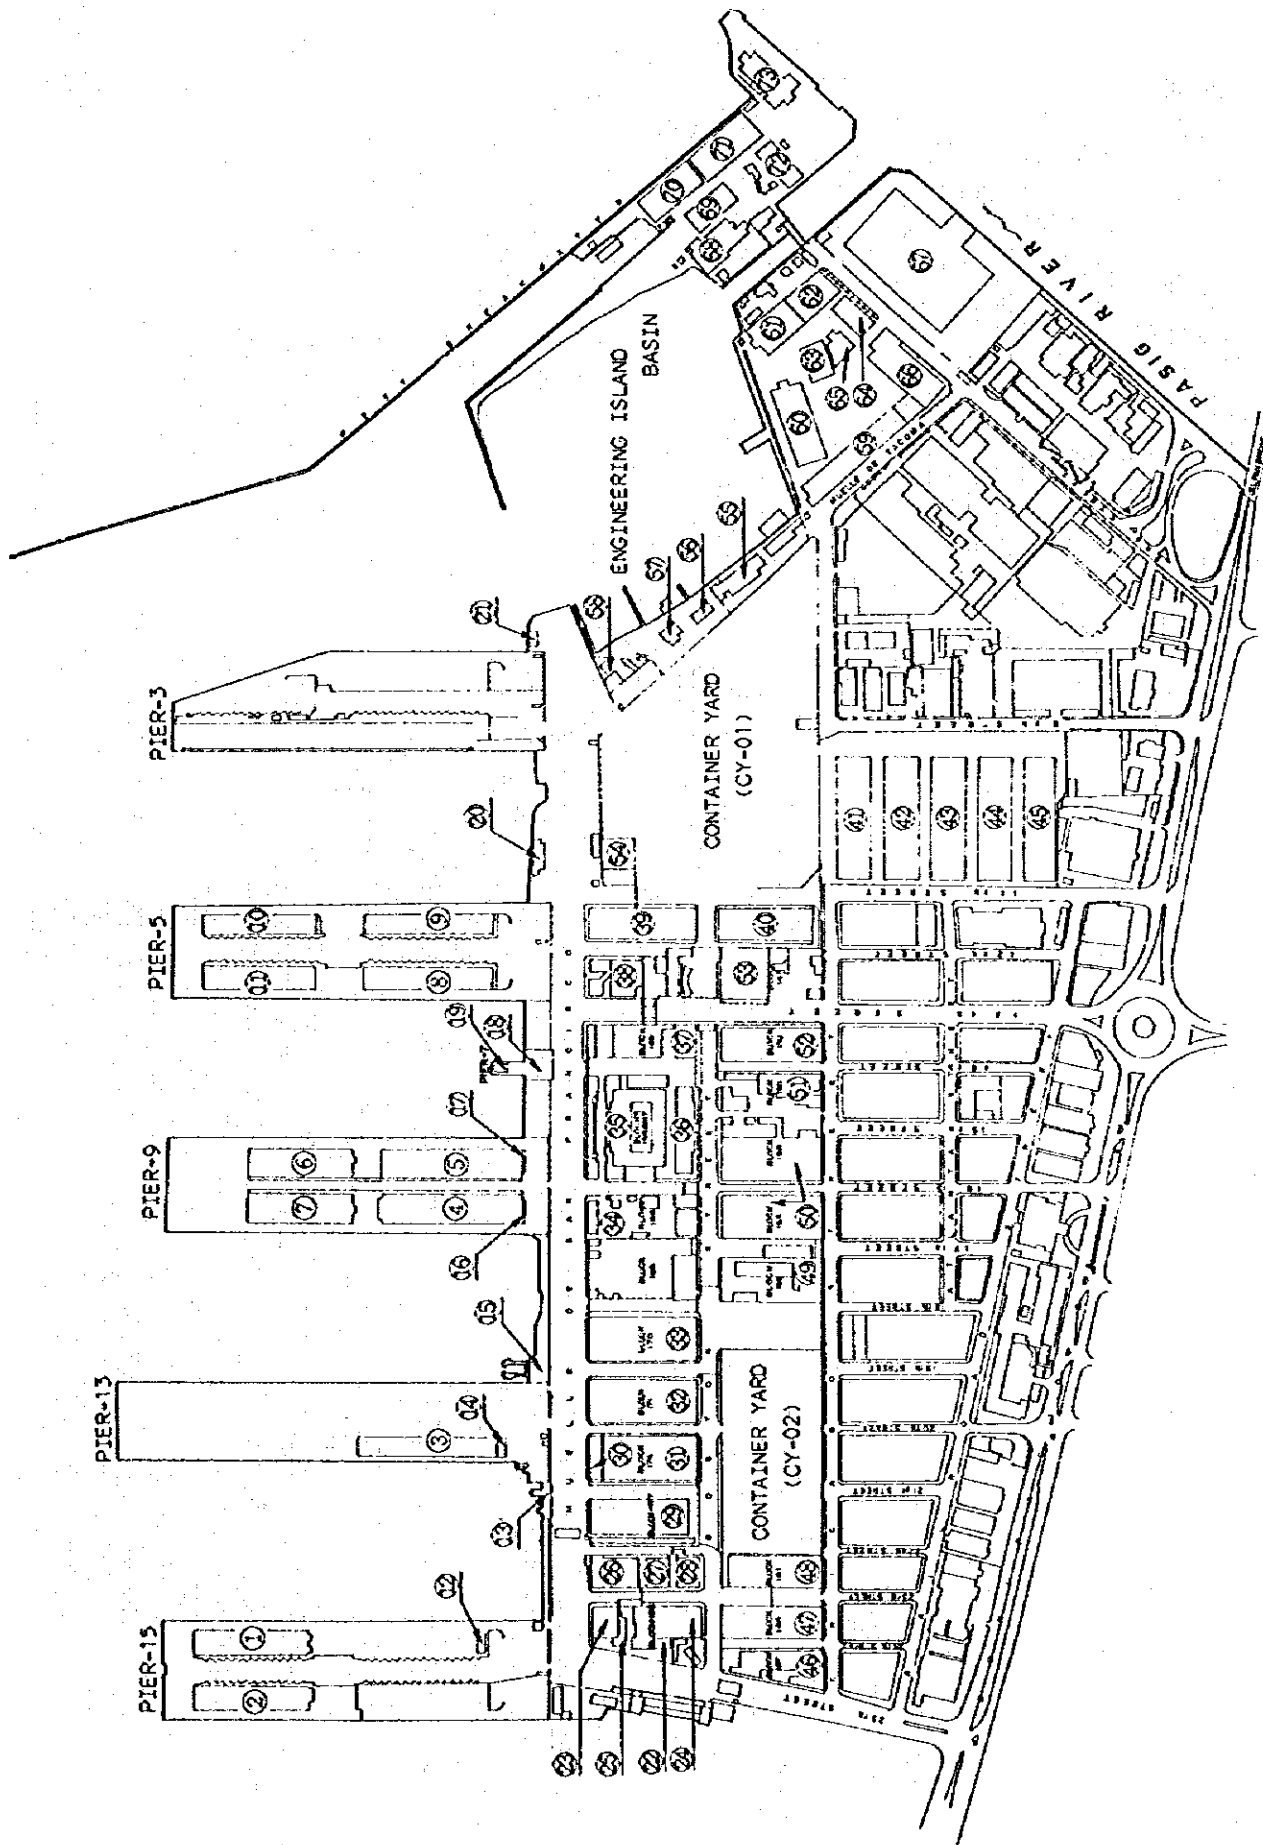
Fig. 3.2.4 Location of Existing Facilities in South Harbor

Fig. 3.2.4 shows the location of these facilities. The size and type of the structures are taken from the inventory list (1981) of the PPA, and the results of the inspection are listed in Appendices 3.2.1 to 4. The structures are categorized into three classes. Class "A" indicates that the structures are sound; class "B" shows that the structures are usable but damaged; and class "C" indicates that the structures are worn out and show some structural problems.
