### 3.3 Structural Survey at South Harbor

The Port of Manila is comprised of North Harbor for domestic trade and South Harbor for foreign trade, and the Manila International Container Terminal (MICT). All the harbor facilities in the Port of Manila were constructed shortly after World War II. The facilities are seriously deteriorated and some parts of the facilities have reached very dangerous conditions for normal port operation because of lack of proper maintenance and repair works. Considering the unsatisfactory situation, the Study Team conducted a series of structural survey/inspection of the existing harbor facilities.

#### 3.3.2 Field Surveys at South Harbor

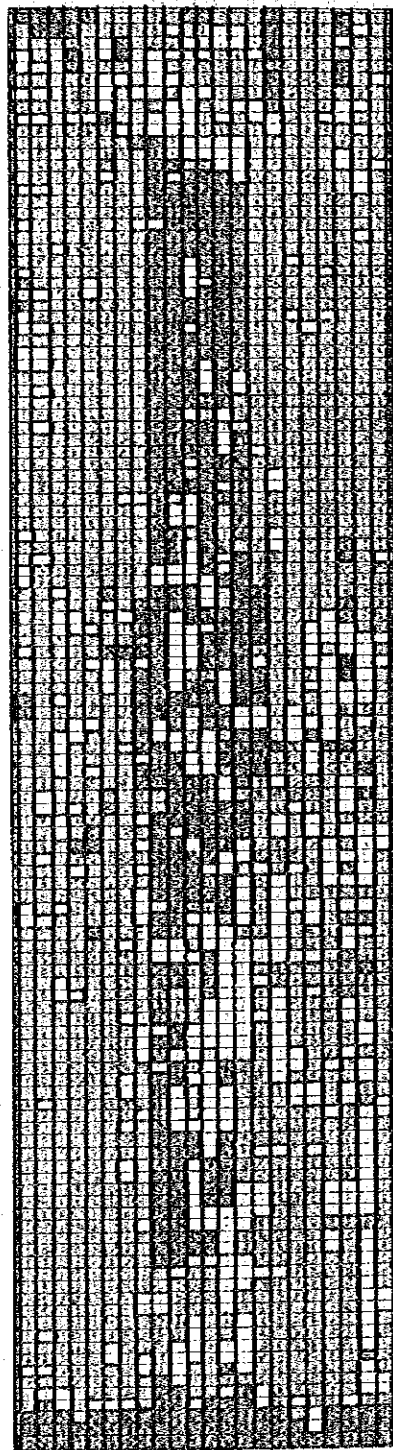
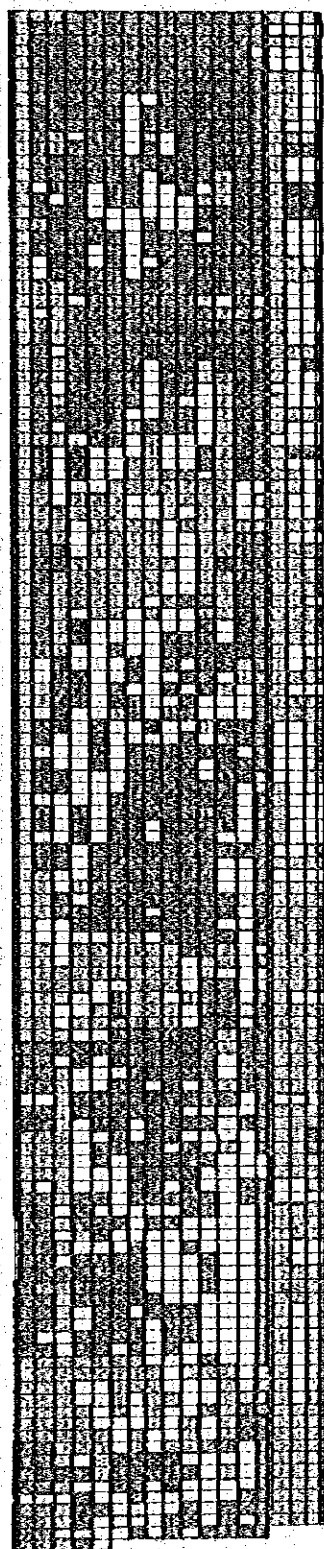
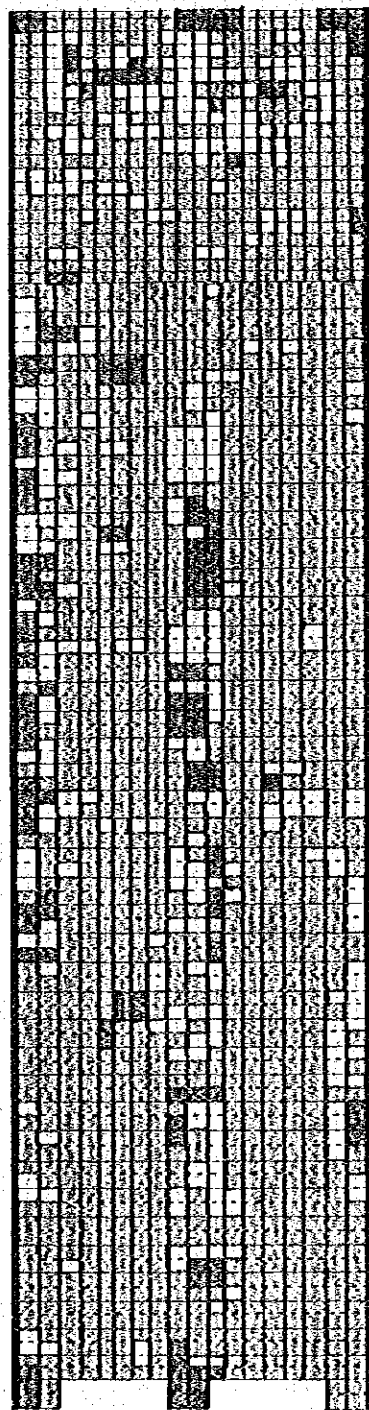
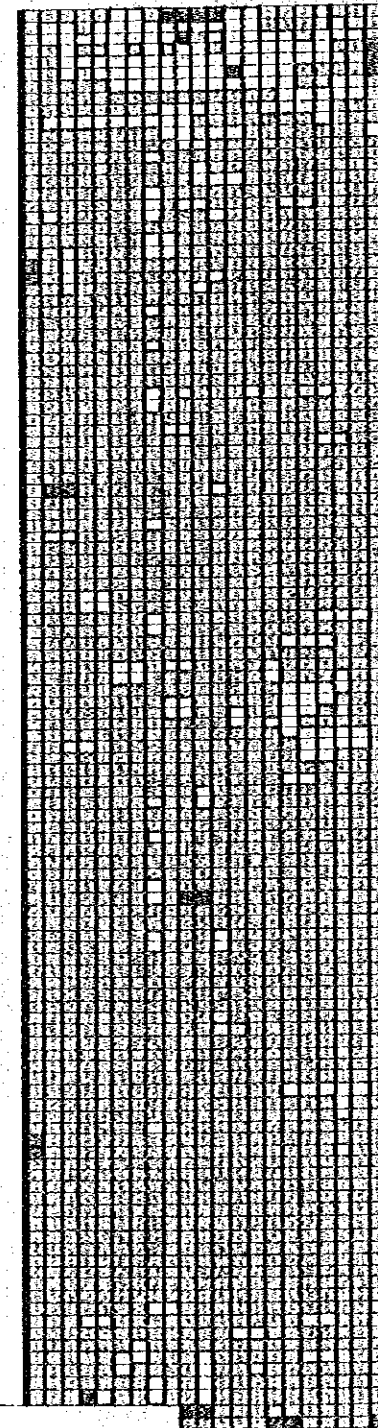
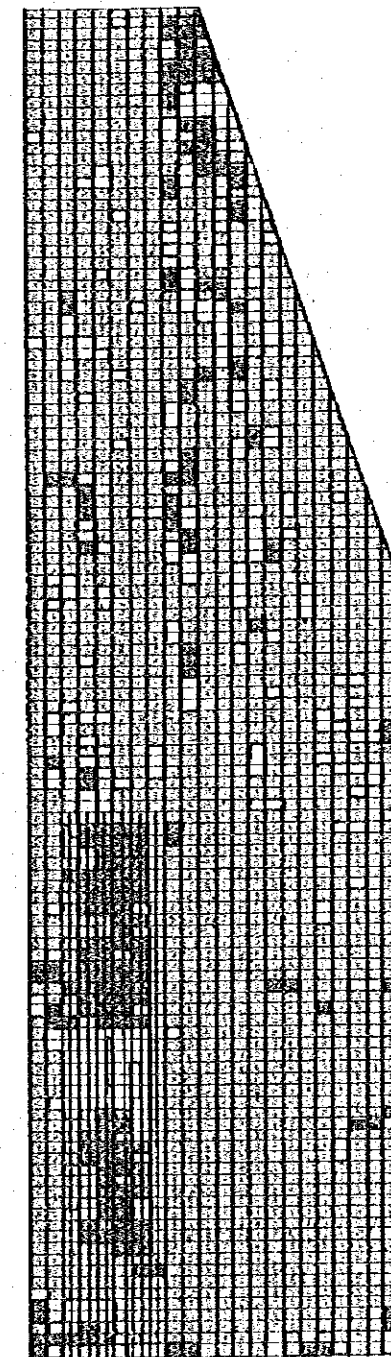
Fig. 3.3.1 Damage Map of Piers

Fig. 3.3.1 is a colored chart showing the degrees of damage as estimated from the visual inspection. Judging from the figure, Pier 5 is the most sound, raising no problems if used as it is. Next, Piers 3 and 9 are mostly sound with about the same level of damage. All the piles are almost sound while the beams and slabs are damaged severely here and there. Repair of this damage will, however, assure their long-term service in the future.

Considerable damage at Pier 15 was observed particularly in the beams and slabs although the piles are mostly sound. Repair of this severe damage is relatively easy since most of it occurs along the lowered passage in the center. The pier could become quite serviceable if the beams and slabs were repaired.

Pier 13 is the most severely damaged, to the extent that even its utilization under the present conditions is dangerous for normal port operation, as overall deterioration of the piles, beams and slabs has developed throughout the pier. Moreover, repair is very difficult because of the deteriorated piles.

According to the results of the item-by-item investigation, all the piers have cracks and resulting free lime and exposure of reinforcement is common, but in addition to such damage Pier 15 shows much more honeycombing than the other piers.

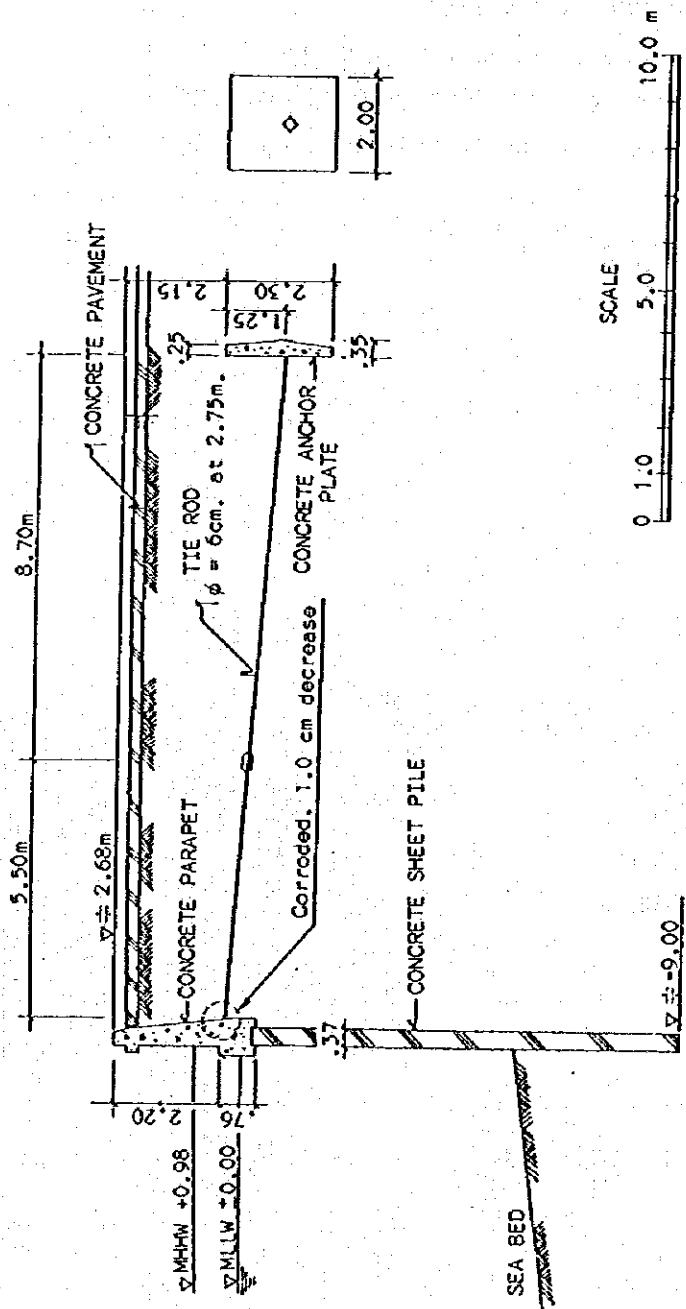
Fig. 3.4.1 Surveyed Section of Pier 8

The most reliable sections were traced based on the results of the survey and relevant documents. Sections of Piers 8 and 16 are presented in Figs. 3.4.1 and 3.4.2 respectively. The historical stages of structural countermeasures are shown in Fig. 3.4.3 according to the investigation and interviews with MPWH and PPA personnel.

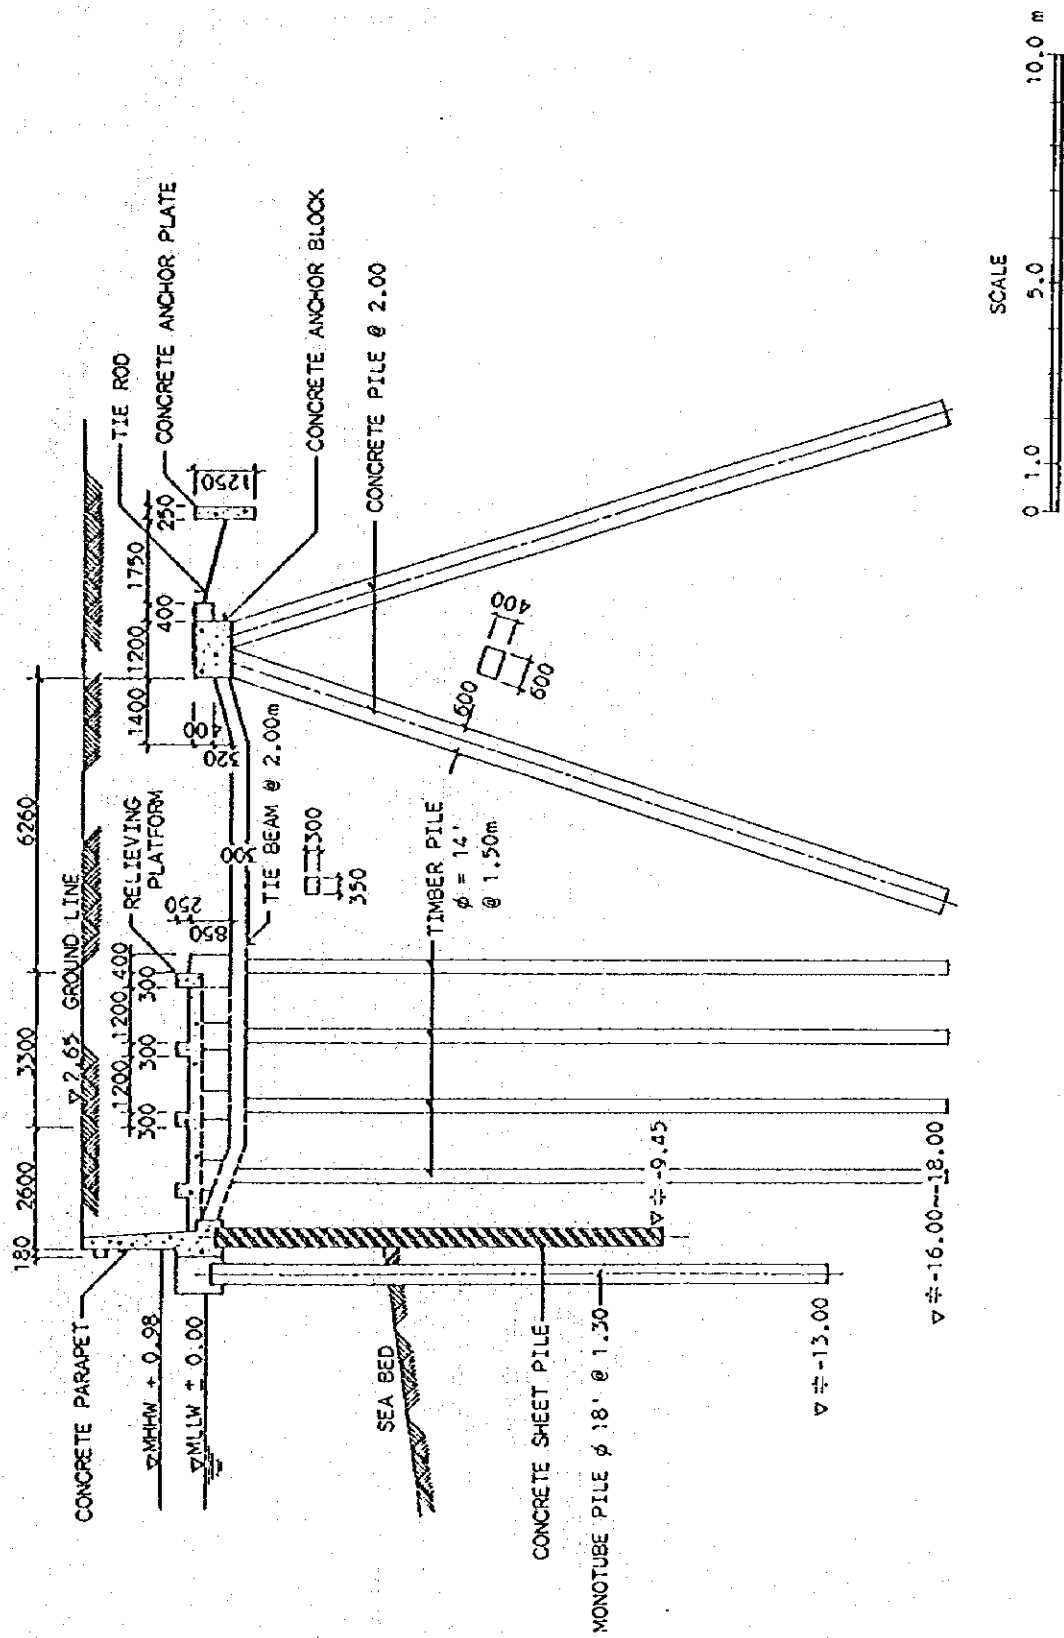
Fig. 3.4.2 Surveyed Section of Pier 16

The trial excavation shows that the reinforced concrete tie-beams are broken and the reinforcing bars are exposed.

The failure of the tie-beams may have been brought about by the initial settlement of the backfilling material shortly after the completion of the structure. The existing tie-beams cannot be expected to transfer the reaction of the sheet piles to the anchor plates. Thus, this pier is very unstable from the structural point of view.

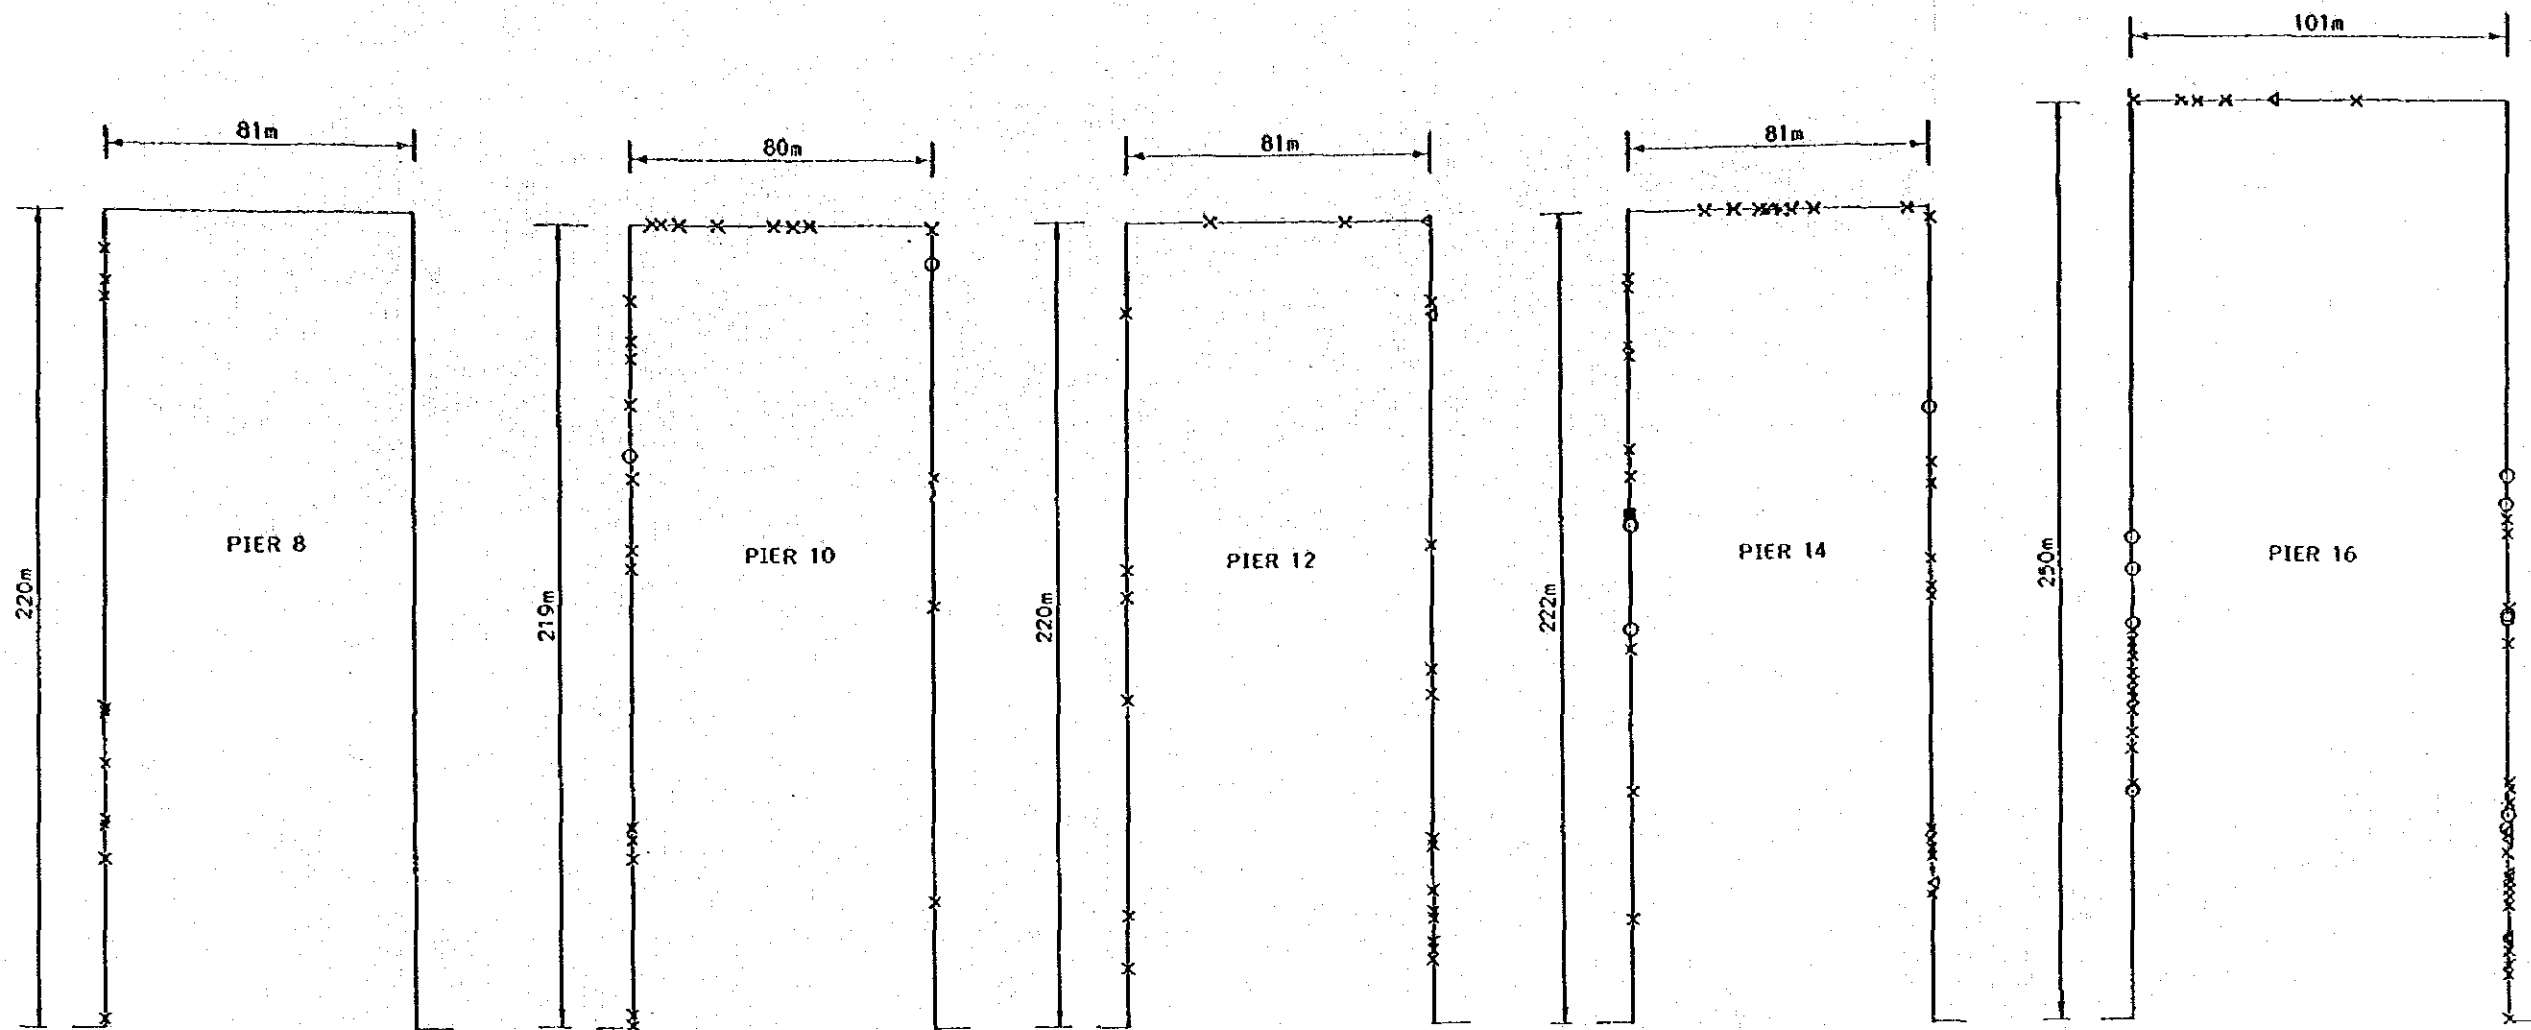
Fig. 3.4.4 Underwater Survey of Concrete Sheet Piles in North Harbor

The results of the underwater survey are shown in Figs. 3.4.4 and 3.4.5. Fig. 3.4.4 shows the location where damage including gaps between the sheet piles was found. Fig. 3.4.5 shows the distribution of gap width at Piers 8 through 16.

Damage to the sheet piles was confirmed at 16 points, which is a little greater than at the other piers. However, because the damage is very small compared with the total length of the perimeter of the pier, there is no problem of structural stability.

Gaps about 30 cm wide were found at 2 points between sheet piles and the other gaps were about 10 cm wide. According to PPA personnel, these gaps caused the leakage or dropout of the backfilling which brought about the settlement. If their claim is accurate, the settlement must be concentrated at a certain area in the backfilling behind the end of the relieving platform.

But it is recommendable to put some type of covering over gaps more than 6 inches wide between the sheet piles. This is because the backfilling material, which has not spilled out yet, might be squeezed out if there were a severe earthquake which would possibly break the existing stable condition of the backfilling material.

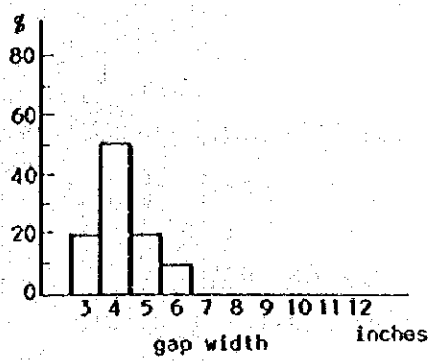
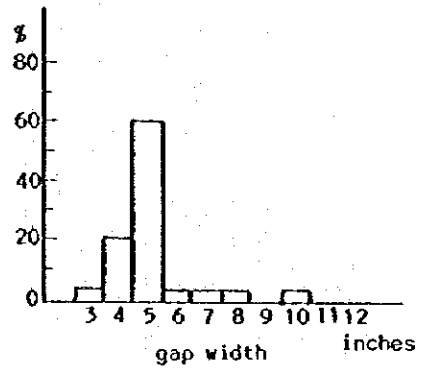
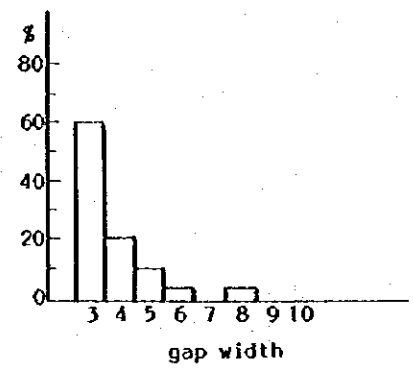
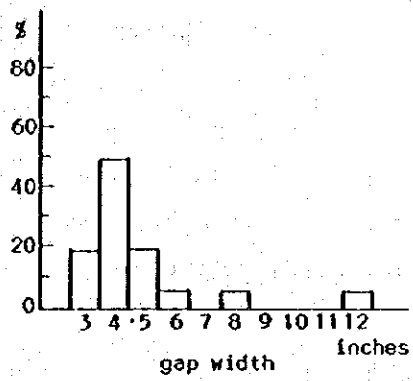
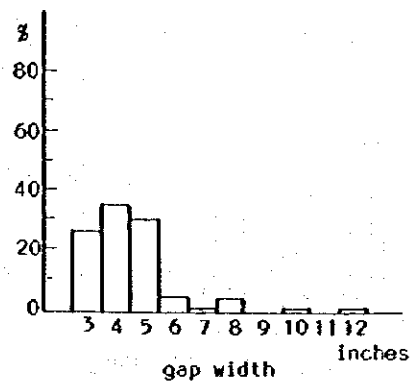
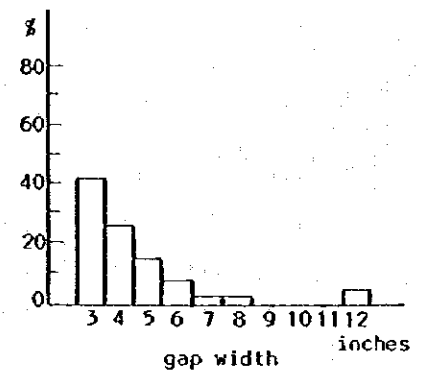
Pier (inches) gap width	P-8		P-10		P-12		P-14		P-8~14		P-16	
	No.	%	No.	%	No.	%	No.	%	No.	%	No.	%
3	2	20	1	4	12	60	5	19	20	25	15	41
4	5	50	5	21	4	20	13	50	27	34	9	25
5	2	20	14	59	2	10	5	19	23	29	5	14
6	1	10	1	4	1	5	1	4	4	5	3	8
7			1	4					1	1	1	3
8			1	4	1	5	1	4	3	4	1	3
9												
10			1	4					1	1		
11												
12							1	4	1	1	2	6
Total	10	100	24	100	20	100	26	100	80	100	36	100

The sheet piles themselves were not significantly damaged, and the gaps between the sheet piles were very small, on average about 10 cm. Therefore, there is no possibility of soil leakage through the gaps. The results of the diagonal boring showed the sheet piles were embedded about 3 m into the sea bed, and driven into a sand layer having an N-value of 20 - 30 according to the soil investigation. The results of the trial excavation showed the concrete wall anchorages were sound, and the tie rods were almost sound except that the joint portions with the sheet piles were corroded, and the diameter of tie rods showed a decrease of about 1.0 cm.
