5. Explanation of Photographs

On the basis of the evaluation of earthquake damages made by Cuzco University, we surveyed seriously damaged buildings.

FACULTY OF CIVIL ENGINEERING AND GEOLOGICAL ENGINEERING
 EVALUATION OF DAMAGES IN ADOBE BUILDINGS IN CUSCO
 EARTHQUAKE OF 05-04-86

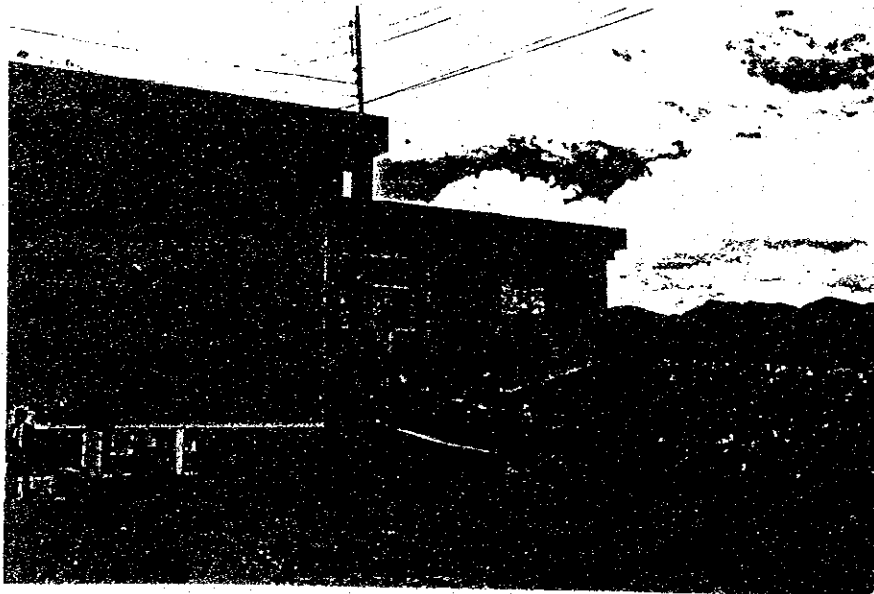
3

Cuzco University. Some buildings were slightly damaged. We can see the damages at the beam-wall joint.

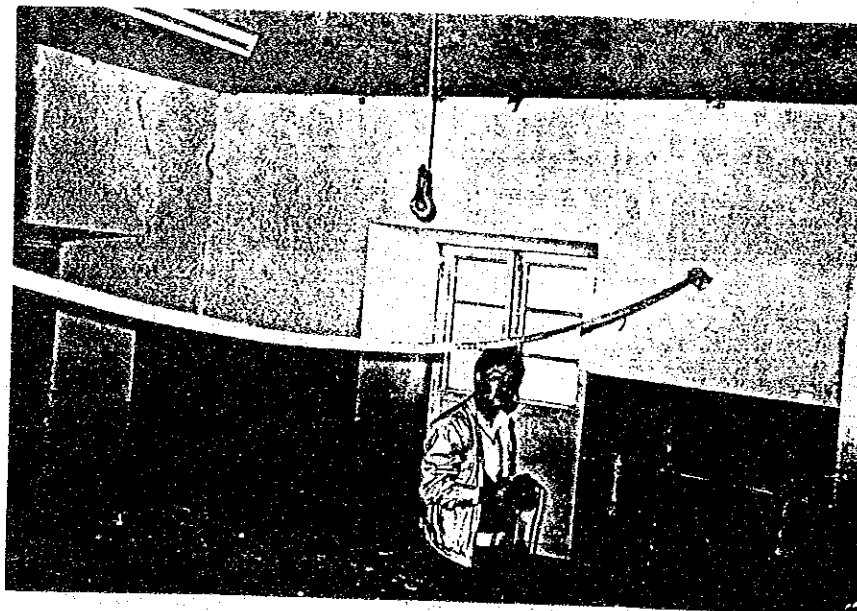
9

The building is very
old. The old type
adobe building has
about 80 cm 100 cm
thick adobe wall.
The reinforcing bar
shown was once used
to prevent walls
from falling outside
but after the
earthquake, the
wall inclined to
the inside.

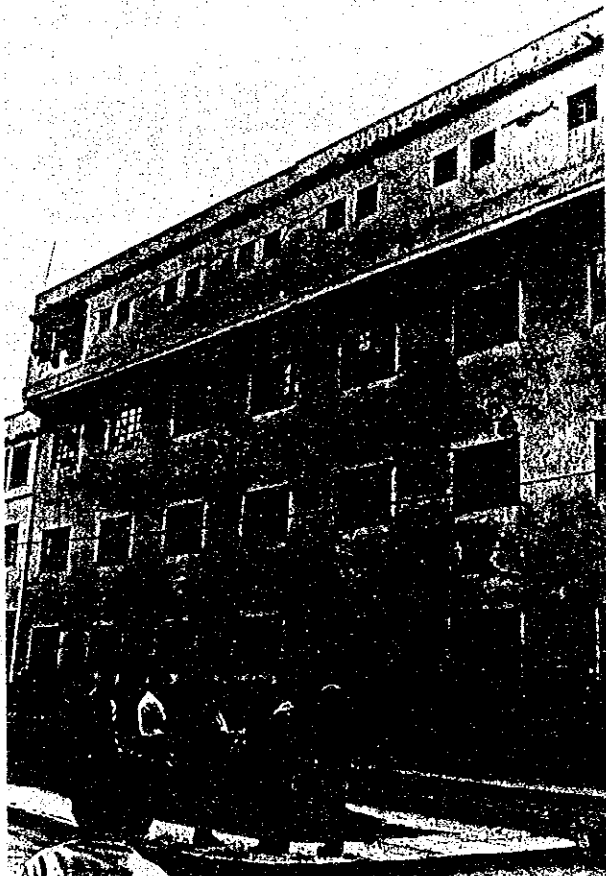
High school. This building is reinforced concrete frame structure; between the frame ordinary bricks are infilled. At the top floor (4th floor) bricks of corner wall were severely damaged. To prevent bricks from falling to the street, workers are destroying the brick wall.

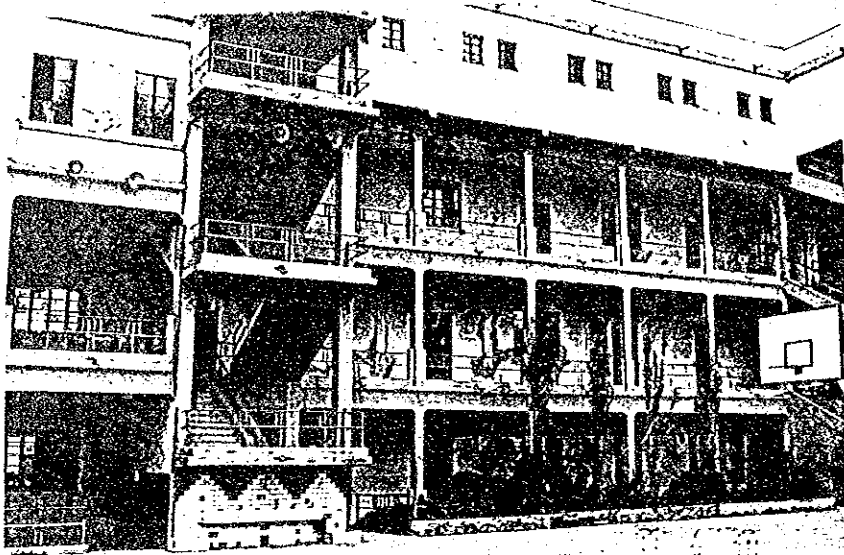
13

Carlos said the building was very damaged in the second storey. That is shown in this picture.

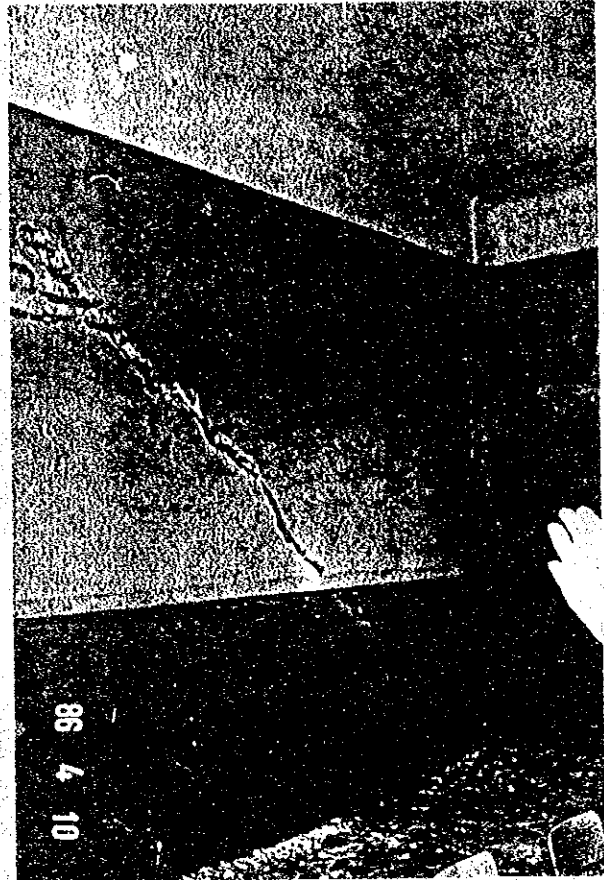
17

Two-storey separation wall of classrooms was damaged by shear force.

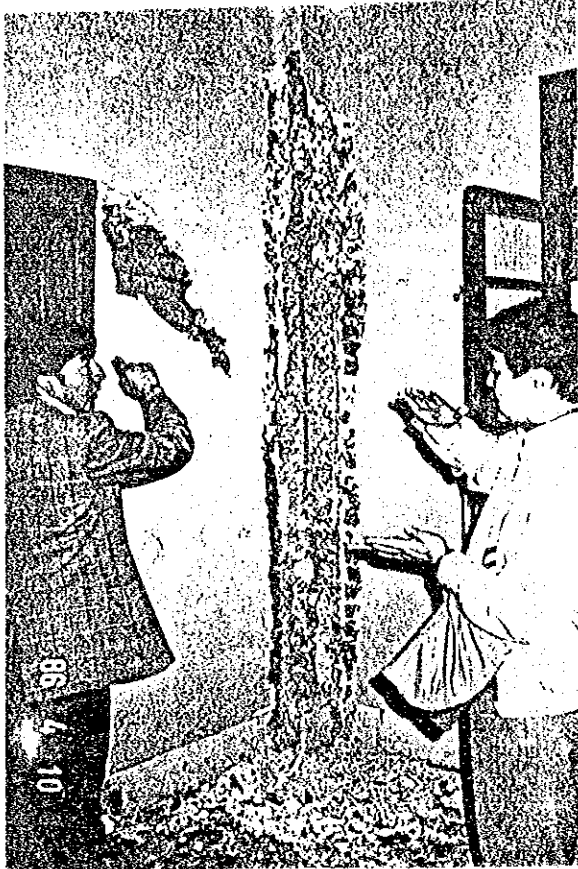
19

Reinforcement condition of columns. The covering was removed for investigation.

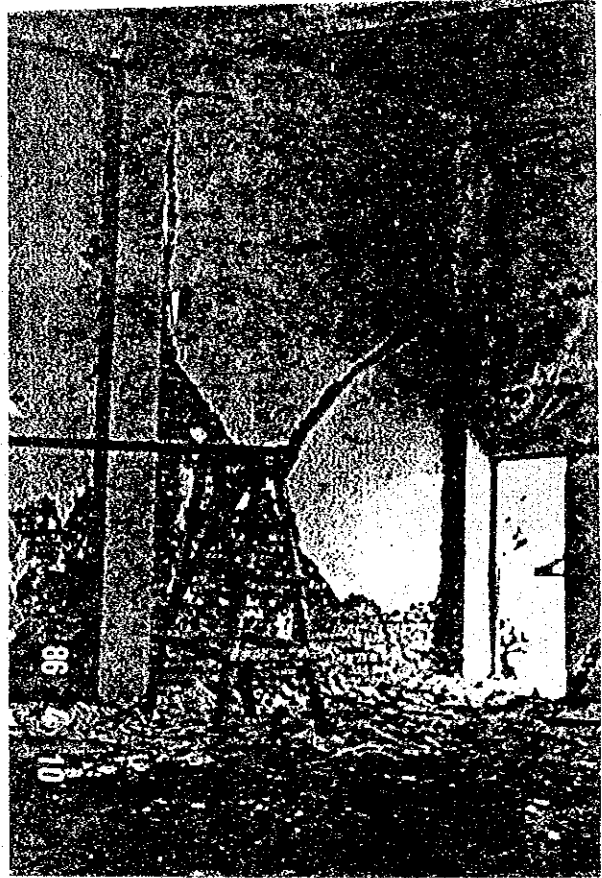
20

Inside the gymnasium damage of capital.

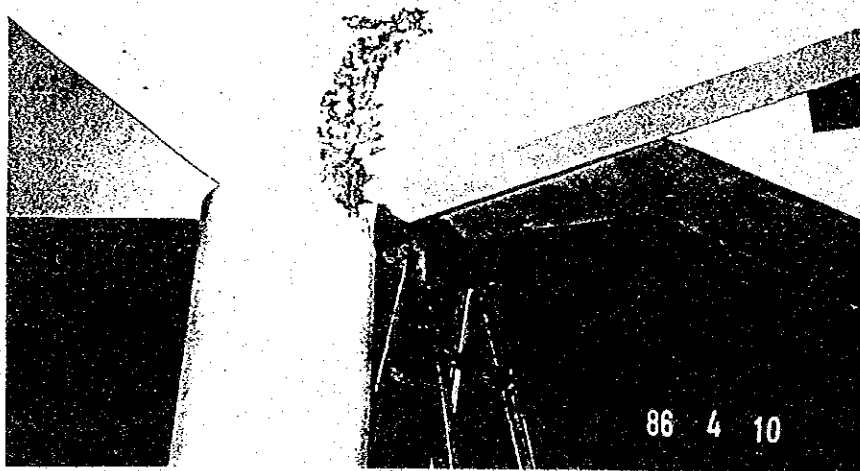
↑ 21

Finishing was falling down.

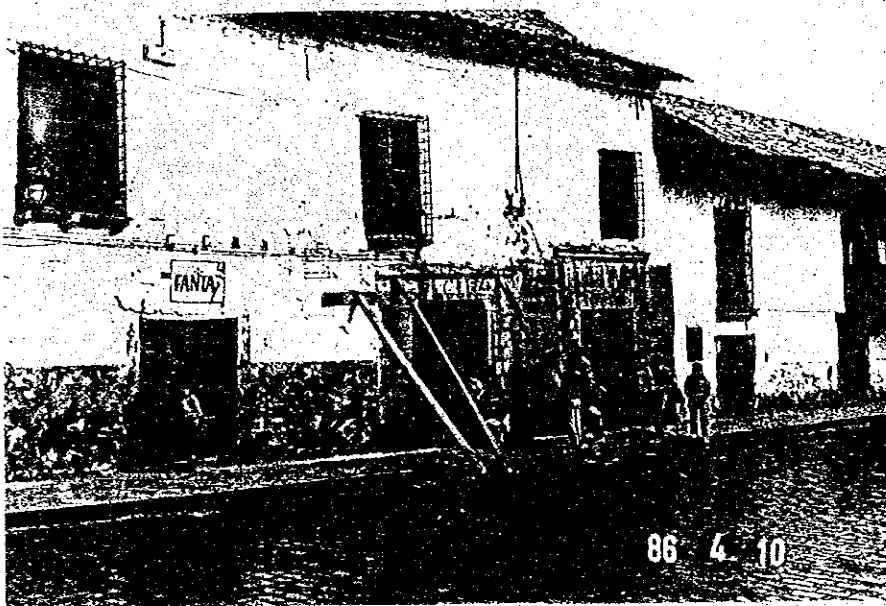
23

Earthquake made the wall incline outwards. (3)

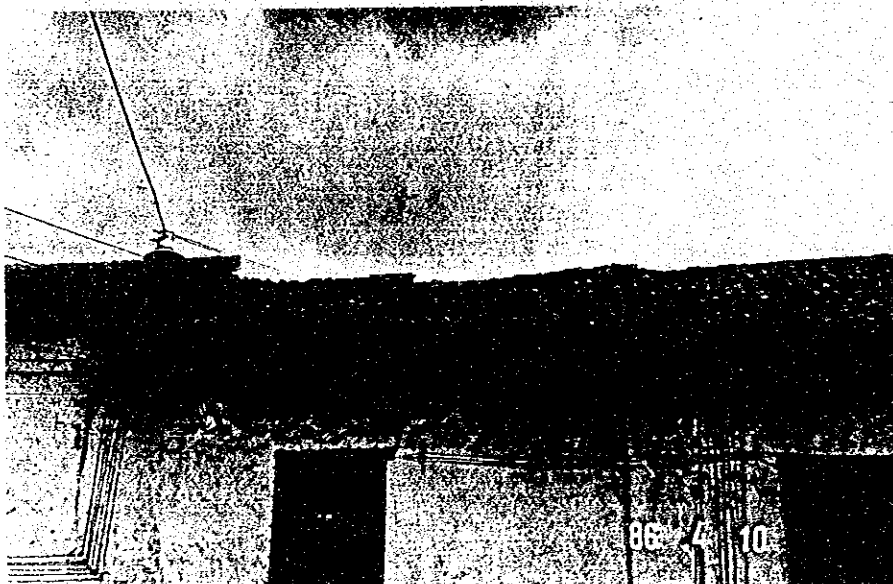
24

Roof was also damaged.

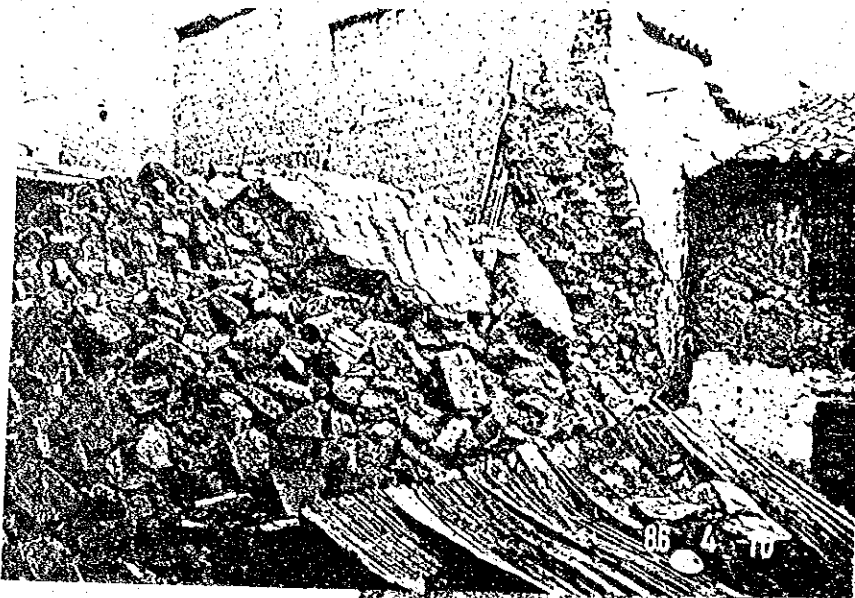
25

One of the adobe walls collapsed inside the building.

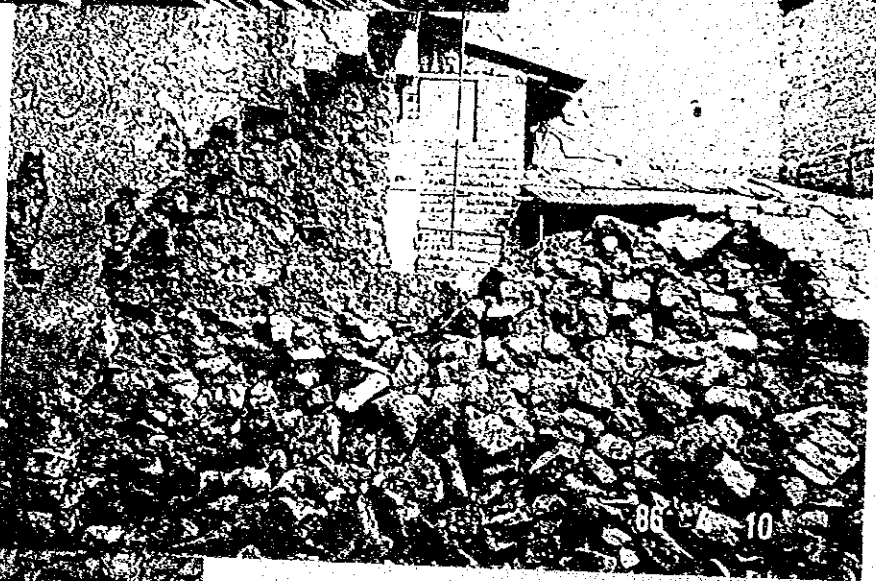
26

One of the adobe walls collapsed inside the building.

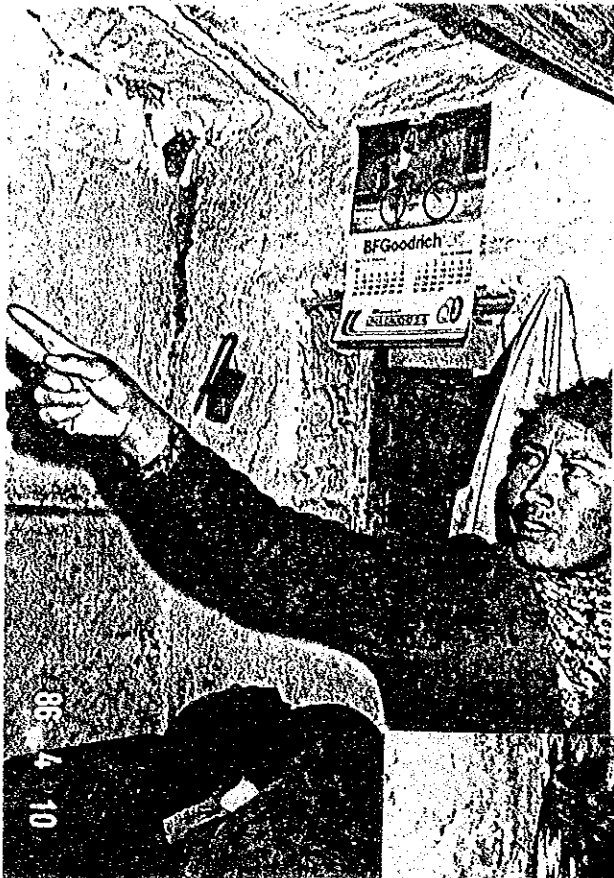
Inside a three-storey adobe building, walls were damaged severely at the second floor. (4)

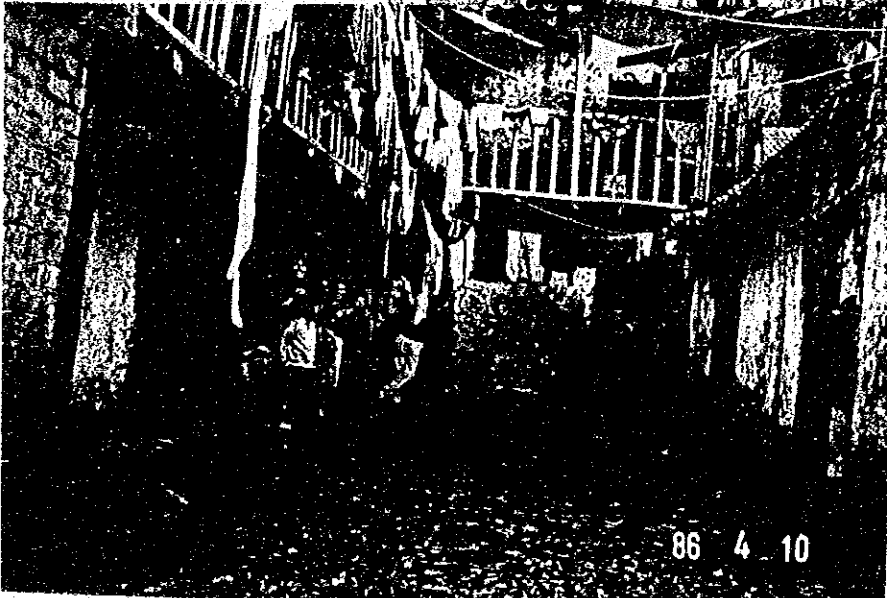
Damaged adobe building. Nine families are living here. (4)

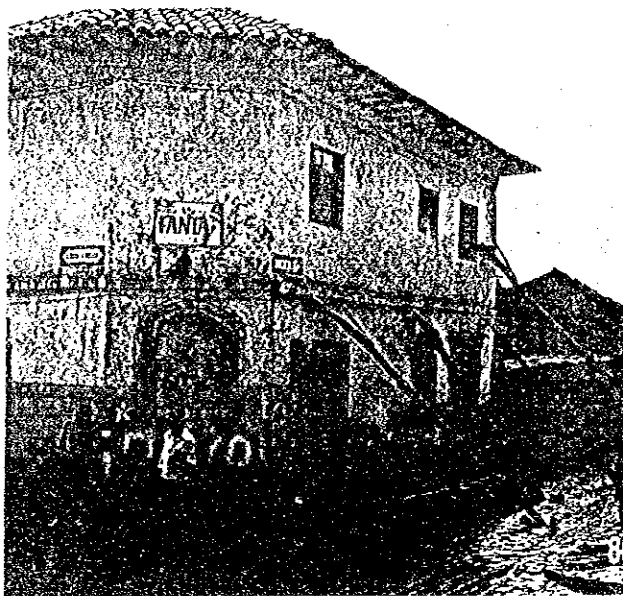
31

Wall inclined to the outside. (5)

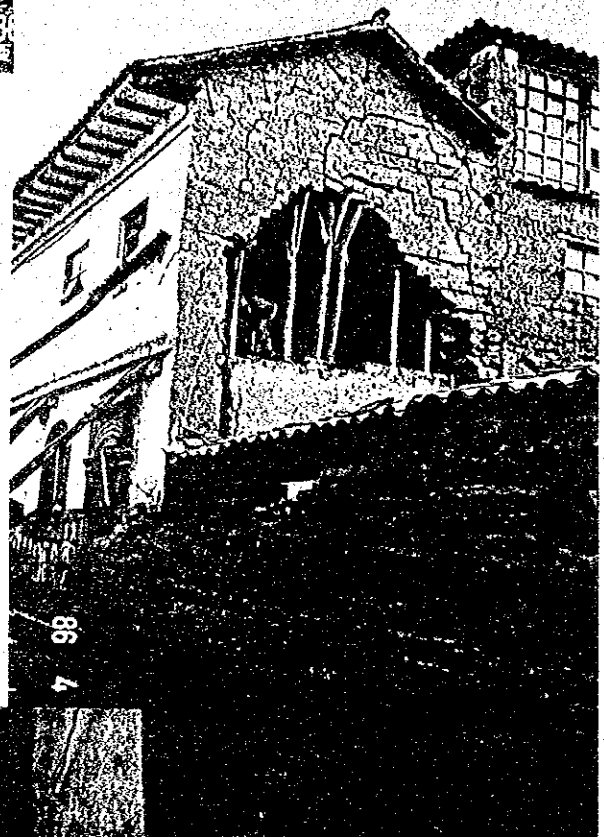
32

Same building, some parts of the walls collapsed. (5)

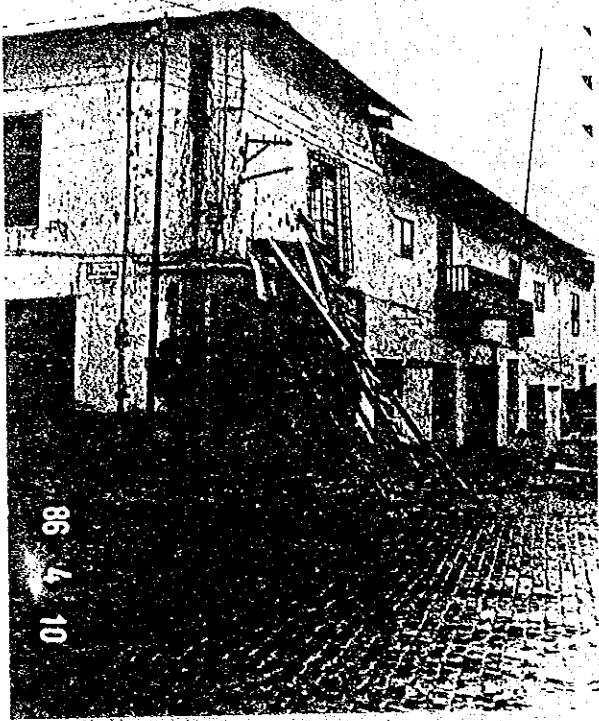
Walls inclined to the outside. (6)

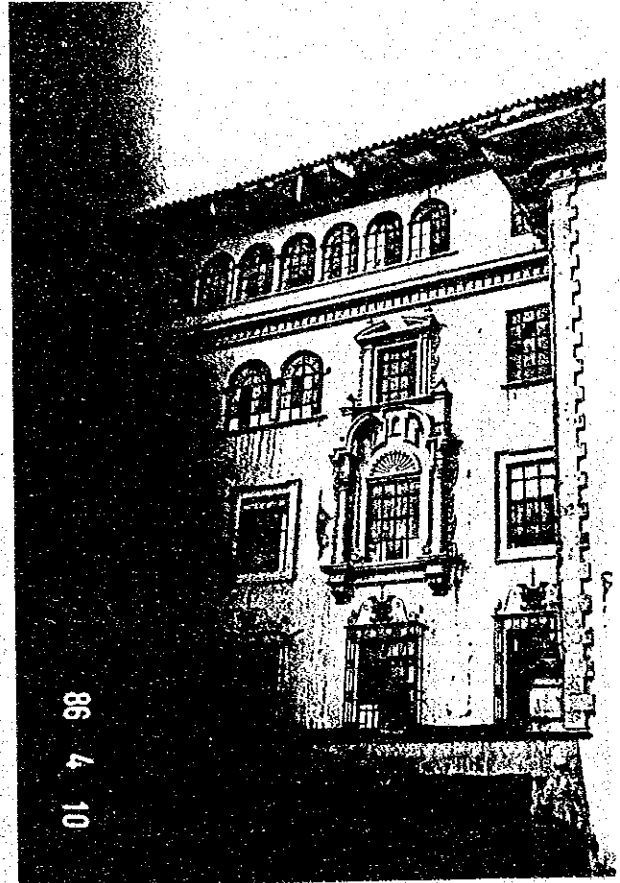
Some buildings' outer walls were inclined to the outside, so road traffic was prohibited. (6)

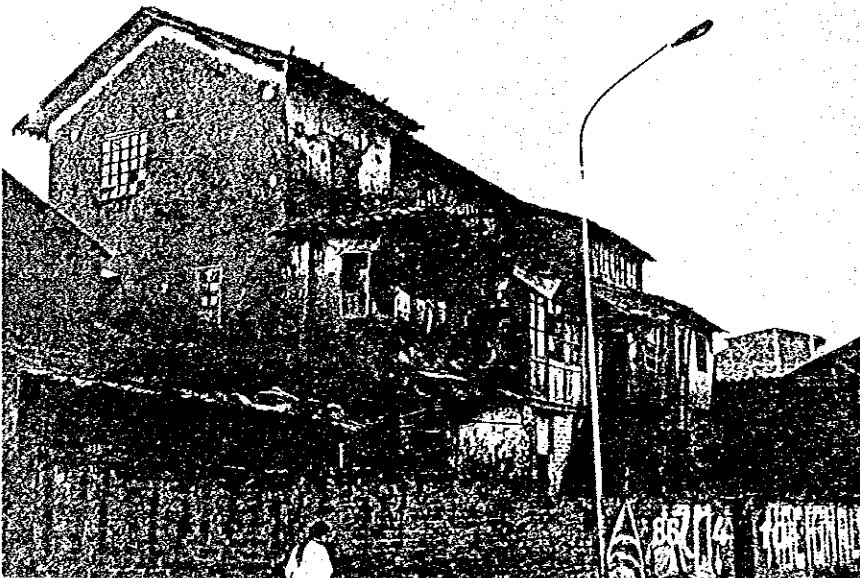
38

This is a four-storey adobe building that stands just at the cliff slope. Adobe outer walls were severely damaged. (7)

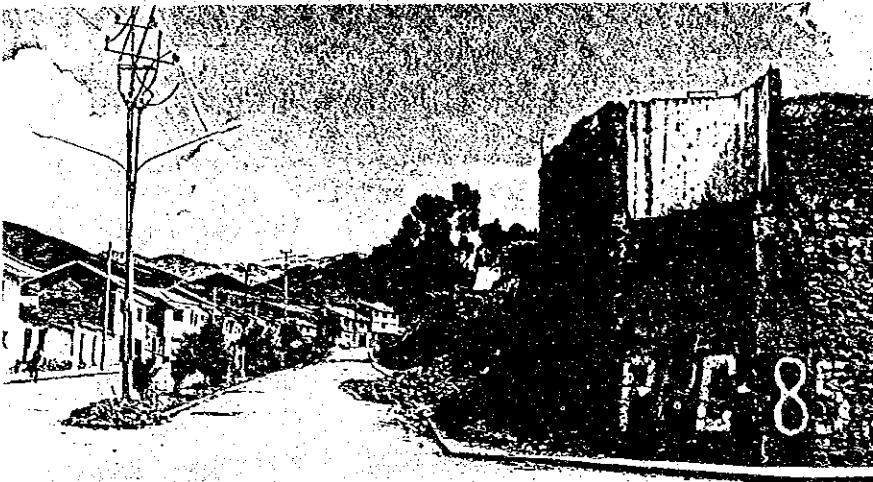
41

Exterior walls of
adobe blocks falled
down to the street.
(8)
