**THE ROMANIA EARTHQUAKE  
SURVEY GROUP OF EXPERTS AND SPECIALISTS  
DISPATCHED BY THE GOVERNMENT OF JAPAN  
SURVEY REPORT**

**June 1977**

**Japan International Cooperation Agency**

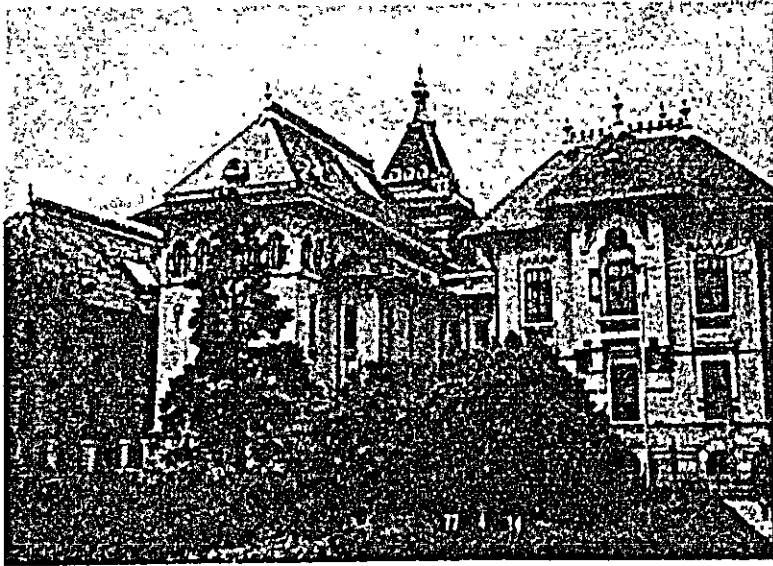
Photo 5.4 The district hall (Brick structure; the exterior looks sound with slight damage but the interior was badly damaged. Craiova)

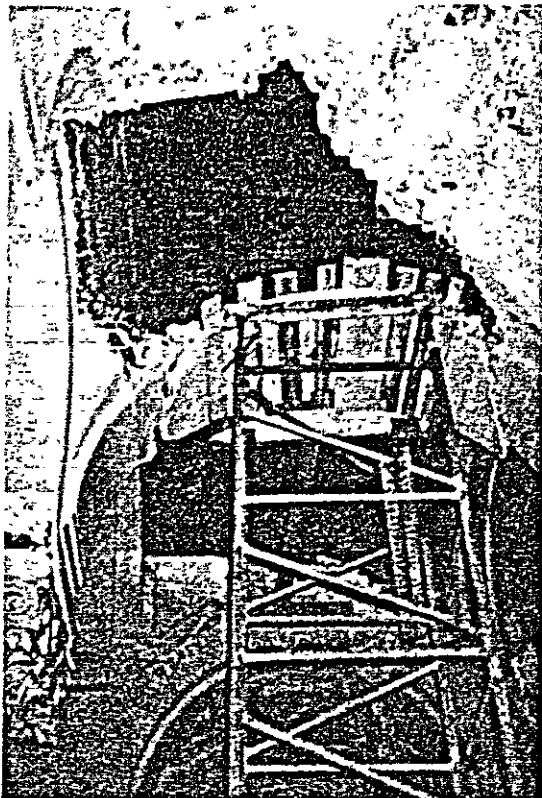
Photo 5.5  
A broken shell-shaped brick ceiling in the hall

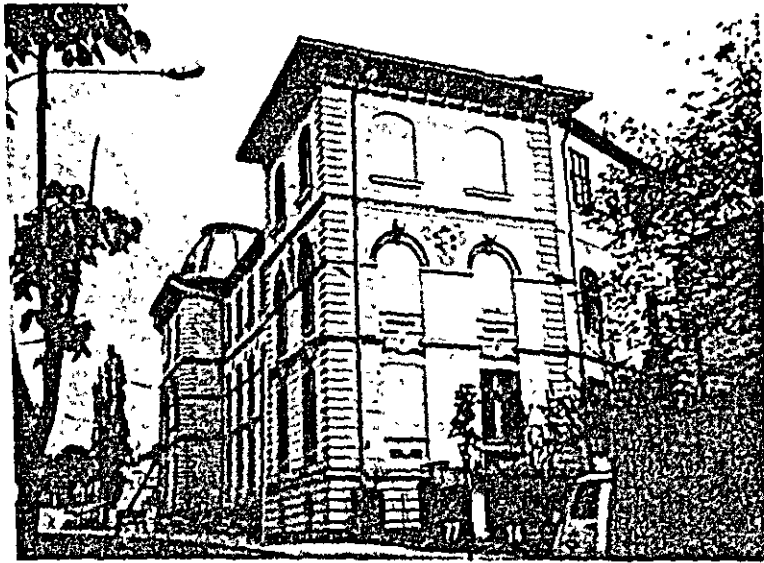
Photo 5.10 A high school in Craiova (Heavy damage inside)

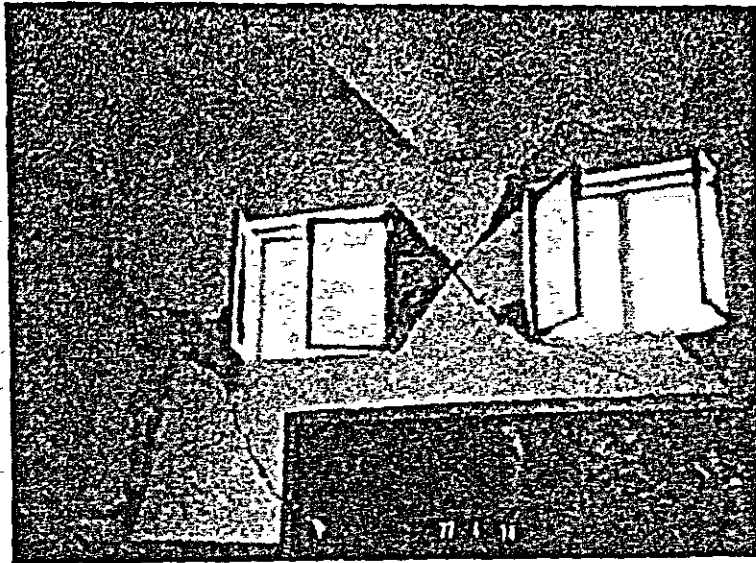
Photo 5.11 A brick wall of the high school with shear cracks.

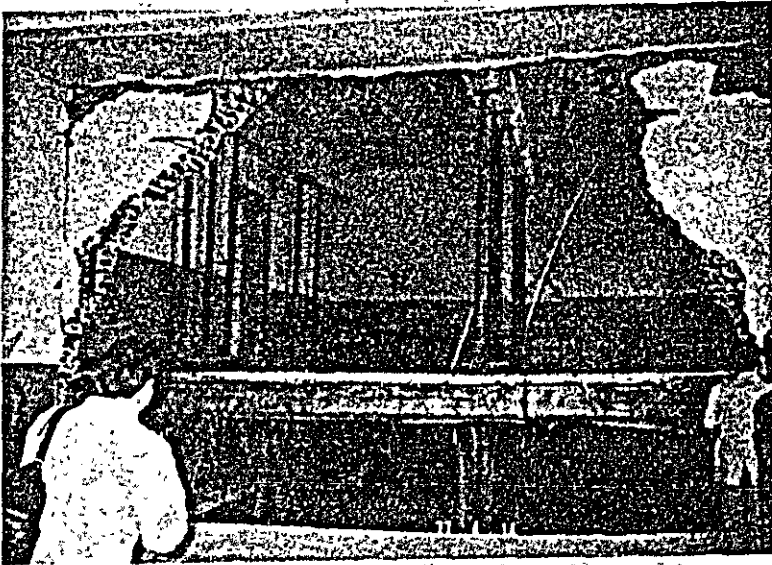
Photo 5.12 A fallen brick wall in the high school

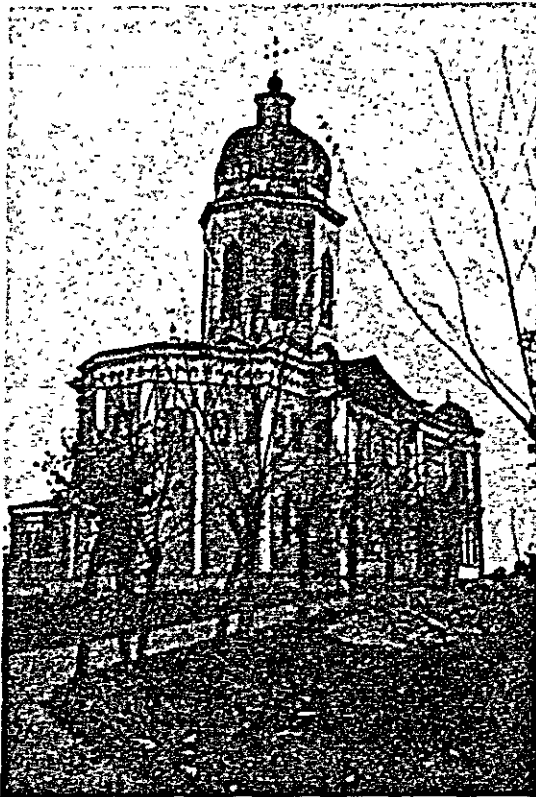
Photo 5.13

A damaged brick church in Ploiesti

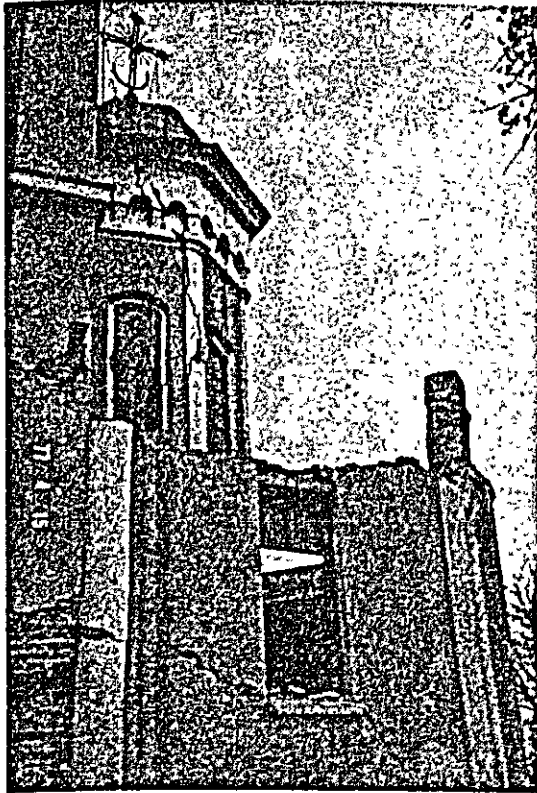
Photo 5.14

Close-up of damage to the church

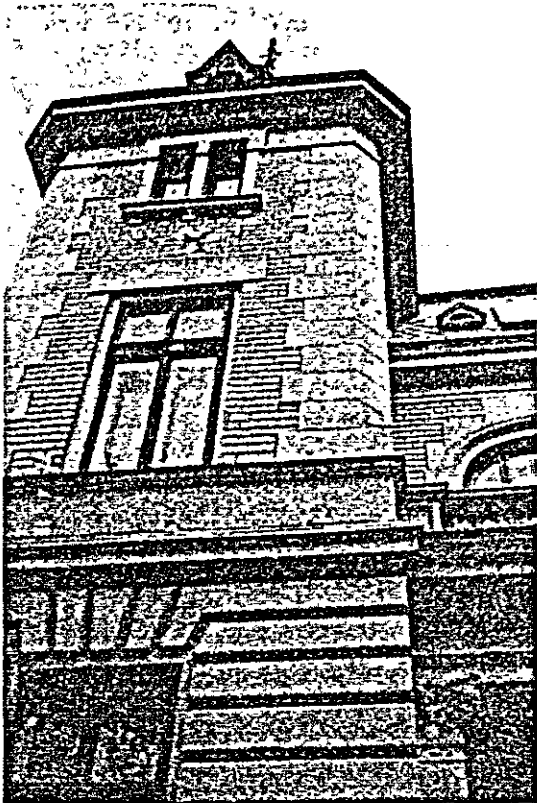
Photo 5.15

This building had some damage, including a 6 mm shift to the north of a part of a projection on the northern side of the second story and conspicuous cracks on the heads of arched windows.

The Japanese Ambassador's official residence in Bucharest. (An old brick two story building with a basement; conspicuous cracks developed in the spandrel beams and the top of the arch)

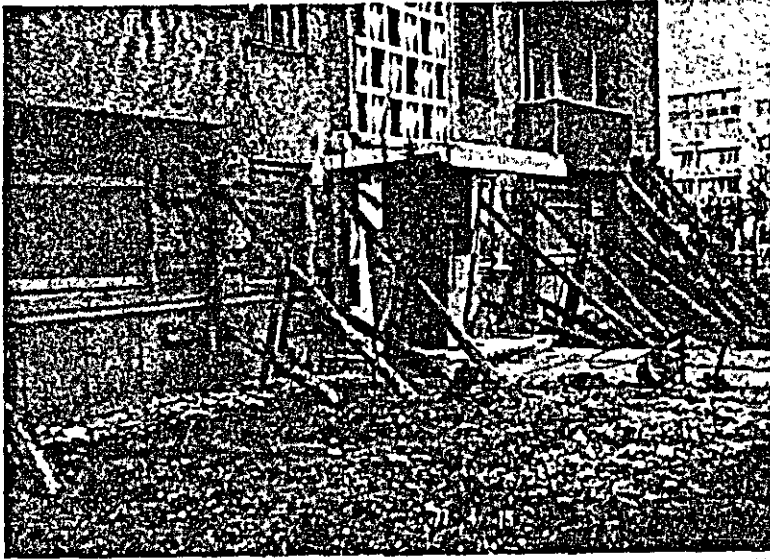
Photo 5.17 A collapsed five-storied brick apartment house.  
(1962, Ploiesti)

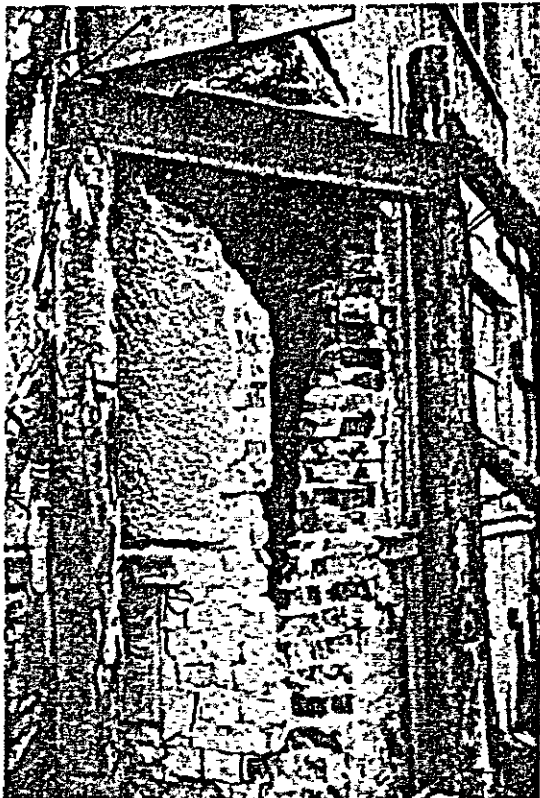
Photo 5.18  
Close-up of damage to the  
apartment building. (Lime-mortar  
joint)

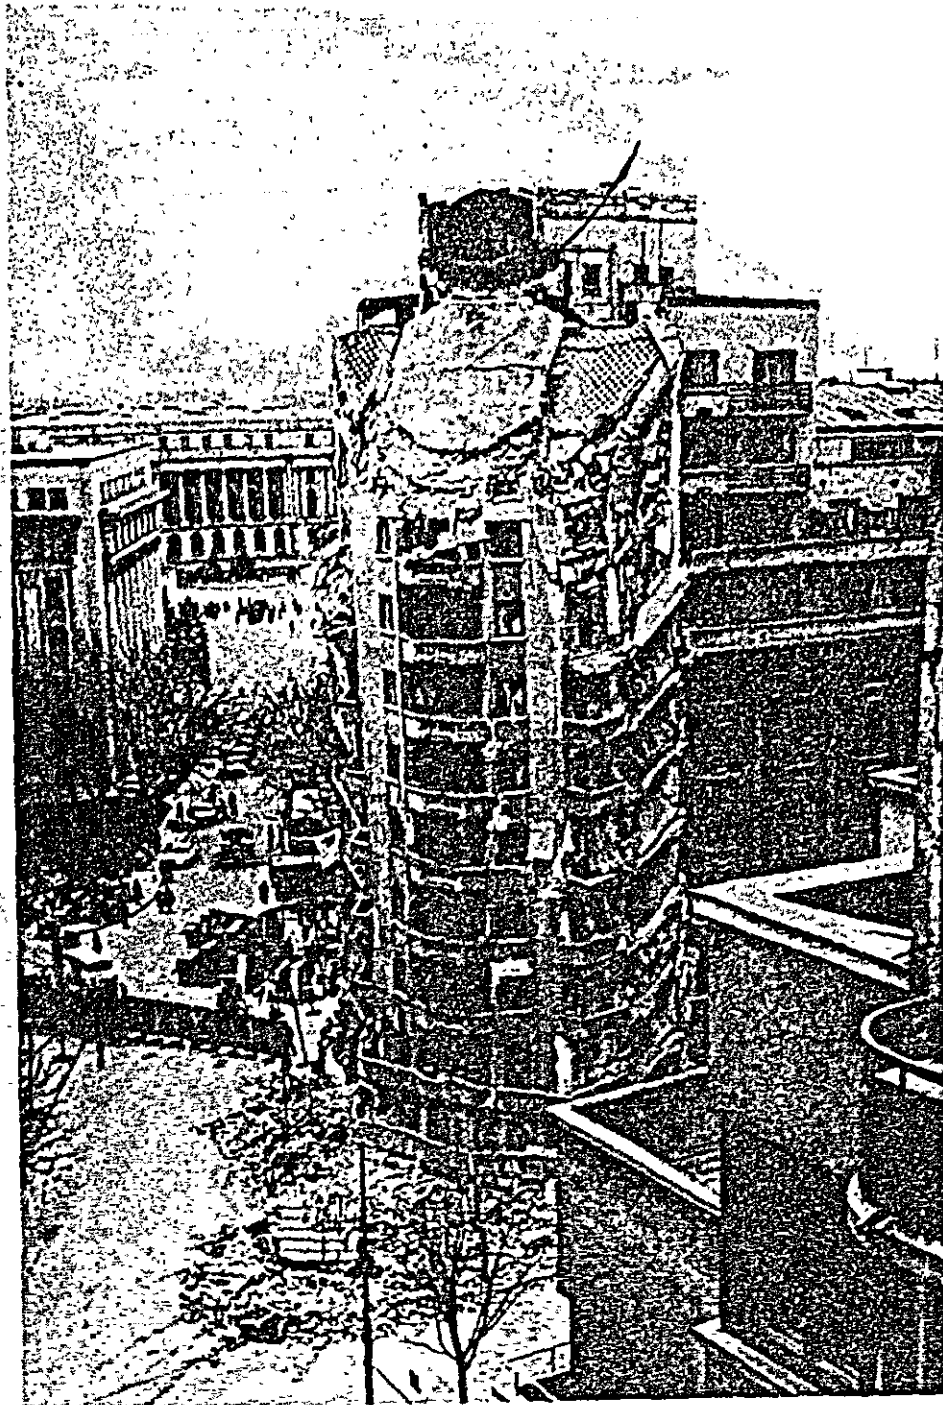
Photo 5.19 A crushed building of reinforced brick construction No. 1, Bucharest

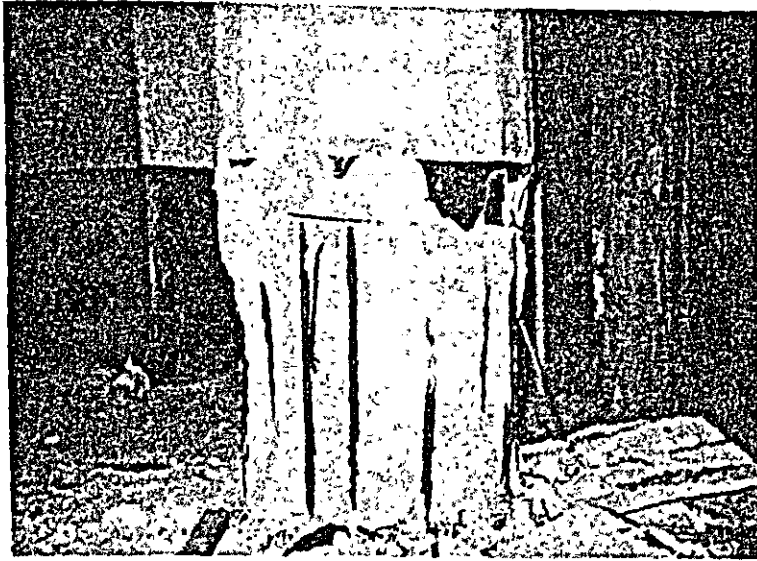
Photo 5.32 Decayed reinforcing bars in a basement column of the building in Photo 5.29.

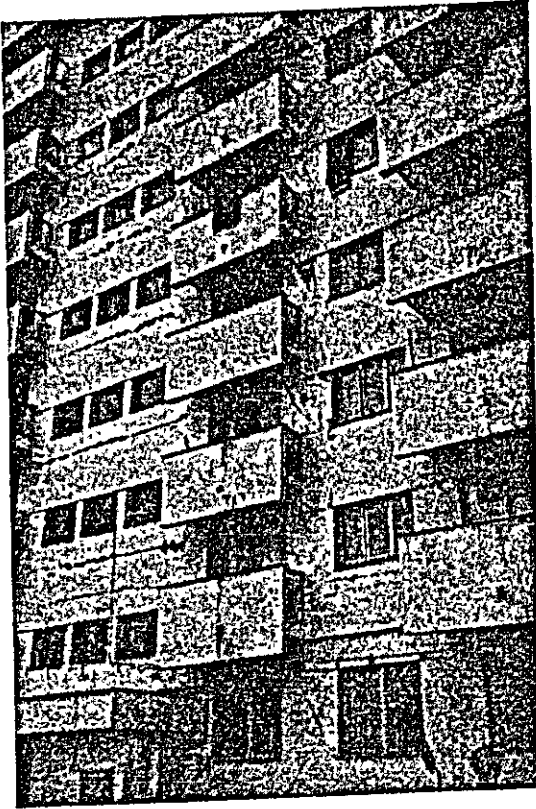
Photo 5.37

Damaged exterior of the same building, Bucharest.

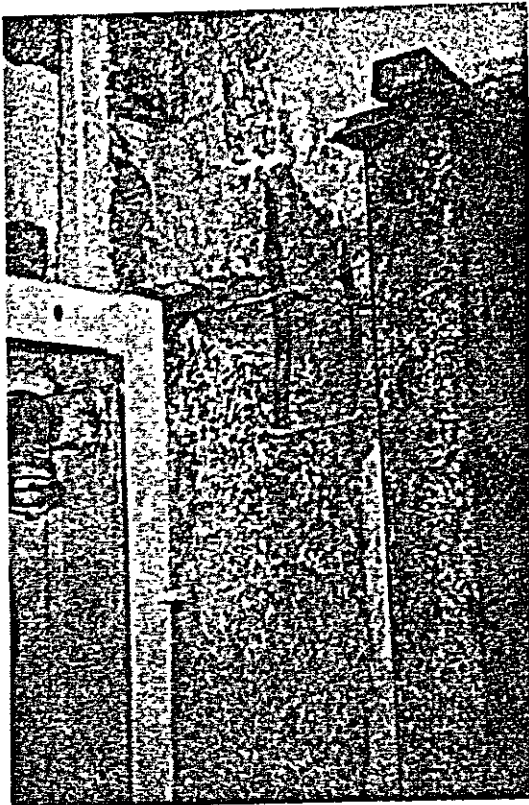
Photo 5.38

Buckling of main vertical bars in a fifth story column of the same building.

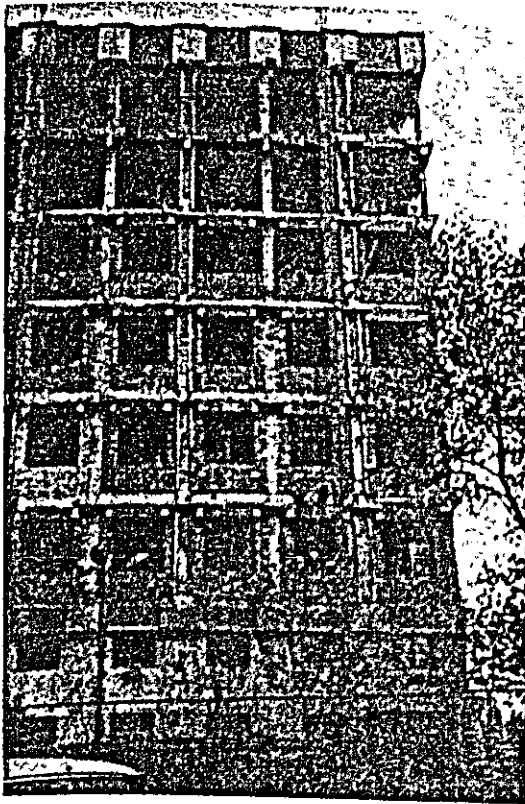
Photo 5.39

An 8-story hospital of reinforced concrete rigid frame construction, Bucharest (Repairs to fallen non-structural walls in progress.)

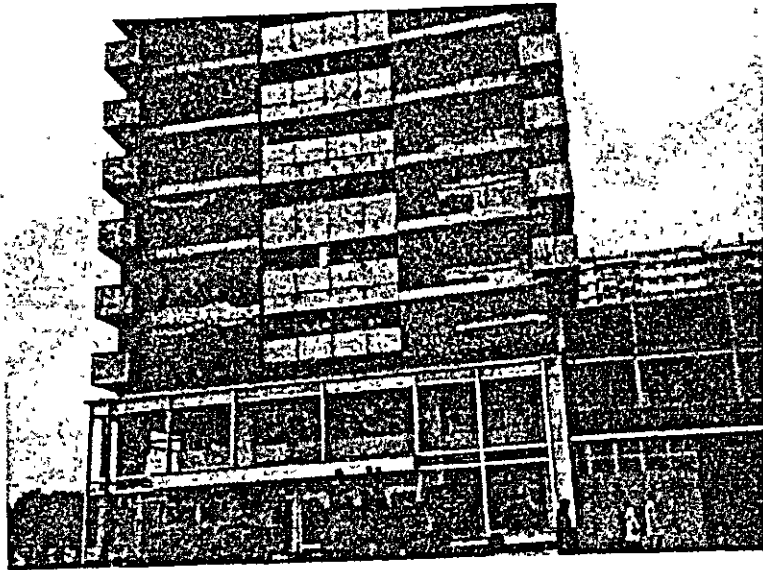
Photo 5.45 Damage to exterior of a 12-story reinforced concrete rigid frame apartment building with a department store on the 1st and 2nd floors, Bucharest.

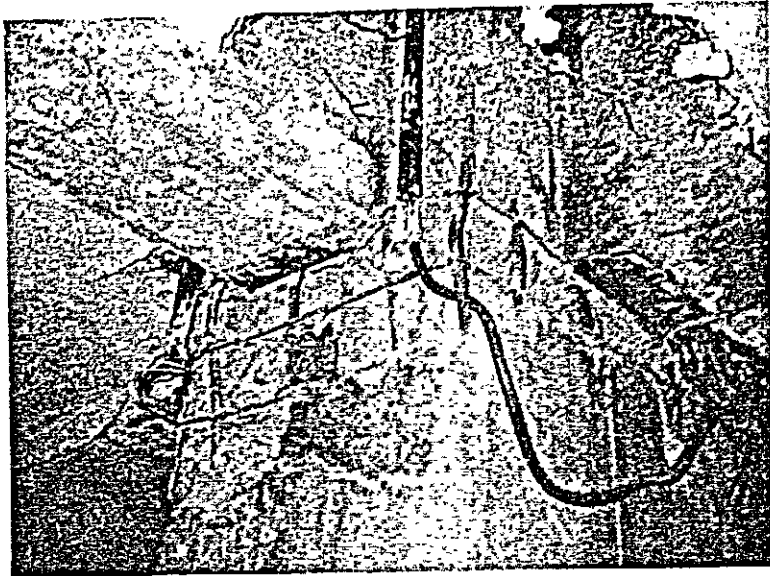
Photo 5.46 An exceptional failure in the 2nd story column capital in the same building, Bucharest.

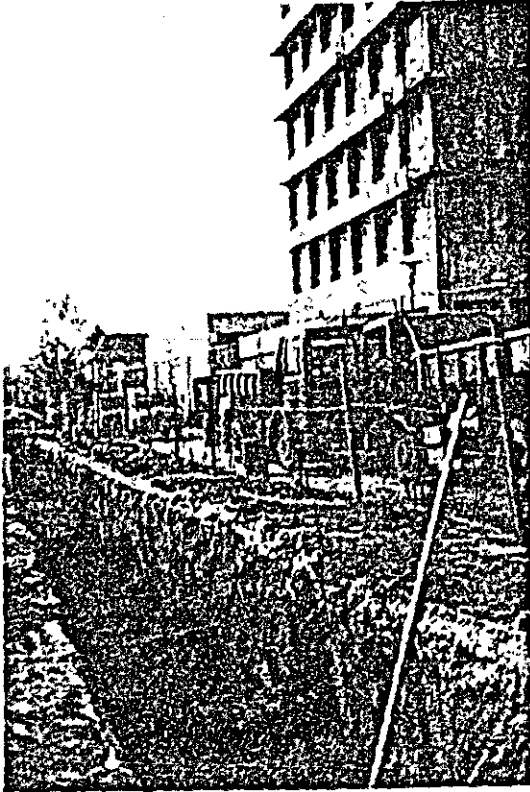
Photo 5.53

A 14-story office building of reinforced concrete rigid frame construction, Bucharest. Inner brick walls and glass panes were almost all broken. (Figures 8 and 9 show the building plan and skeleton diagram.)

The building was not destroyed. But there was damage to some of the main structural parts, e.g., column rupture accompanied by buckling of main reinforcing bars on the 2nd, 3rd and 7th floors, numerous shear cracks in wall beams and a shear failure of an inner column. In addition, non-reinforced brick walls inside were badly damaged everywhere and many window panes were broken.

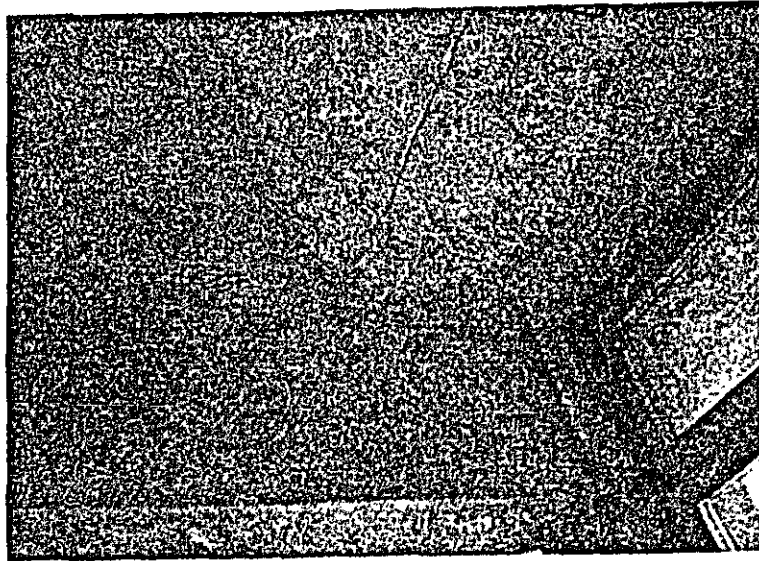
Photo 5.57 Rupture of a column capital and a shear crack extending to the floor slab of the same building, Bucharest.

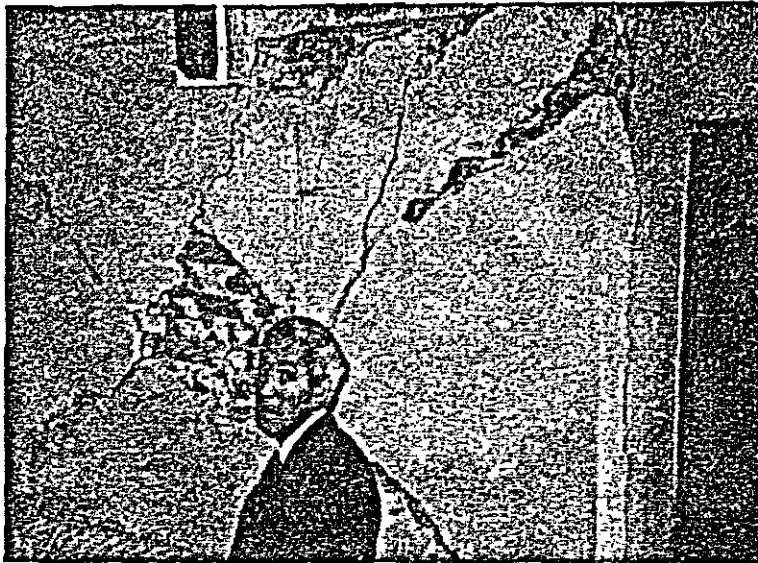
Photo 5.58 Shear failures in a non-reinforced brick partition wall inside the building, Bucharest.

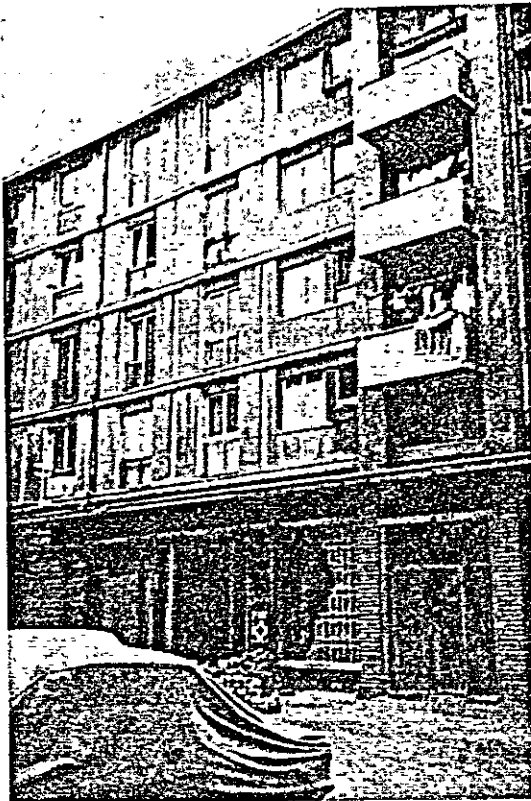
Photo 5.62

A damaged five-story apartment-shop building of reinforced concrete rigid frame construction, Ploiesti.

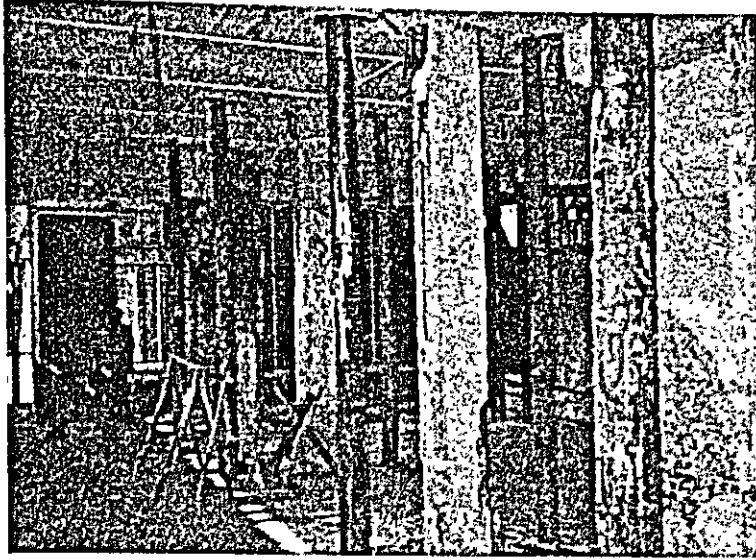
Photo 5.63 The interior of the 1st story of the same building, Ploiesti.

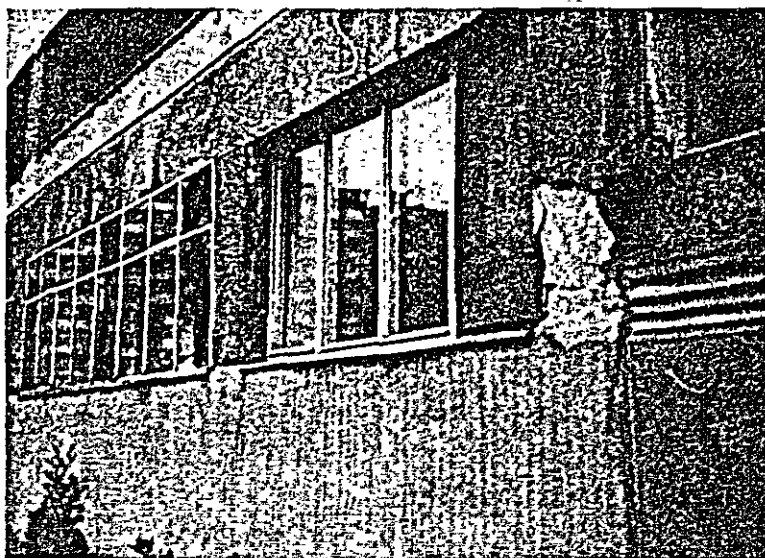
Photo 5.68 Failure of the wall-end column and broken glass panes of an 11-story apartment building of reinforced concrete wall apartment building, Bucharest. (In the ridge direction, the wall runs only to the midpoint.)

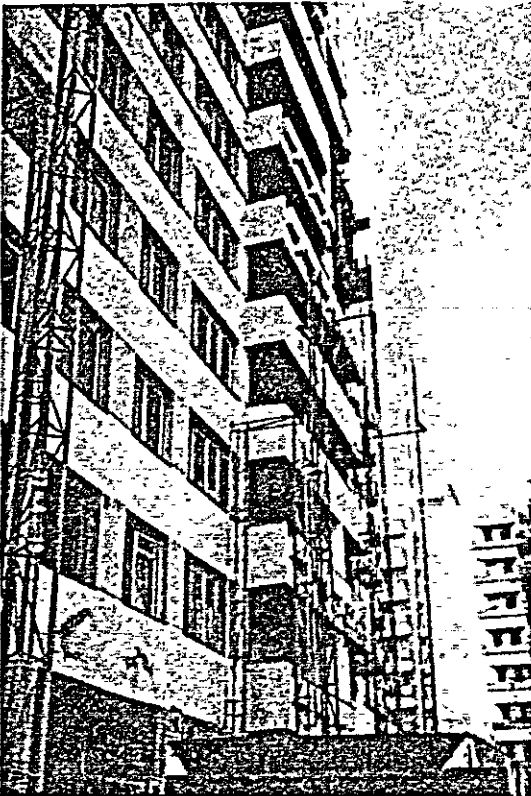
Photo 5.72

An 11-story reinforced concrete wall apartment building with a basement, Bucharest. (An adjacent building of the same type totally collapsed, resulting in the death of 90 people)

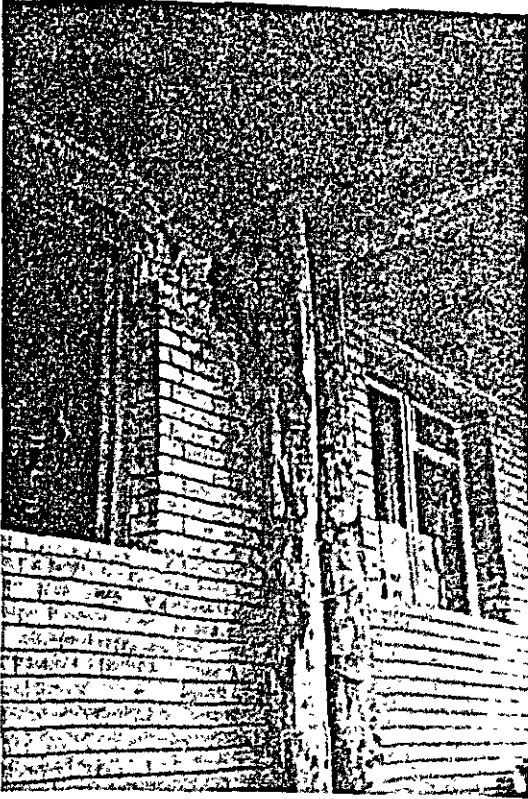
Photo 5.73

Failure of a 1st story wall-end column of the same building, Bucharest. (The exterior wall in the ridge direction in this photo is a weak non-reinforced brick wall. The structural wall runs only in the midway of the building; measured natural periods were 0.5 seconds for the ridge direction, 0.7 seconds for the span direction.)

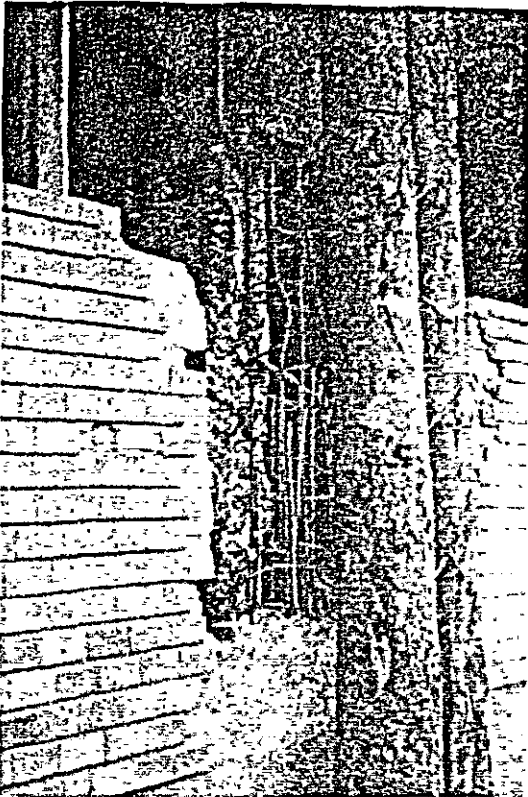
Photo 5.74

Failure of a 1st story wall-end column of the same building just before reinforcement, Bucharest. (Buckling of column main reinforcing bars is exposed.)

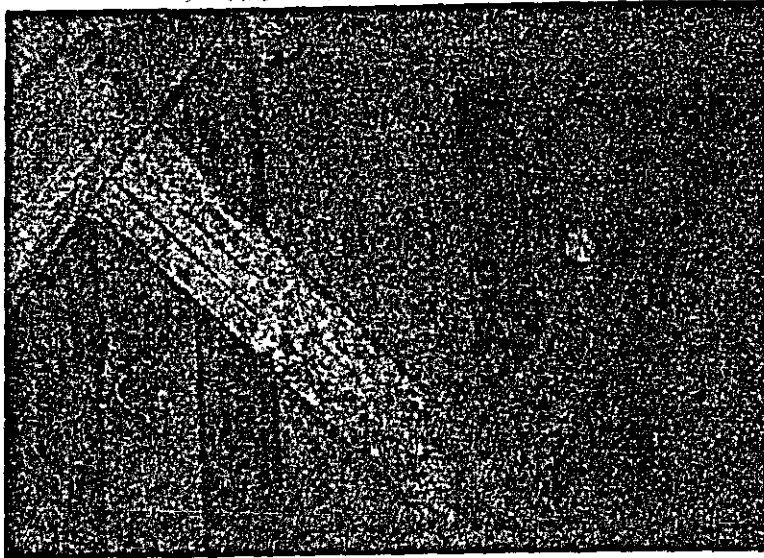
Photo 5.75 Failure of the 1st story wall in the span direction and buckling of reinforcing bars, Bucharest.

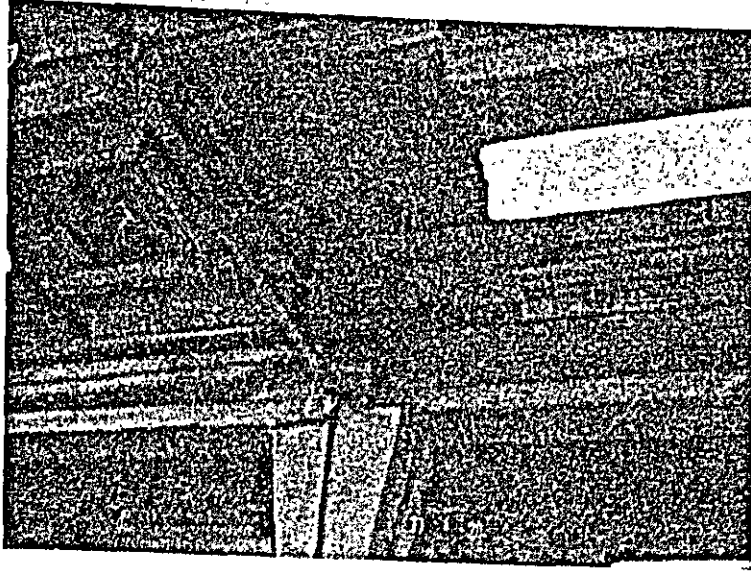
Photo 5.80 A one-story plant of precast, prestressed construction, Bucharest. (Cast-in-place columns; 6 m in story height; the natural period, about 1.5 seconds; slightly damaged)

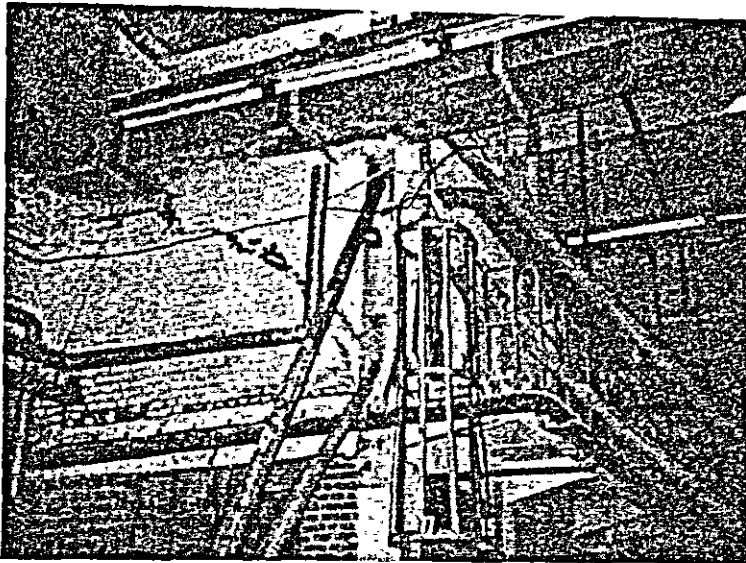
Photo 5.81 Cracks in a partition brick-build wall of a one-story plant, Ploiesti. (Cast-in-place columns, precast beams and floor slabs; 9 m tall.)

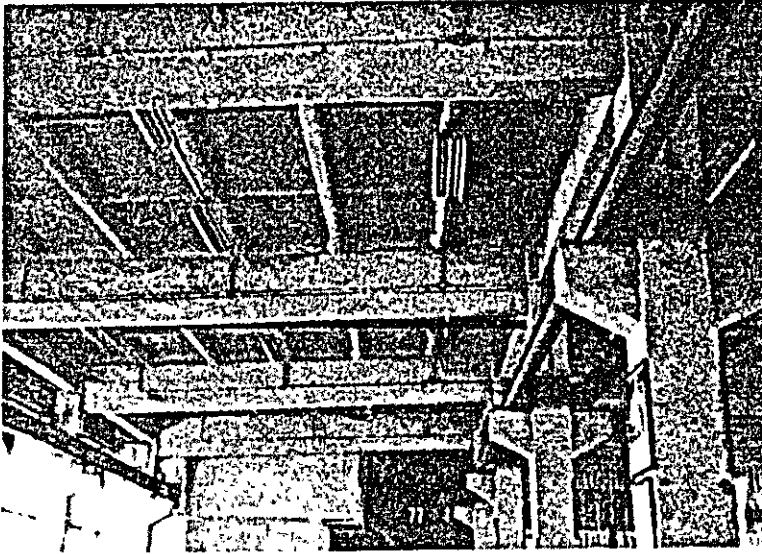
Photo 5.82 A five-story plant with cast-in-place rigid frame and precast floor slabs, Bucharest. (Slight damage to the structure)

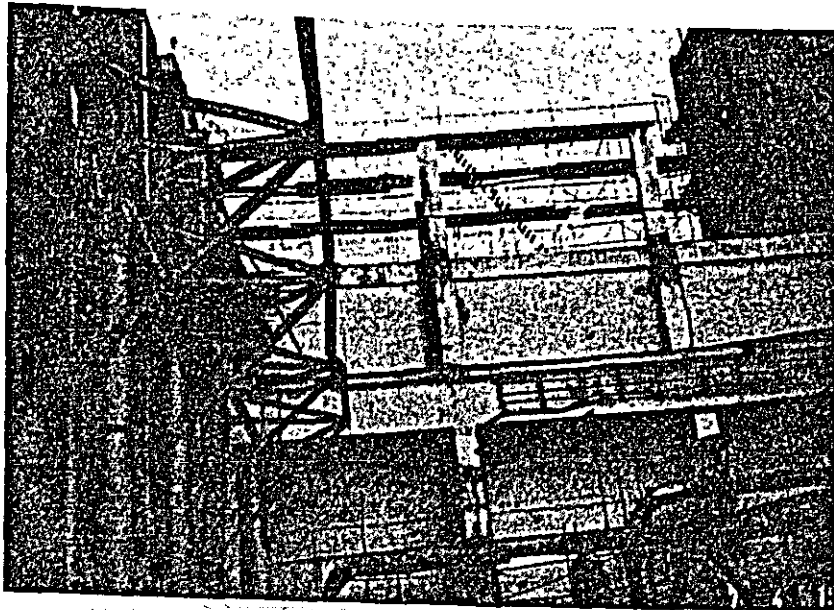
Photo 7.2 Brazi Thermal Power Plant after collapse of roof truss in Ploiesti.

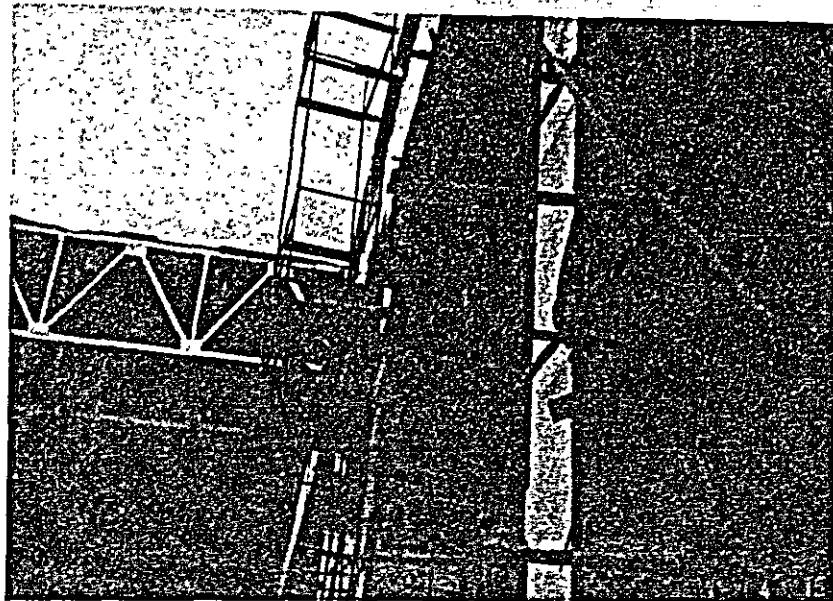
Photo 7.3 The same plant viewed from a different angle.

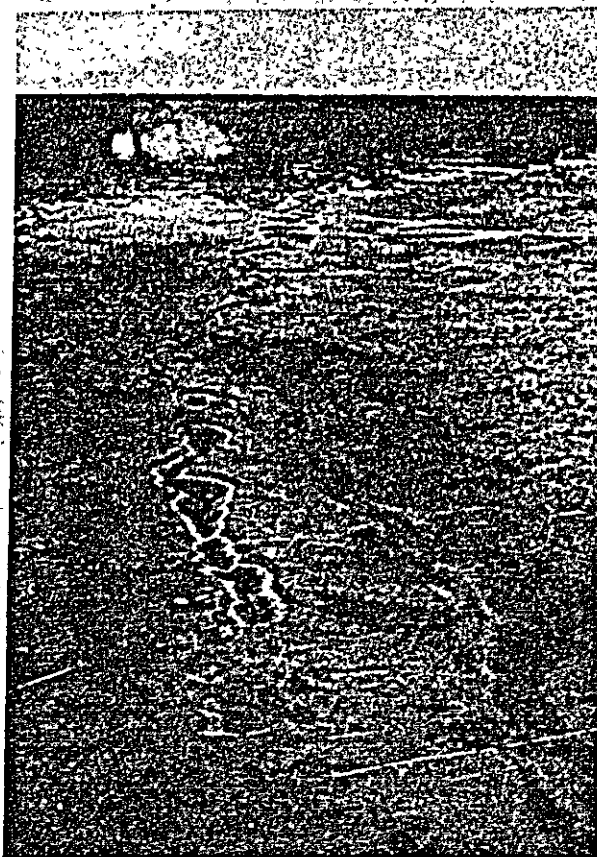
Photo 7.4 Sandy soil liquefaction at Faurel

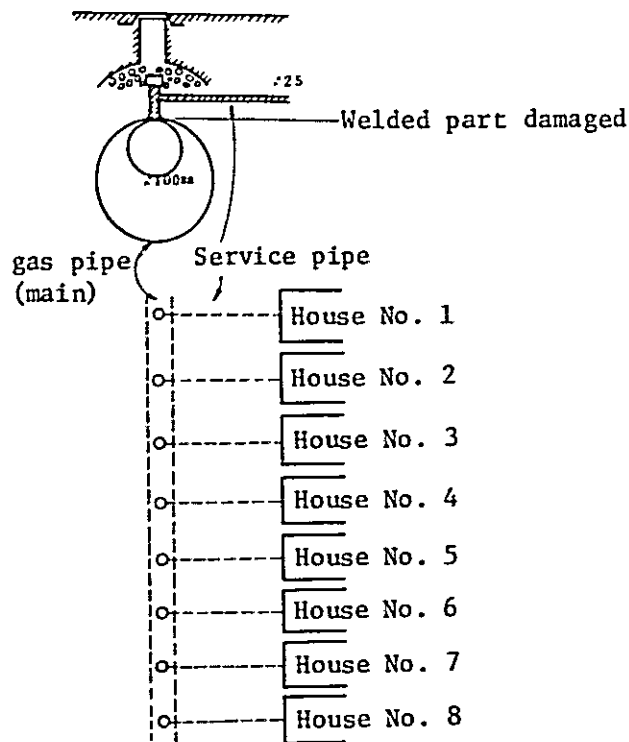
Fig. 8.8 Conditions of Damage to Gas Pipes in Pitesti
