## 2-3 Siltation

CHAPTER 3  
NATURAL CONDITIONS  
SURROUNDING ASAU HARBOUR  
AND VAIUSU BAY

CHAPTER 4  
INVESTIGATION OF THE EXISTING  
MAIN WHARF OF APIA PORT

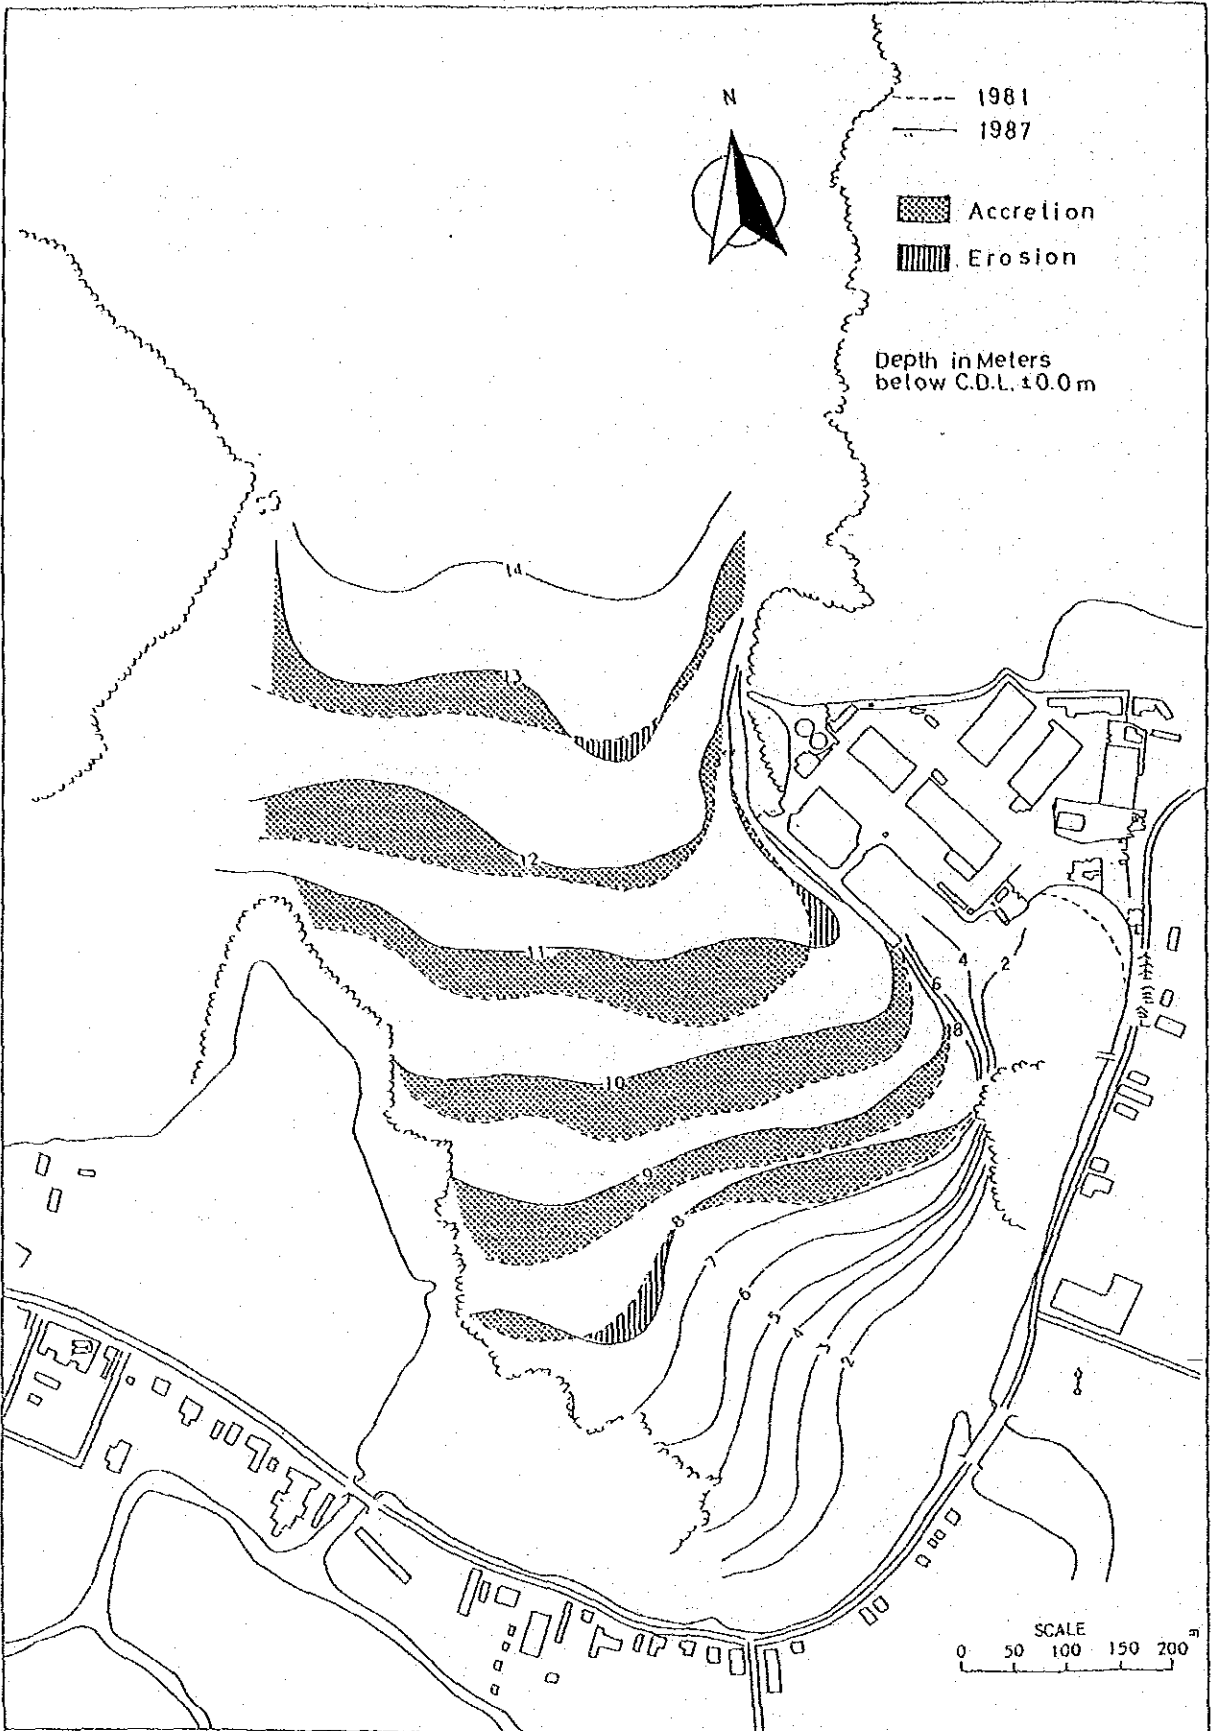
Fig. 2.3.3 Comparison of Water Depths, 1981 and 1987

69. The siltation volume in the turning basin,  $126,000 \text{ m}^2$ , is estimated as  $9,500 \text{ m}^3/\text{year}$ , i.e.  $7.5 \text{ cm}/\text{year}$ , and the maximum siltation rate is estimated as  $12 \text{ cm}/\text{year}$  at the center of the turning basin.

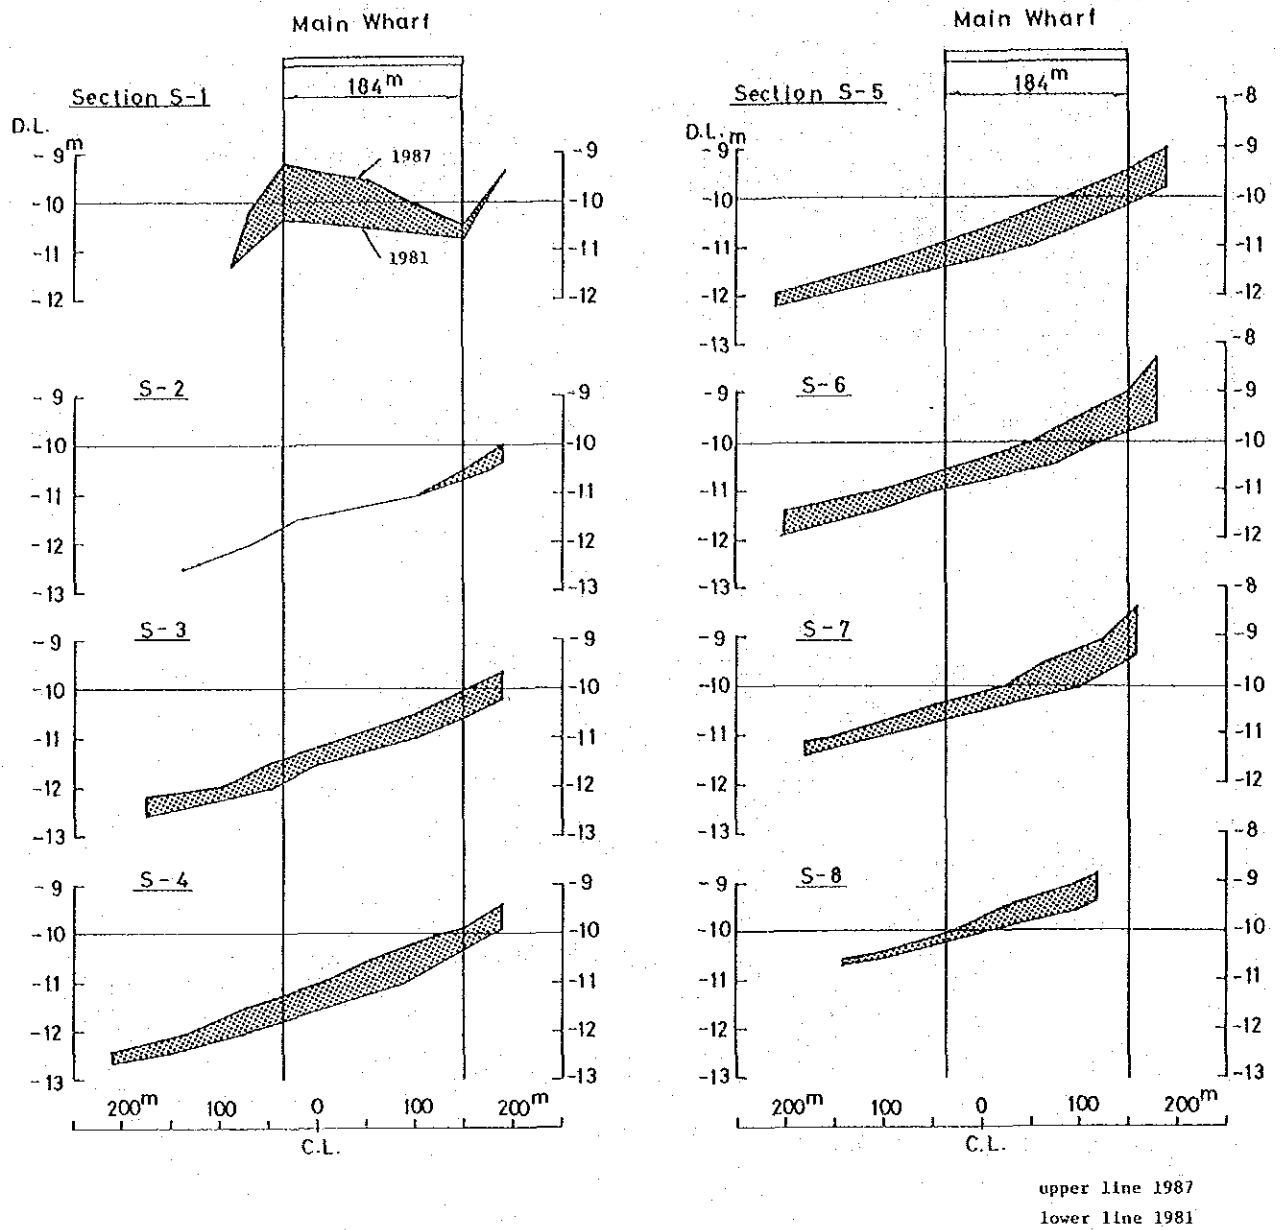
Fig. 2.3.5 Comparison of the Past Sounding Charts

The study team obtained only the drawings of this report. Judging from the comparison of two sounding charts, 1975 and 1981, contours are shifting towards the outer port of the harbour in the center of the harbour and the maximum shift of the 35 feet line is approximately  $100 \text{ m}$  in 6 years. At the western inner part and near the northwestern end of the wharf, there is indication of minor scouring.

The author compared five Sounding Charts from 1975, '78, '81, '82 and '83 in five sections. Three lines are parallel and two lines are perpendicular to the Main Wharf. The estimated siltation rate is 1.8m in 15 years, i.e. 12cm per annum on the average.

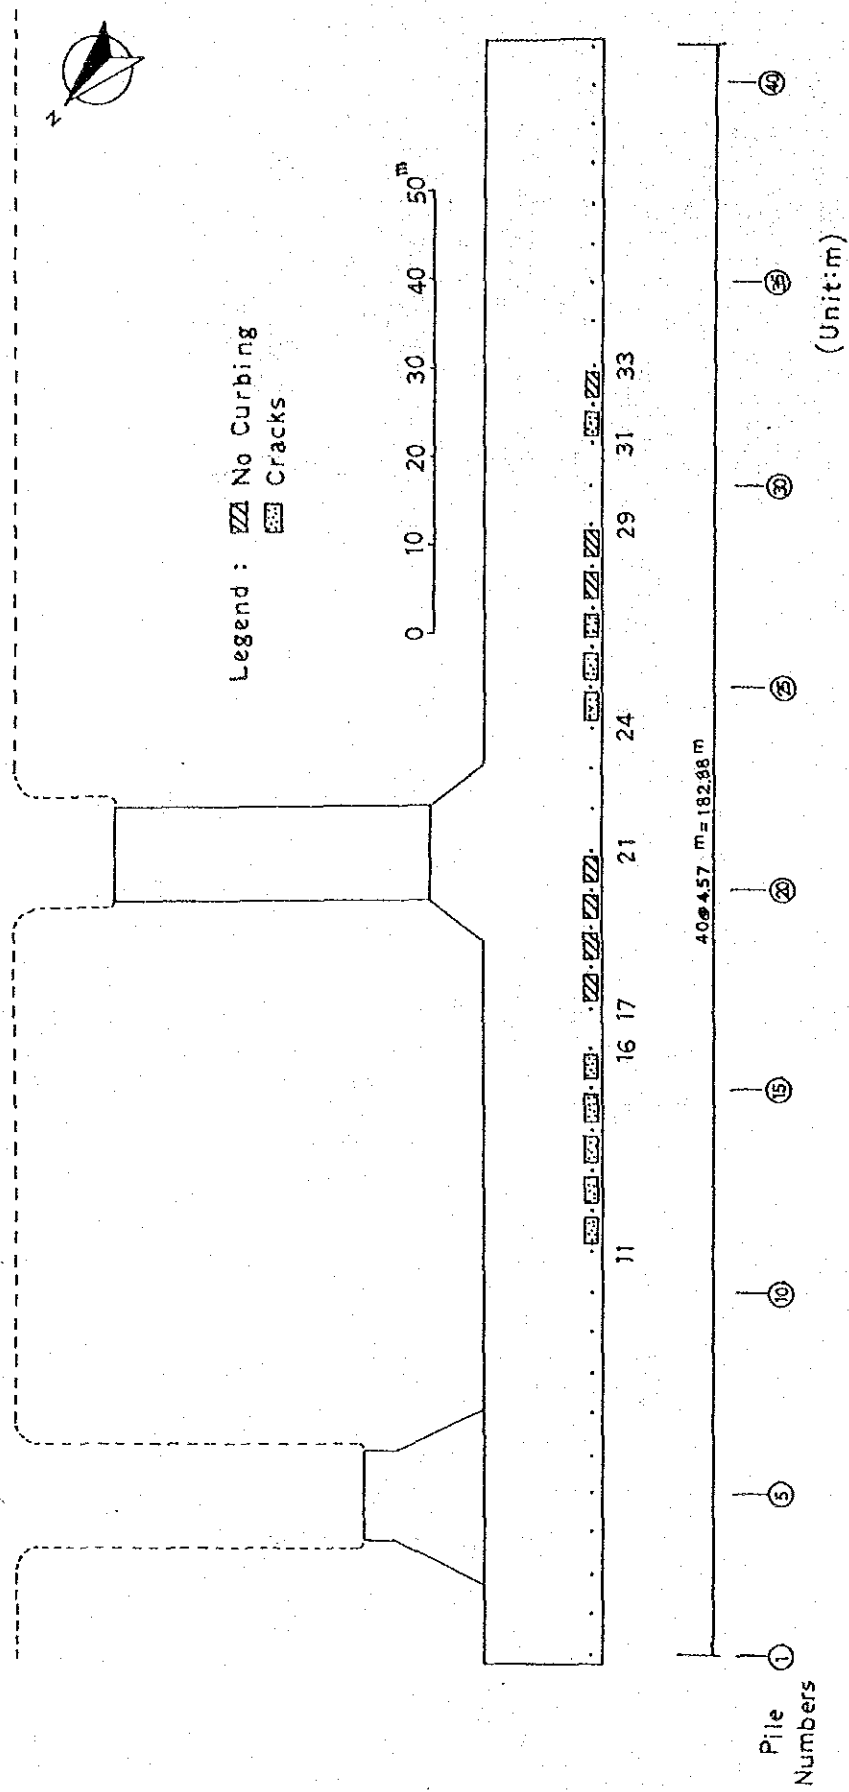
Fig. 4.2.1 Location of Damaged Curbing

6. The curbing of the wharf is damaged at 16 locations and the fender system is also considerably damaged from berthing impact at about 5 places. The results of the investigations are shown in Fig. 4.2.1 and Fig. 4.2.2 respectively. No significant damage to the bollards was observed.

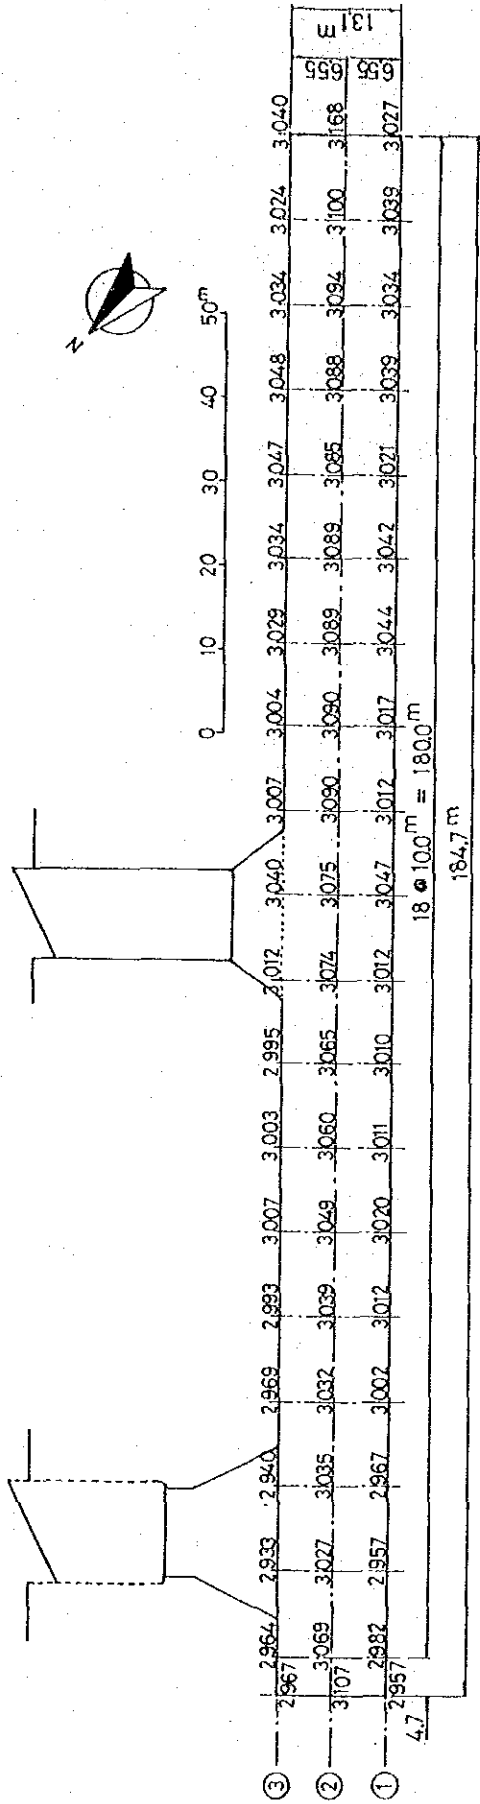
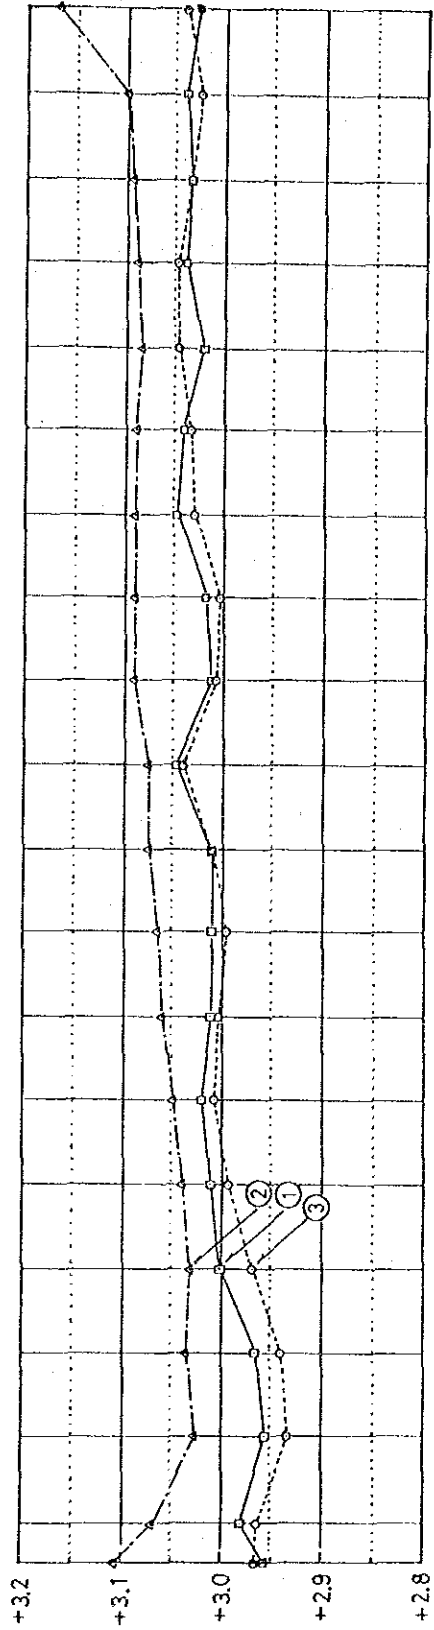
Fig. 4.2.3 Results of Leveling Survey

8. The elevation of the deck was surveyed for the entire area of the wharf using a level. The results are shown in Fig. 4.2.3. Though a subsidence of about 10 cm has taken place at the extreme northern end of the deck, it is judged that no significant nonuniform subsidence is shown since no significant cracks are observed on the slab surface as described above. All the piles supporting the deck are driven to the hard bearing stratum of rock, and this is considered as the main reason for the high stability against sinkage of this wharf.

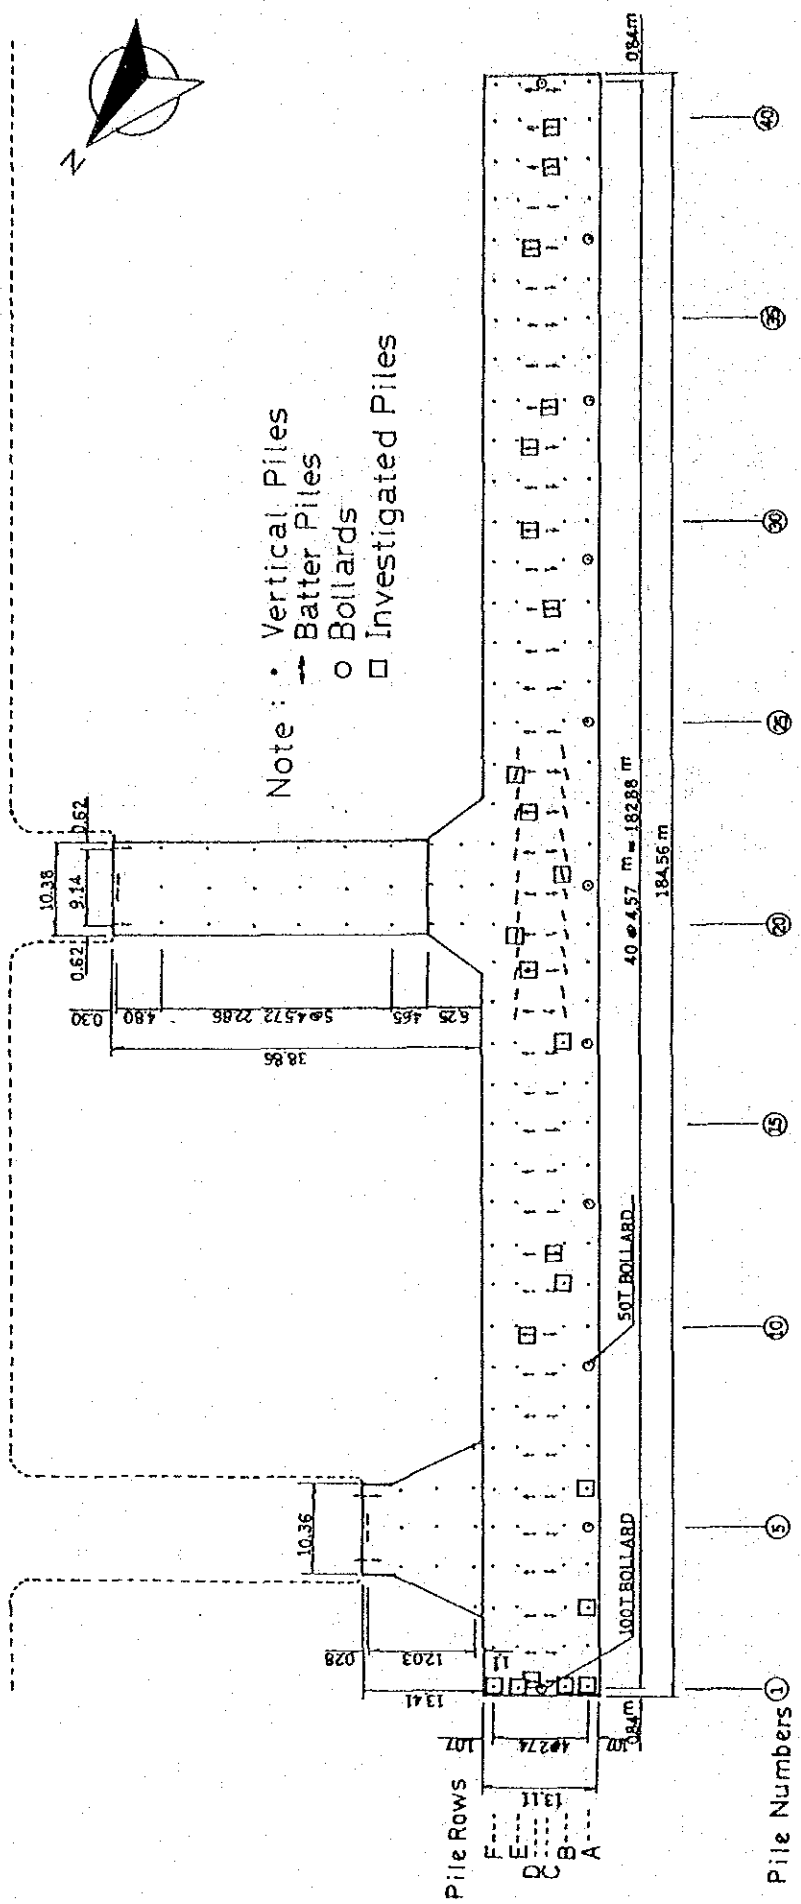
Fig. 4.2.4 Location of Selected Piles

10. Based on the results of the preliminary visual survey on the overall condition of the piles, 23 heavily damaged piles were selected for detailed underwater investigation in such a way as to enable a comparison of the present condition with the condition during the previous surveys carried out by the Royal New Zealand Navy in 1966 only five months after the

- ① Northward part; No.1 piles (row/A - F) are most damaged and concrete sleeves are missing below -5.0m.
- ② Center part; At No.19D and No.24E/N piles, big holes in the concrete sleeves are observed at -8.0m.
- ③ Southward part; H-shaped steel of No.37D pile is exposed at -4.5m.

Pile No.	Row	Location under L.W.L.	Remarks
1	A	-5.0 m	H.S.S. visible, concrete missing
	B	-4.0 m	Hole, reinforcing exposed
	D	-7.0 m	No tremied concrete is visible
	E	-4.0 m	Concrete missing
	F	-7.5 m	Concrete missing
	3	A	-4.0 m
6	A	-8.0 m	Concrete missing
10	D	-7.5 m	H.S.S. visible
11	B	-8.0 m	Hole, cracked all around
12	C	-7.5 m	Hole, cracked
17	B	-7.0 m	H.S.S. exposed, partly tremied concrete visible
19	D	-8.0 m	Large hole, H.S.S. exposed
20	E/N	-5.0 m	Cracked all around
21	B/S	-7.0 m	Small hole, cracked all around, H.S.S. exposed
23	D	-7.5 m	Large hole, H.S.S. exposed
24	E/N	-8.0 m	Large hole, cracked all around
28	C	-7.5 m	Cracked all around
30	D	-6.5 m	H.S.S. exposed
32	D	-10.0 m	Hole 0.4 m in diameter, H.S.S. visible
33	C	-9.5 m	Horizontal crack, 1cm breadth
37	D	-4.5 m	Hole, H.S.S. exposed
39	C	-8.0 m	Hole, H.S.S. exposed
40	C	-7.5 m	H.S.S. exposed, concrete missing

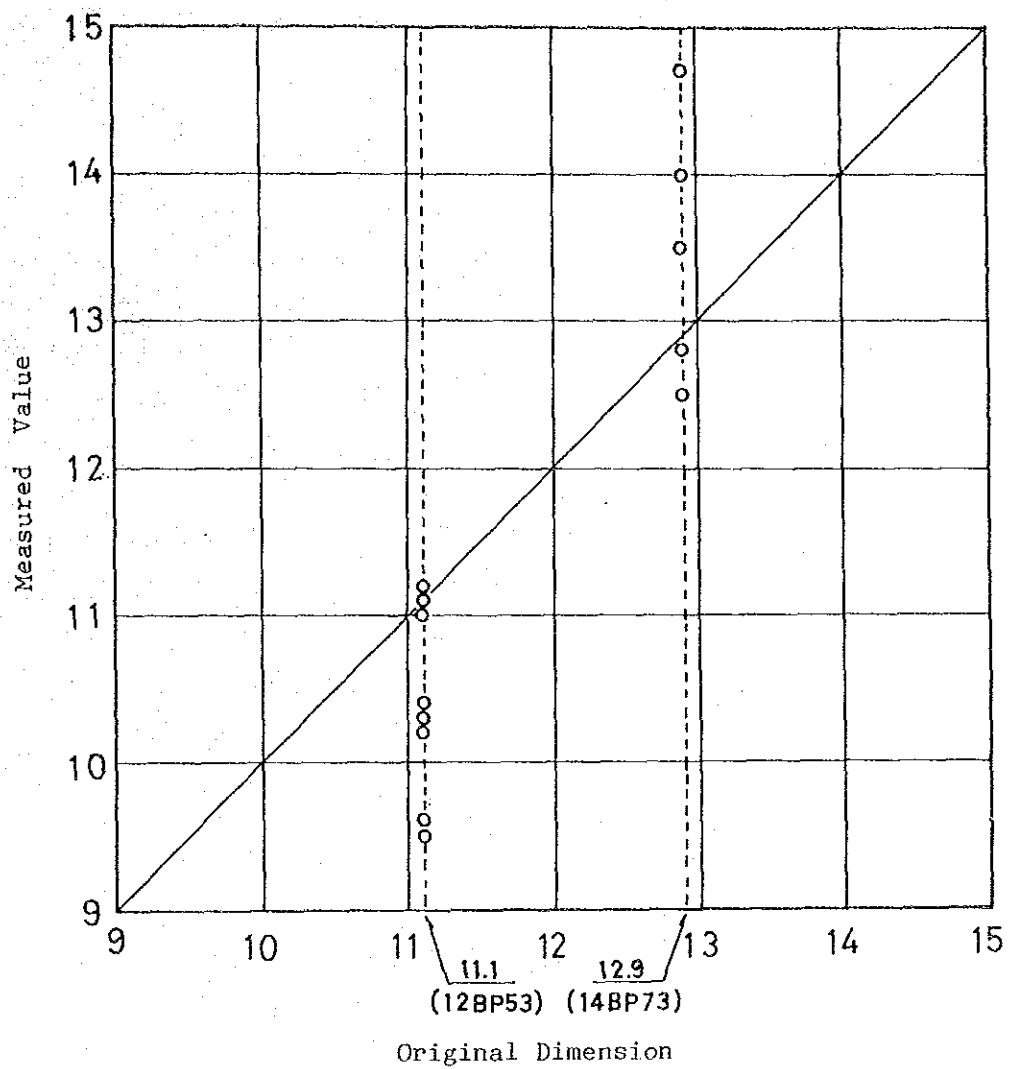
Fig. 4.2.5 Results of Thickness Measurement

the piles when the pile driving was conducted. Therefore, it is reasonable to discuss the corrosion rate using the results of the thickness measurement on 12BP53 piles. Though the original dimensions with allowance of the H-shaped steel piles can not be determined because of the production variation, it is assumed that the difference between the original dimension and the measured value is the reduced thickness caused by corrosion.

15. Using the thinnest datum (No.1E pile), the corrosion rate would be estimated as 0.08 mm/year, (1E, -1.6mm/20year). As 0.1 mm/year is the standard corrosion rate of steel parts in water, it is assumed that 0.08 mm/year is a reasonable corrosion rate.

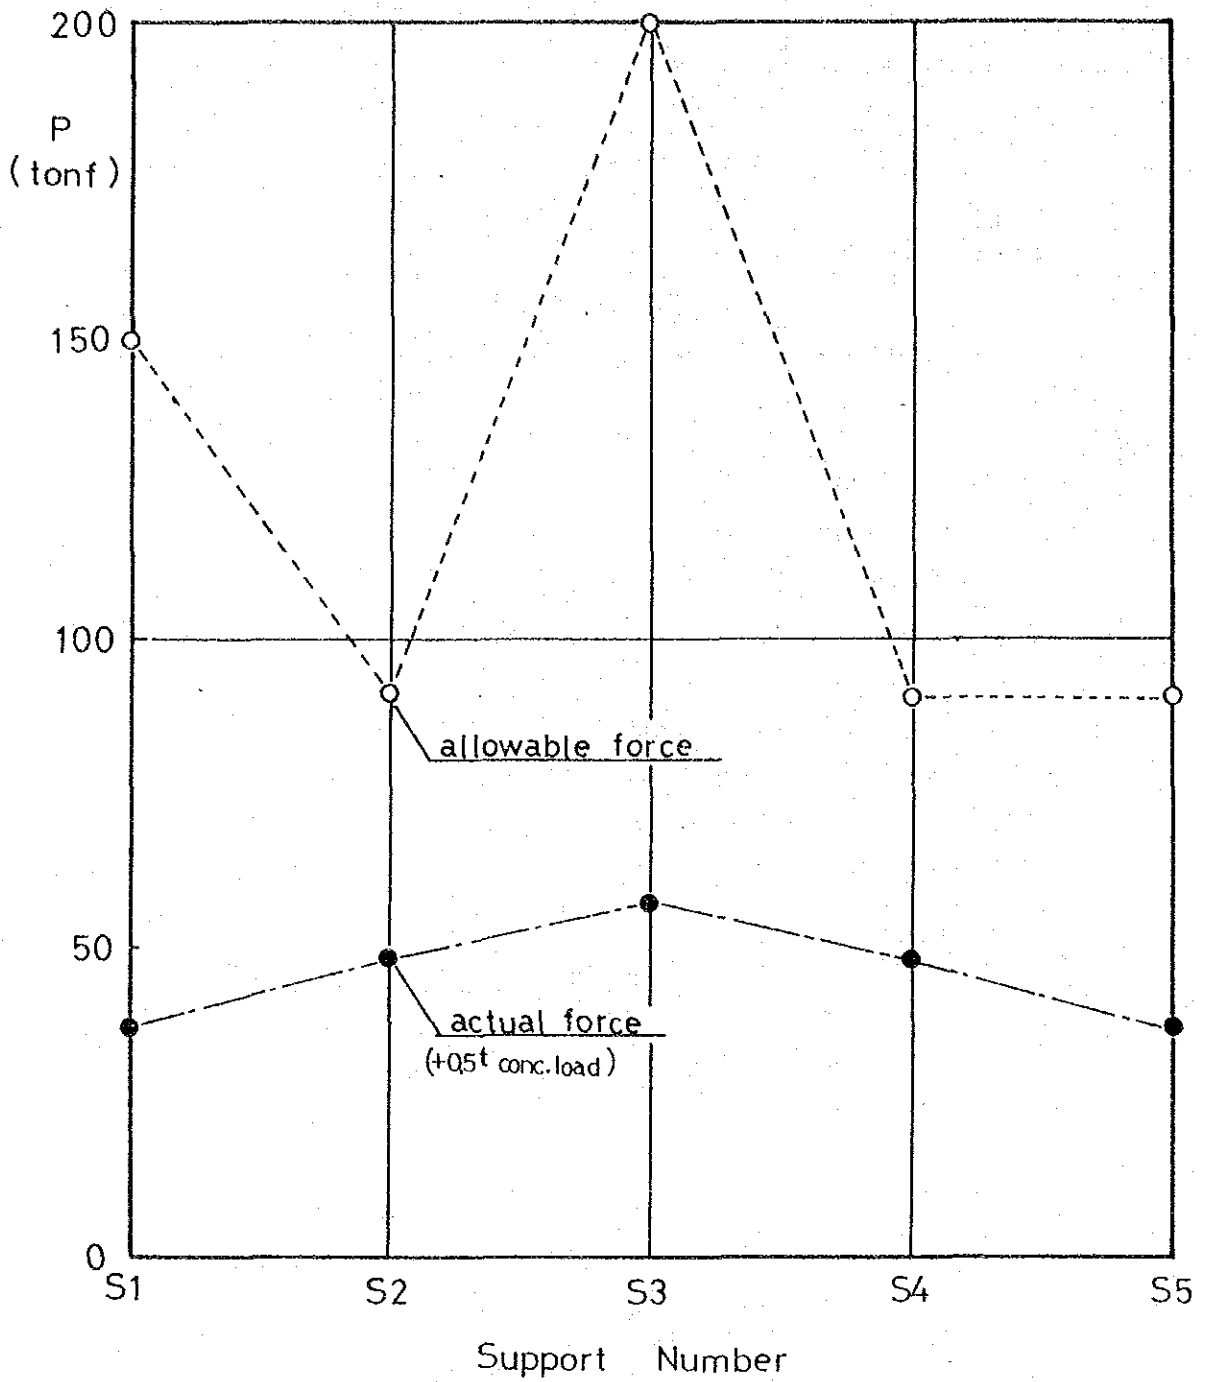
Fig. 5.6.2 Relation between the Actual Acting Force and the Allowable Force

The relation between the actual acting force and the critical buckling load in 1966 is shown in Fig. 5.6.2.

As the corrosion rate of the H-shaped steel section is equal for all the piles, it is concluded that the piles of row B and E are exposed to the severest conditions.

16. The remaining life of the piles of row B and E with a corrosion rate of 0.08mm/y is estimated at about 8 years from 1987 up to about 1995.
