REPORT ON COUNTERMEASURES AGAINST COASTAL HAZARDS BY CYCLONE IN THE COOK ISLANDS

MARCH 1987

JAPAN INTERNATIONAL COOPERATION AGENCY

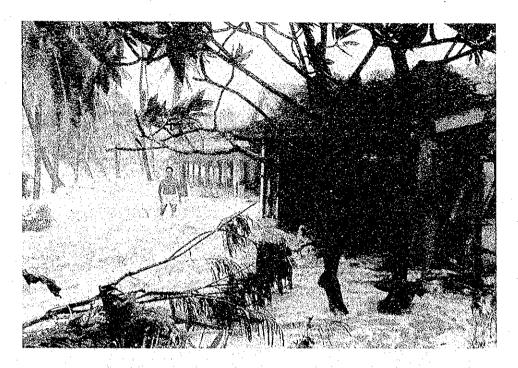
At the back of Main Road, Avarua* (10 AM, 2 January 1987)

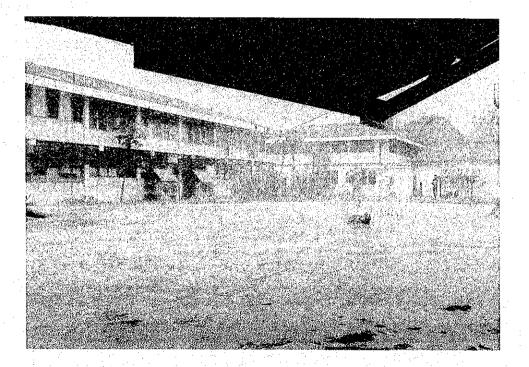
Government buildings at the back of Avarua Harbour *

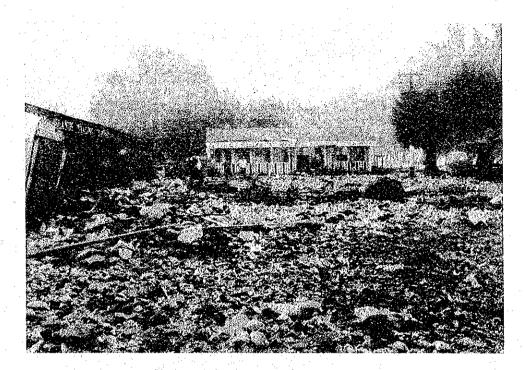
Stones brought on Avarua area *

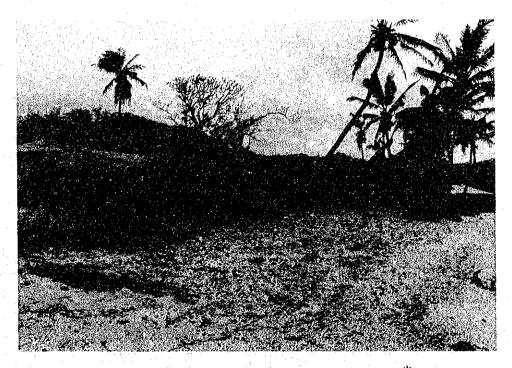
Broken houses, east of Avarua Harbour *

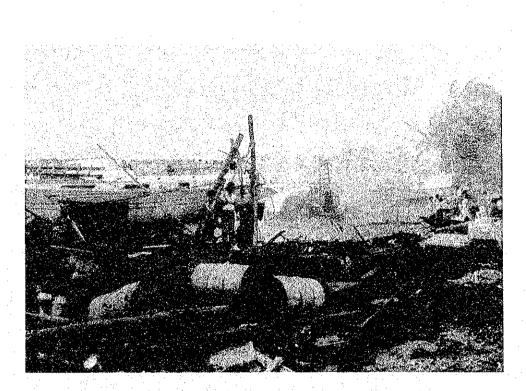
Boats and debris on the apron of Avatiu Harbour*

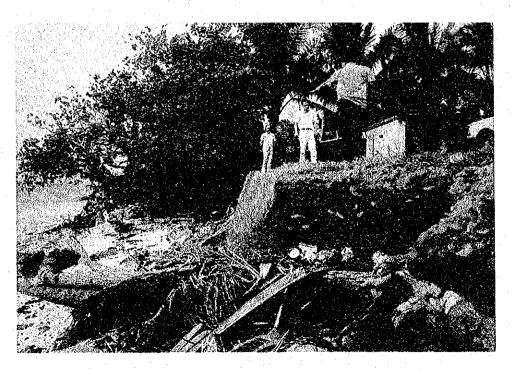
Beach erosion at a south coast

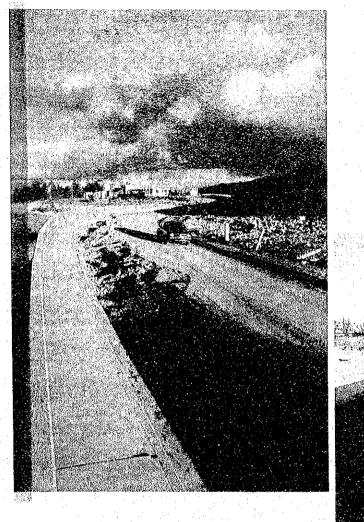
Road behind seawall at the west end of the runway Damages due to wave overtopping (left^{*}) and suction through seawall gaps (right)

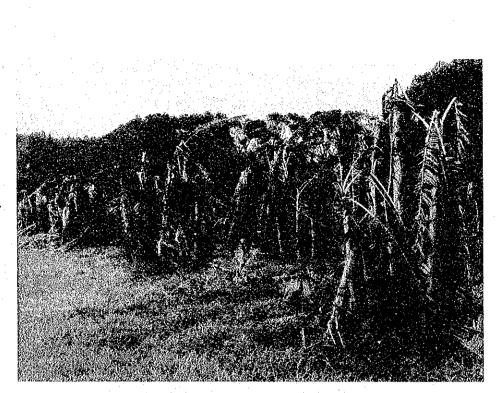
Bananas *

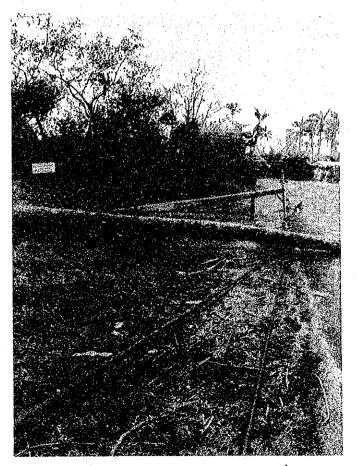
Fallen trees and electric cable *

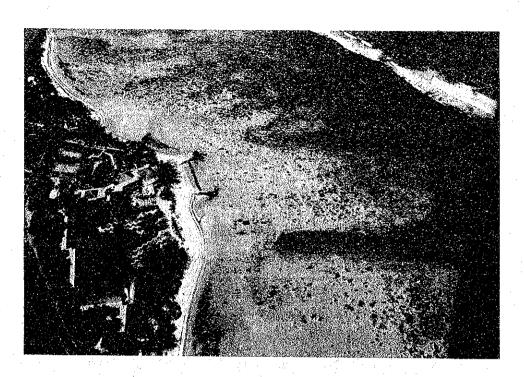
Beach around Rarotongan Hotel, strong lateral current

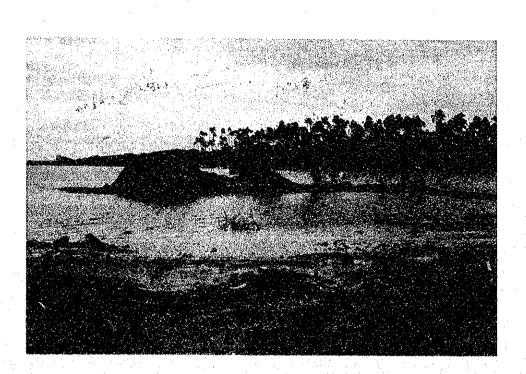
Sand removal, only one place allowed at Ngatangija

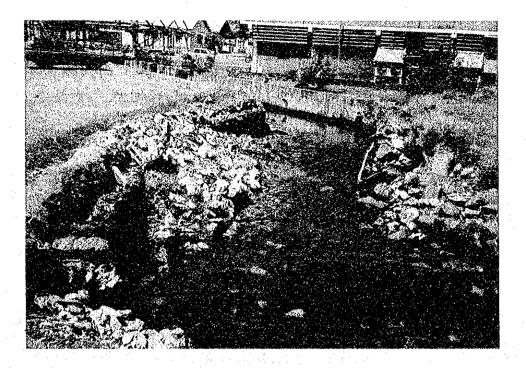
Near the mouth of Takuvaine Stream to where coral debris reached

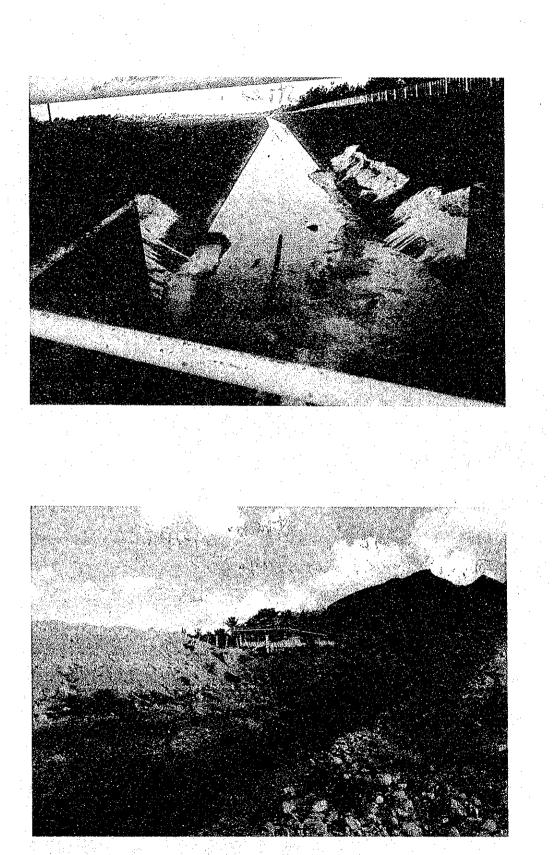
Stream in the airport, buried by seaborn sand and coral rubble stones.
