Report on Countermeasures against Coastal Hazards
by Cyclone in the Cook Islands.

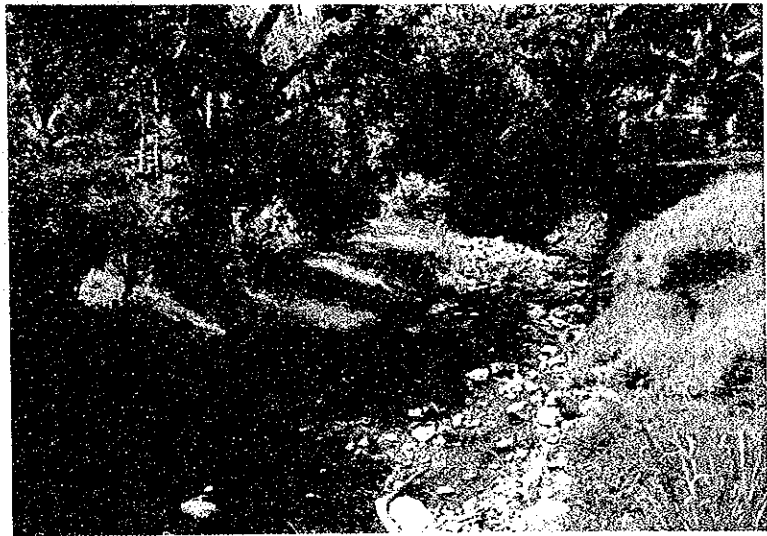
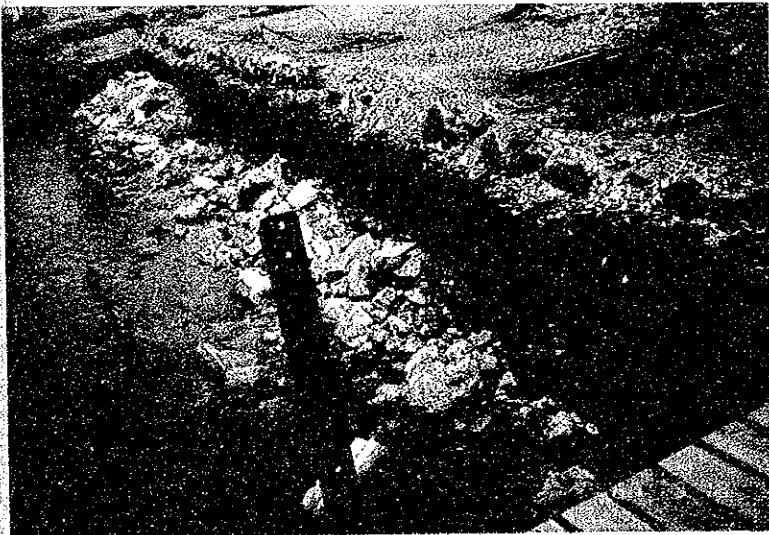
Avatiu River from
upstream (above)
to outlet (below)

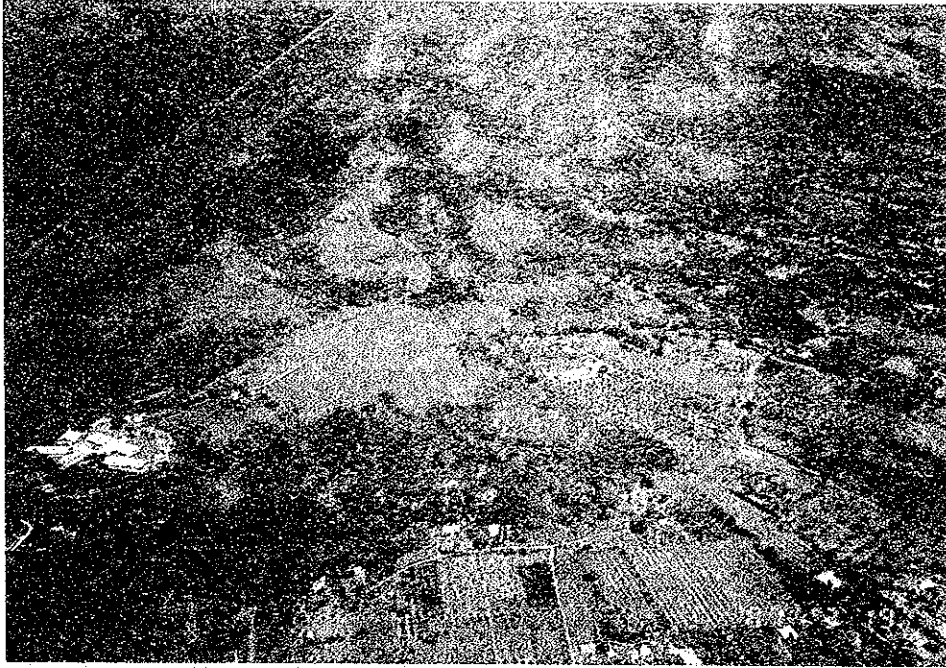
Developed high land area as farms
