INVESTIGATION REPORT
ON
THE COUNTER-MEASURES

FOR
THE PHILIPPINE-JAPAN FRIENDSHIP HIGHWAY DAMAGED
BY
TYPHOON DIDANG

AUGUST, 1977

JAPAN INTERNATIONAL COOPERATION AGENCY

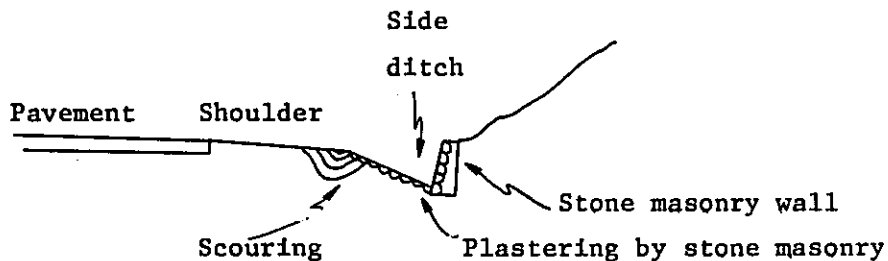
Figure I-4-1 Shoulder Scouring

Lateral and vertical scouring of shoulder resulted the destruction of side ditches. Specially, this type of damage is common in mountaineous area, where road is curving continuously.

Figure I-4-1 and Photo I-4-6 show typhical damage of shoulder scouring.

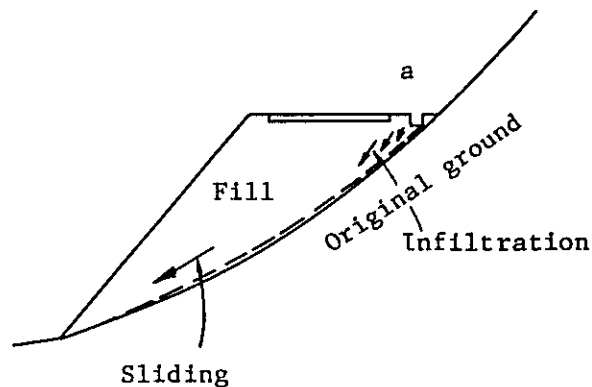
Figure I-4-2 Fill Section

- a - The destruction of hillside ditches will induce the water to seep or infiltrate through the embankment and will result in the sliding of the entire fill section. (Figure I-4-2)

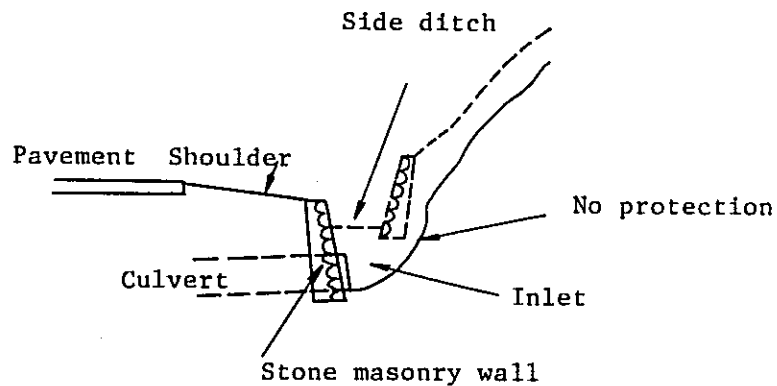
Figure I-4-5 Inlet without Covering

Figure I-4-5 shows the inlet without covering. This type of inlets is very simple and only has small amount of capacity and will be easily scoured. (Photo 1-4-7)

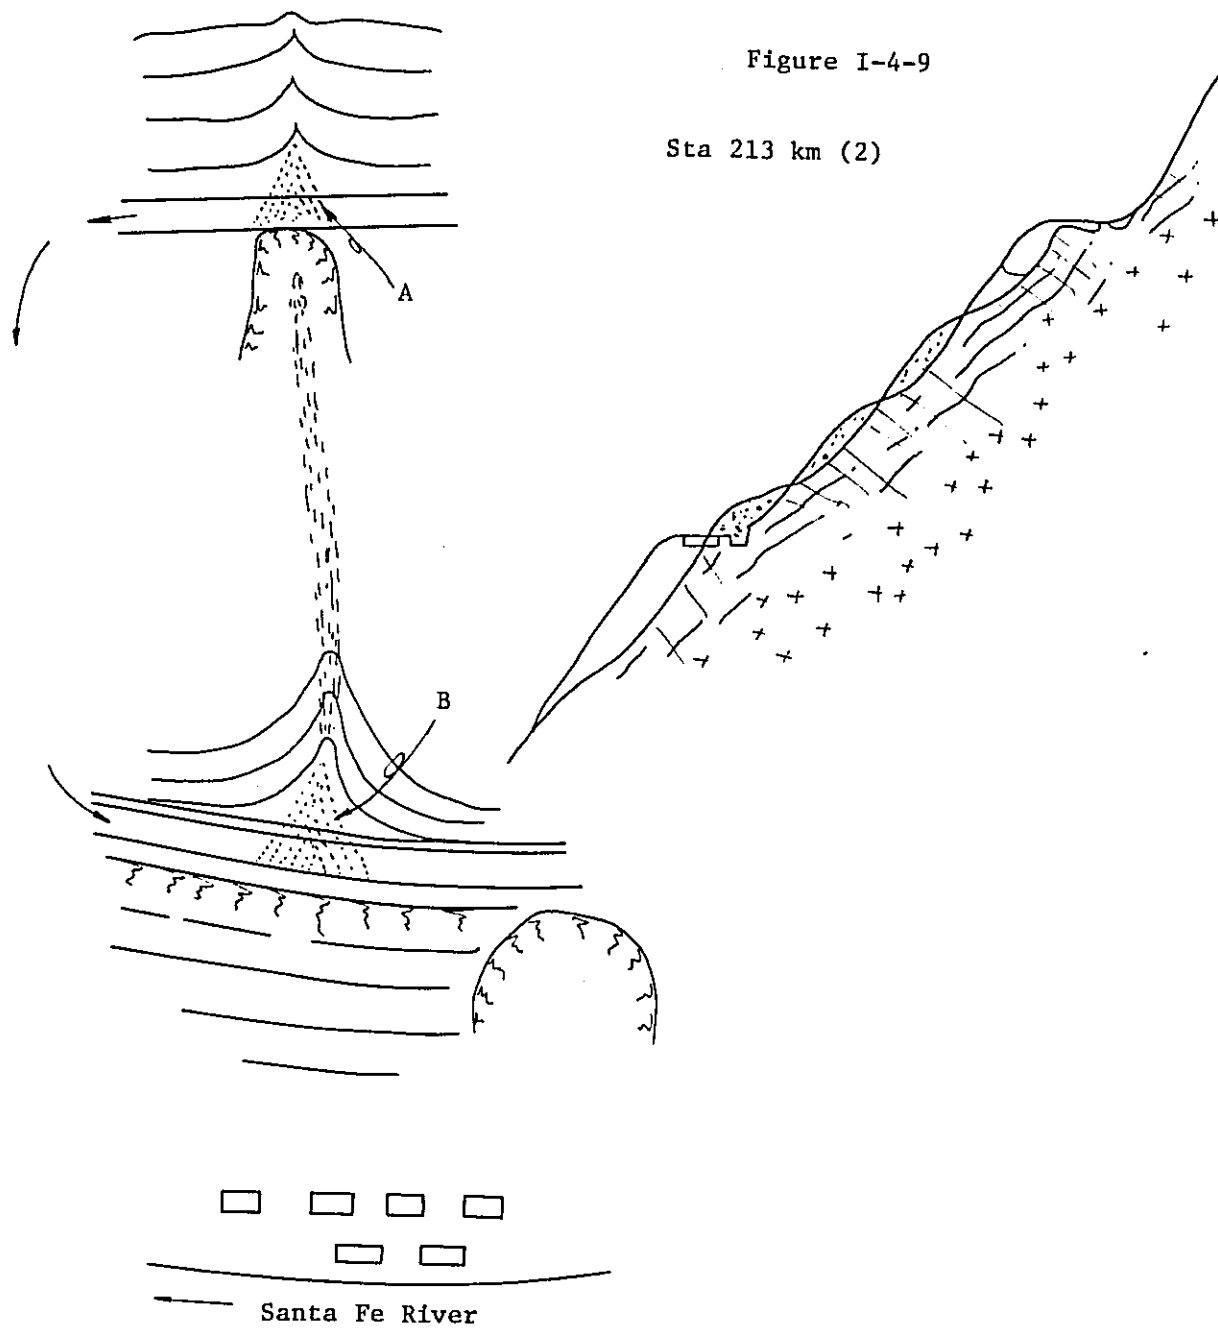
Figure I-4-9 Sta. 213 (2)

The road was damaged by the same reason of Sta. 213(1).

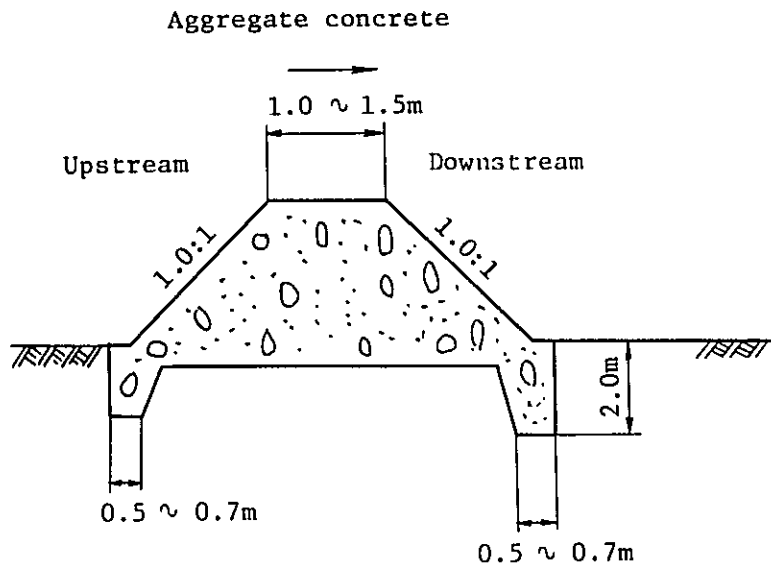
Anyway, installed spur dykes at damaged portions will be predicted the lack of strength against the flood water, because these are only covered by stone plastering.

Foot penetration on the tip of spur dyke

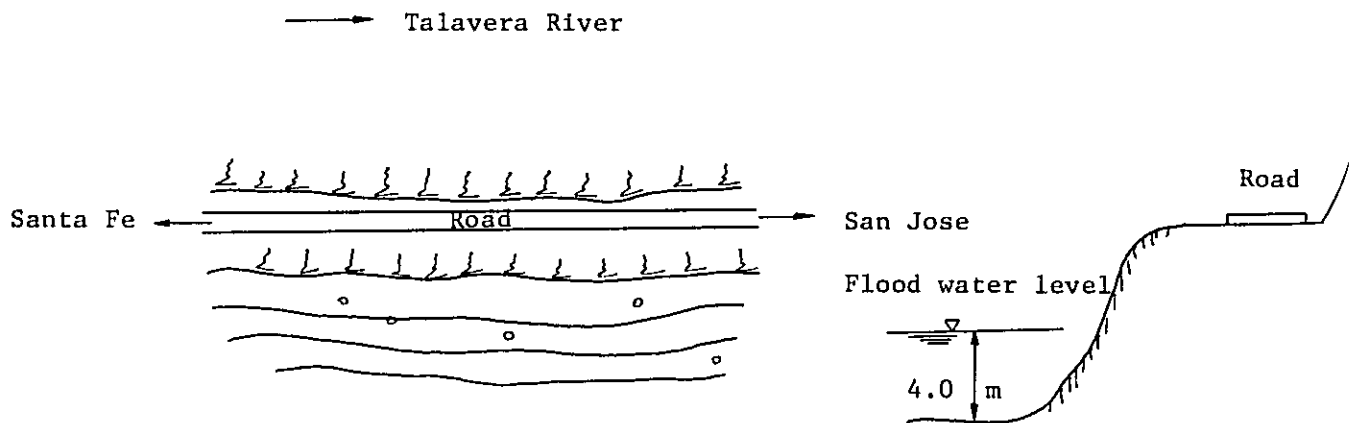
Figure II-1-36 Sta. 166 + 400 Situations

The river-side slope at this point of road is the natural steep slope having 15 meters height and adjoins to the gentle concave portion of the Talavera River.
