PRELIMINARY SURVEY REPORT
FOR
IMPROVEMENT OF OPERATIONS
OF
THERMAL POWER PLANTS

JULY 1982

JAPAN INTERNATIONAL COOPERATION AGENCY

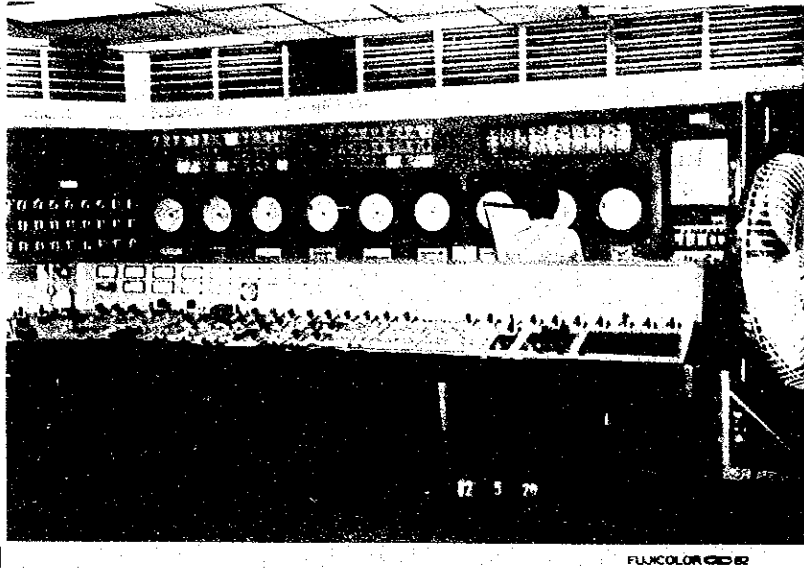
Malaya Thermal Power Plant Unit No.1, No. 2
Front Part of Central Control Board
(BTG Control Board)

Energied alarm lamps (Some of them are lit by malfunction.)

8) Alarm and annunciation system reset	○
9) Re-wiring for defective wiring specially bare wiring around main turbine supervisory devices	○
5. Water Treatment Facilities

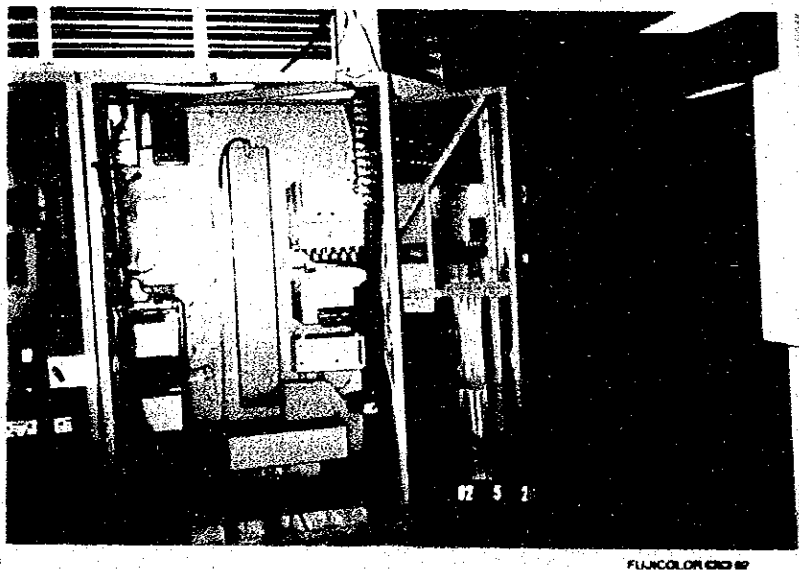
Malaya Thermal Power Plant Unit No. 1, No. 2
Rear Part of Central Control Board

There is no cover and dust is accumulated on the terminal, etc.

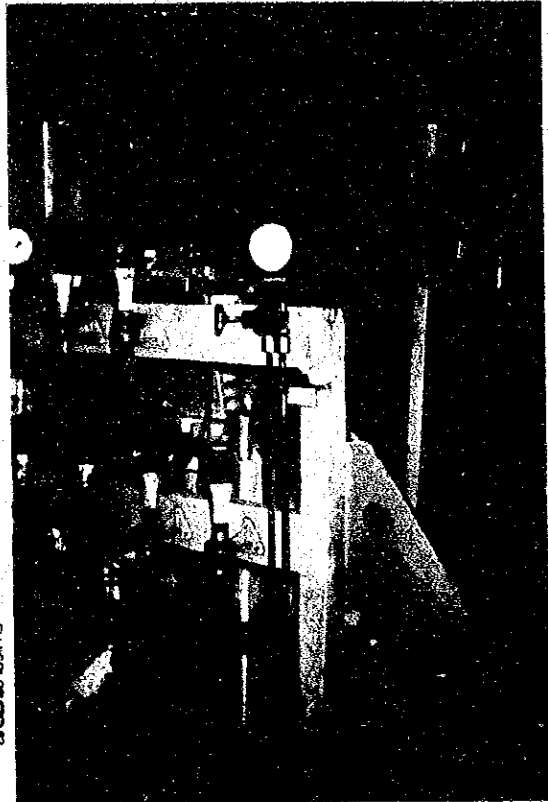
Instrumentation Around Main Turbine

Bare cabling without protection by conduit and flexible tube

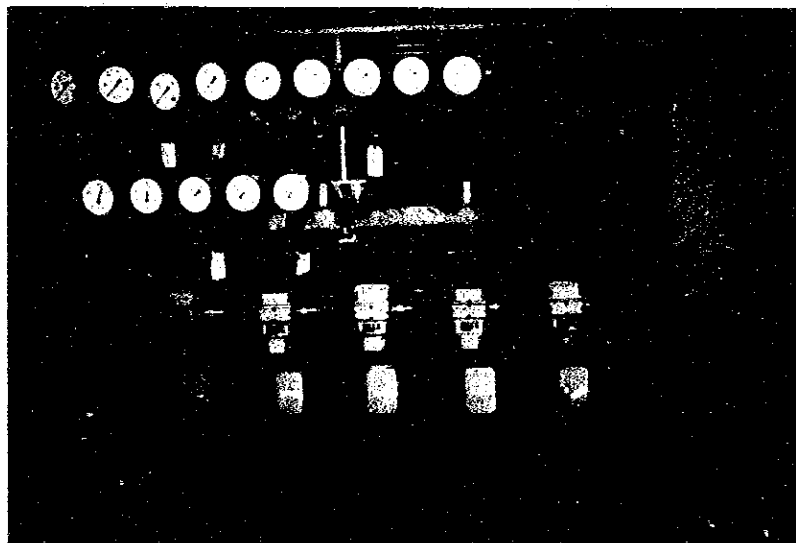
Instrumentation around Main Turbine

Bare local rack of protection instrument for
main turbine

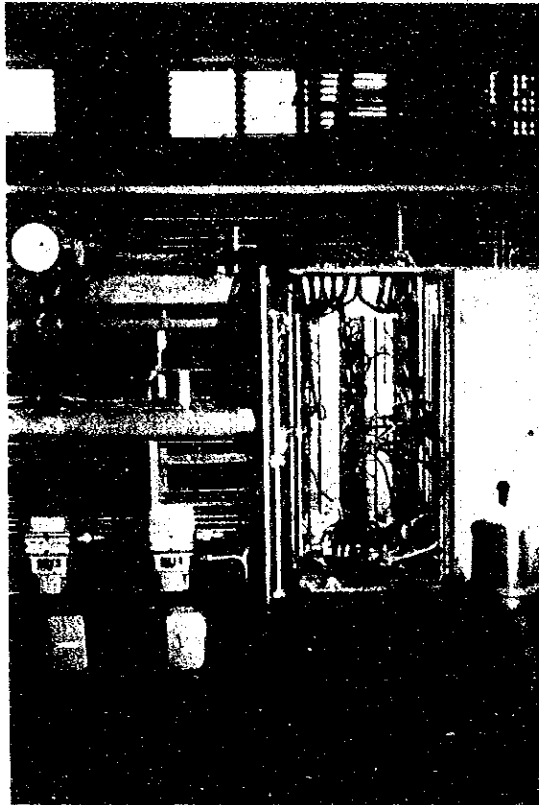
Malaya Thermal Power Plant Unit No. 1
Instrumentation around Main Turbine
 (Inside of Terminal Box)

Soot, dust and remained cable are remarkable.

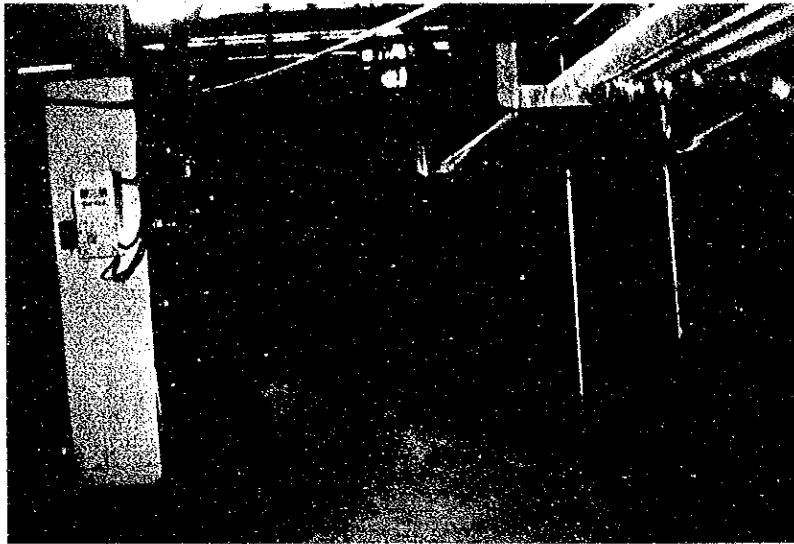
Motor Control Center

Standing water by leakage of piping and disorderly cabling are striking.

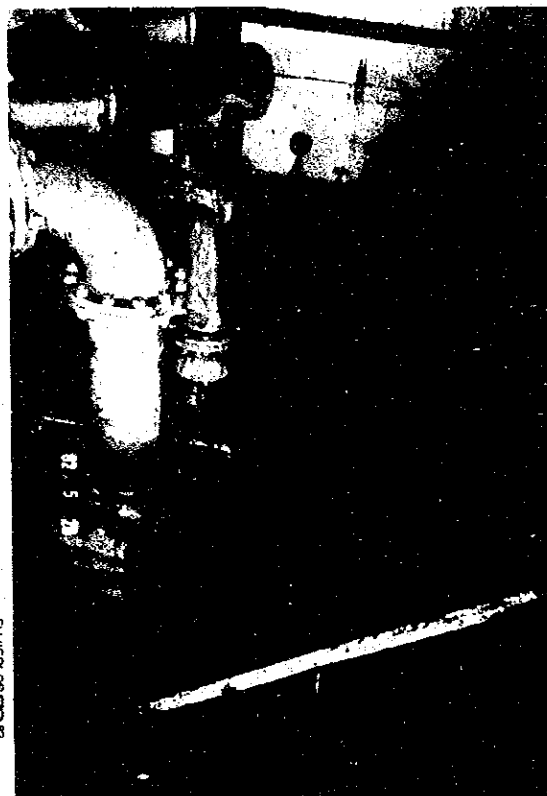
Malaya Thermal Power Plant Unit No. 1, 2
Ash Handling Slurry pump

Pump is under water (unusable).

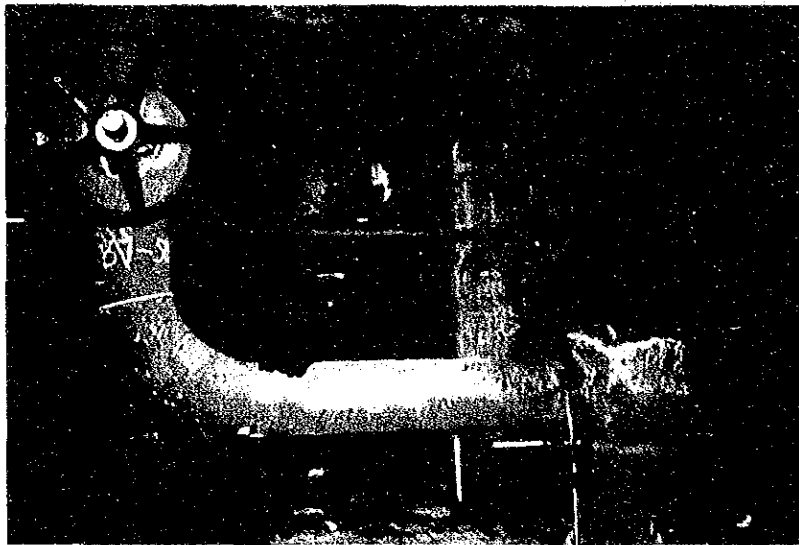
Start-up By-pass Valve

(Many traces of maintenance)

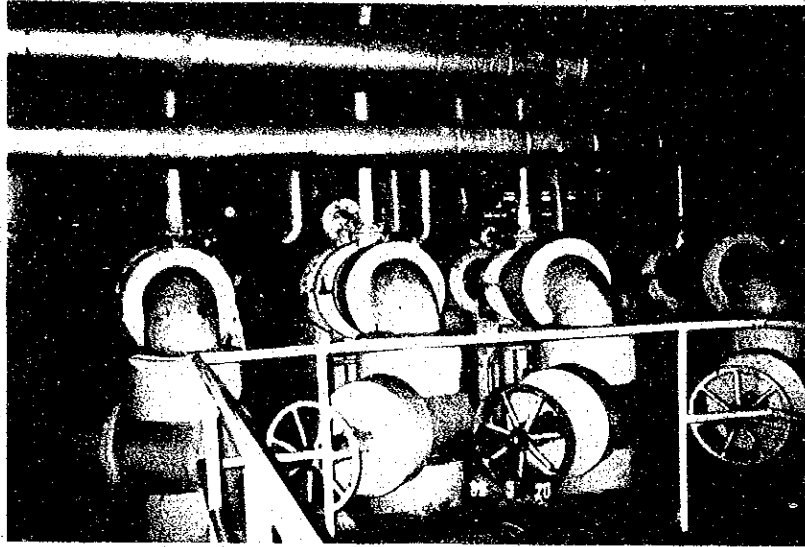
Air Extractor

Flow direction and valve identifications are not marked.

By-pass Valve (difficult operation)
