(II-8) Major Ferdinando E. Marcos Veteran Regional Hospital

II-8 MAJOR. F. MARCOS MEMORIAL HOSPITAL

2. Present Infrastructure Situation (Electric facilities)

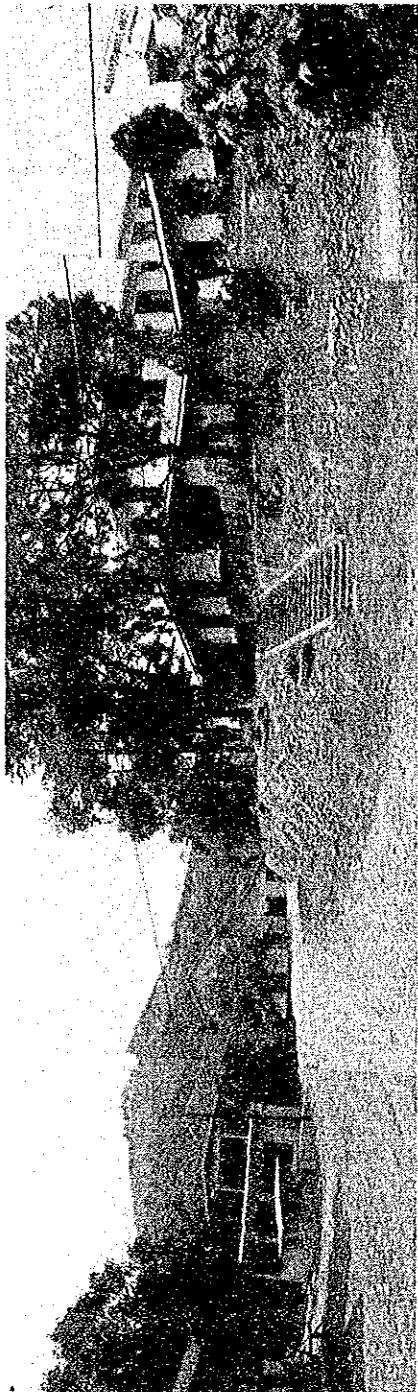
A two-storied wooden main building constructed in 1945, a one-storied out-patient building and a ward are arranged like the letter "u", with the main building in the center. Behind them, a dining hall, guest house, garage, nurse dormitory and laboratory are arranged side by side through connecting corridors, forming a small space against the main building. The hospital is located on a hilltop. It is higher than the school adjacent to it on the right by about 10m. There is little flat portion, and since buildings occupy the site fully, no land for extension can be obtained.

Old hospital complex

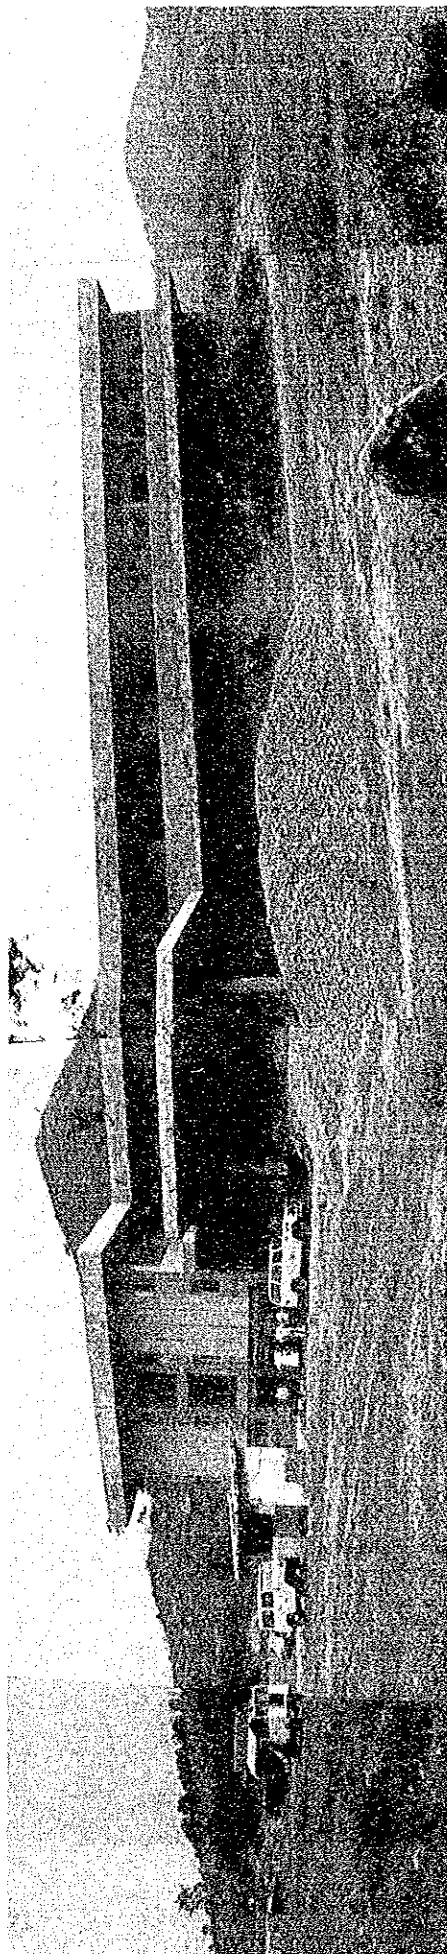
For the site, the mid-slope of the hill was cut and the cut soil was pressed to the valley side, for levelling. However, since the retaining wall for filled portion and the retaining wall for the face of cut slope are not constructed, the face of the slope collapsed due to rain, and the portion in the rear of the building now being constructed was filled with sediment up to the second floor level, and the filling flowed away. The levelling work is very imperfect.

New hospital building in new site (under construction)

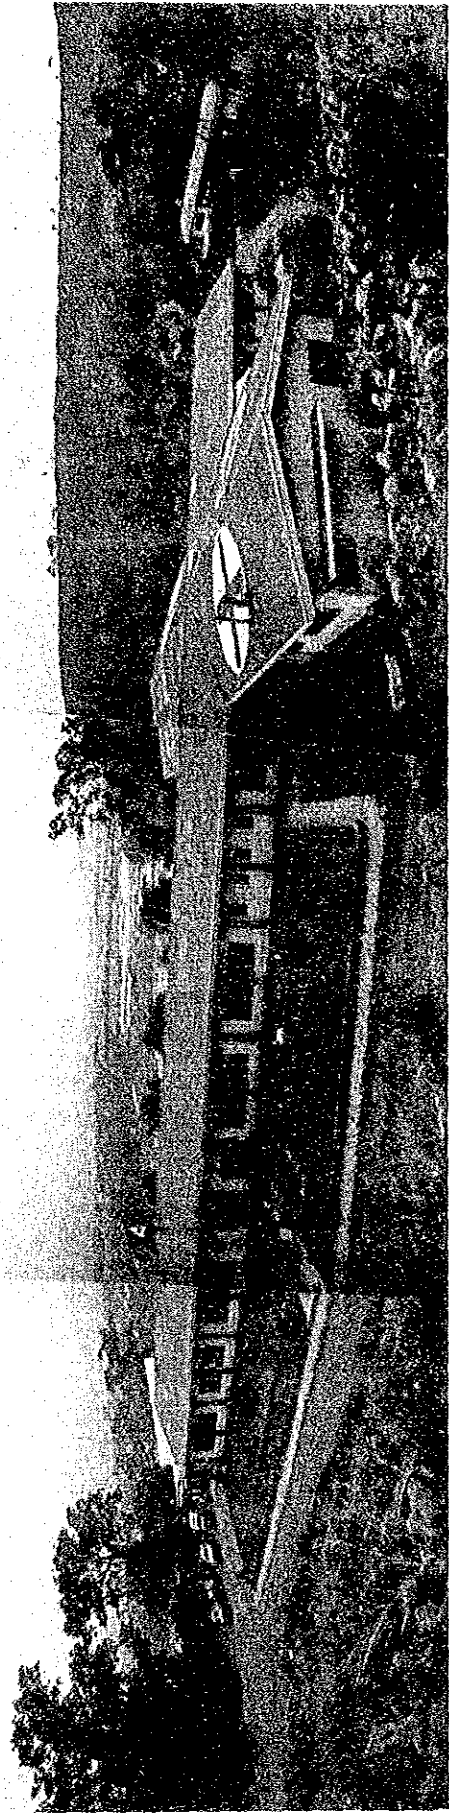
This hospital, too, was constructed on the site created by cutting and levelling the mid-slope of a mountain. The scenery of the country and overlapping mountains of Bambang seen from this height can soothe patients, but the paucity of flat area at the site greatly affects the arrangement of buildings. This cross-shaped hospital is small, being a one-storied building of reinforced concrete construction with 50 sickbeds. In 1976, it was constructed in the new site, but the exfoliation of paint on the roof and the soil of the external walls are conspicuous. A nurse dormitory will be completed this year on the south of the hospital, one step higher on the mid-slope of the mountain. In addition, there is an annex containing a garage and power room, at the back. All buildings are of one-storied reinforced concrete construction.

Main building

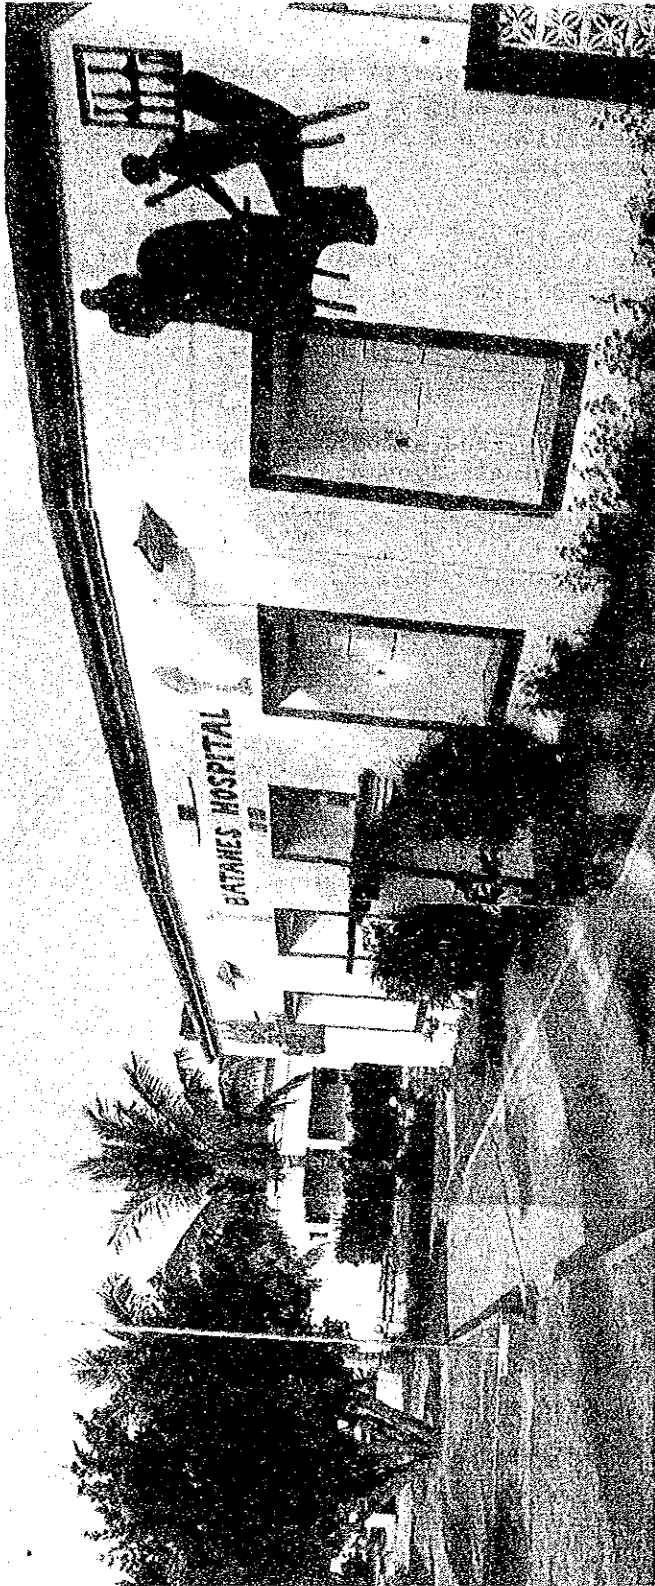
This hospital, located along a trunk road connecting an airport with a port in this island has buildings with thick walls peculiar to this island. Walls as thick as 40 to 50cm with stones fixed by lime are widely used by old private houses in this district. This district is in the route of the typhoons which arise in the typhoon season every year, and probably because of the damage experienced from typhoons, houses with thick walls must have been built. The thickness of the walls is also used to intercept the sunlight and to protect doors and windows from the damage of wind. However, since the roofs are covered with palm fronds, they seem to be often blown away by wind.

Front view of main building

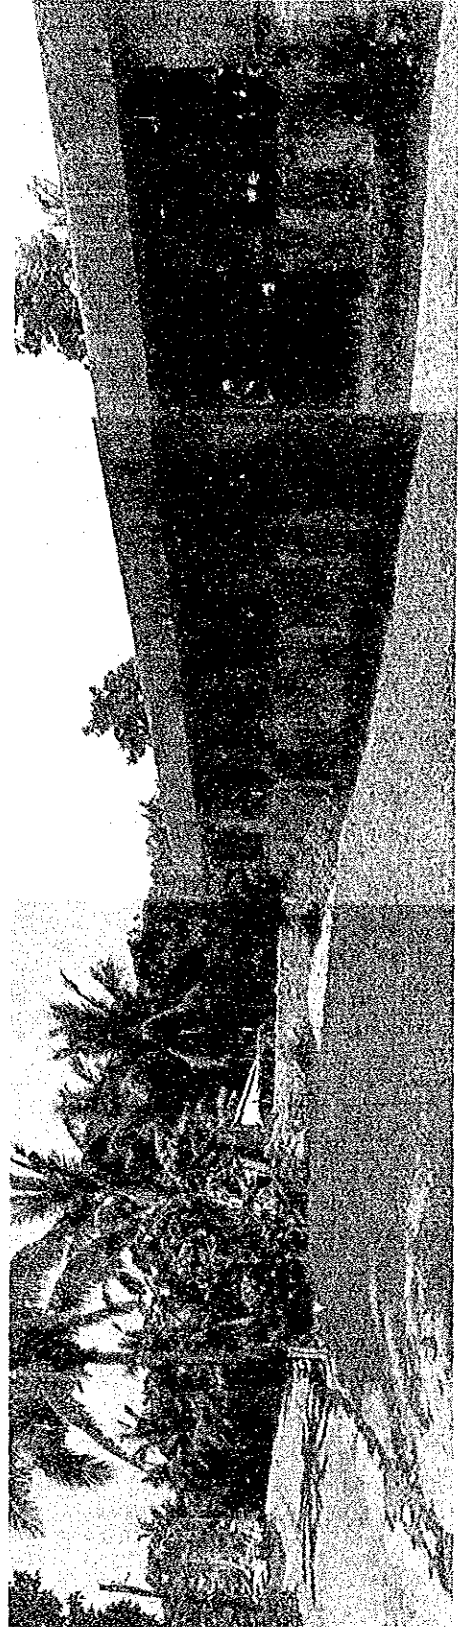
The hospital was constructed in 1946 with the aid of the USA, and was extended 4 times since then, to be enlarged to the present scale. The main building is of one-story reinforced concrete construction, partially two-storied. The walls are as thick as 50 to 80cm. For external windows and entrance doors, "gate bars" are hooked outside, using the thickness of walls, to protect the openings from wind and any flying materials. At the back of the main building is a building containing a dining room, laundry and power room, and further behind is a ward, the construction of which is now being suspended. It is a one-storied building of reinforced concrete construction with 50 beds and 270m² area. With only the skeleton and roof completed, the construction has been suspended for 2 years. Therefore, the galvanized iron roof sheet generates red rust.

New building (not completed)
