**REPORTS OF GEOLOGICAL SURVEY
FOR
CIVIL ENGINEERING WORKS**

REPORTS OF GEOLOGICAL SURVEY FOR CIVIL ENGINEERING WORKS

Reports of Geological Survey for Civil Engineering Works compiled by Kazuji Uno, Expert on Engineering Geologist dispatched by the Japan International Cooperation Agency (JICA) to the Republic of Indonesia under the Colombo Plan Technical Cooperation Scheme (dispatched duration: from July 1974 through July 1980).

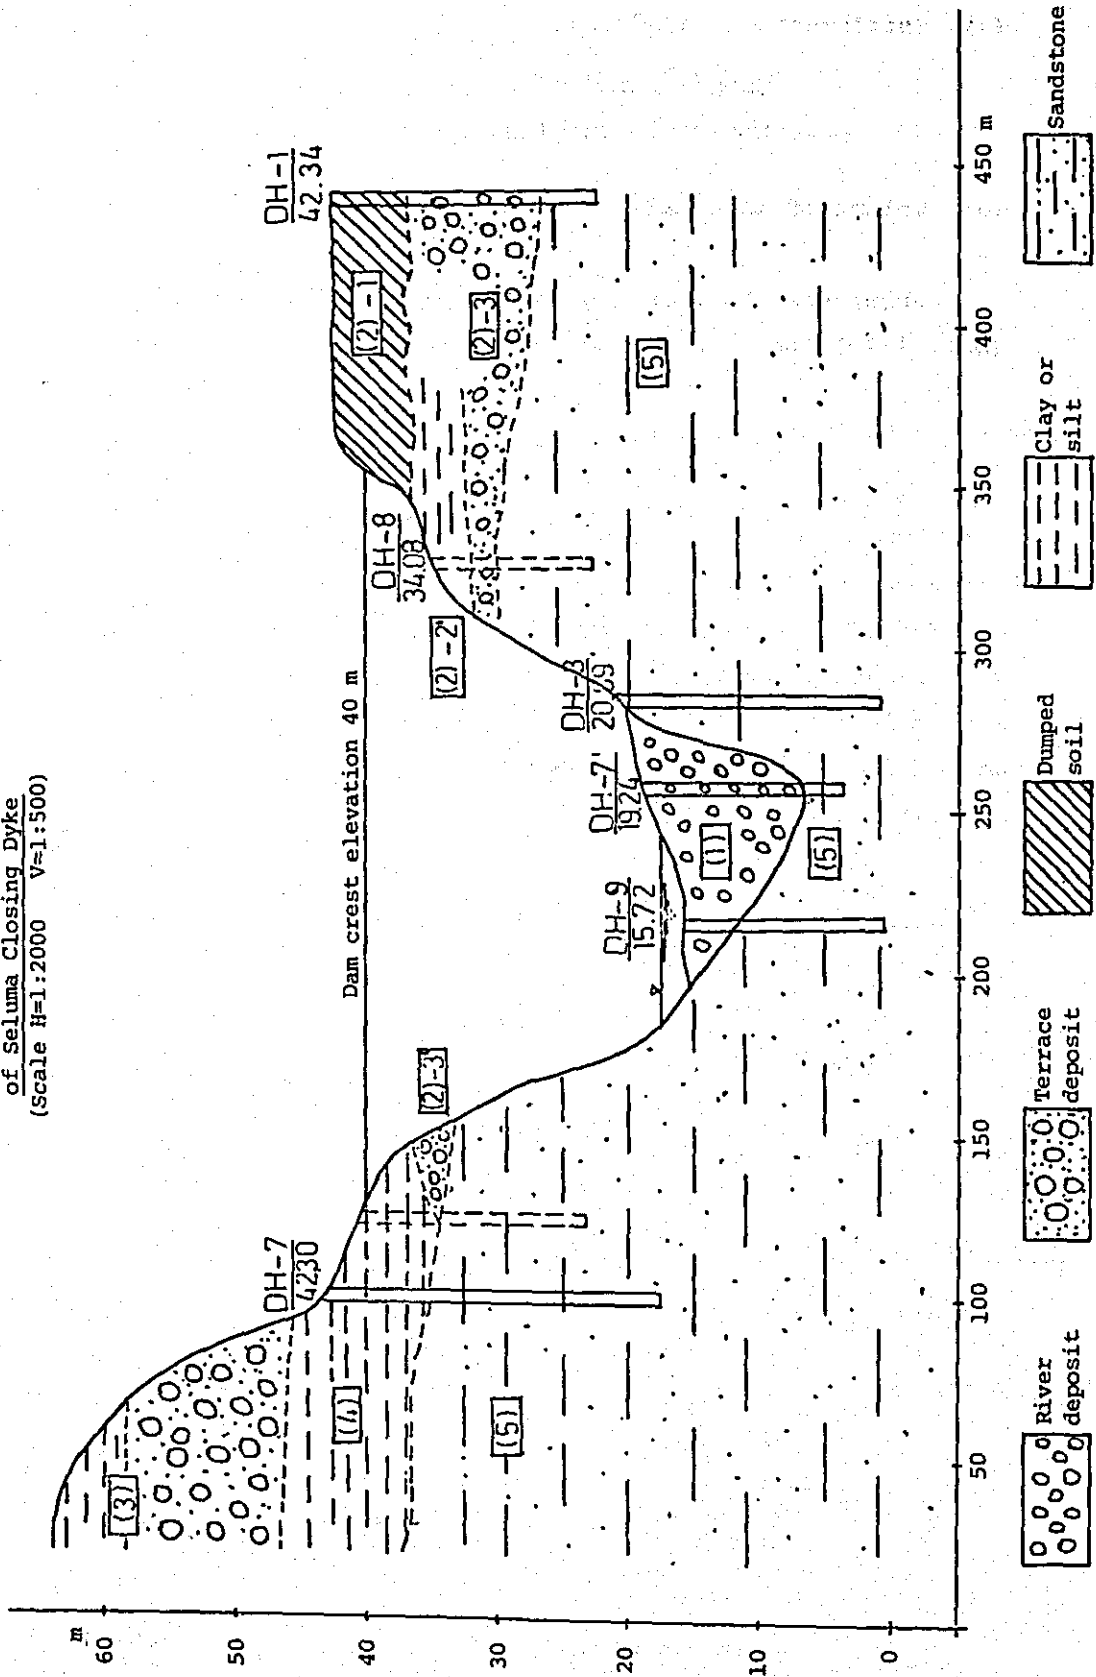
The Geological Sketch Section
of Seluma Closing Dyke
(Scale H=1:2000 V=1:500)

On the left side, gravel layer (2)-3' is found out newly. The relation of these gravel layers between (2)-3 and (2)-3', and between clay layer on left side (4) and silt and clay layer (2)-2' on the right side are not clear geologically.

The distribution of these layers at dam site must be made to clear and not to be estimation as far as possible. Then, it is recommended to make it a rule to make trench of 1 - 2 meters depth along the dam axis by bulldozer or man power at the survey of dam geology.

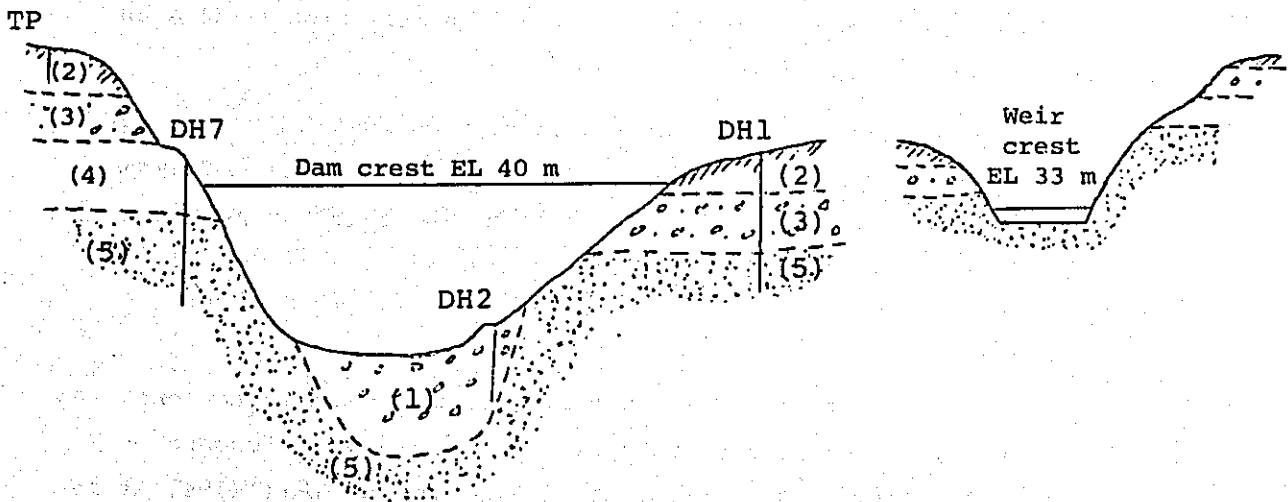
(1-1) The sketch profile to get the general idea of dam geology.

On the next figure, the reduced scale varies arbittarily.

Terrace deposit (2) (3) on the right side must to be the dam basis. There are no data about their bearing capacity and permeability. If the gravel (boulder) bearing layer (3) is permeable, it will raise a problem of foundation treatment.

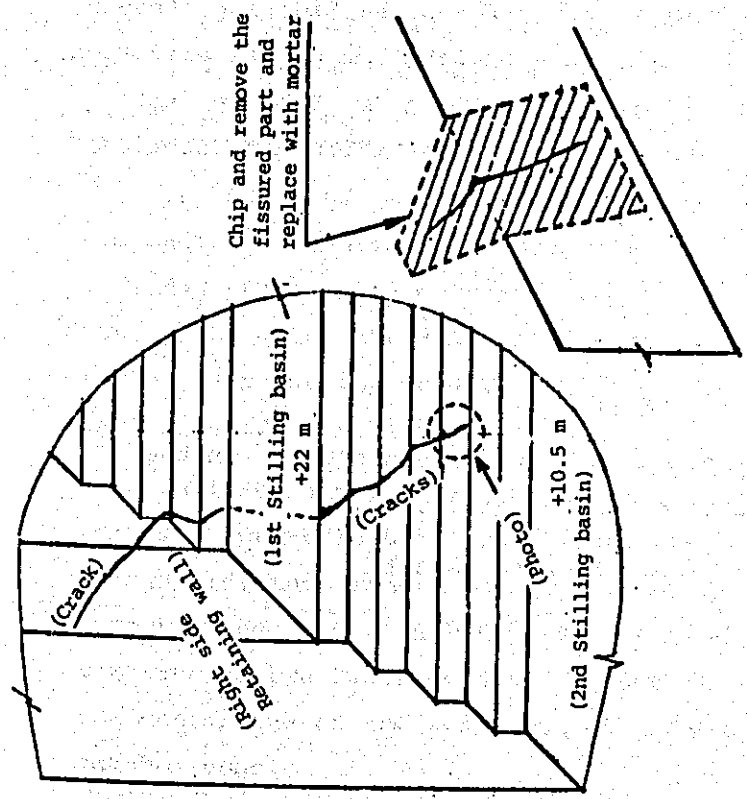
Fig. 5 Sketch of Cracks and its Treatment

With regard to crack or fault, it is reported that cracks of 2 - 3 cm in width occurred on the excavated surface on the 2nd crest and the west side retaining wall of 1st stilling basin by the earthquake on November 9, 1977 and these cracks were not affected by the twice earthquakes in February 1978. According to the survey, these cracks are regarded as a same continuous fault. The strike of fault plane (ie. the direction of line that the fault plane intersects the horizontal plane) is almost N 35° W, and the dip (ie, the angle between the fault plane and the horizontal plane) is almost 45° to EN direction. The width of opening of fault caused by the earthquake last year are 0 - 5 cm but 1 - 2 cm on an average. There are no sign of displacement toward horizontal or vertical direction.

Judging from such situation, it may be possible for treatment to use ordinal way which has been applied for the fault treatment of dam foundation. That is, concrete plug and grouting are usually adopted for the fault larger than several ten cm in width. For small fault as found in this case, it is usually to remove the fractured or softened zone in the both sides of crack and to place wedge of mortar or concrete as deep as possible. (See Fig. 5)

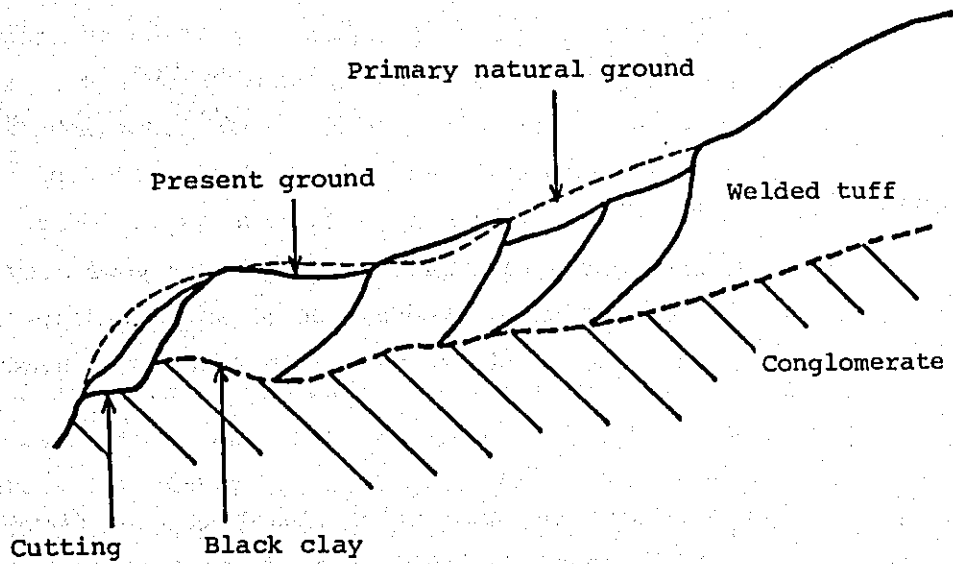
Fig. 5 Shidabaru Dam

- Fig. 5 After the cutting for spillway and road, cutting slope composed of welded tuff, begun the slide on large scale. Welded tuff itself had not character of sliding but there was black clay layer only several cm and it acted as lubricant and could not be reserved water.

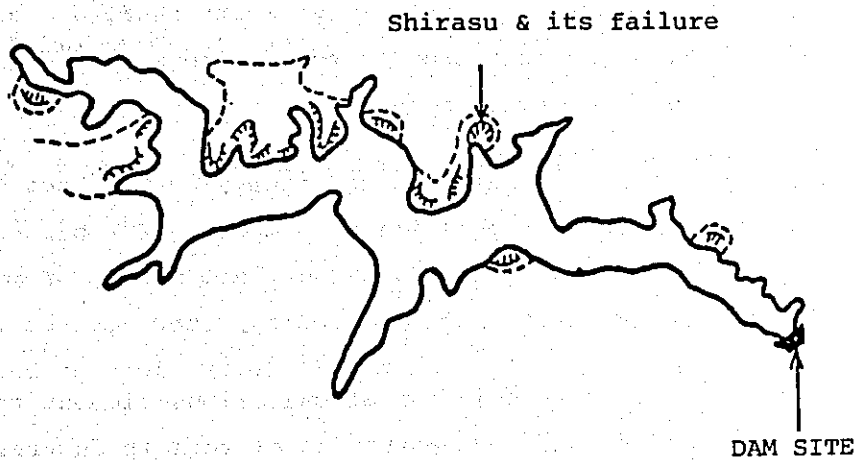
Fig. 6 Ayanami Dam

- Fig. 6 Almost all slope of Shirasu (volcanic silty sand) are suffered by failure. Maximum height of failure is about 25 m, their lengths are sumed up to about 2.5 km, their total volume calculated about 400 thousand m^3 and it is estimated to increase the volume by 50% in water. As the distribution of Shirasu around this basin is not so extensive and failures have not affected so much on water volume of reservoir in this case.
