REPORT ON THE STUDY ON ENERGY CONSERVATION PROJECT IN THE KINGDOM OF THAILAND VOL. 1

-CERAMICS/GLASS AND PAPER FACTORY-

JANUARY, 1983

JAPAN INTERNATIONAL COOPERATION AGENCY

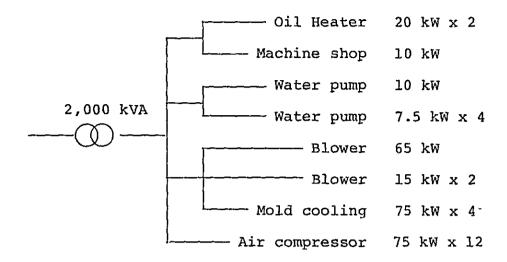
Electric equipment are installed in numbers to fit in with two glass melting furnaces. Currently, however, one of the melting furnaces is at rest, so the factory is experiencing excess capacity that much. Some of electic equipment are being idled away.

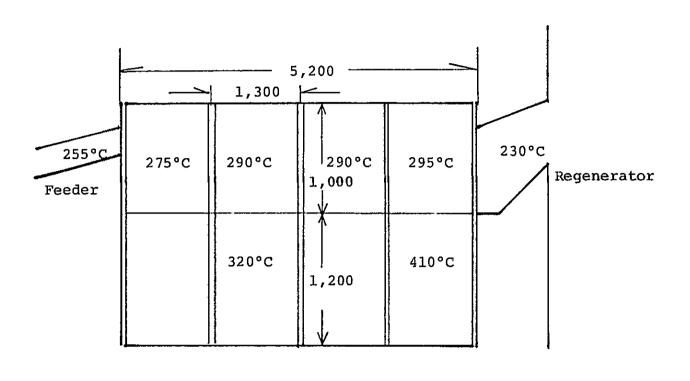
Fig. 1 Surface Temperatures of the Furnace Wall

- 6. Problems in Heat Control and Potential Solutions
 - (1) Air ratio

According to the results of an analysis made of the oxygen content in exhaust gas from the melting furnace, the oxygen content at the bottom of the regenerator is:

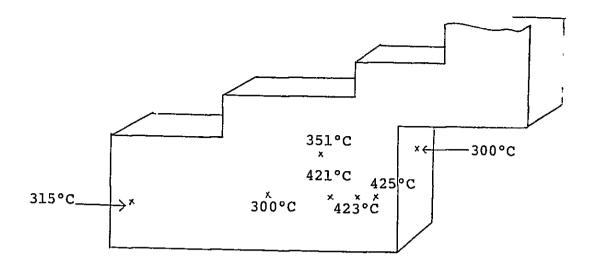
Surface temperature on the side walls of the melting furnace

The application of the insulating blanket will cost less than 60,000 bahts, which may be recovered in a short period of time.

However, the life of bricks must be carefully considered as the application of the blanket will increase the temperature of the bricks on the inside of the furnace.

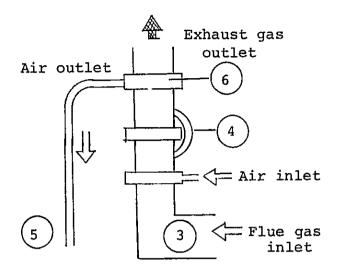
Temperature in different parts of the recuperator

Measuring points		Temperature (°C)
1	Temperature of the refiner	1,250
2	Temperature in the melting	1,493
	furnace	
3	Temperature of exhaust gas	1,373
4	Temperature of preheated air	505
	midway	
5	The same as the above (in the duct)	398
6	Temperature of exhaust gas outlet	672

a. Air for the refiner burner can be efficiently preheated by use of recovered heat from exhaust gas or hot air collected from the top of the melting furnace.
