SECTION 5

MAE MOH FACTORY
REHABILITATION PLAN

Section 5 Mae Moh factory rehabilitation plan

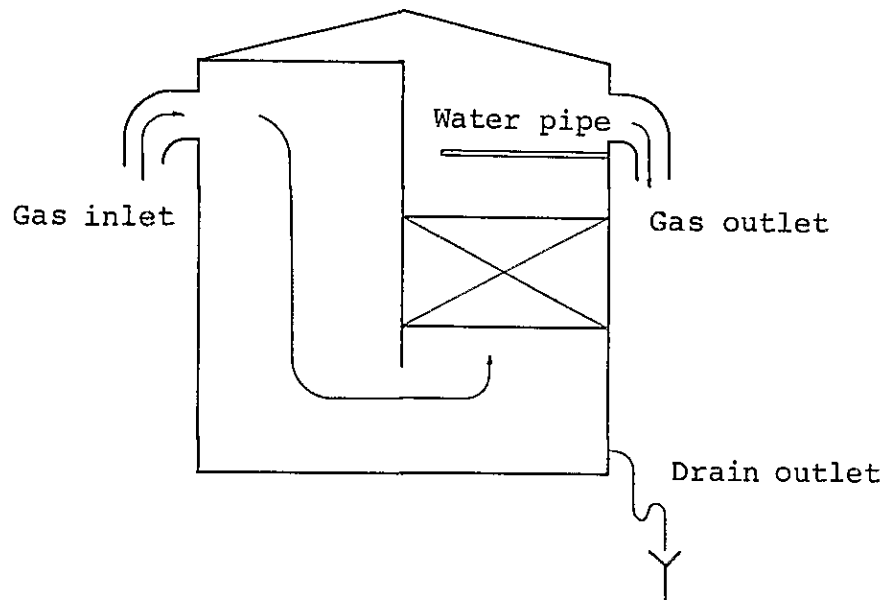
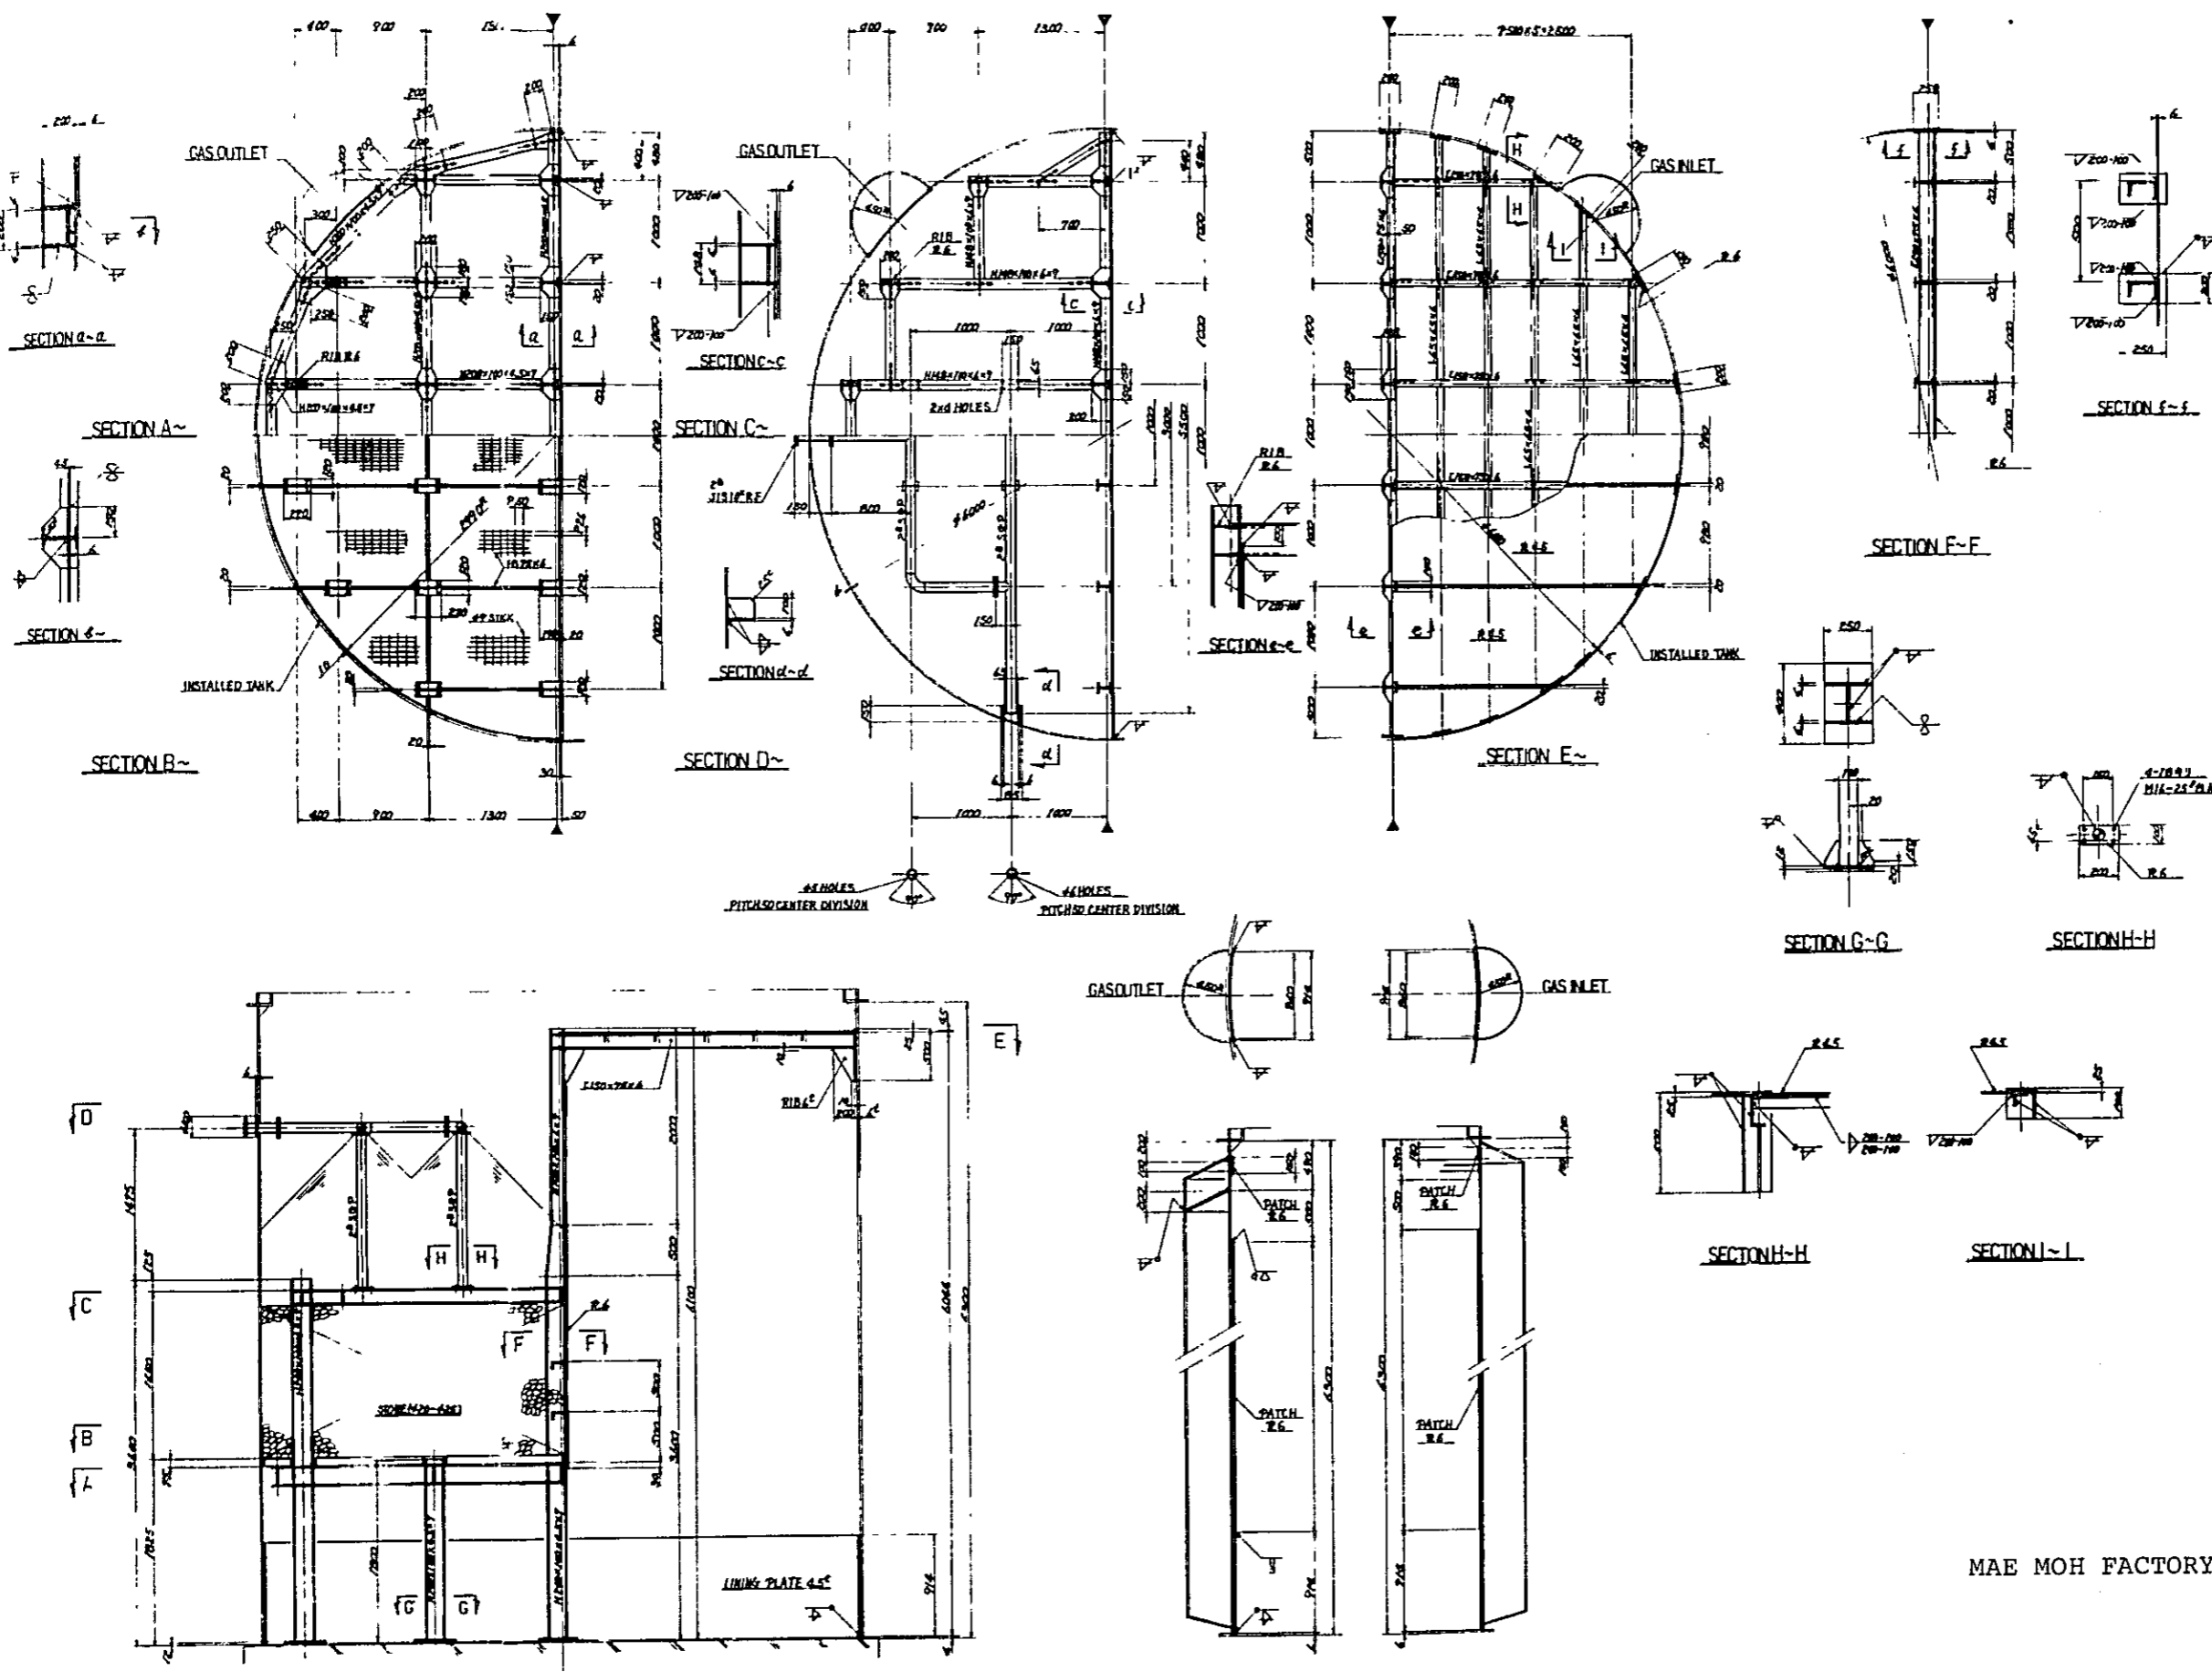
Schematic Drawing for the Remodeling of NO Removal Tank

Dusts produced at gasification plant cause influences to the downstream Adip Plant and Ammonia Plant.

The drain (mist of water) and fly ash were, at the first, separated by the gravity force in the left hand room of Tank. Then the fly ash is separated by the packed bed. Water pipe is installed to wash the packings.

For the removal of dusts, it is recommended to modify the existing No Removal Tank to Filter.

Main procedures for the modifications are to divide the tank by the wall at the center vertically, where one side shall be kept vacant to enable the dust and drain in the gas sinking by their gravity and the another side shall be provided with Filtering layer of stones (or ceramic balls) against coming-up gas flow. While, it is planned that the dusts filtered and clogged at the filter layer can be removed by water cleaning.
