BOLIVIAN NATIONAL RAILWAYS'
REHABILITATION PROGRAM

FINAL REPORT

VOLUME II

MARCH 1980

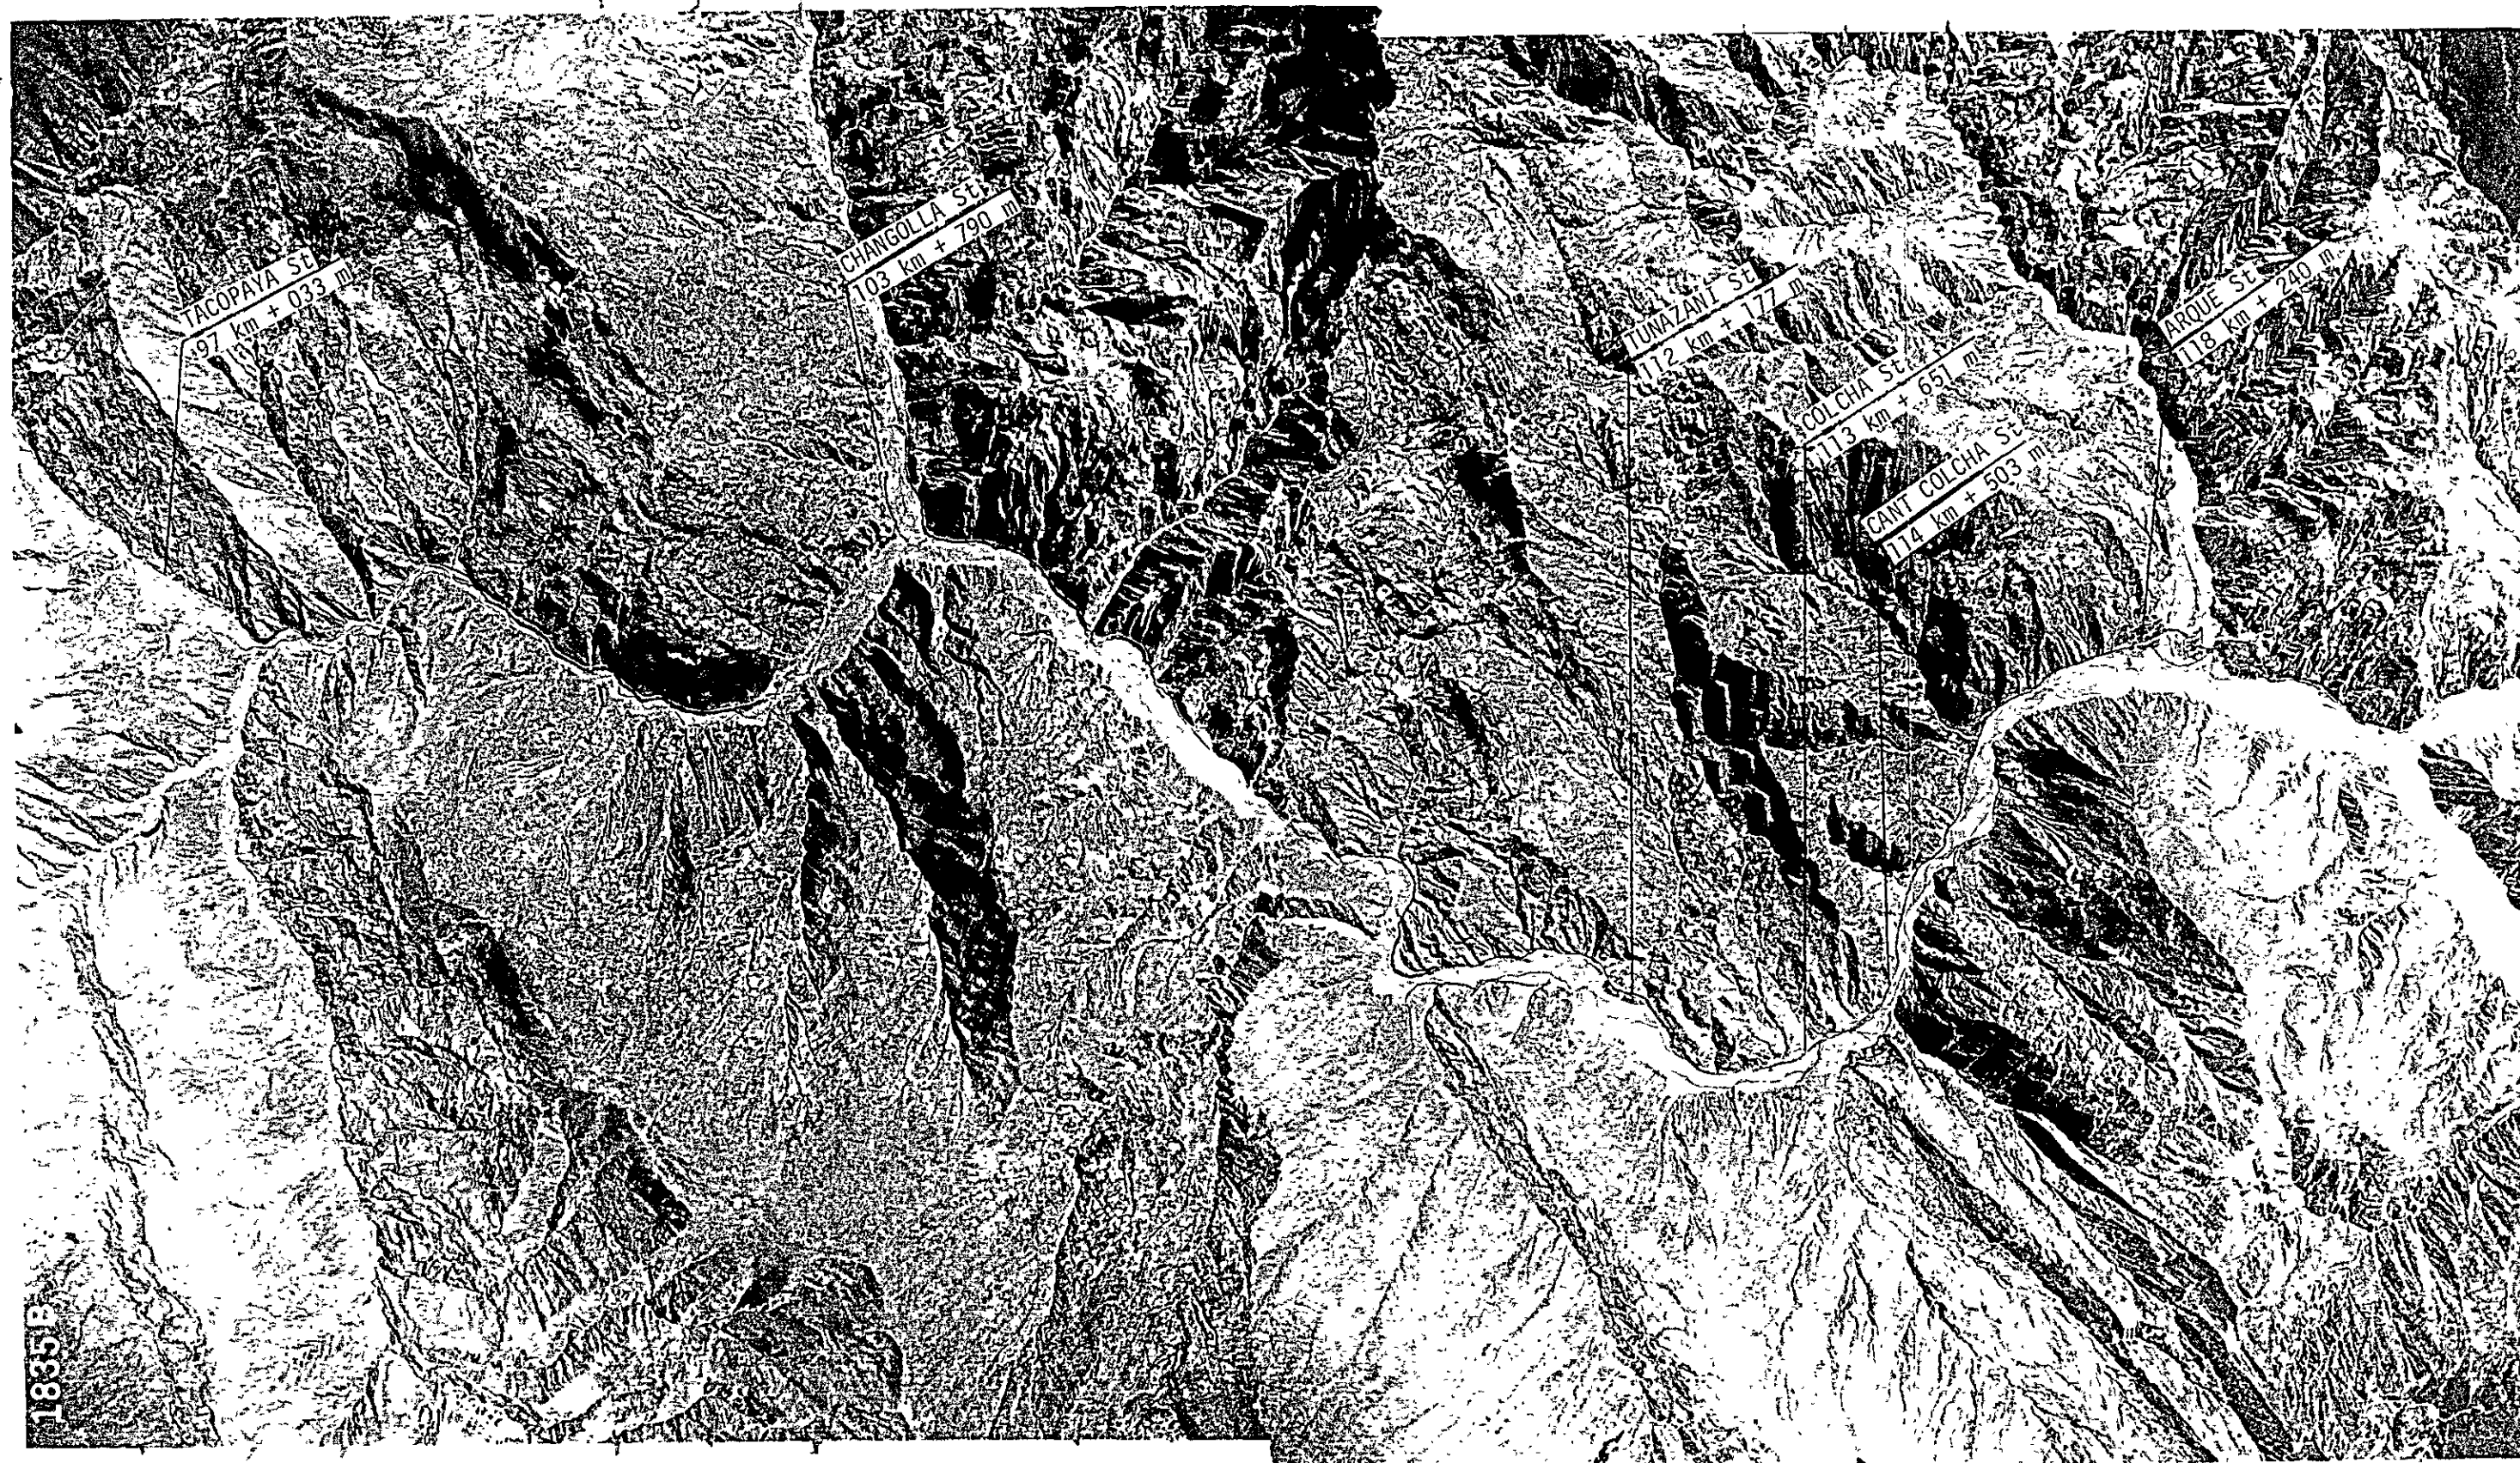
Photo 2.2.1 Aerial Photograph
(97 km - 120km)

In the Rio Arque carving the eastern slope surface of Cordillera Oriental, the watercourse alongside the NW - SE weak zone is featured by slope failure and slide and talus while the other course in square to that zone forms a steep gorge with soaring cliffs. The valleys in branch streams are also developed in the direction of the weak zone, flowing out a great deal of debris. However, since the base rock consists of sedimentary rocks with small joint intervals, there seldom exists any rocks of huge size in excess of 1 m dia. Photo 2.2.1 shows the view alongside the railway taken by aerial photograph.

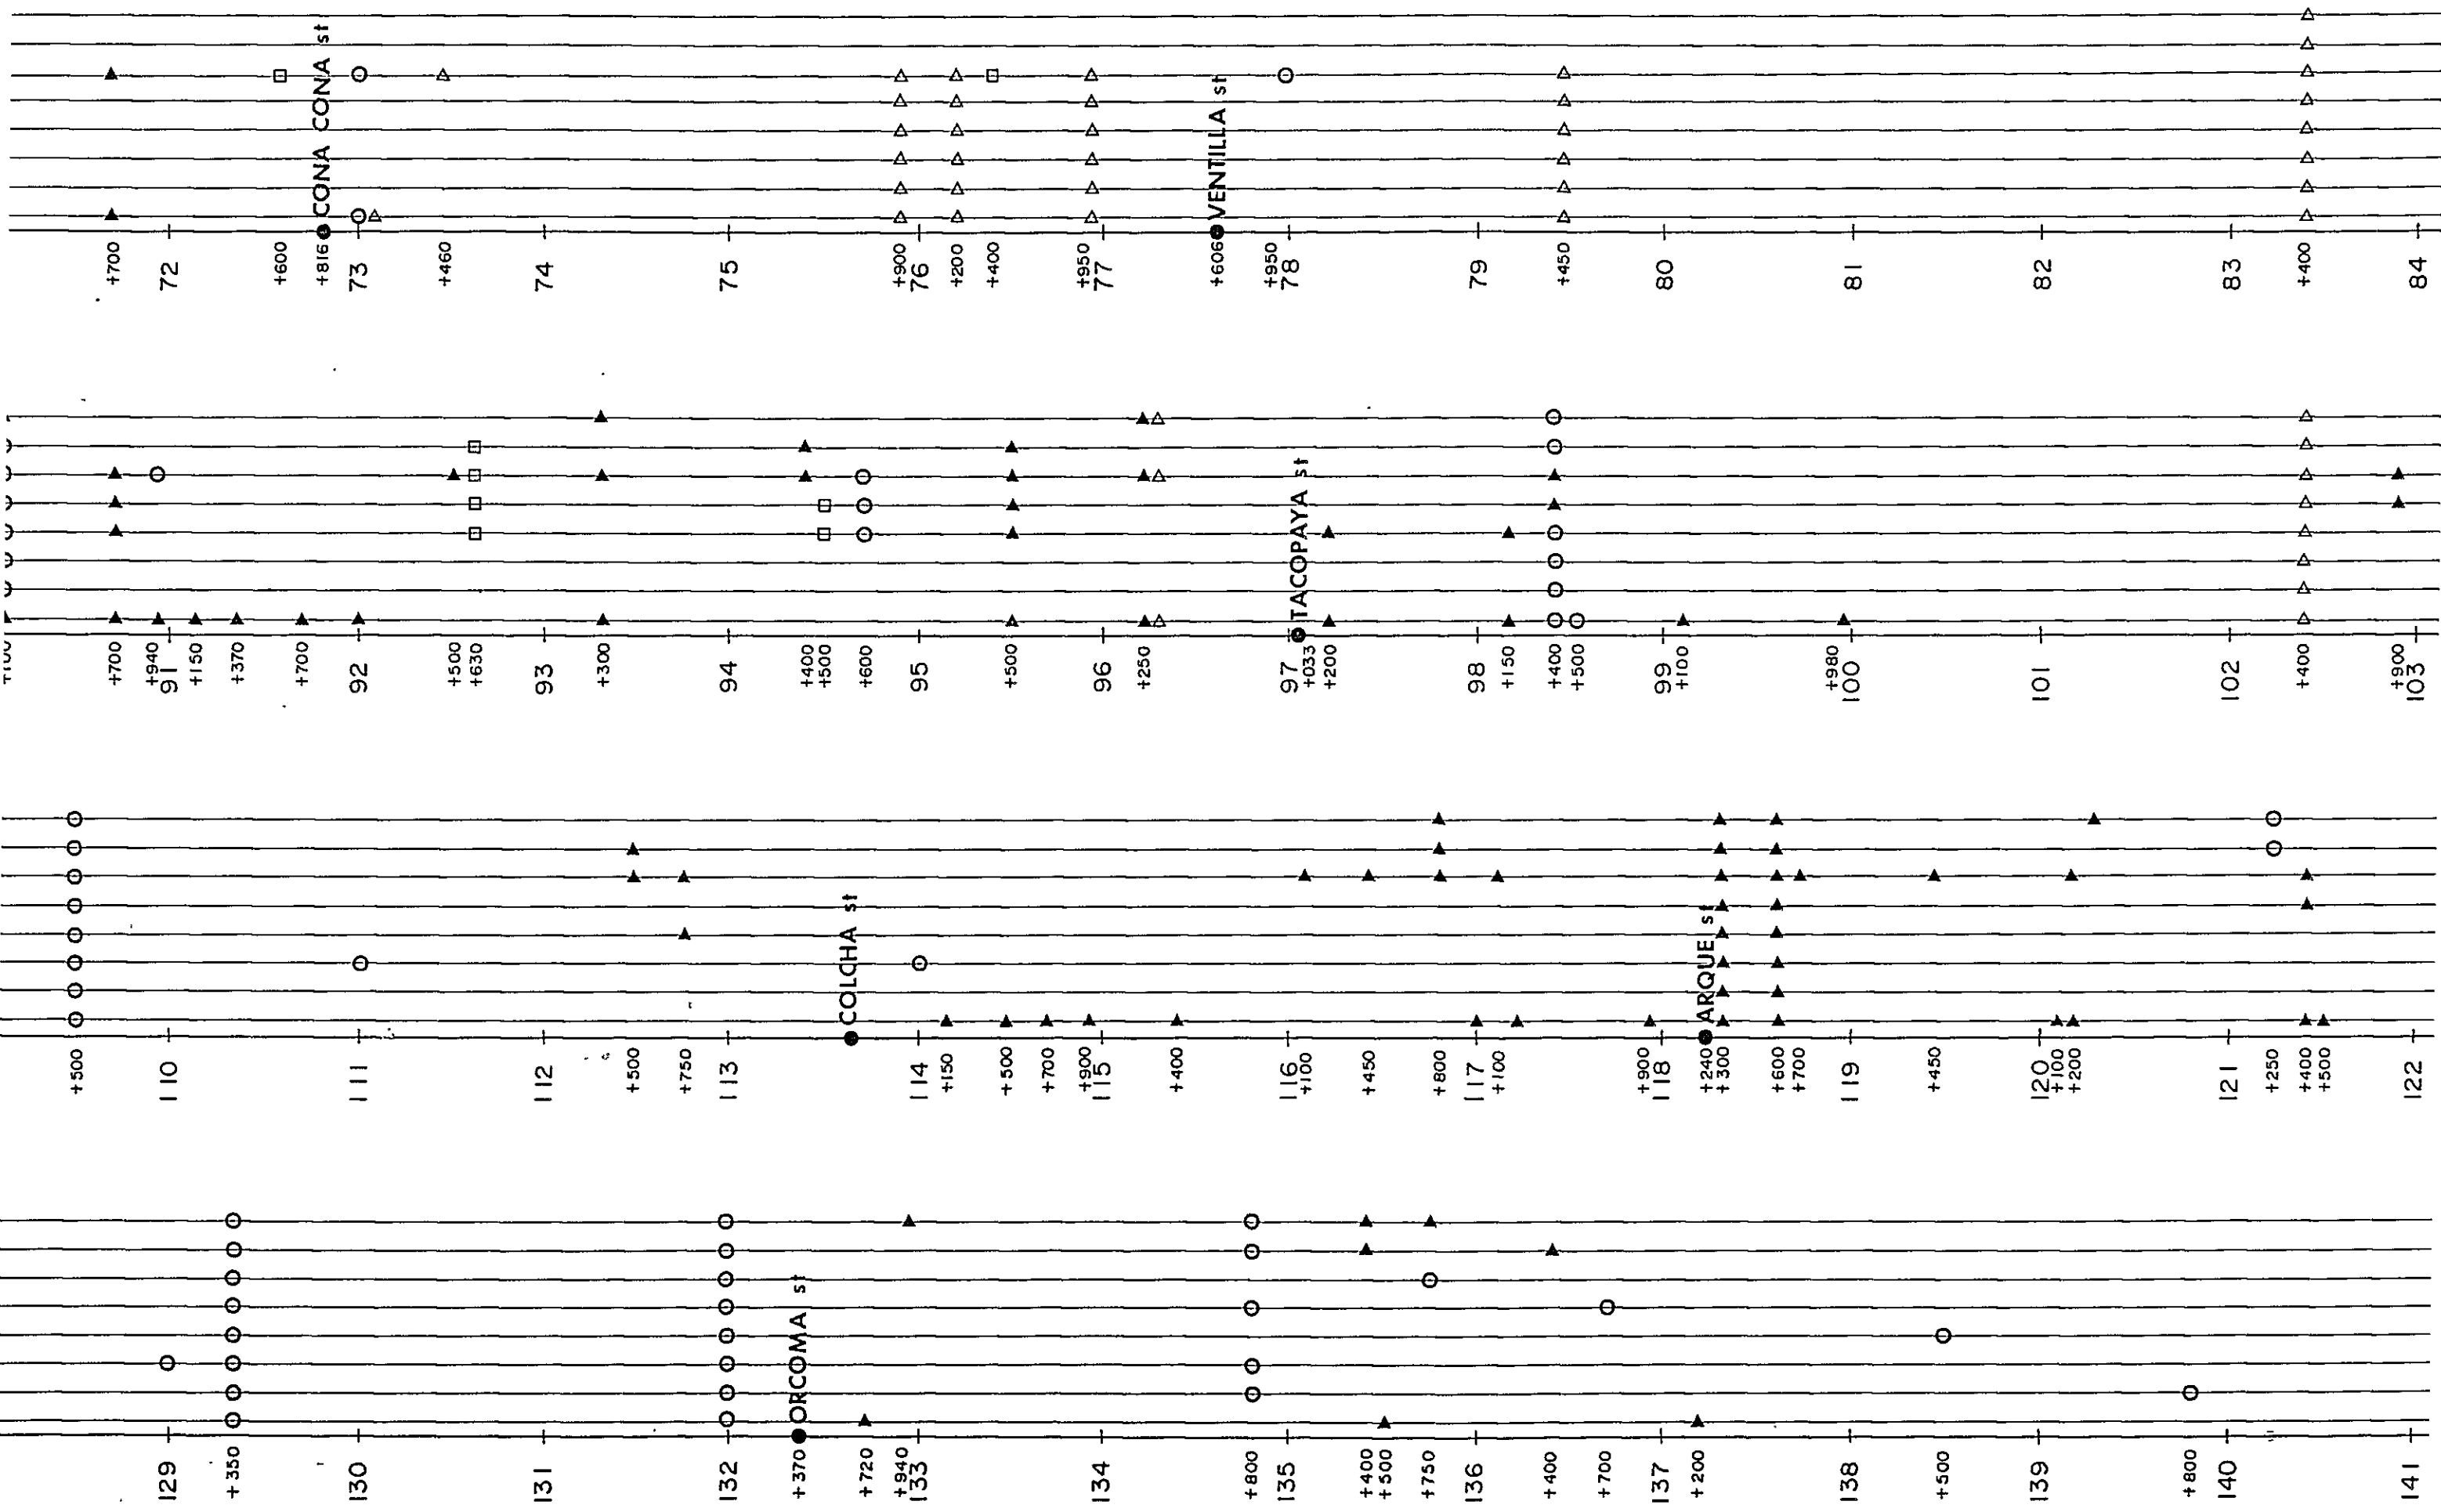
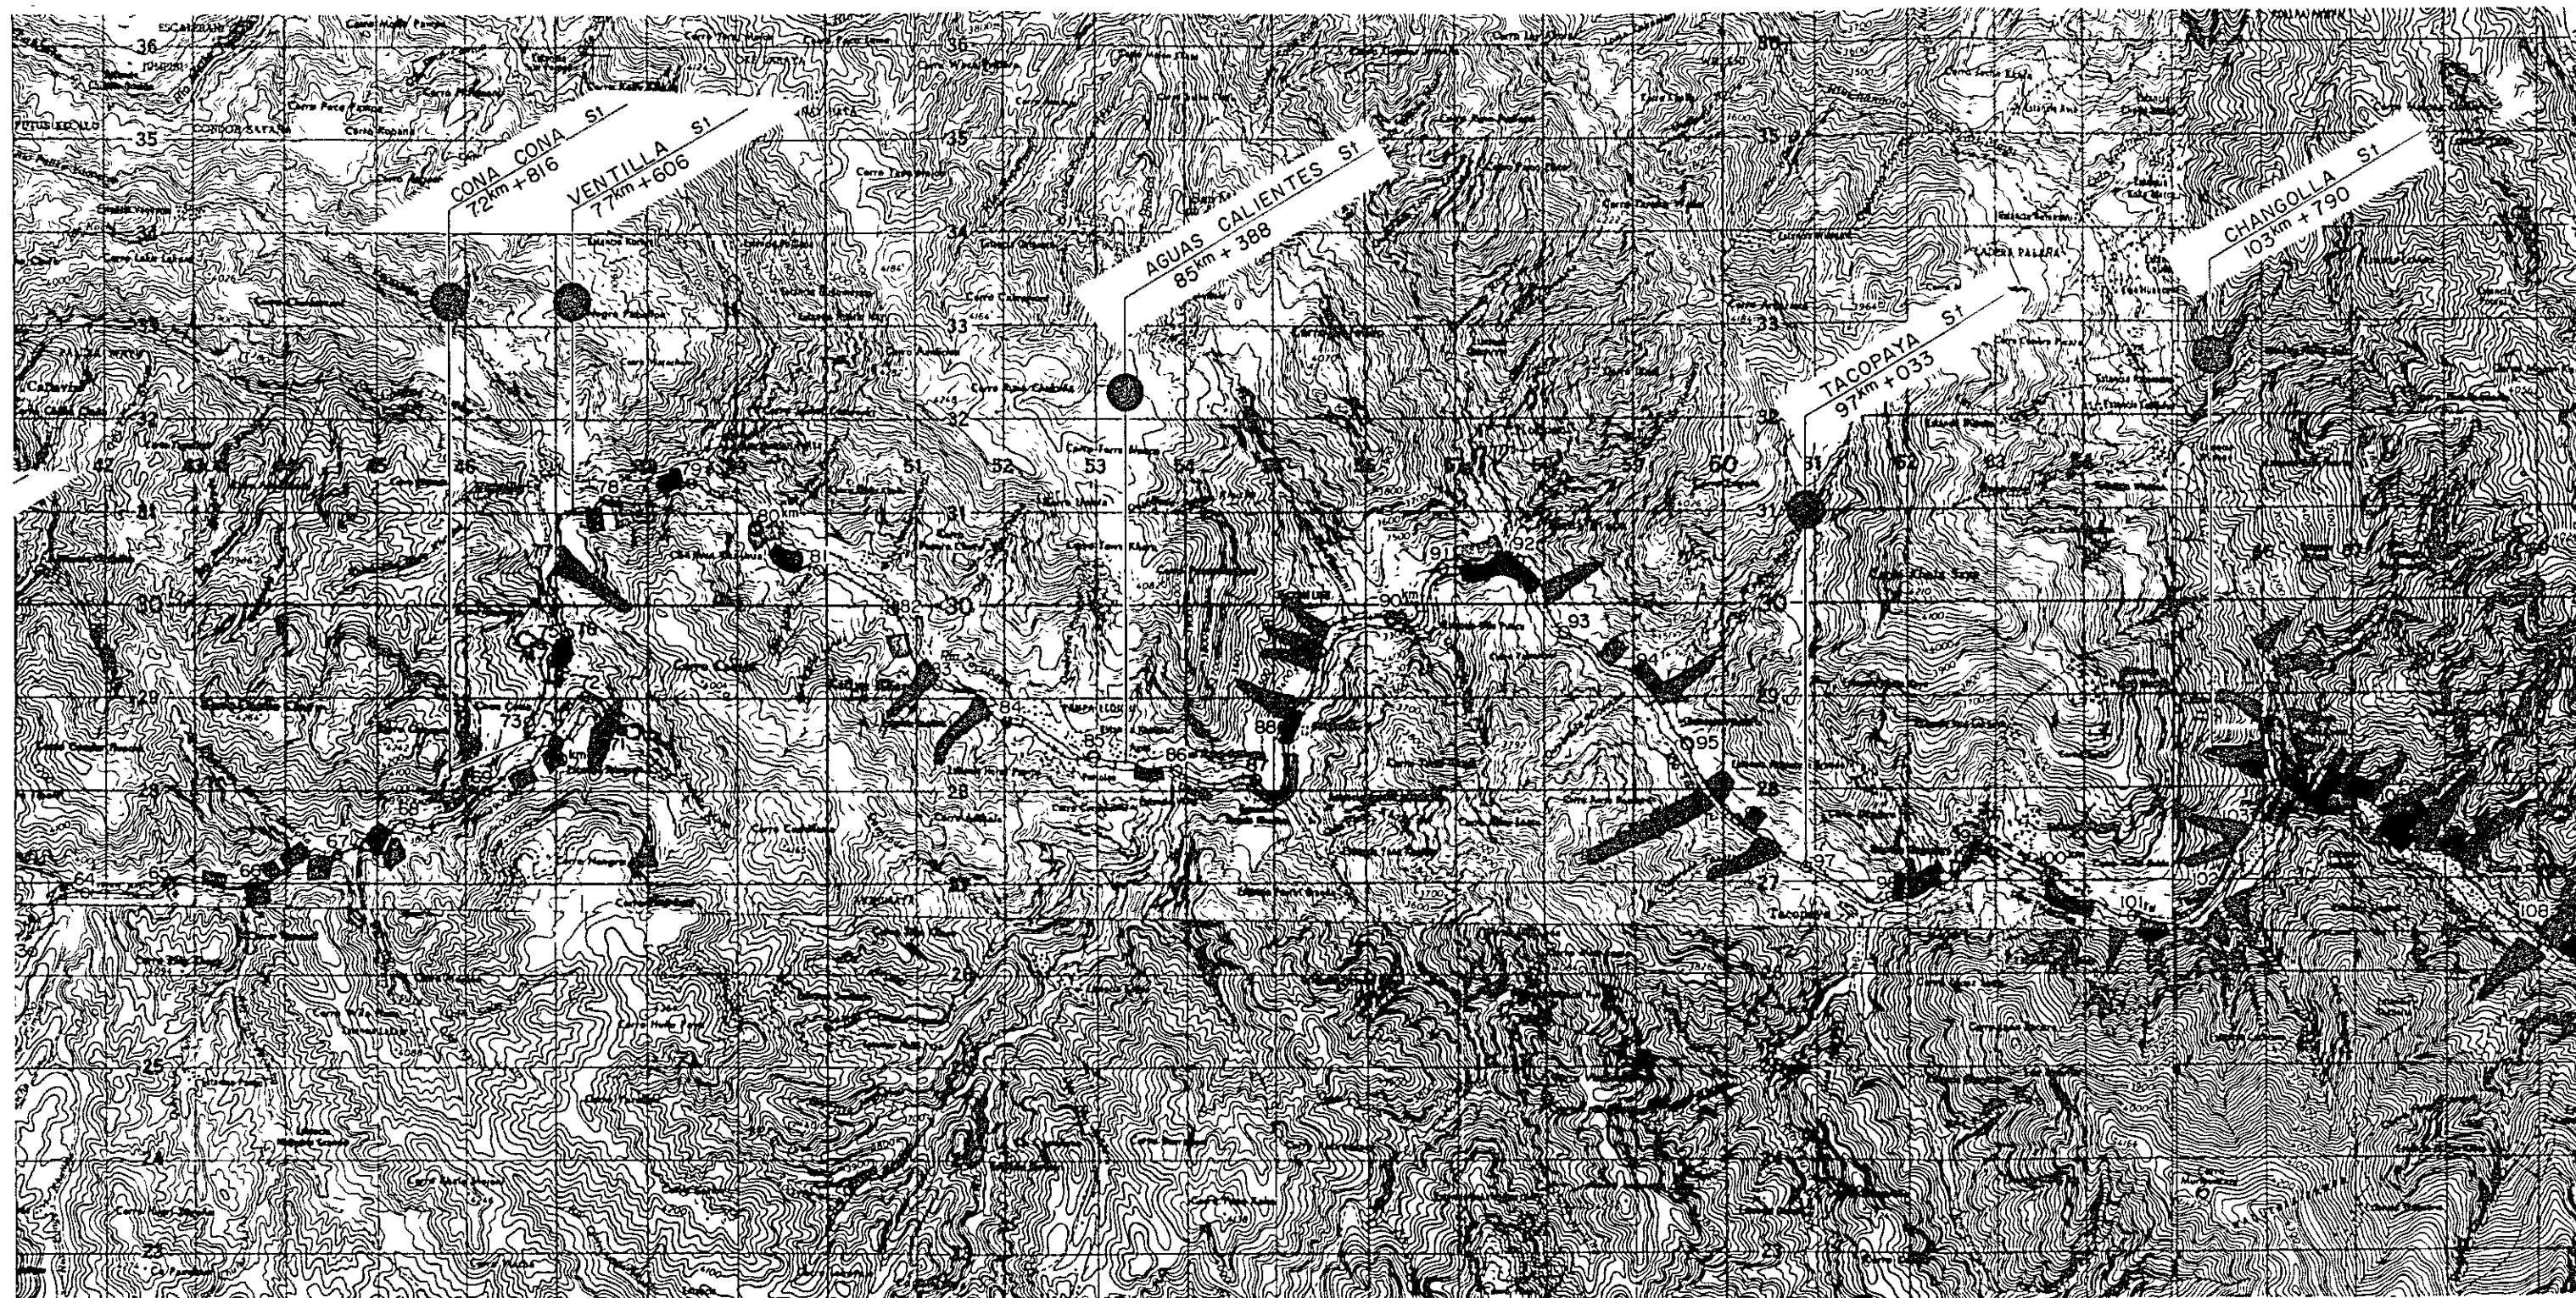
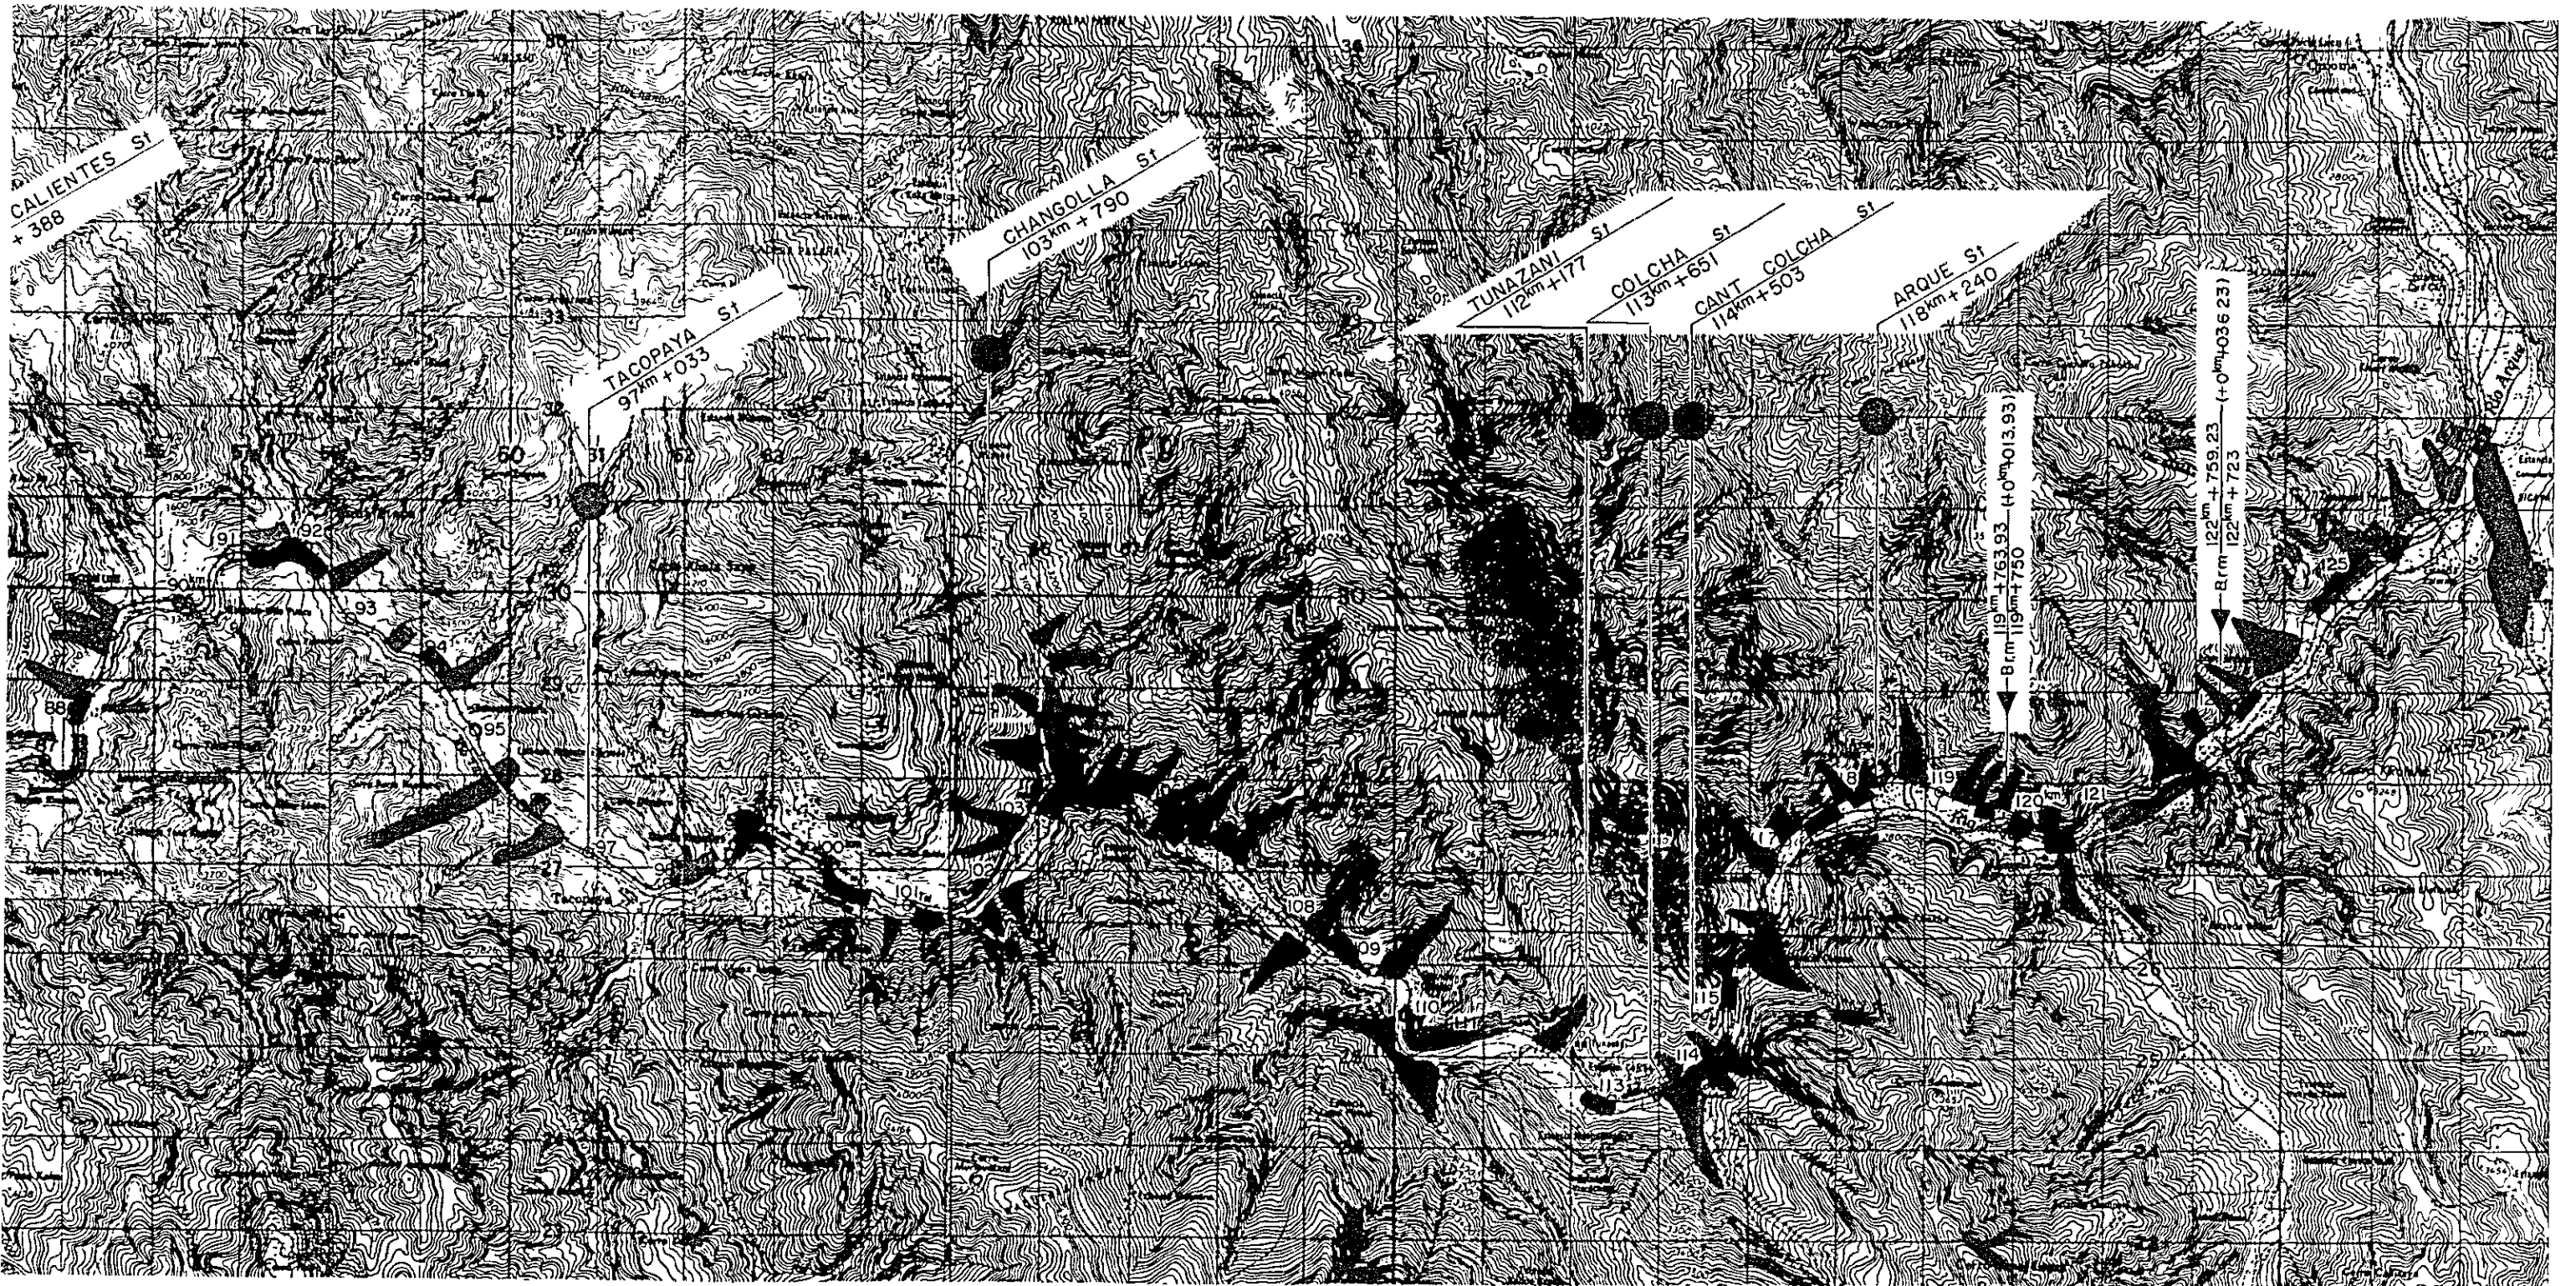
Fig. 2.2.5 Damaged Condition Map (1)

Incidentally, Table 2.4.1 includes a list of dangerous points as discovered by the latest survey. Fig. 2.4.1 shows a record of disastrous damages experienced during the 1972 - 1979 period.

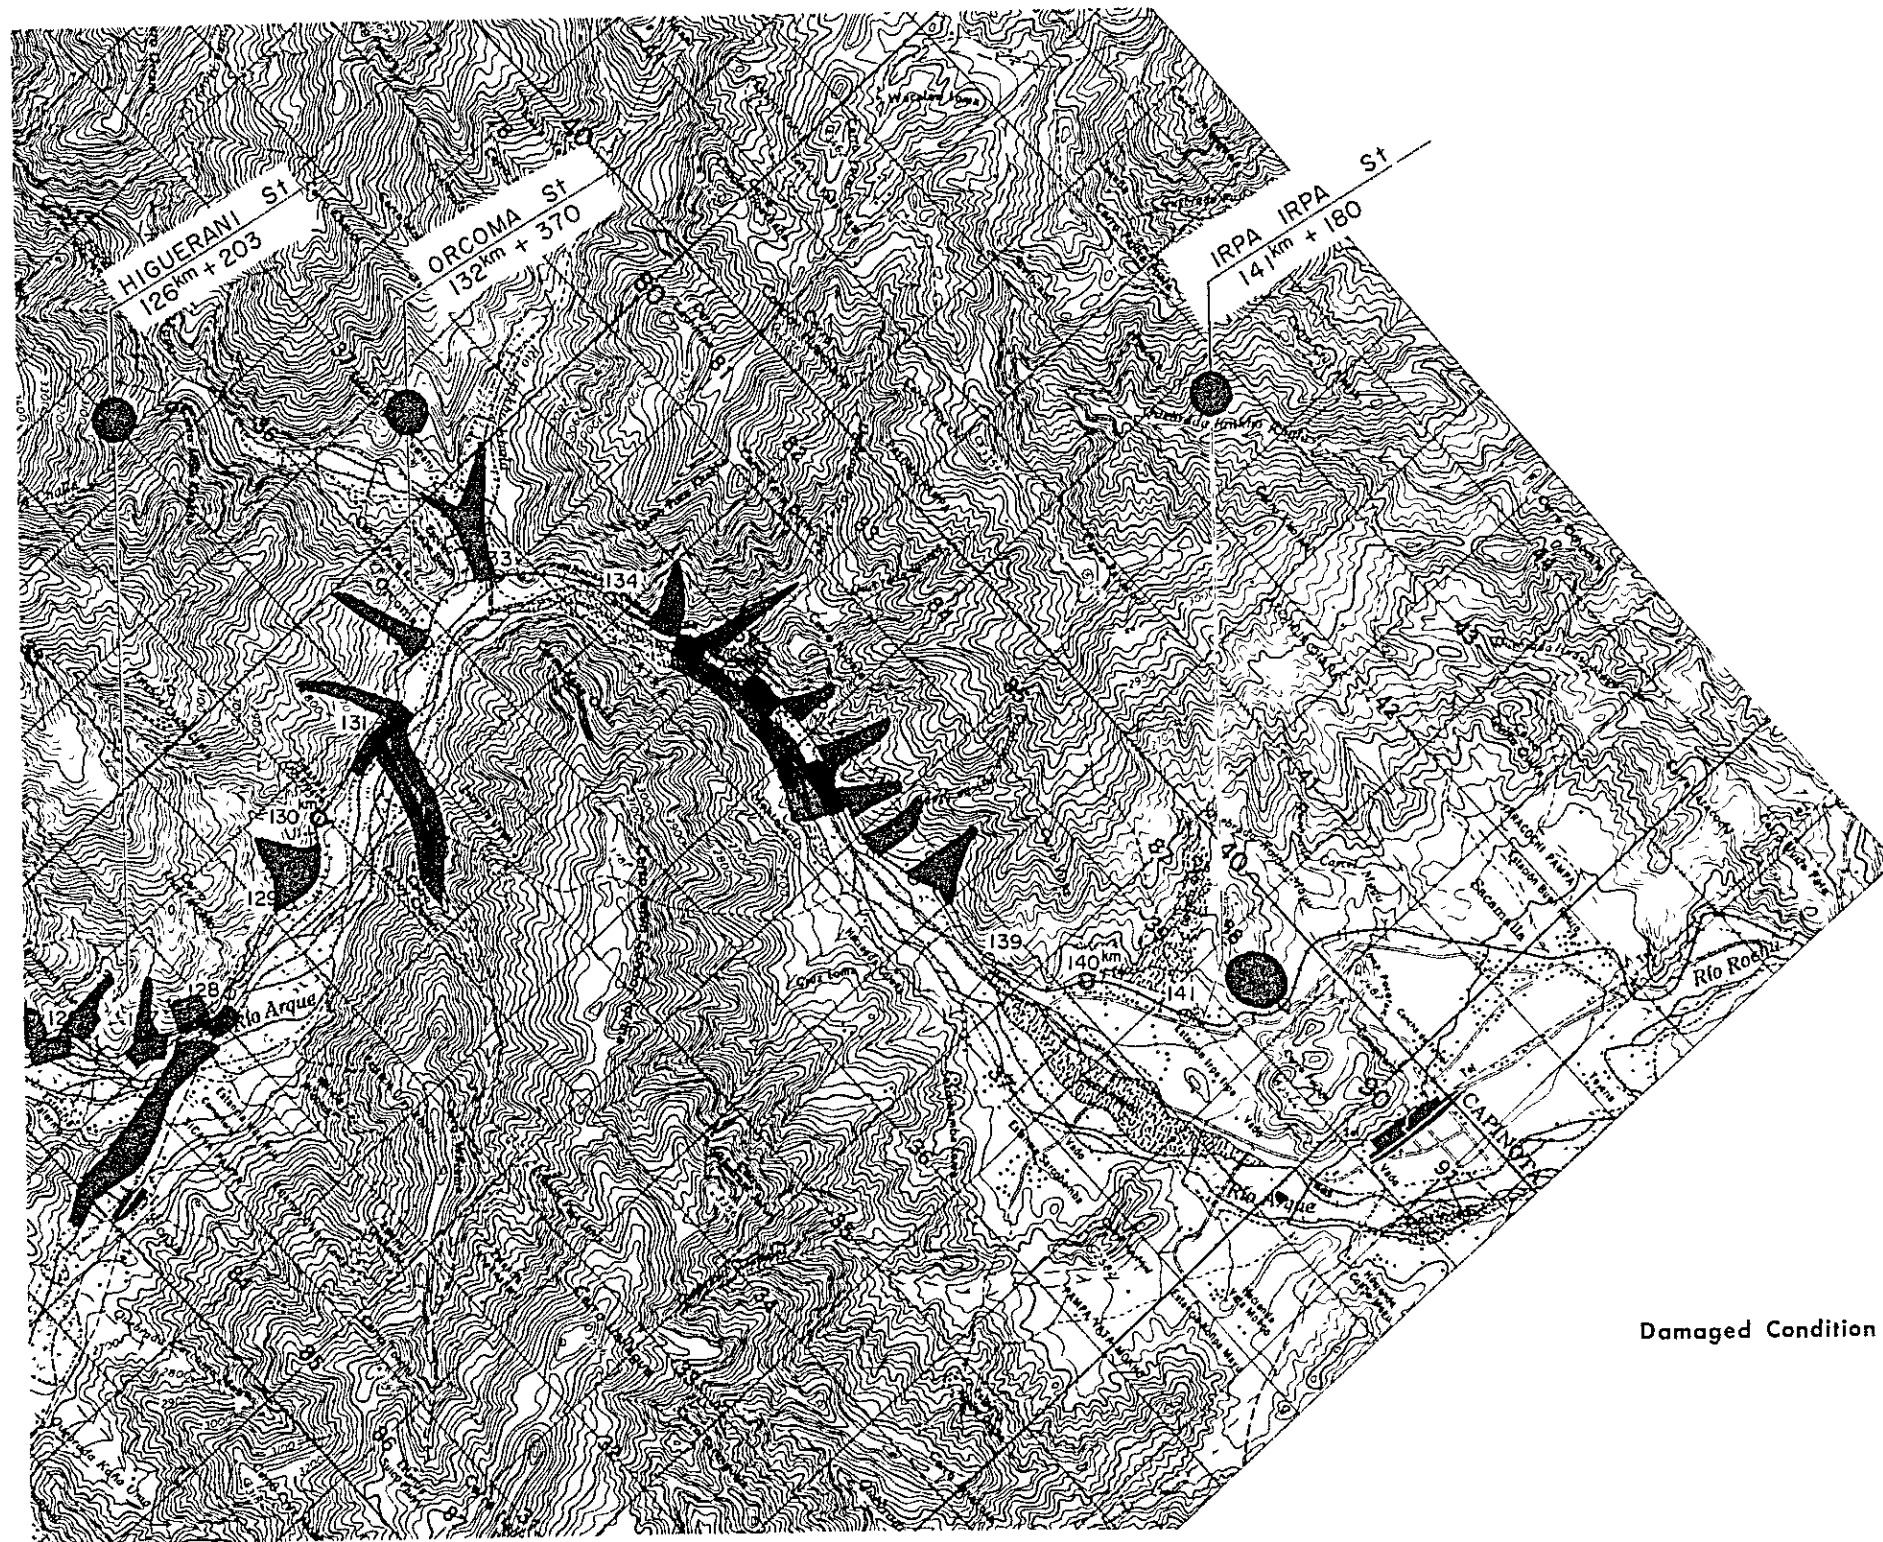
Damaged Condition Map (2)

Erosion of Revetment

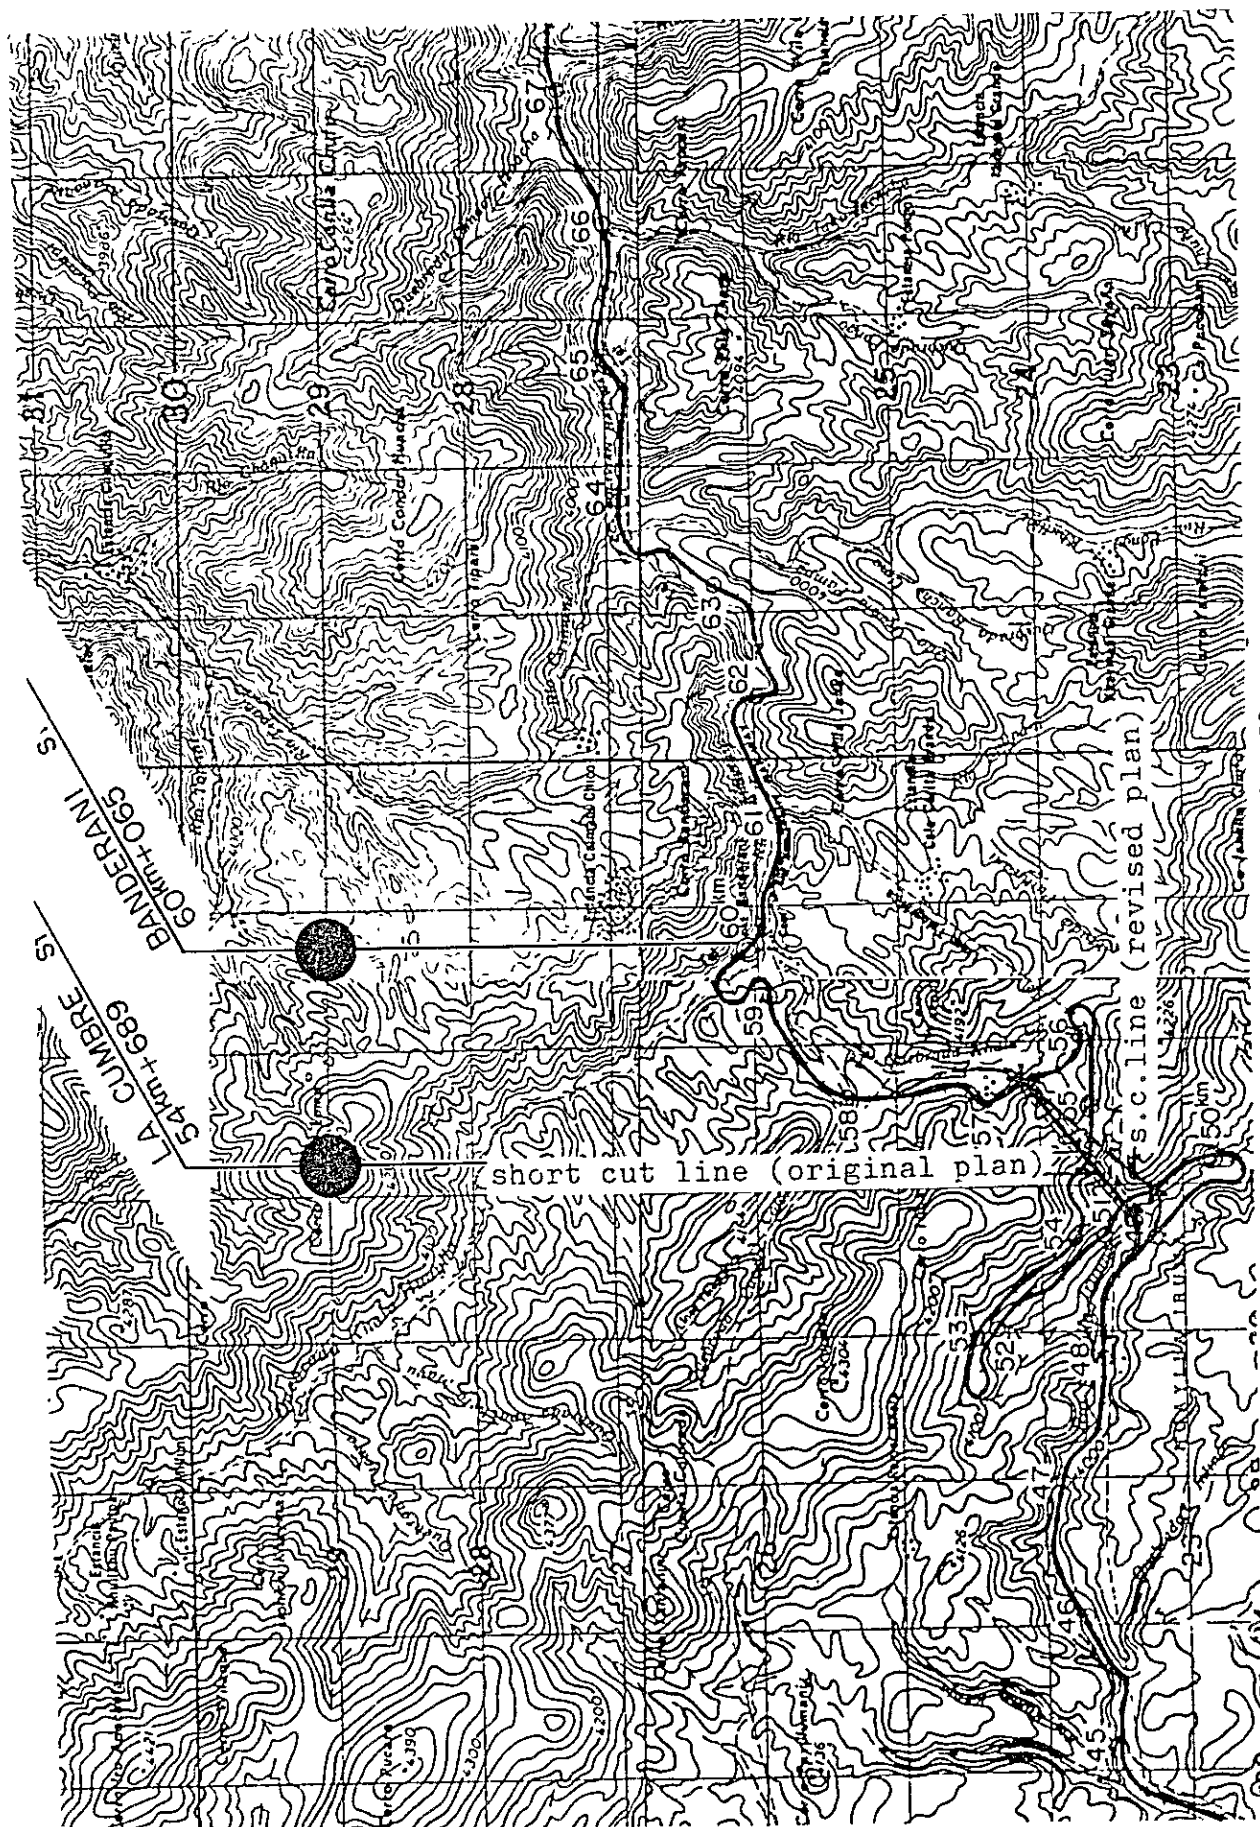
Fig. 3.3.2 Tunnel Construction Plan

Although such sediments may not originate so much ground water, the geological condition for that section does not seem to be favorable for the sake of maintenance even after completion of the tunnel. For this reason, in order to avoid such inconvenience to a possible extent, it is considered better to move the ENFE's originally planned route slightly to the south as shown in Fig. 3.3.2.

Prior to start of the construction work, all unconfirmed conditions of unconsolidated sediments and rocks must be checked by boring test.
