**REPORT OF THE ADVISORY TEAM
ON
THE GUIDLINE FOR Mt. SEMERU PROJECT**

JAPAN INTERNATIONAL COOPERATION AGENCY

E	X	F
J		R
81 - 23

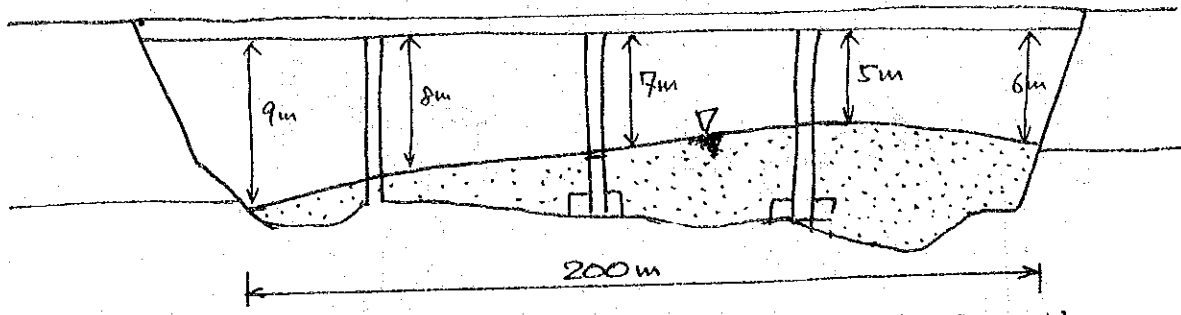
Fig.-11 Flood mark of the mudflow remained on the surface of the piers of K.Mujur Bridge

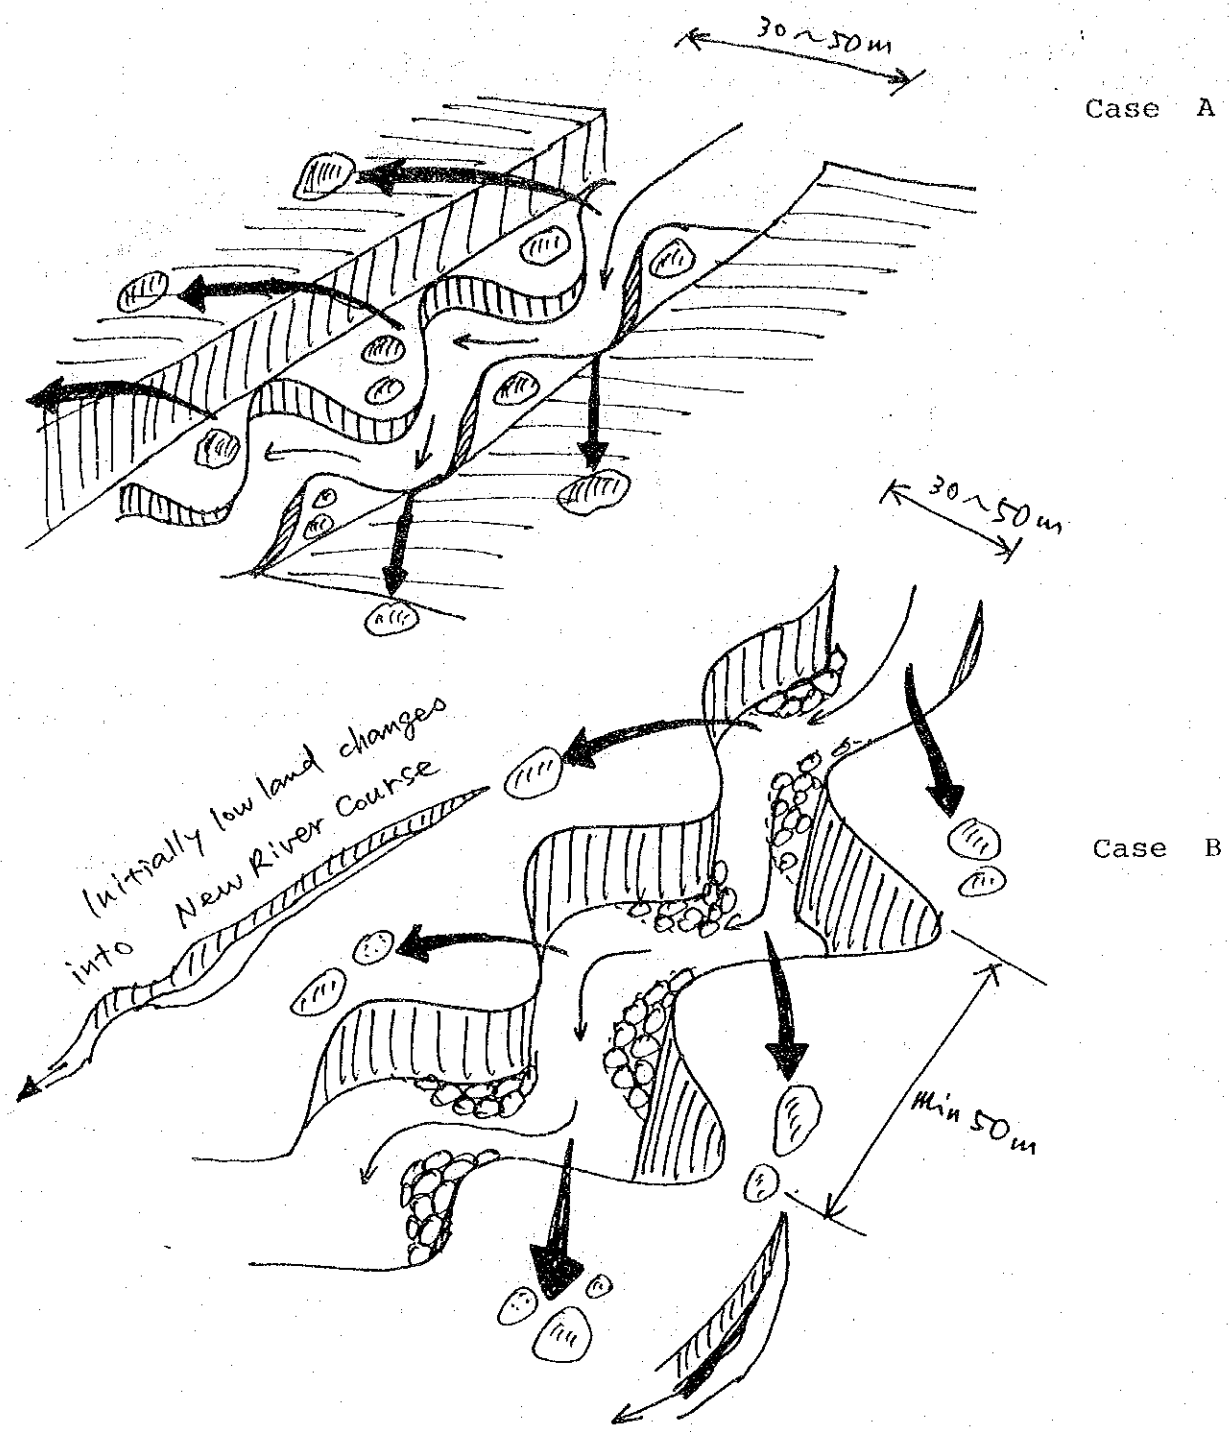
Fig.- 13 Sketch of the Sharp Bends

Riverbed gradient is approximately $1/15$ -- $1/20$
 If the gradient of the land surface is minus, overtopped material spreaded tremendously wide and sometimes made new river course.

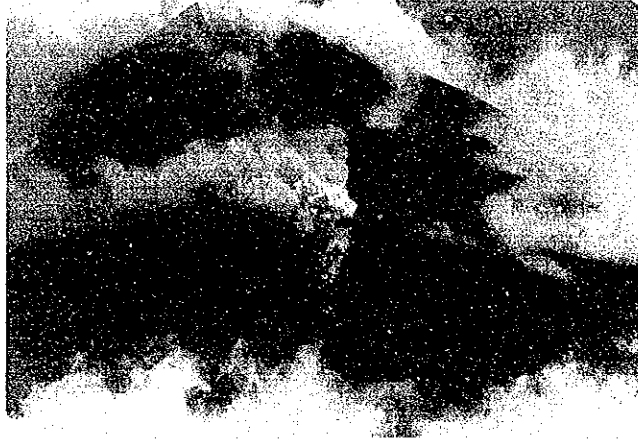
Photo-1 Lava Avalance
Occurs every thirty minutes, this is the biggest material source at this moment

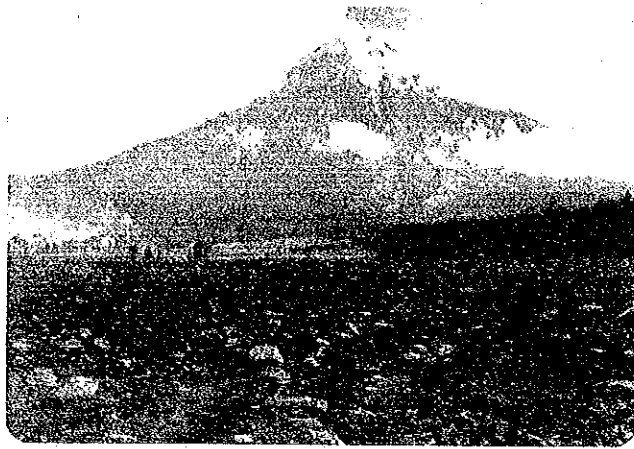
Photo-4 Lower reach of K.Besuk Kember
Two third of Desa Oro Oro Ombo that had been situated here was disappeared. Along the path of N.A., trees are burnt. White cloud shows the steam eruption due to remaining heat of N.A. deposit.

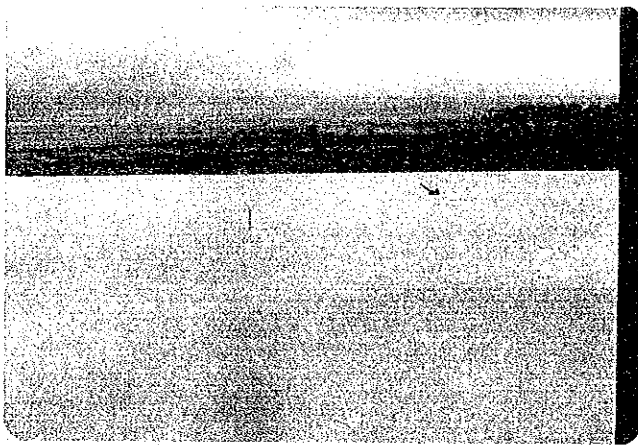
Photo-5 K.Lenkong area
Inside of so-called old crater is inundated due to the deposit that dams up the flow of K.Lenkong.

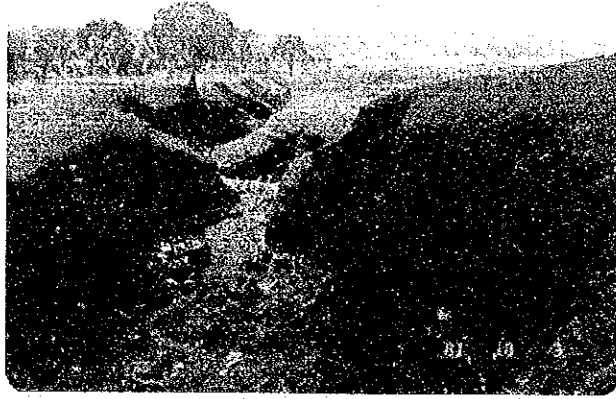
Photo-10 Water Source Area of K.Tunggeng
Rapid flow eroded the riverbed considerably.
The balance of the material deeply depends on
the eroded depth. Old N.A. deposit looks quite
tough and it makes the river course sharp
bending.

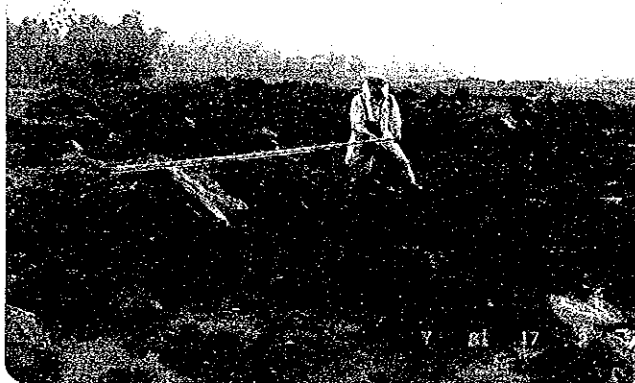
Photo-12 Middle reach of K.Besuk Sat
Almost of all big boulders are left in the middle
reach in which riverbed gradient is gentle and
river width is big.

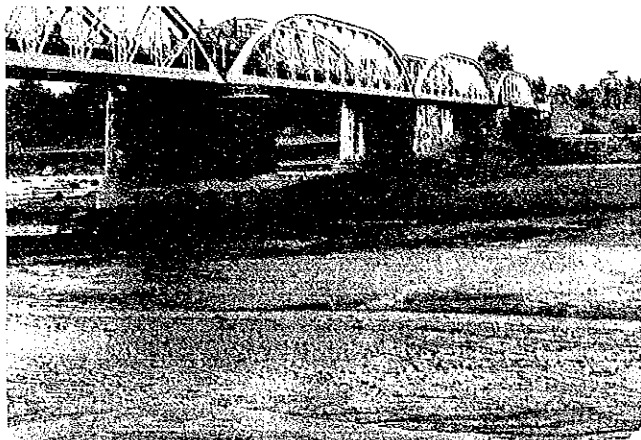
Photo-14 Flood marks remained on the piers show the big difference of the flood level because of the bending of the river course and high flow velocity.

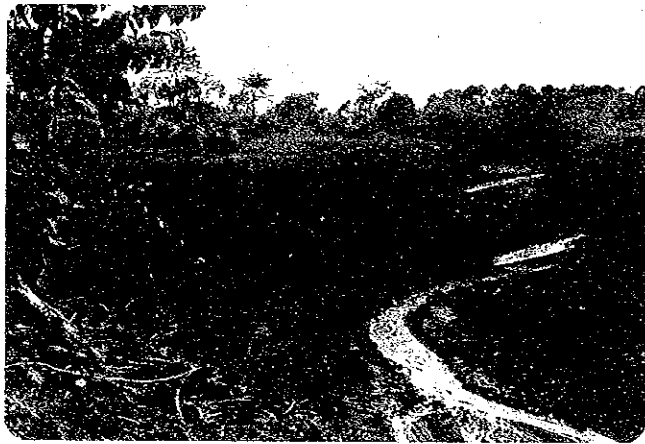
Photo-17 Situation of K.Besuk Sat Lama
Sharp bend of the river course causes overtopping.

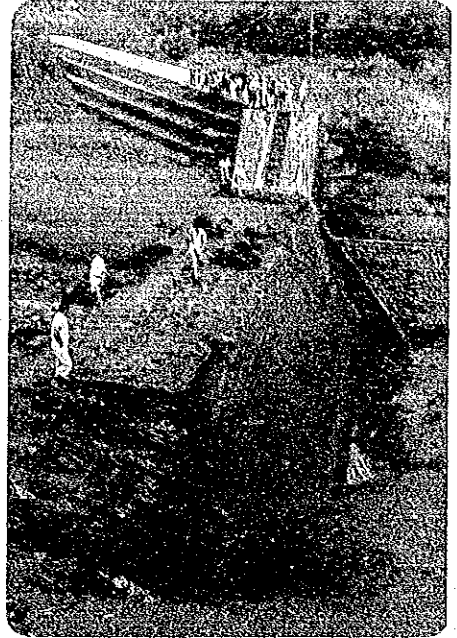
Photo-22 Crest of the Dam
The crest of the right side was about to be broken due to attack by boulders and scouring. This part must be rehabilitated and enforced.

1. Repair and enforcement.
 1. Besuk Sat No. 1 Sabo Dam
 2. Besuk Kobokan Sabo Dam
 3. Besuk Sat No. 4 Consolidation Dam apron and abutment must be enforced and carefully maintained

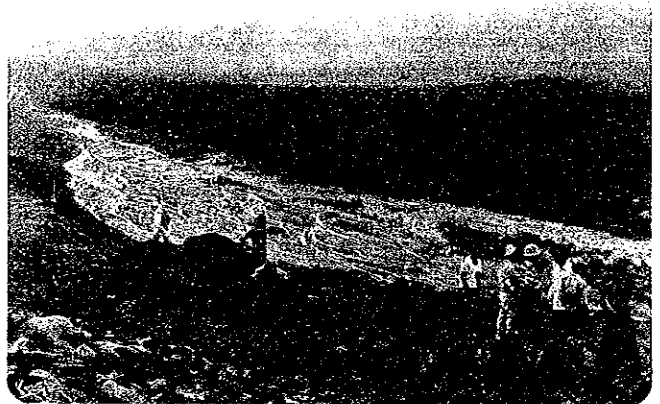
Photo-24
Besuk Sat Lama
Overtopping occurred because of small passing capacity due to narrow width of the channel. Revetment work was completed in order to prevent a flood to Lumajang. But flooded. This part must be widen urgently.

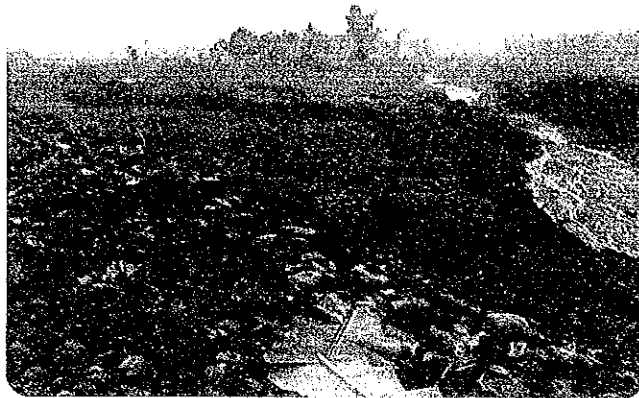
Photo-25 Breaking point just the spot of the revetment works.
Dikes made of cobbles was completely broken.

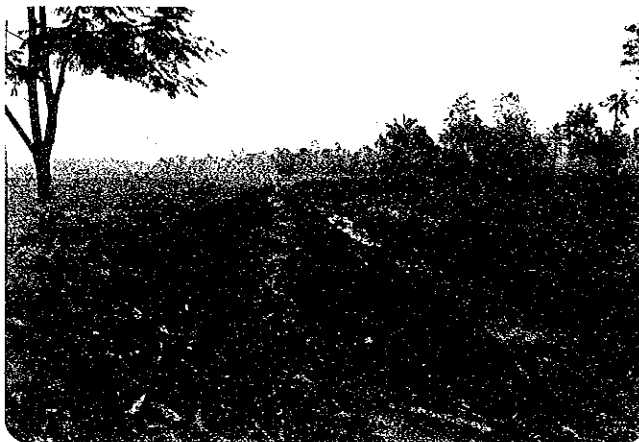
Photo-26 Breaking point of K.Besuk Sat left bank near
Desa Kertosari.

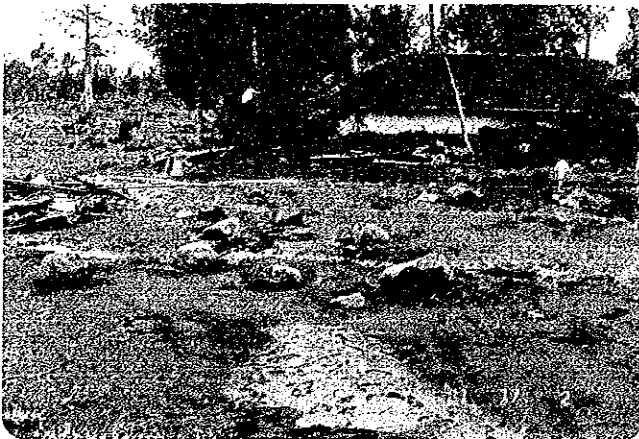
Photo-27 Damage situation at Desa Kertosari

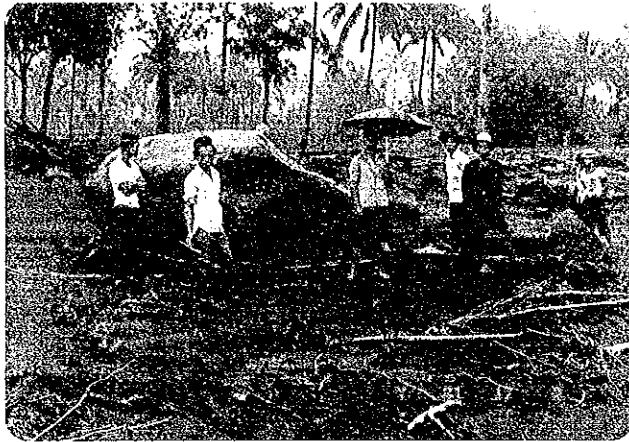
Photo-28 Big boulder carried by lavar
Desa Kertosari. Weight is supported to be 20t.

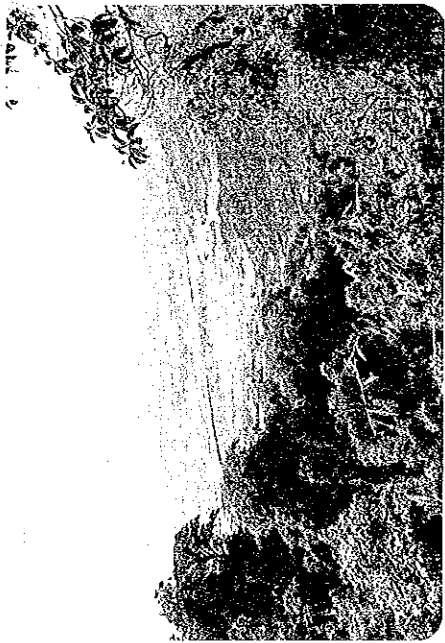
Photo-31 K. Repla flooded Second Fan
Fan formation processes are actively going.
Villages and paddy field are situated just on the
riverbed and seriously damaged.

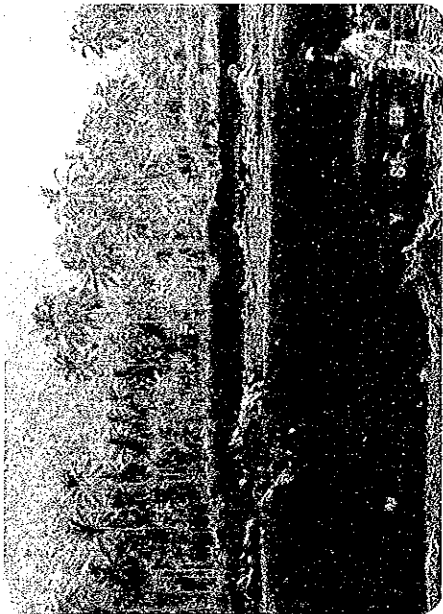
Photo-33 Alluvial Fan of K. Rejaili---Fan Head area
Situation of dissection
Judging from the position of
the boulders debris flow with
typical front rushed down
several times.

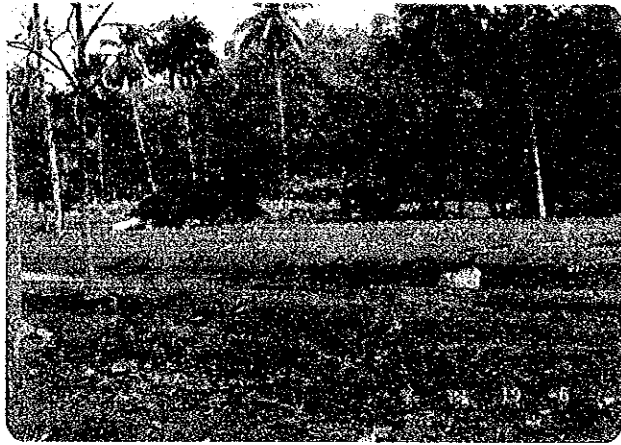
Photo-38 Disasters on the fan of K.Rejali (secondary fan)
fan head-mid fan fan head
