REPORT OF THE JAPANESE SURVEY MISSION
ON
THE GRAVING DOCK CONSTRUCTION PROJECT
IN SURABAJA, INDONESIA

December 1970

OVERSEAS TECHNICAL COOPERATION AGENCY
GOVERNMENT OF JAPAN

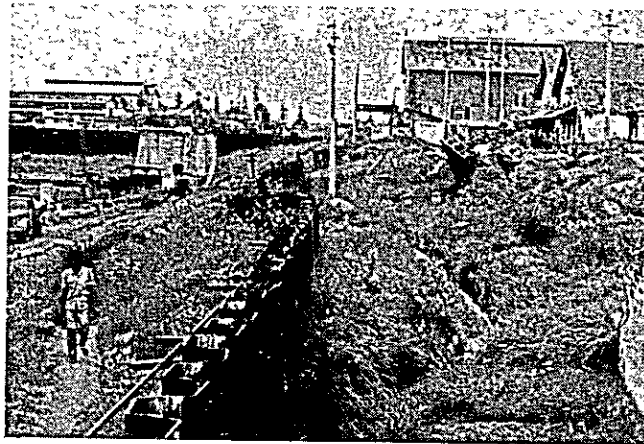
SCENE OF A SLOPE FAILURE ACCIDENT
AT THE STEEL SHEET PILING OF THE
GRAVING DOCK

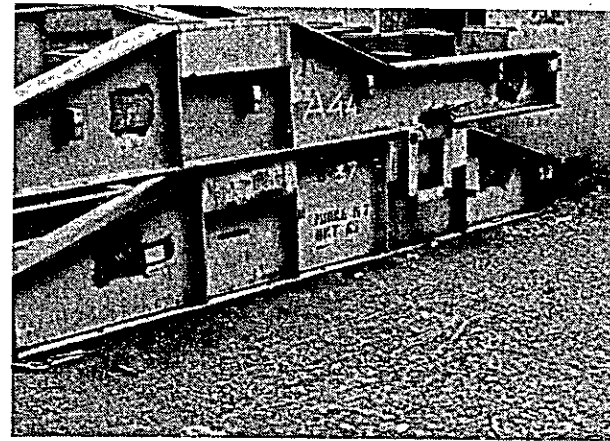
EQUIPMENT ASSEMBLIES LEFT IN THE OPEN

Some machines are stored indoors, and others outdoors according to the types. Except for those packed machines carefully prevented from moisture and rust, machines simply coated with an anticorrosive were found left naked by twos and threes in the open or directly placed on the ground.

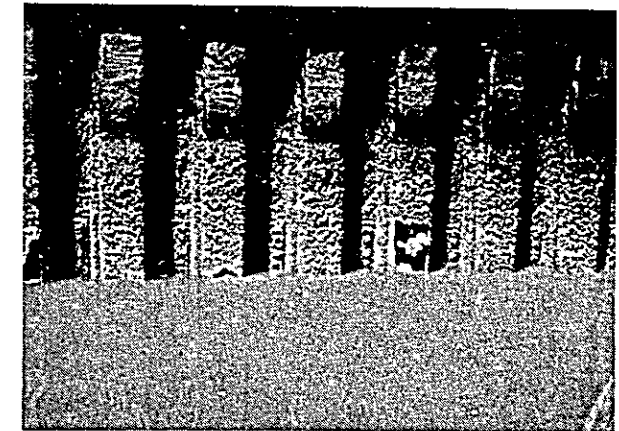
PART OF THE CORRODED STEEL SHEET PILE RIVETMENT

These sections are of a steel sheet piling structure, and the steel sheet piles used are IV type equivalents. Sections B and E are excessively corroded at a height of A. R. P. + 1 M — so much so

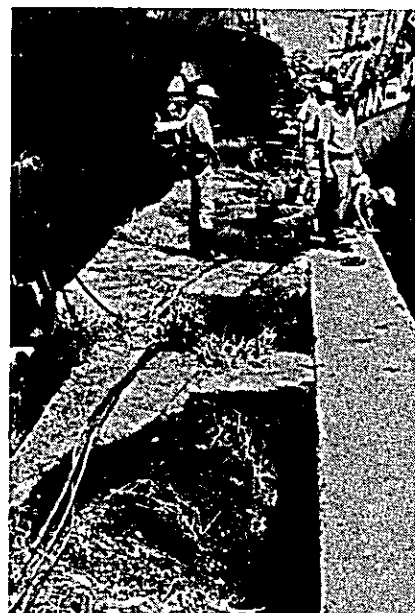
CAVED-IN STEEL SHEET PILE APRON

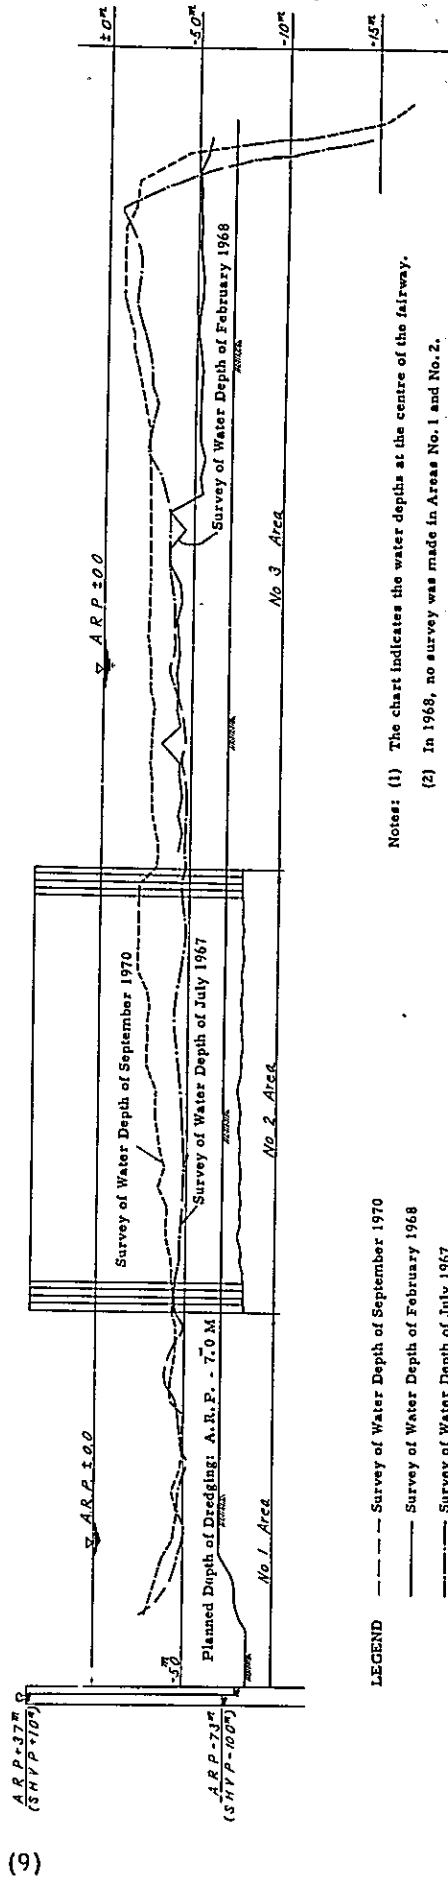
DRAWING-5
ACCUMULATION OF SAND FROM 1967 to 1970.

The approach being a blind channel, earth and sand cannot enter it at any portion of it other than its entrance. The condition of sand accumulation attests to it. A survey, for instance, which was made of the depths at various portions of the approach by the use of a echo-sounder in September 1970 indicated that the approach was -1 to -3 metres deep at the entrance, getting deeper and deeper as the dock got near. In Area No. 2,

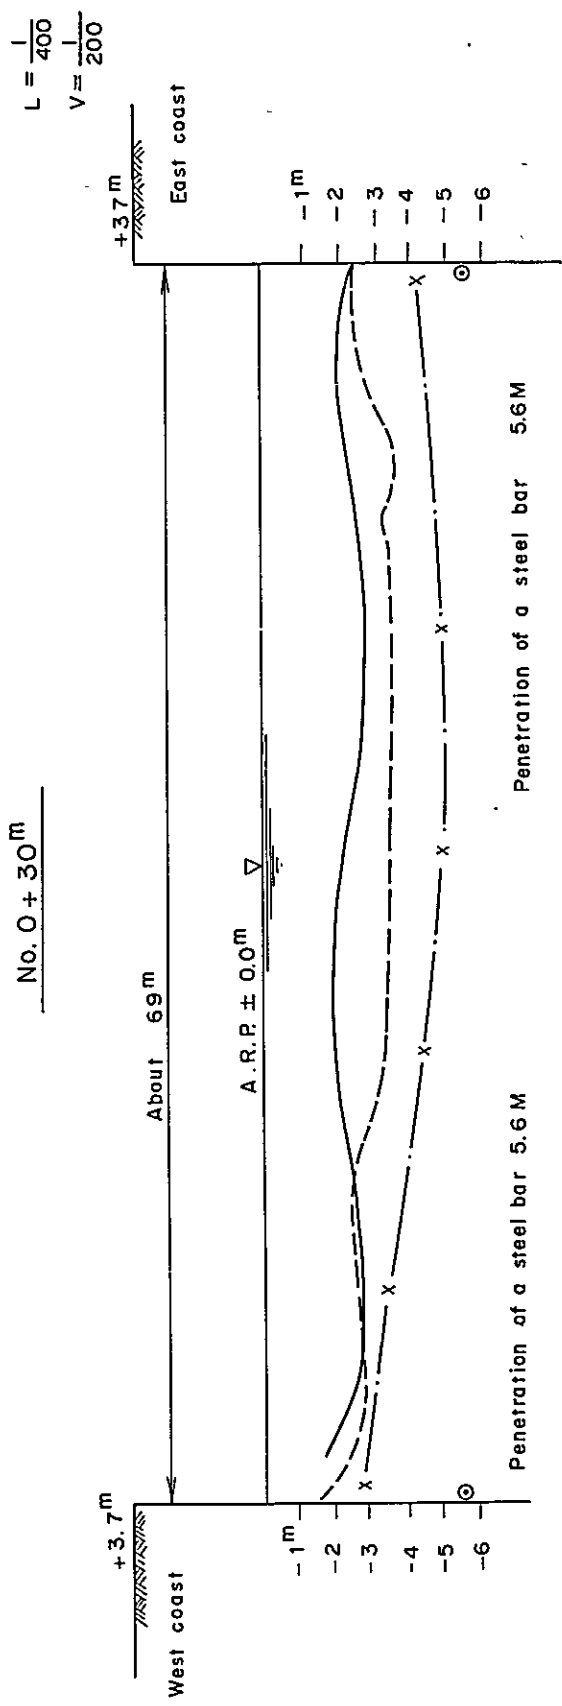
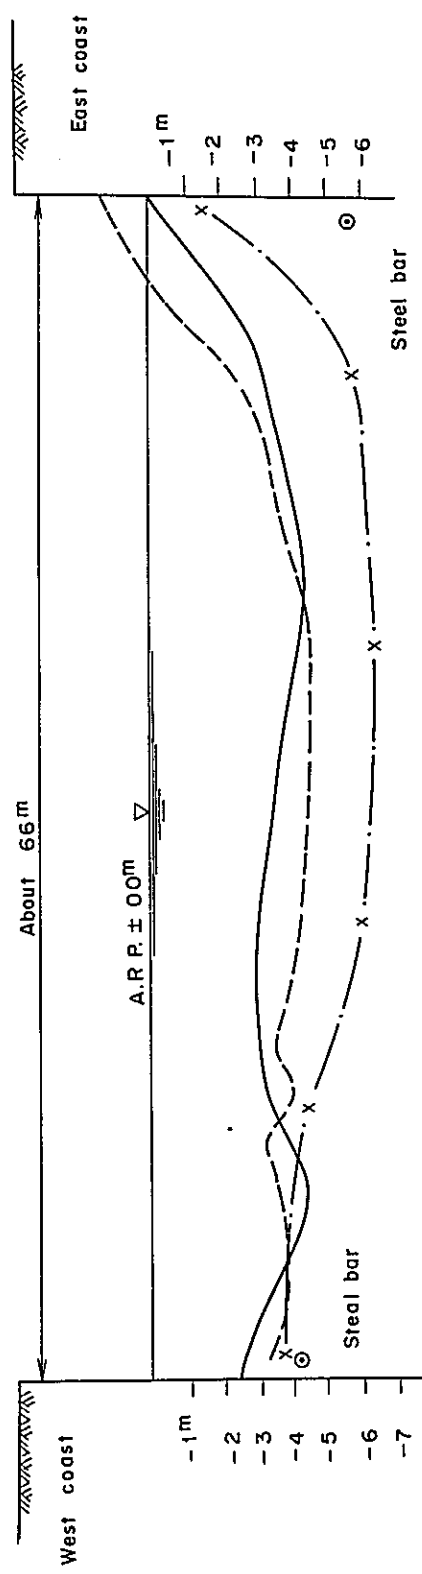
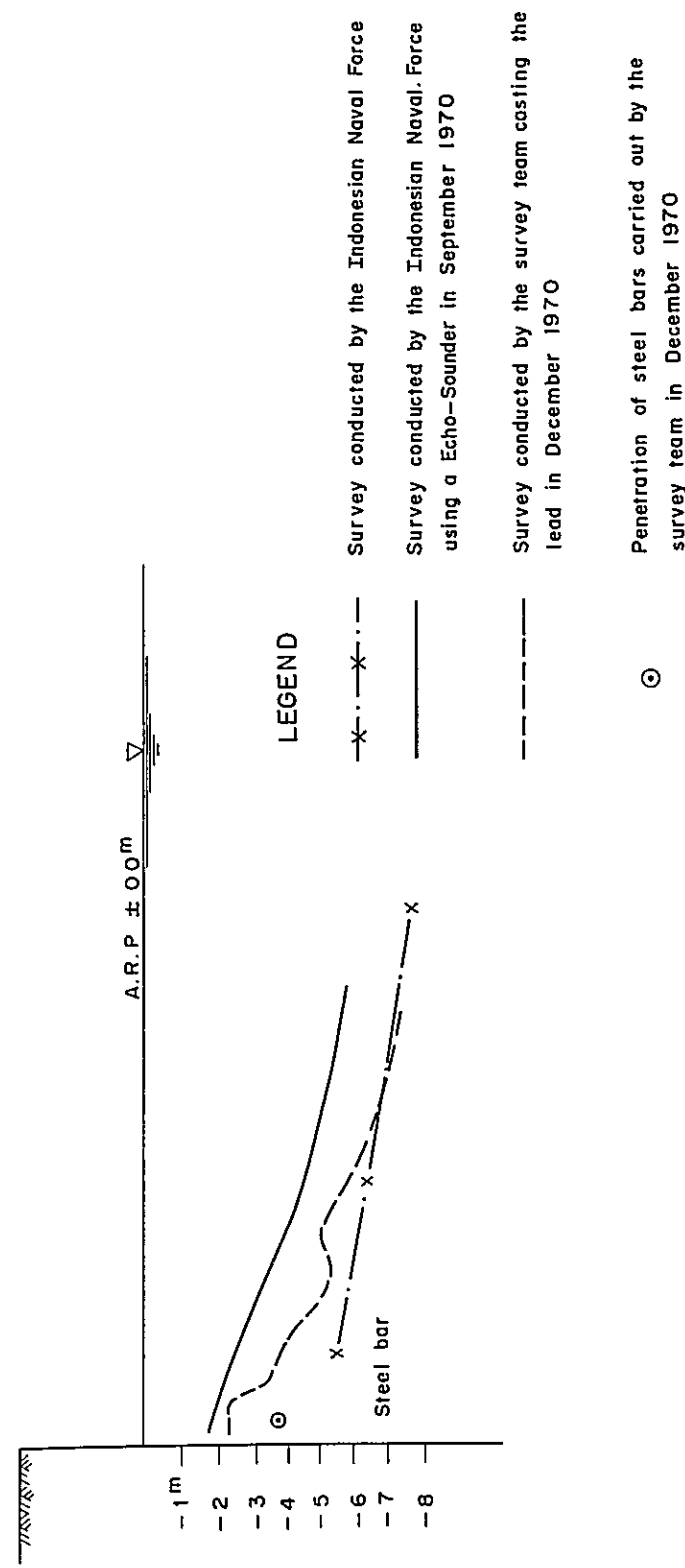
DRAWING - 9
SURVEY OF THE DEPTH OF THE APPROACH
AND PENETRATION OF STEEL BARS

A glance at a sample of earth and sand collected by divers, condition of the earth and sand being dredged and earth sticking to steel bars observed during a survey of the interpenetration of them permitted it to be presumed that the bottom of the approach consists of blackish fine particles like ooze.
