WATER SUPPLY IN ISLAMABAD
LEAKAGE CONTROL

JULY 1971

prepared for
OVERSEAS TECHNICAL COOPERATION AGENCY
GOVERNMENT OF JAPAN

by
JAPAN SURVEY TEAM FOR WATER SUPPLY IN ISLAMABAD

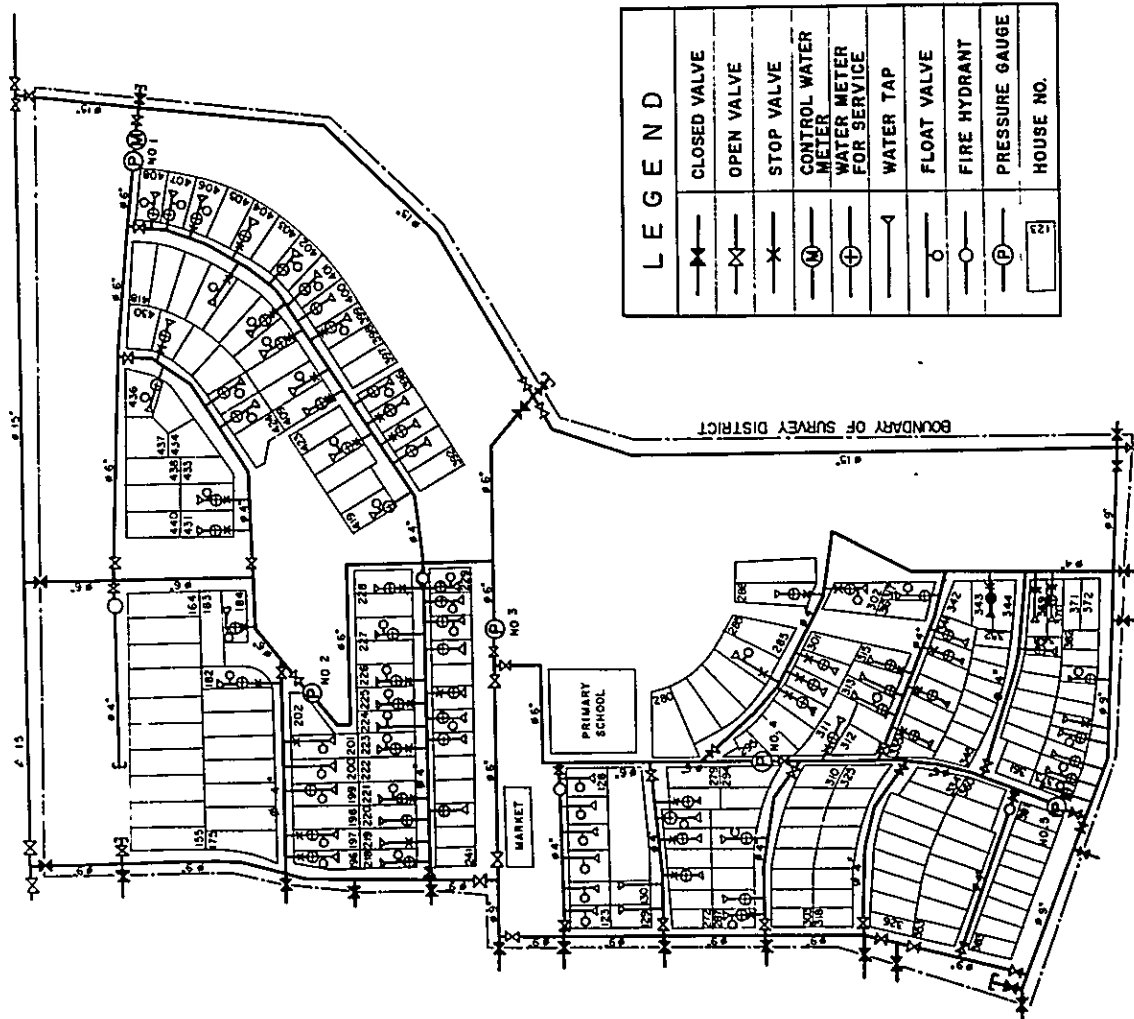
FIG. 1 COMPLETION DRAWING OF
LEAKAGE PROTECTION WORKS

SURVEY DISTRICT	F-6/3
DISTRIBUTION PIPE	
Ø 15"	3,900 FT
Ø 9"	4,800
Ø 6"	7,350
Ø 4"	5,700
VALVE	
Ø 15"	3 NOS
Ø 9"	10
Ø 6"	15
Ø 4"	31
FIRE HYDRANT	4 NOS
SERVICE CONNECTION	94 NOS
LEAKAGE	
LEAKAGE BEFORE PROTECTION WORKS	
LEAKAGE AFTER PROTECTION WORKS	
AMOUNT OF LEAK PREVENTION

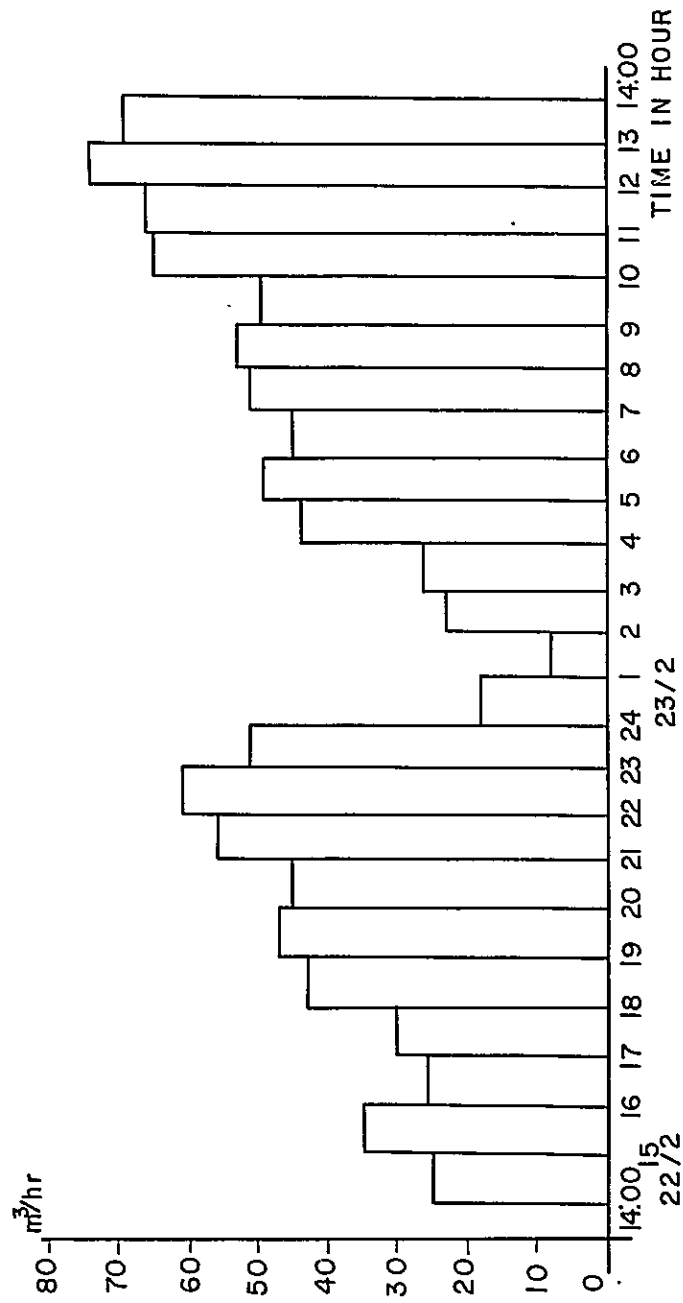
FIG.2 VARIATION OF WATER FLOW AT CONTROL POINT

The first measurement of water supply volume was carried out on February 22 and 23, 1971, while the volume of water lost through leakage could not be measured because some of the valves and stop valves were not functioning properly, it served as demonstration to CDA staff for them to carry out the measurement by themselves in the future. However a survey on the time vs flow volume relation for a period of 24 hours was successfully conducted, and the results of the survey are shown in Fig. 2. While, reveals the actual status of water consumption in this district.

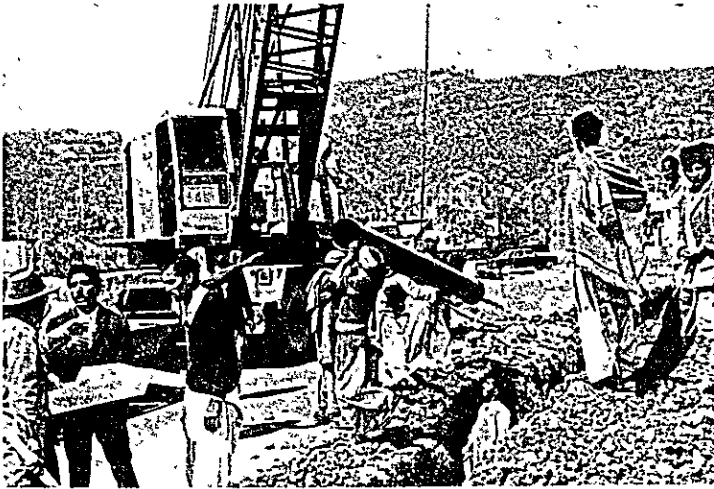
In the course of demonstration of above, it was found that in the case of PRCC pipes, leaking sound was detected nearly always at intervals of 10 feet. Thus, it was decided to replace PRCC pipes with ductile iron pipes, ϕ 12" in diameter, which were donated by the Government of Japan, and was executed accordingly. However, in this district alone, an aggregate of 2,750 feet of PRCC pipes still remain to be replaced. Leaks detected in cast iron pipes were repaired by the use of Devcon A (product by Kimmon Manufactory Co., Ltd.).

$\phi 9''$ distribution pipe
 replacement works in
 Islamabad
 March 1971

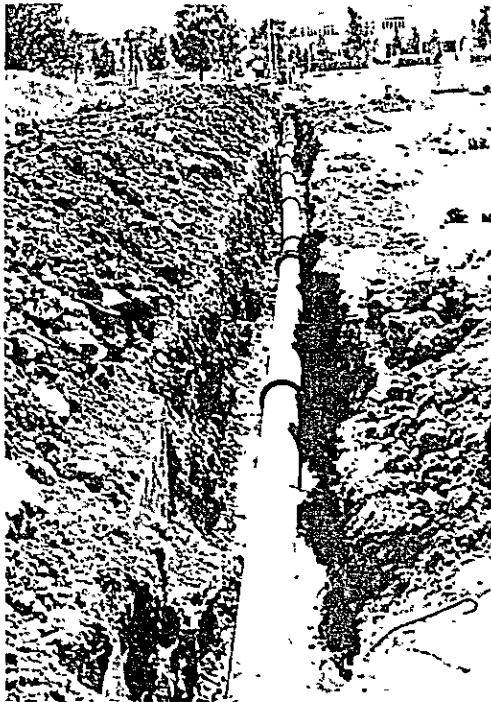
Replaced pipe line,
 $\phi 250$ mm DIP
